OCS Report
MMS 2009-027

**Investigation of Pollution Incident
Area 6B, Block 5165, Platform A
Lease OCS-P 0241
7 December 2008**

Pacific OCS Region
Off the California Coast

U.S. Department of the Interior
Minerals Management Service
Pacific OCS Regional Office

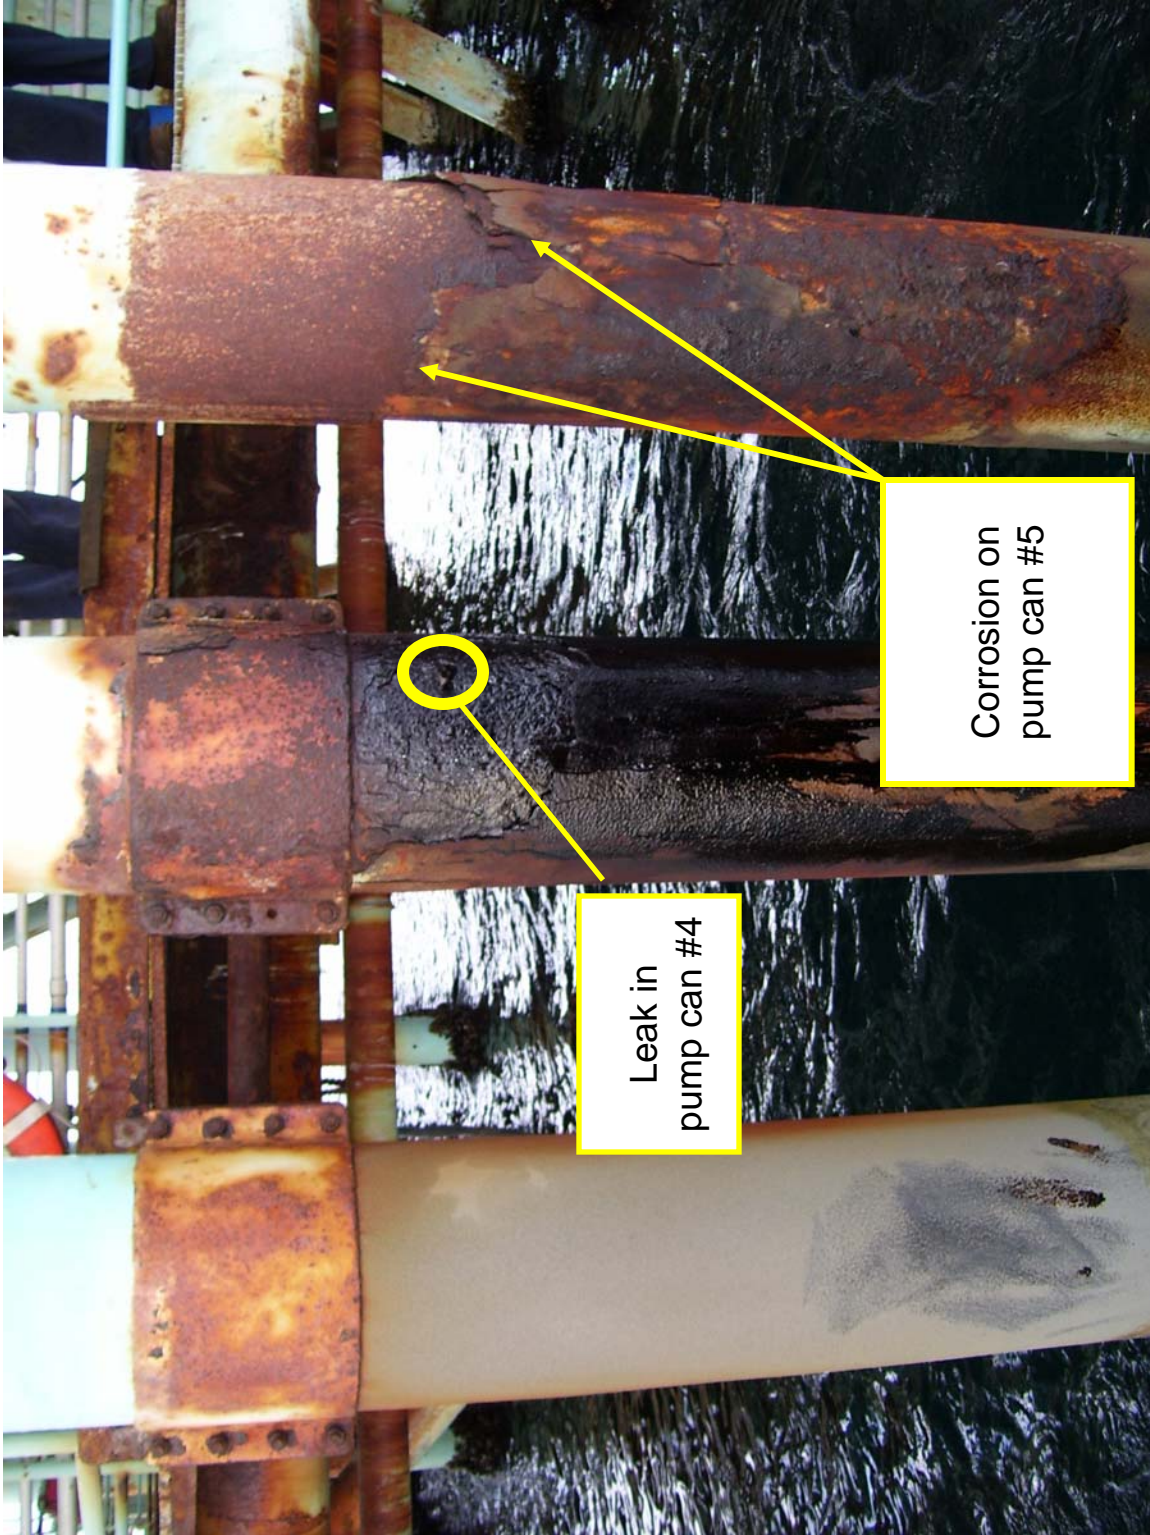
Pollution was discovered at 0701 by a field vessel, and the platform was subsequently shut-in at 0705 hours. MMS was notified at 0710 and arrived on the platform at 0730. The pollution incident was related to a 3/8" – 3/4" hole on the #4 pump can. (*For post-mortem photograph of hole, see Attachment 2.*) From 0800 to 0830, DCOR was working on plugging the hole. By 0830, DCOR had successfully plugged the hole and covered the area with Splash-zone (protective coating).

In January 2002, a corrosion-related leak occurred on pump can #5 on Platform A at the stability bracing clamp at the +14 deck. (*For photograph of corrosion on pump can #5, see Attachment 2.*) The #5 can was placed out of service at this time. The operator at this time (Nuevo Energy) did not implement any preventive measures to ensure integrity of the remaining two pump cans. In November 2004, Plains Exploration and Production Company (PXP) became lease owner/operator of Platform A. The panel is unaware of any precautionary measures that PXP may have had in place during their five-month tenure on the facility.

The hole developed as a result of the failure of the integrity of the pump can. This failure was due to external corrosion in the area of the location of the stability clamp at the +14 level. This corrosion is evident to the water line; however, it appears to be accelerated near the location of the stability clamp. Pictures taken post incident verify this condition. Given this evidence, the failure of the integrity is directly caused by the extreme amount of corrosion on the pump can.

Location of leak in pump can #4 and corrosion on pump-can #5

- Take #4 pump can out of service on Platform A.
- Test and evaluate all existing pump cans still in service in the Pacific OCS Region (pressure test and UT as needed).
- Develop a team to phase out all pump cans and replace with deck pumps in the Pacific OCS Region.
- Assess and evaluate all existing process components below the production deck.

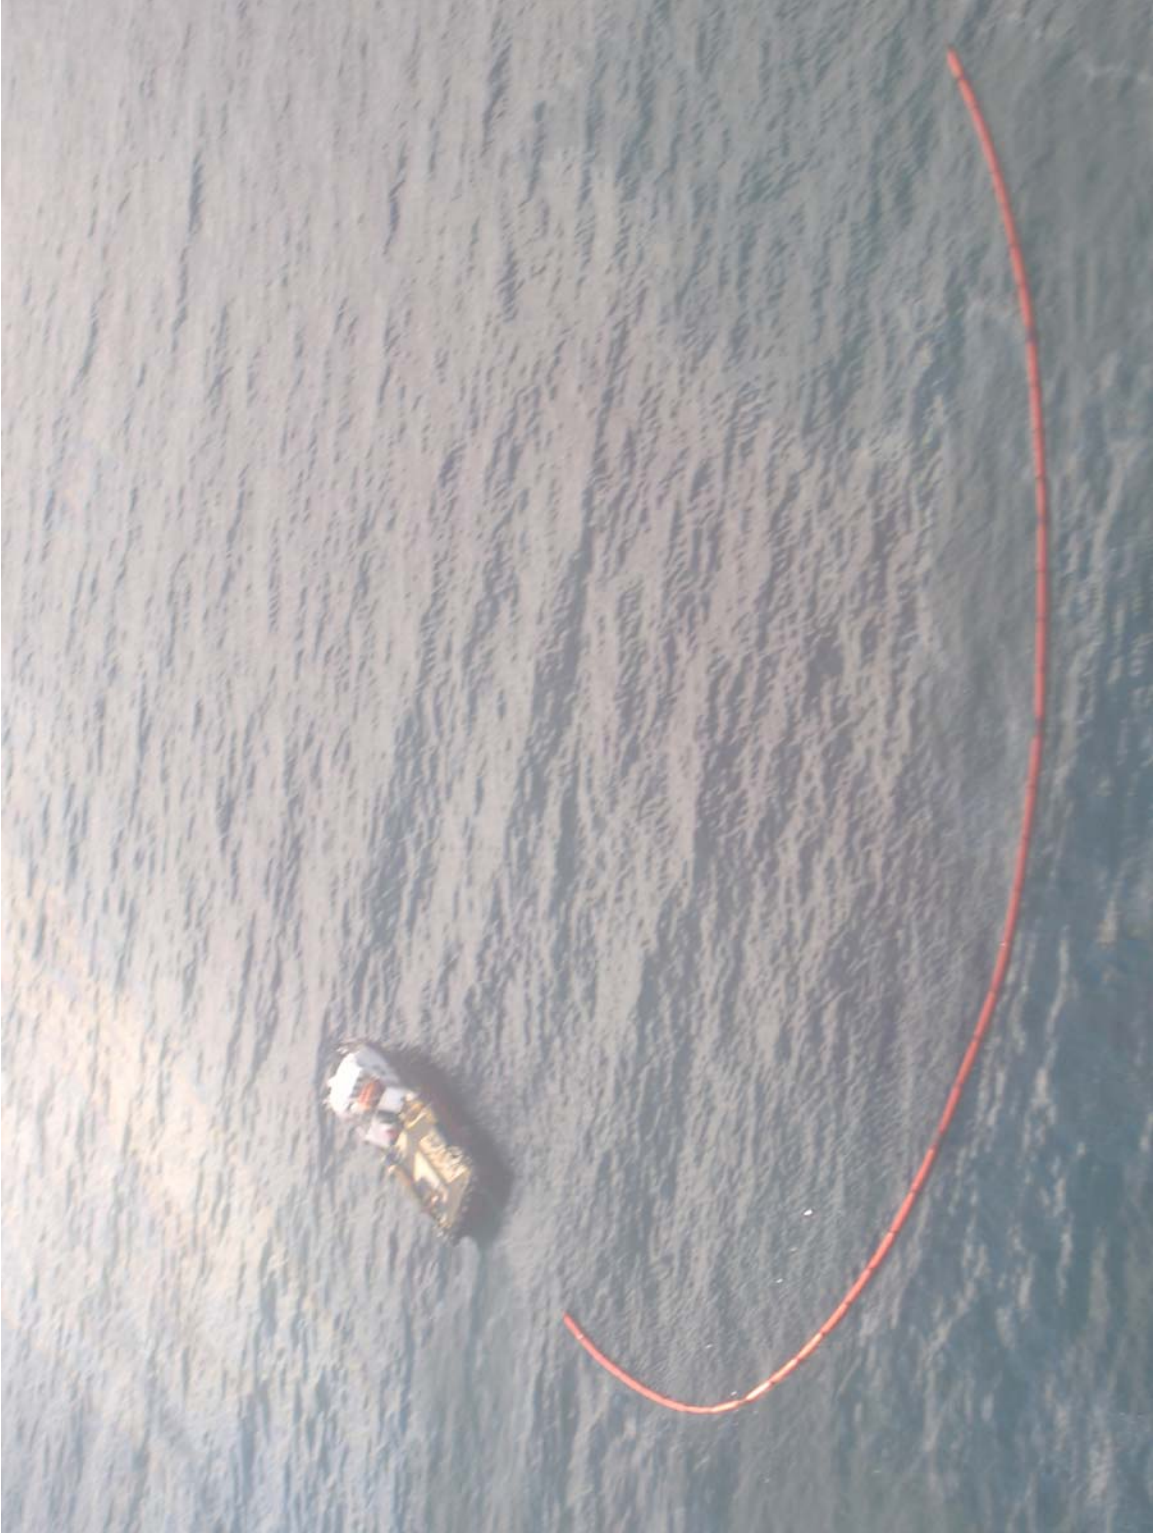
Attachment 3

Eleven vessels responded to the spill. Two vessels had boom capability. First vessel had boom deployed by 1015 hours. The second vessel had its boom deployed by 1200 hours. Spill response vessels remained on location conducting skimming operations through December 9, 2008. DCOR reported that 19.16 barrels were recovered during the skimming operations. (*For photograph of vessel response, see Attachment 3.*)

Vessel response to 12/7/2008 pollution incident

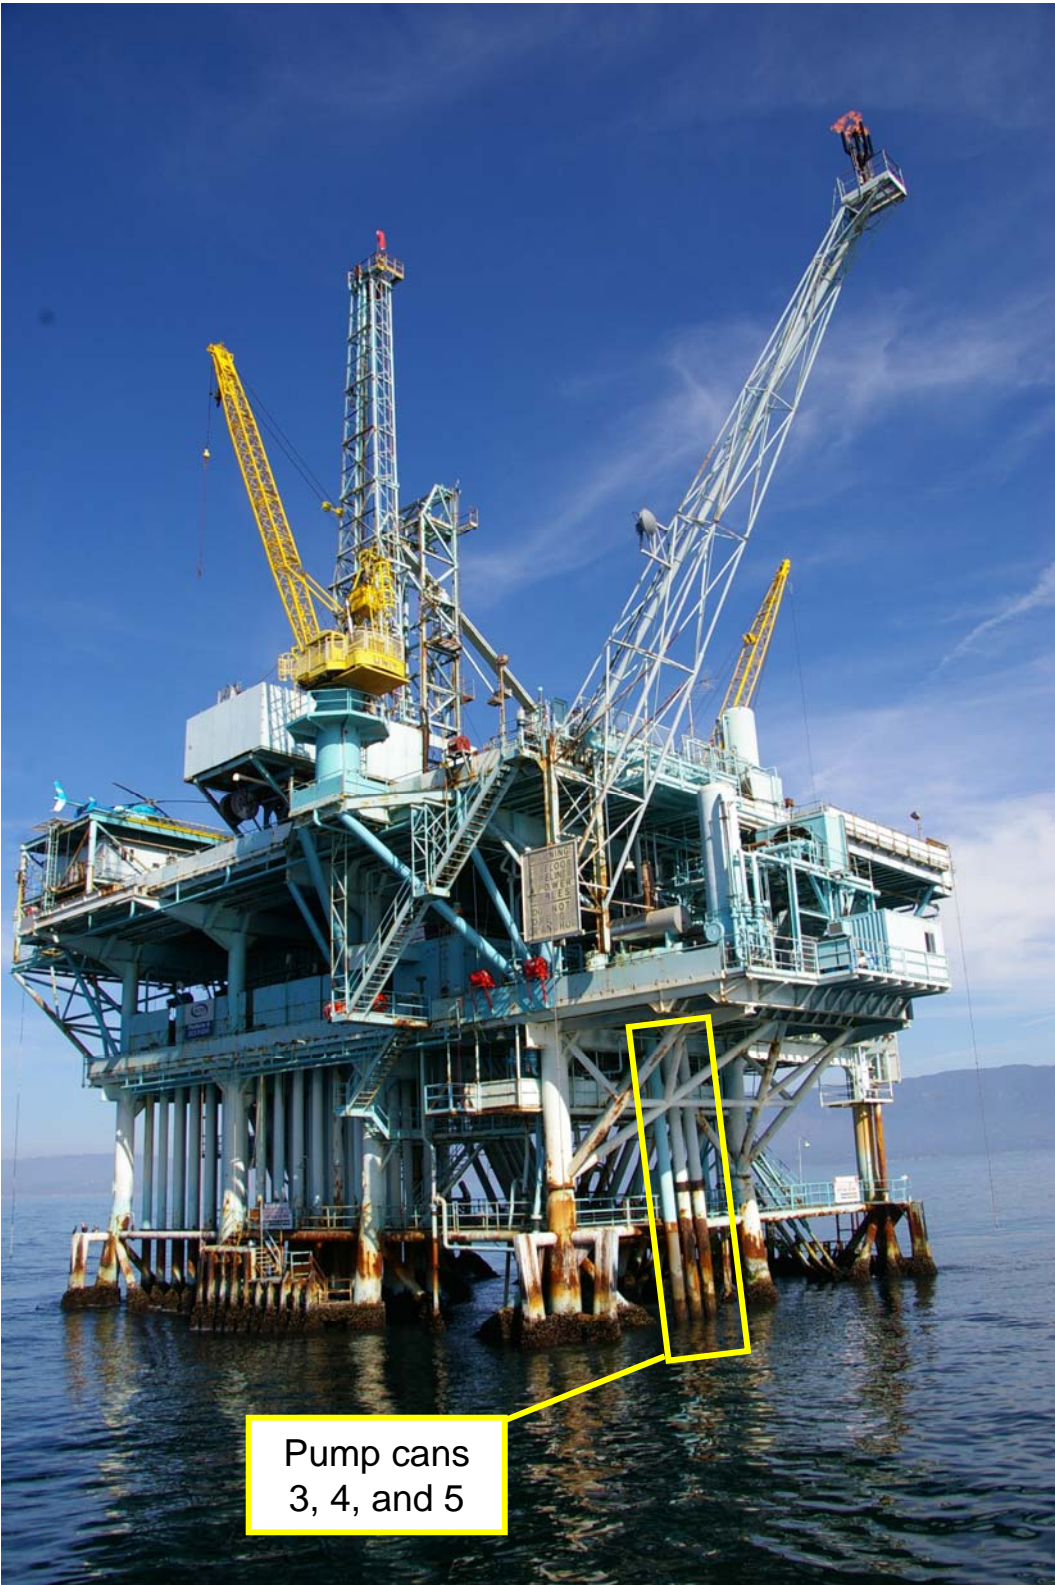
The pump can is a large, 20-inch diameter pipe sealed at bottom and top and suspended from the production deck. The pump can is 60 feet in length and extends from an elevation of +47 feet to -13 feet below the water line. The three pump cans are located on the outboard side of the platform which prevents easy access for inspection. This location also exposes the can to the likelihood of significant external corrosion. Further, the pump cans are not protected against allision by external guards nor do they have containment protection in the event of integrity failure. Additionally, the pump cans do not appear to have any external protective coatings other than paint. *(For photograph of pump cans in relationship to the platform, see Attachment 4.)*

Due to the location and proximity of the pump cans to the water line, the probability of corrosion is greatly increased. Further, the physical location of the pump can on the outboard side of the platform prevents a 360 degree visual inspection. Therefore, locating these pump cans on the outboard side of the platform, near the water line or in the water, is considered a contributing cause of the incident.

Location of pump cans in relation to the platform
