Cargo Hose Rupture and Release of Anhydrous Ammonia During Offloading of a Werner Transportation Services Cargo Tank Motor Vehicle at the Tanner Industries Plant Swansea, South Carolina July 15, 2009

Accident Summary Report

NTSB/HZM-12/01/SUM PB2012-917002

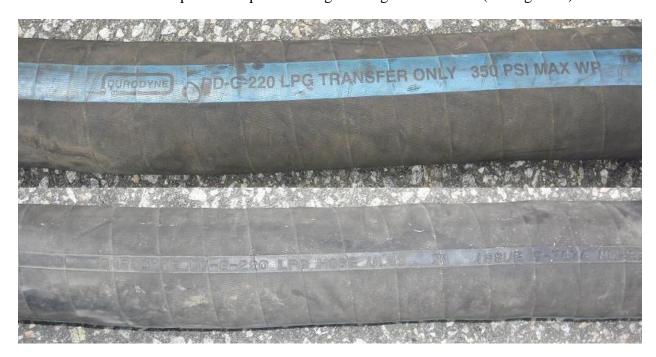
Figure 1. Blue Mylar and imprinted stripes on accident hose.

of several different layers of material that are chemically compatible with LPG, but not with anhydrous ammonia. The innermost layer of the hose was made of nitrile rubber, followed by three sequential layers of polyethylene terephthalate (PET) yarn braids encased in chloroprene rubber and an outer layer of neoprene rubber. The PET yarn braids are used to mechanically reinforce the hose, and they provide the hose with the majority of its strength. The hose had a nominal inner diameter of 2 inches, an outer diameter of 2 3/4 inches, and a bend radius of 14 inches. It was rated for use between -40° F and 180° F. The hose had been approved by Underwriters Laboratories Incorporated (UL) and met the UL 21⁶ standard for LPG hose. The maximum allowable working pressure of the hose assembly was 350 pounds per square inch, gauge (psig), and the minimum specified hydrostatic burst strength was 1750 psig, in accordance with UL 21.

The hose was imprinted with text. One side of the black neoprene cover of the hose featured a blue Mylar stripe extending along the length of the hose with the Durodyne logo and "DD-G-220 LPG TRANSFER ONLY 350 PSI MAX WP" printed in black. The phrases "To prevent serious injury or property damage use for intended purpose only," "Warning: Use of damaged hose could be hazardous; inspect hose and couplings prior to each use," and "Textile reinforcements meet UL21" were also embossed along the imprinted blue Mylar stripe. The opposite side of the hose had "DURODYNE DD-G-220 LPG HOSE UL21 ISSUE E-7874 MH29239 SPEC DD-G-220 TEXTILE BRAID WP 350 PSIG 4Q05 INSPECT HOSE BEFORE USE" embossed on an imprinted stripe extending the length of the hose. (See figure 1.)

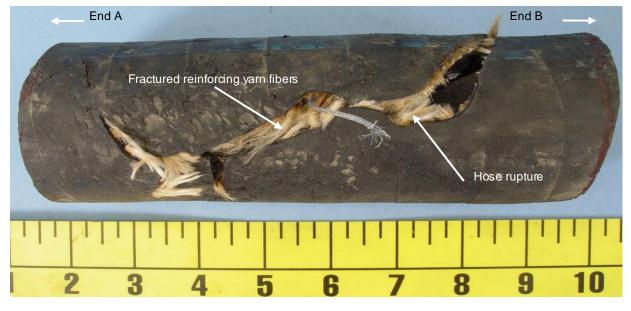
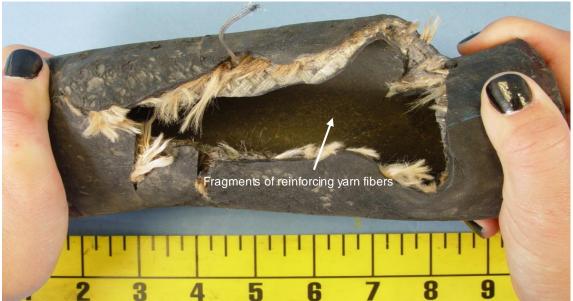
Figure 3. Views of outside (top) and inside (bottom) of ruptured section of accident hose.

The exterior surfaces of the hose assembly contained only superficial abrasions. No gouges, slices, or other defects were noted on the surface of the hose, including the areas adjacent to and abutting the rupture area. The black text on the blue Mylar stripe was abraded in multiple locations so that the stenciling along the length of the hose could not be read; however, several sections of the hose assembly were free of abrasions or stains, and the text could be read. The embossed text on the imprinted line could be read along the length of the hose assembly.

Fractographic ¹⁰ evidence indicates that the rupture in the accident hose assembly initiated on the interior wall of the hose and propagated outward. The NTSB's Materials Laboratory identified a definitive fracture origin on the surface of the fracture that was indicative of relatively slow crack growth. (See figure 4.) Several secondary cracks were noted in the interior wall of the hose near the fracture origin; however, the interior surface did not appear to be degraded from anhydrous ammonia exposure.

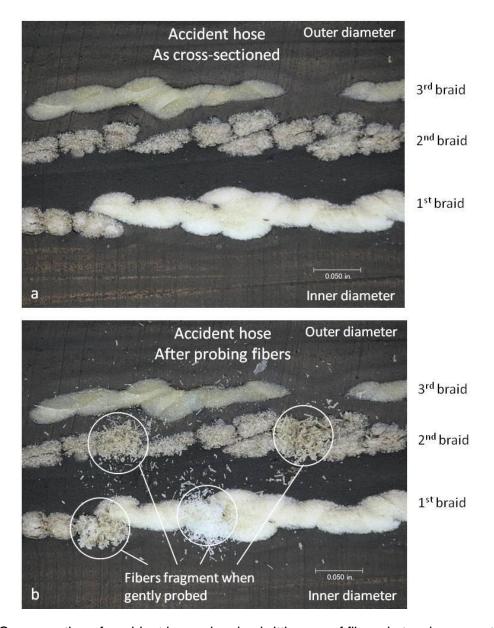
Figure 5. Cross-section of accident hose showing brittleness of fibers in two innermost PET braid layers.

The reinforcing fibers in the two innermost PET braid layers of the hose assembly appeared to be severely damaged on both halves of the fracture surface along the entire length of the ruptured area. In some parts of the ruptured area, the fibers were clumped together and appeared to be encased in salt-like particles. Laboratory analysis of the hose assembly revealed that the fibers in the two innermost PET braid layers were degraded to the point that they were brittle and friable when strained or mechanically flexed. (See figure 5.)

The PET used for the yarn braids is not chemically resistant to anhydrous ammonia or ammonium hydroxide. As documented in several studies, ¹¹ exposure to anhydrous ammonia or ammonia-related compounds results in a chemical reaction (ammonolysis) that can cause PET fibers to degrade and lose strength.

Testing completed by both the NTSB's Materials Laboratory and an independent laboratory 12 confirms that the PET fibers in the accident hose had sustained chemical degradation that dramatically reduced the strength of the PET fiber. The NTSB concludes that the accident hose failed because it was not chemically compatible with the anhydrous ammonia in the cargo tank that caused the chemical degradation, the loss of mechanical strength, and the ultimate failure of the cargo hose.

Require cargo tank motor vehicle carriers and transfer facilities to verify (1) that cargo transfer hose assemblies, whether carried on the vehicle or provided by the facility, are chemically compatible with the hazardous material to be transferred and (2) that drivers verify hoses are marked as compatible with the material to be transferred before either loading or unloading operations begin. (H-12-3)
