#### NTSB National Transportation Safety Board

Sun & Fun Lakeland Florida March 30, 2012

# Personal Flying: How Safe Do You Want to Be?

Earl F. Weener, Ph.D. NTSB Board Member

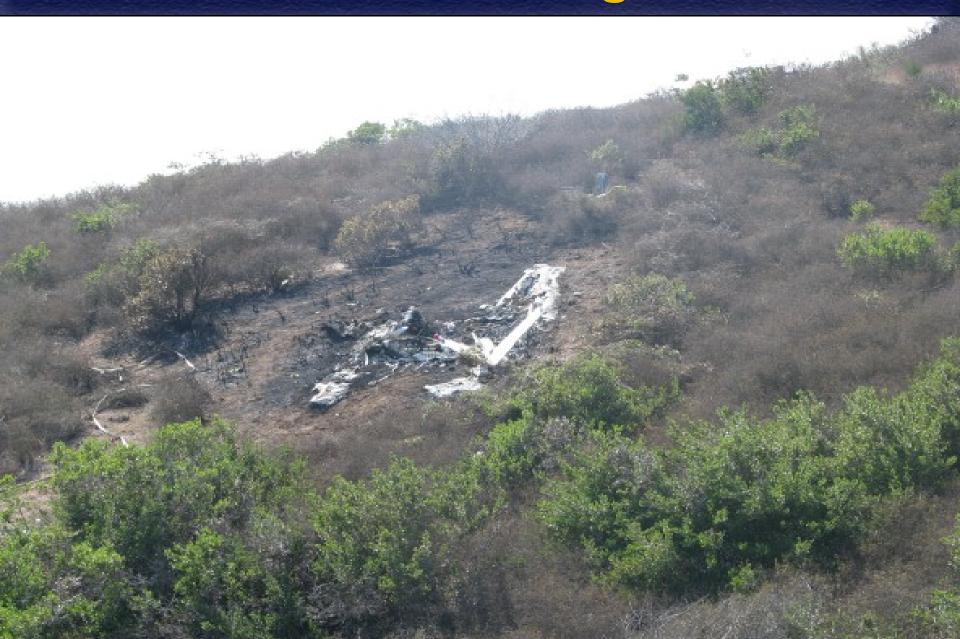
- Accident #LAX08FA300
- Beechcraft A36
- Approach to KCRQ, Carlsbad CA airport, 331 ft msl
- One person onboard, fatal
- Weather 100 ft ceiling, ¼ mi visibility,
   wind 280 degrees at 5 kt
- ILS 24 minimums 200 ft ceiling, ¾ mi visibility

- Accident sequence
  - ATC cleared for ILS approach RW 24
  - Tower issued "low altitude alert" and advised pilot he was south of localizer
  - Two minutes later pilot stated he was "aborting" the approach
  - One minute later pilot stated "I'm in trouble"

- Radar tracks
  - Two miles from approach end RW24 airplane crossed LOC at 800 ft heading south
  - Track started tight left-hand turns
  - Altitude fluctuated between 600 and 1100 ft msl
  - Last radar return showed airplane at 900 ft msl and 56 kt ground speed
- Wreckage confined to initial impact area

The pilot's failure to maintain control during the instrument approach and attempted go-around

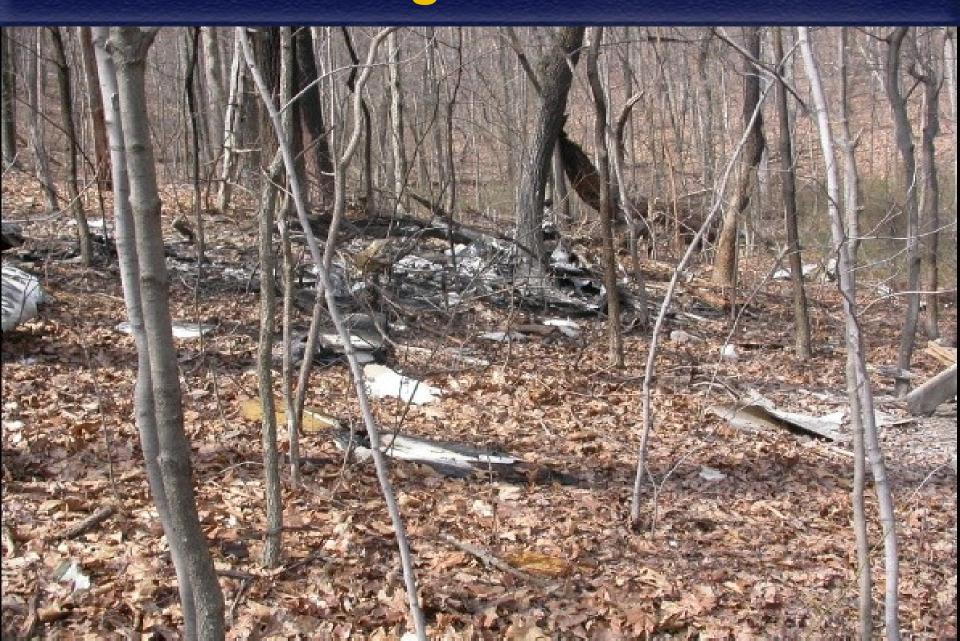
- Accident NYC08FA138
- Cirrus SR22
- Night IFR Departure Front Royal Virginia, KFRR, 709 ft msl
- Two fatalities pilot & son
- Weather Winchester, KOKV, 15 mi S
  - Wind 340 deg at 4 kt
  - 3 mi visibility in rain
  - Broken 2,400 ft, overcast 3,000 ft

- Accident sequence
  - IFR clearance direct COGAN intersection, climb and maintain 4,000, expect 5,000 10 minutes after departure
  - Prior to takeoff, Desired Course set to 050 deg, approximate direct course to COGAN
  - Airplane departed RW27
  - GPS waypoint COGAN selected during takeoff roll
  - Aircraft path continued west, consistent with GPSS not selected

- Flight path
  - Total time of flight 80 seconds
  - First 40 sec, runway heading, climbing 900 to 1,000 fpm
  - 25 sec, vertical speed decreased to 0 fpm,
  - then up 2200 fpm,
  - then decreased to 700 750 fpm up
  - Airplane reached 2,200 ft msl and 140 kt ias
  - Last 6 sec, steep descending turn to left, roll to 95 deg and pitch to 27 deg down

The pilot's failure to maintain clearance from rising mountainous terrain, and his failure to turn toward his assigned course during initial climb. Contributing to the accident were the low ceiling, reduced visibility, dark night conditions and rising mountainous terrain

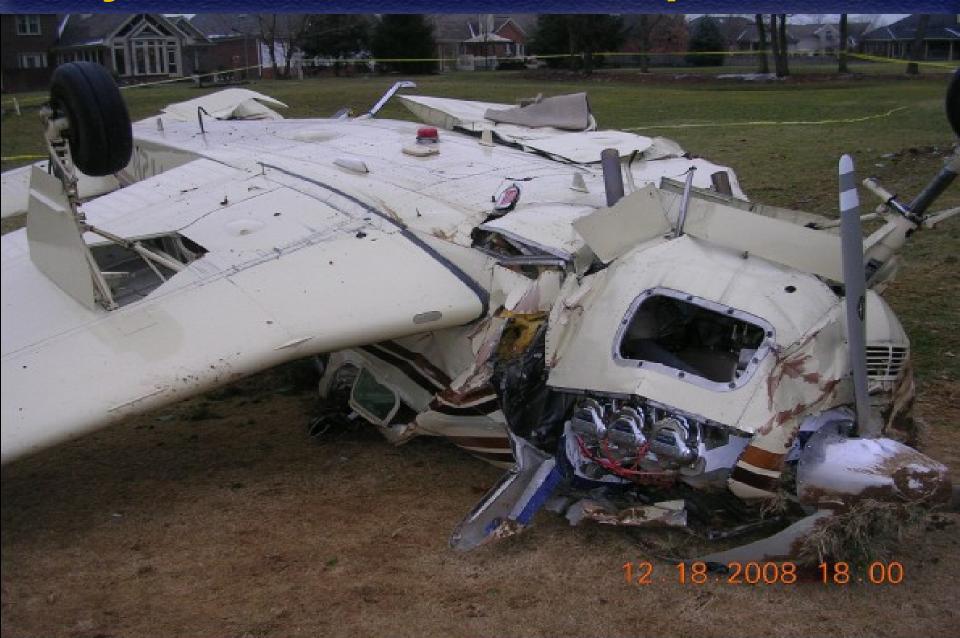
- Accident ERA09FA093
- Beechcraft 36
- Night IFR approach, Bowman Field, KLOU, Louisville, KY
- One fatality pilot
- Weather
  - Winds 330 degrees at 3 kts
  - Ceiling overcast at 800 ft
  - Visibility 6 miles in mist

- Total airframe time 6274 hours
- Engine IO 520, 58 hours since overhaul
- Pilot observed oil pressure problem
- Mechanic advised to have problem checked

- Aircraft right wing struck tree at height of about 30 ft along side a golf course
- Aircraft came to rest inverted approximately 175 ft from tree
- Front section of cabin roof crushed in
- Fuel recovered from left tank, right tank separated from aircraft
- Initial examination revealed engine would not rotate

- Engine teardown
  - Crankshaft and counterweight assembly fractured through at forward fillet radius of #2 main bearing journal
  - #2 main bearing journal showed scoring consistent with bearing rotation
  - #3 main bearing journal fractured at rear fillet area

- NTSB Materials Lab found presence of silk thread patterns and gasket making material on sealing surfaces of the main bearing bosses
- Material not part of engine manufacturer maintenance documentation, TCM SIL 99-2B
- #2 main bearing boss severely damaged on both halves, including rotation mechanical gouging and deformation of the boss area behind the bearing, including mushrooming deformation of the boss

The pilot's continued operation of the aircraft with known deficiencies. Contributing to the accident was the improper sealing of the engine case during overhaul

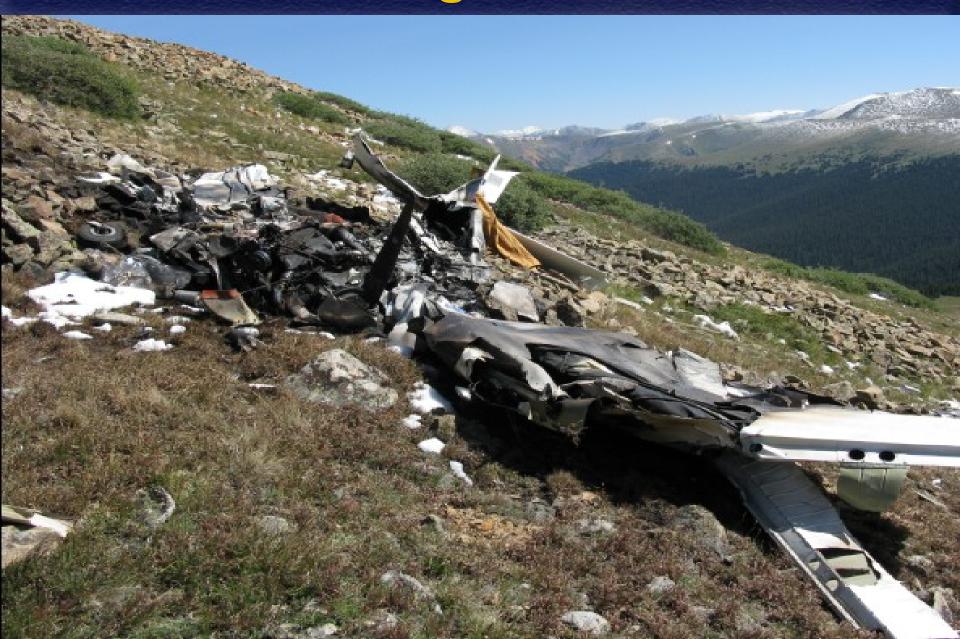
- Accident DEN08FA141
- Cessna 182T
- Four fatalities pilot and 3 passengers
- VFR flight from Steamboat Springs Colorado to Brenham Texas
- No record of weather briefing or flight plan
- Impacted terrain on Mt Guyot, near Georgia Pass, Park County, Colorado
- Weather IMC in general area

- Accident flight NTSB meteorology analysis
  - At departure marginal VMC with overcast above and scattered clouds at and below flight level
  - Weather at accident site deteriorated rapidly after departure
  - Pilot likely encountered level 2 thunderstorm
  - Lost control and impacted terrain
    - Approximately 55 degrees nose down
    - Wings level
  - Wreckage located at 12,300 ft msl

The pilot's failure to maintain aircraft control after inadvertently encountering instrument meteorological conditions. Contributing to the accident were the pilot's failure to obtain a weather brief and the severe weather conditions.

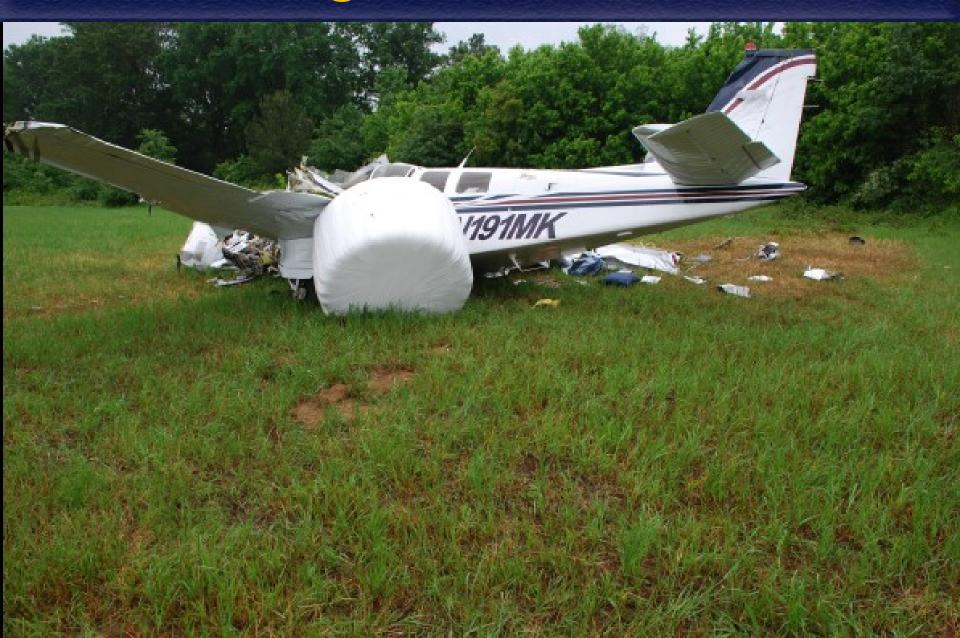
- Accident ERA09FA289
- Beechcraft A36
- Pilot & fwd passenger fatal; two aft passengers received minor injuries
- IFR flight plan; VMC conditions
- Flight from Destin, FL to Newnan GA
- Accident location was Beauregard, AL
- Weather scattered at 3,900 ft, 10 mile visibility, winds 120 degree at 5 kts

- Accident sequence
  - Second leg of trip
  - Picked up 3 passengers at intermediate airport
  - In cruise at 7,000 ft, engine lost power
  - Restarted, but subsequently lost power again
  - Forced landing approach to pasture
  - Collided with trees and large rolled bale of hay

- Post accident investigation
  - Fuel selector to right tank 1 qt fuel present
  - Right tip tank breached but contained 4 ½
     gal
  - Left fuel tank separated from airplane
  - Left tip tank breached but contained ½ gal
  - Before trip
    - 74 gal usable in main tanks
    - 20 gal usable in combined tip tanks
    - 25.4 gal drained to make weight & CG

- At takeoff for 2<sup>nd</sup> flight leg, about 48.6 gal in mains and 20 gal in tip tanks
- Performance calculations indicated that more than 48.6 gal would have been used by point of initial loss of power
- Likely used all main fuel but not tip fuel

The pilot's improper fuel management, which resulted in a total loss of engine power due to fuel starvation.
