The anatomy of an accident: Colgan Air flight 3407

Robert L. Sumwalt
February 12, 2010

Loss of Control on Approach
Colgan Air, Inc., Operating as
Continental Connection Flight 3407
Bombardier DHC-8-400, N200WQ

DCA09MA027

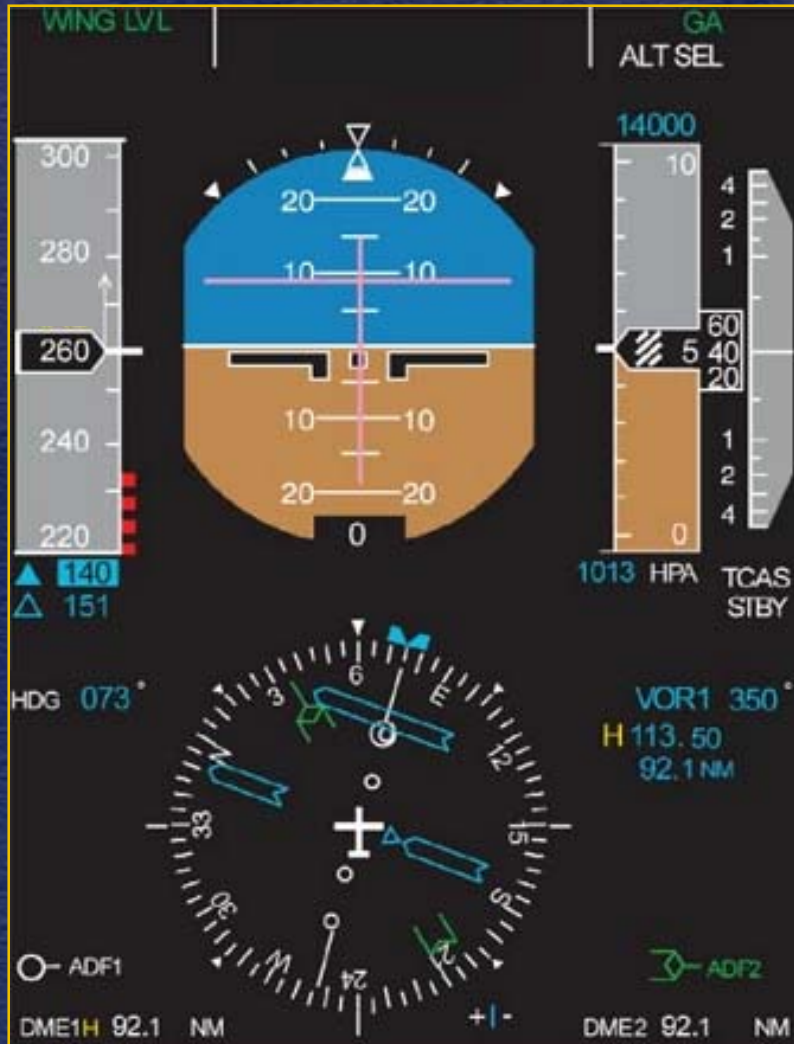
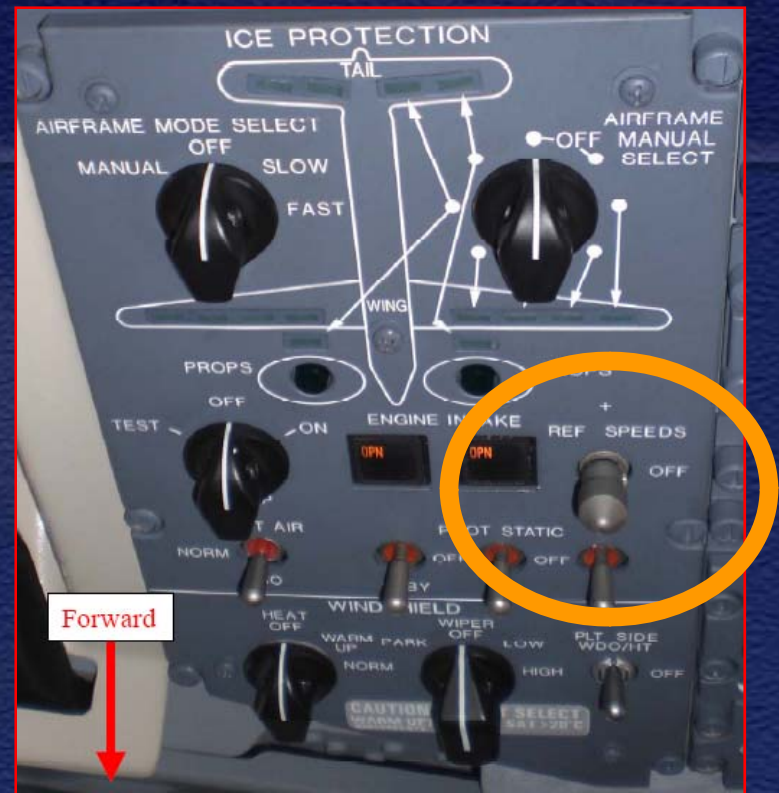
Primary Flight Display

Mismatch of Landing Ref Speeds

- Flight operated in light-to-moderate icing en route and on approach
- Captain set reference speeds switch to increase (icing conditions)
- First officer obtained landing speeds for non-icing conditions
 - Mismatch with position of ref speeds switch resulted in landing speed that was 13 knots lower than stick shaker activation speed
 - 118 vs. 131 knots

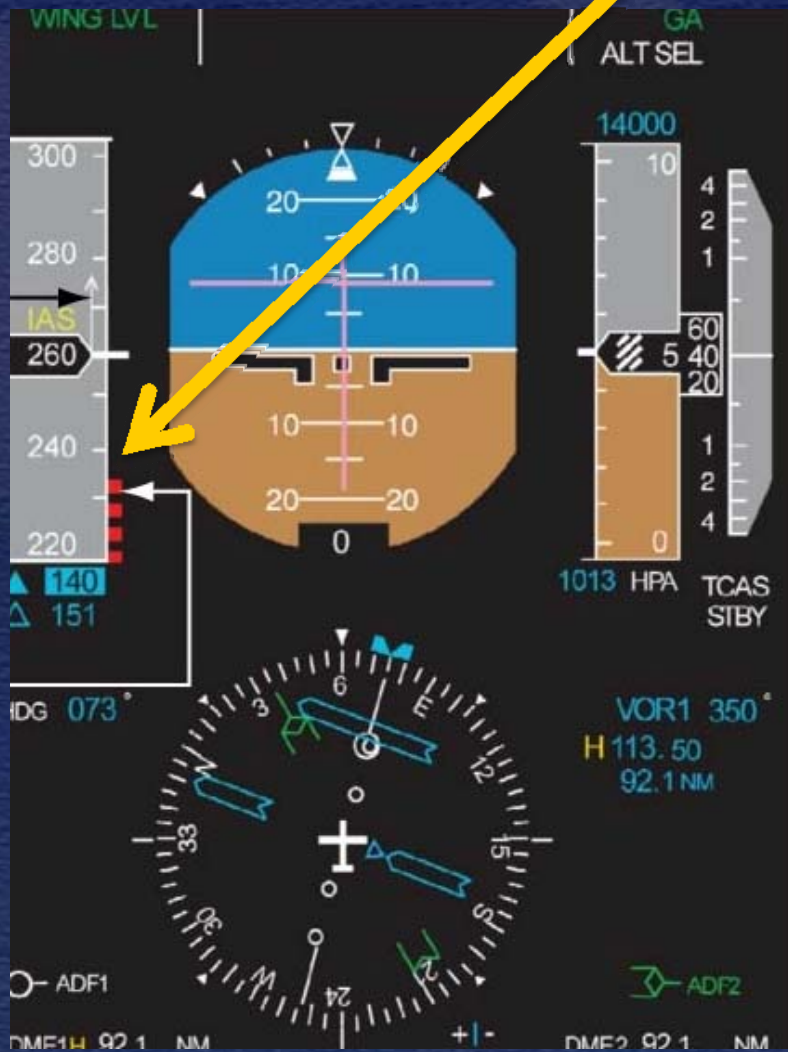
No Cautionary Range

- The Q400 airspeed indicator lacked low-speed awareness features, such as an amber band above the low-speed cue ...that would have facilitated the flight crew's detection of the developing low-speed situation.
- An aural warning in advance of the stick shaker would have provided a redundant cue of the visual indication of the rising low-speed cue and might have elicited a timely response from the pilots before the onset of the stick shaker.
