AL BALDA POLICE STATION  
HILLA, IRAQ

**SIGIR PA-05-015**  
**JANUARY 27, 2006**

## Project Assessment of the Al Balda Police Station in Hilla, Iraq

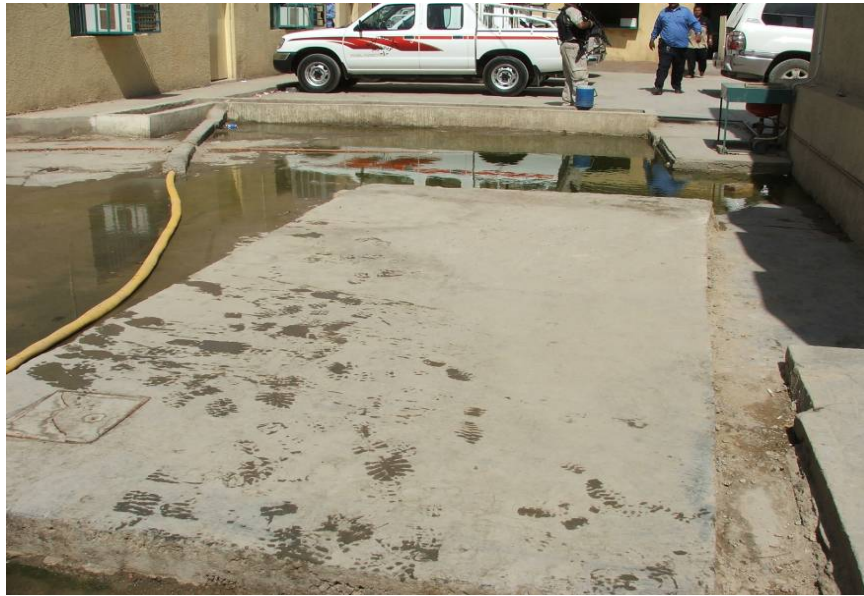
The contract's BOQ required the installation of a septic tank and the repair of an existing septic tank. The site visit verified the septic tank location. The ground level surface of the septic tank (concrete slab) did not appear to have adequate drainage based on observed standing water in the area. After discussions with the USACE QAR, we learned this tank is not connected to a leach field or city wastewater collection system. This system was designed as a holding tank, requiring sewage to be pumped out on a recurring basis. A yellow drain pipe was observed leading from the new cafeteria building to the septic tank manhole. This line was partially encased in concrete and partially exposed. The installation/rehabilitation of the septic system appeared consistent with the contract requirements. During the rainy season, there may be water drainage problems. For an illustration of the concrete cover of the septic tank and the standing water above the concrete pad, see Site Photo 3.

**Site Photo 3. Septic Tank Cover with Un-drained Water**

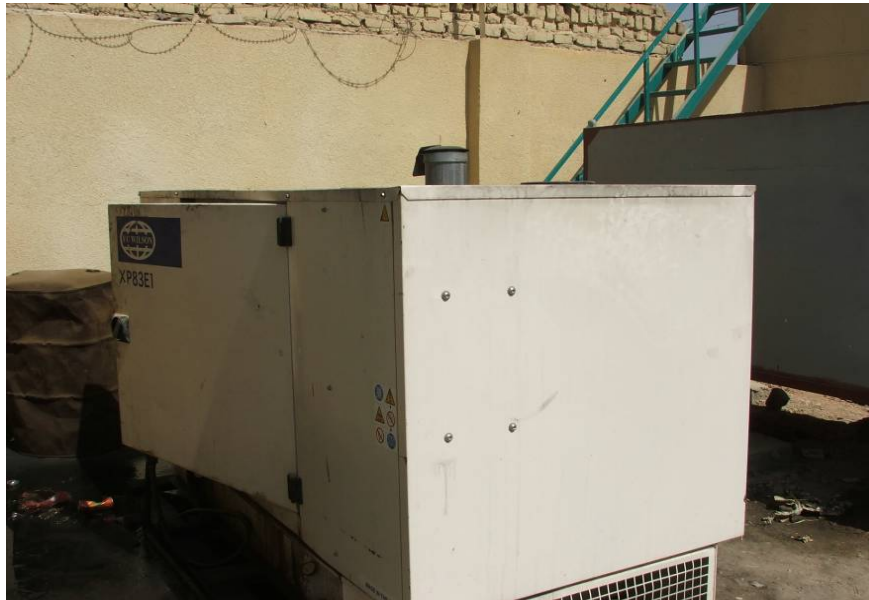
Contract Modification #P0001 required the supply and installation of a generator and a fuel tank. The contract did not specify the size of the generator required. The generator and fuel tank were on site and located to the right of the inside perimeter main gate. The generator factory nameplate lists the following information: company name - FG Wilson (Engineering) Ltd, Model - XP83E1, Serial Number - FGWPEP03ED0A24307, Year of Manufacture - 2004, Rated Power - 82.5 kilo Volt Amp (kVA), Rated voltage - 400/230 V, Rated Frequency - 50 Hz, and Rated Current - 119 A. For an illustration of the generator housing, and the 82.5 kVA generator inside the housing, see Site Photo 4 and Site Photo 5, respectively.

**Site Photo 4. Generator Housing**

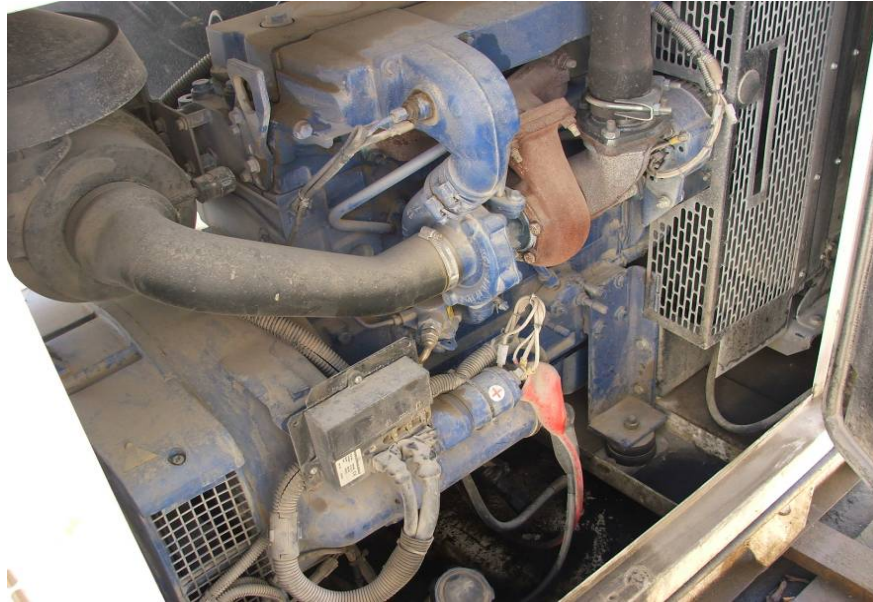
**Site Photo 5. 82.5 kVA Generator**

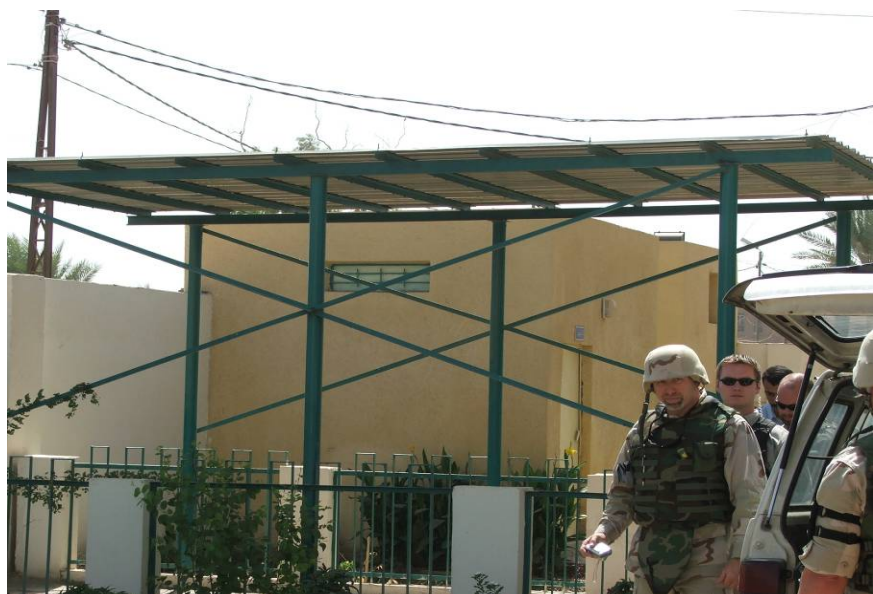
- Construction of covered entrance  
Contract Modification #P0001's BOQ required the new construction of 99 M<sup>2</sup> of canopies with steel frame supports and corrugated steel sheet roofs. A new canopy was located between the pedestrian gate and the front door of the Police Station. In addition, a canopy used for automobile parking was located between the generator units and the newly constructed cafeteria building. Both canopies were composed of painted steel frames and corrugated metal roofs. During the site visit, no discrepancies were noted regarding the construction of the canopies. For an illustration of the entrance canopy and the automobile canopy, see Site Photo 6 and Site Photo 7, respectively.

**Site Photo 6. Entrance Canopy**

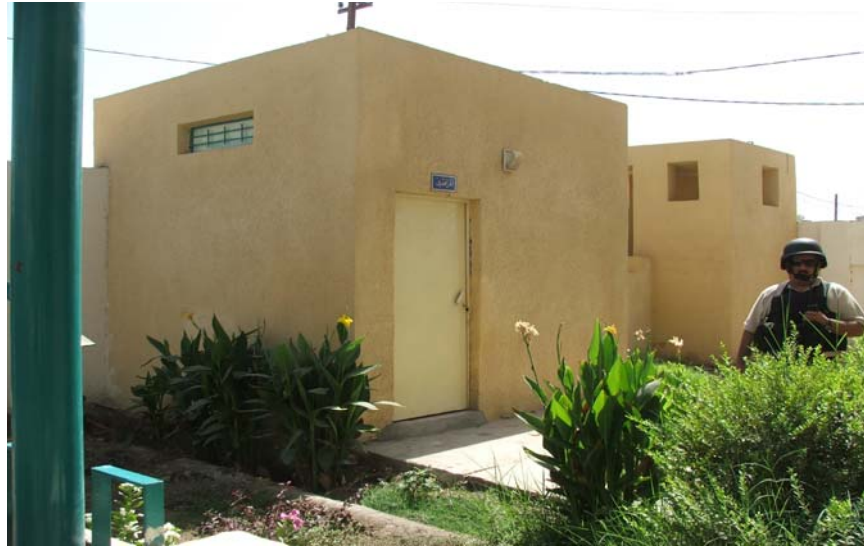
The contract's BOQ required the construction of four small buildings with specific dimensions: (1) a dormitory building (4M x 9M), (2) a cafeteria building (4M x 5M), (3) an information building (4M x 6M), and (4) an arms storage facility building (4.11M x 5.62M). The site visit verified the buildings were constructed and were currently in use. For an illustration of the cafeteria building's exterior front, see Site Photo 8; the exterior of the information building can be seen in Site Photo 9. The buildings appeared to be consistent with the contract's requirements.

**Site Photo 9. Exterior View of the Information Building**
