BORDER FORTS  
NUMBERED 602, 604,  
628, AND 634  
SULAYMANIYAH, IRAQ

**JANUARY 31, 2006**

SUBJECT: Report on Project Assessments of Border Forts Numbered 602, 604, 628, and 634 in Sulaymaniyah, Iraq (Report Numbers SIGIR PA-05-021, PA-05-022, PA-5-023, and PA-05-024)

## Border Forts Numbered 602, 604, 628, and 634 Sulaymaniyah, Iraq

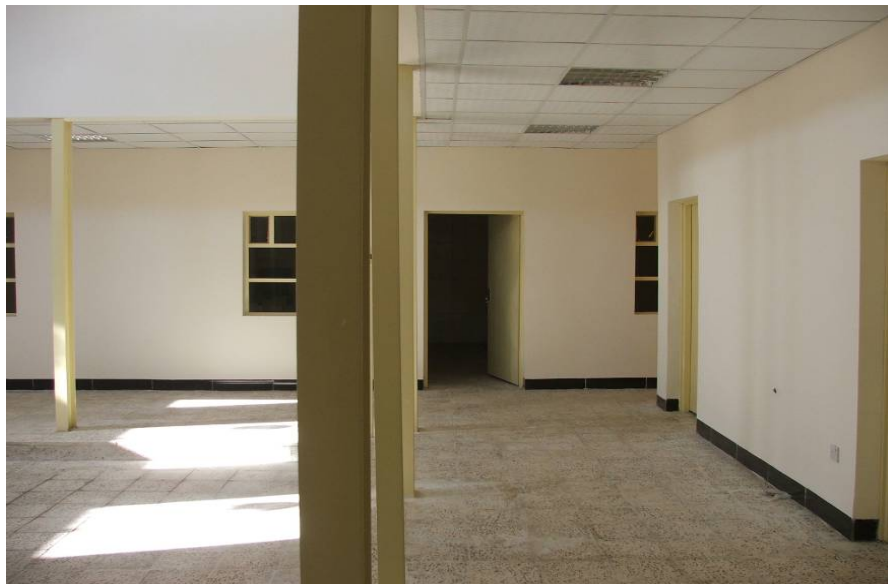
The contract and design required the construction of structural steel I-beam columns and a steel I-beam frame on reinforced concrete footings. The four border forts are scheduled for structural steel retrofit to reinforce the installed undersized and standard strength I-beams and to incorporate the additional snow load requirements. The retrofit of the structural I-beams had not commenced at the time of the site visit. The site visit revealed that several of the I-beam columns were not installed plumb and that some of the I-beam lateral members were not properly aligned. See Site Photos 1 and 2, for an illustration of I-beam columns not installed plumb at the Marwa and Issawa Border Posts. See Site Photo 3 for an illustration of an I-beam lateral member not properly aligned. Improper installation of the structural I-beams will decrease the design strength of the structure. The Contractor Project Manager said the I-beams would be re-installed correctly when the structural steel retrofit is done.

**Site Photo 1. Steel I-Beam Columns – Not Plumb (Marwa #628 Border Post)**

At the time of the site visit, the retrofit of the structural steel I-beams on the upper and lower roof had not commenced. Retrofit of I-beams is required because of the installation of undersized I-beams and the inadequate live loads used in the design calculations. Snow loads were not added to the live loads during the calculations for the structural steel requirements for the facility. The retrofit design and updated welding QC plan were being submitted to the PCO for review and approval.

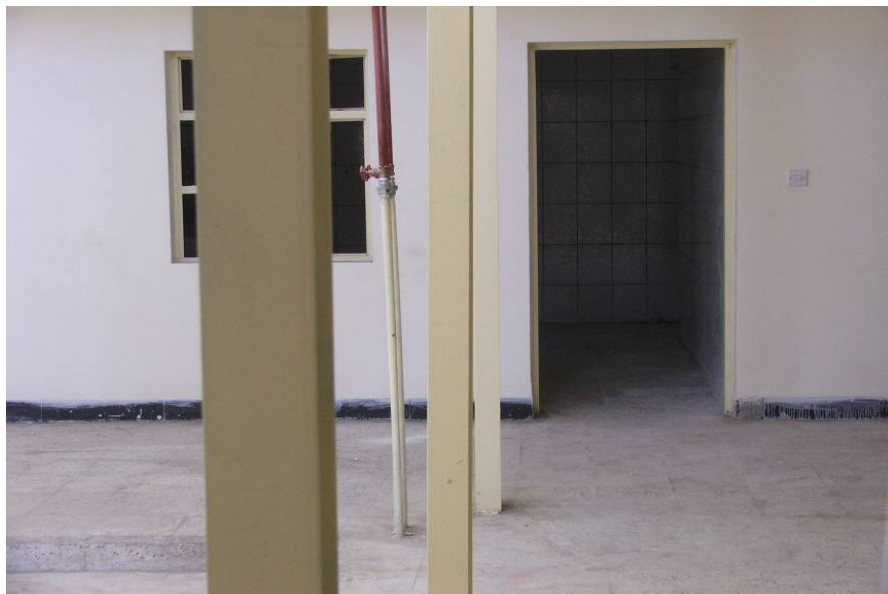
**Site Photo 2. Steel I-Beam Columns – Not Plumb (Issawa #604 Border Post)**

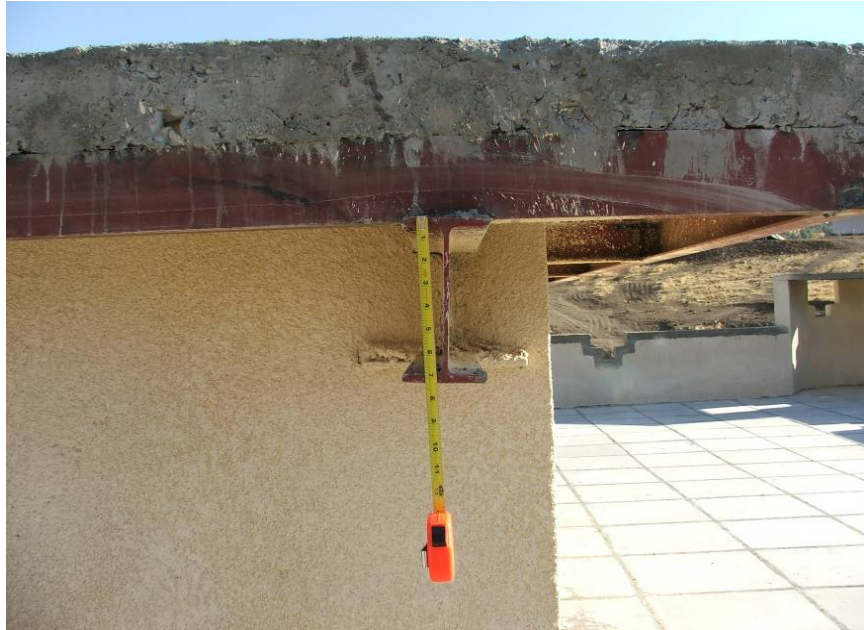
**Site Photo 3. I-Beam Lateral Member Not Properly Aligned (Marwa #628 Border Post)**

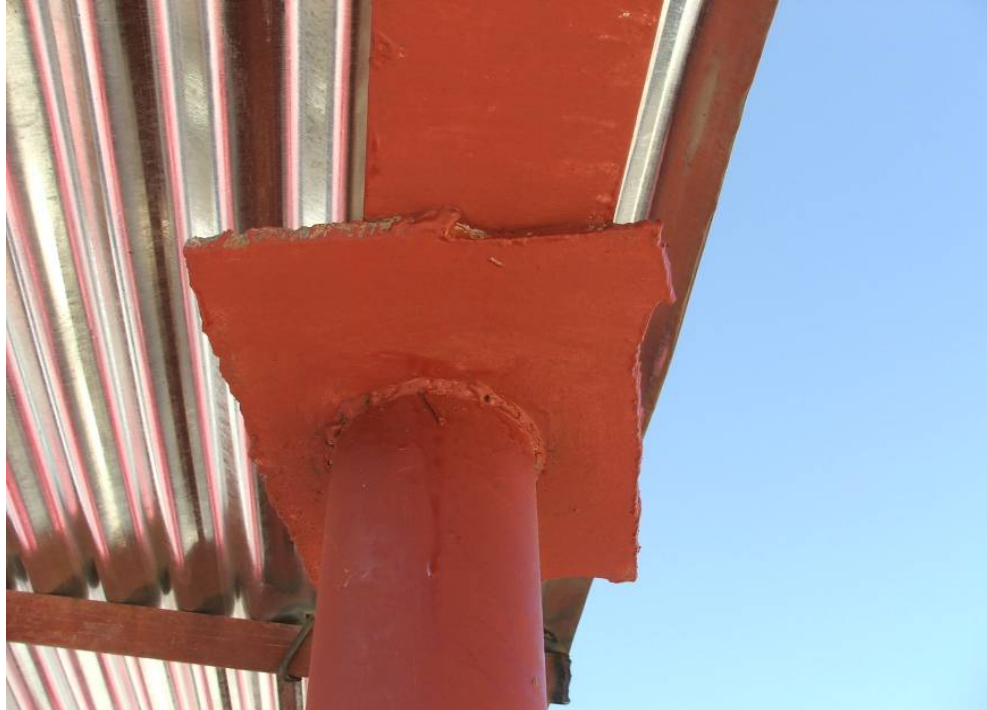
The steel generator shed, automobile parking area, and roof-mounted water tanks had a common construction deficiency. At several locations, the upper column bearing plate was only connected to the I-beam on one edge because the tubular steel columns were not properly angled resulting in a decrease in the strength of the connection due to less welded area. For illustrations of the upper column bearing plate being connected on one edge at the Issawa Border Post (Site Photos 9 and 10).

**Site Photo 4. Bearing Plate on Roof-Mounted Water Tank Canopy  
(Azmick #602 Border Post)**

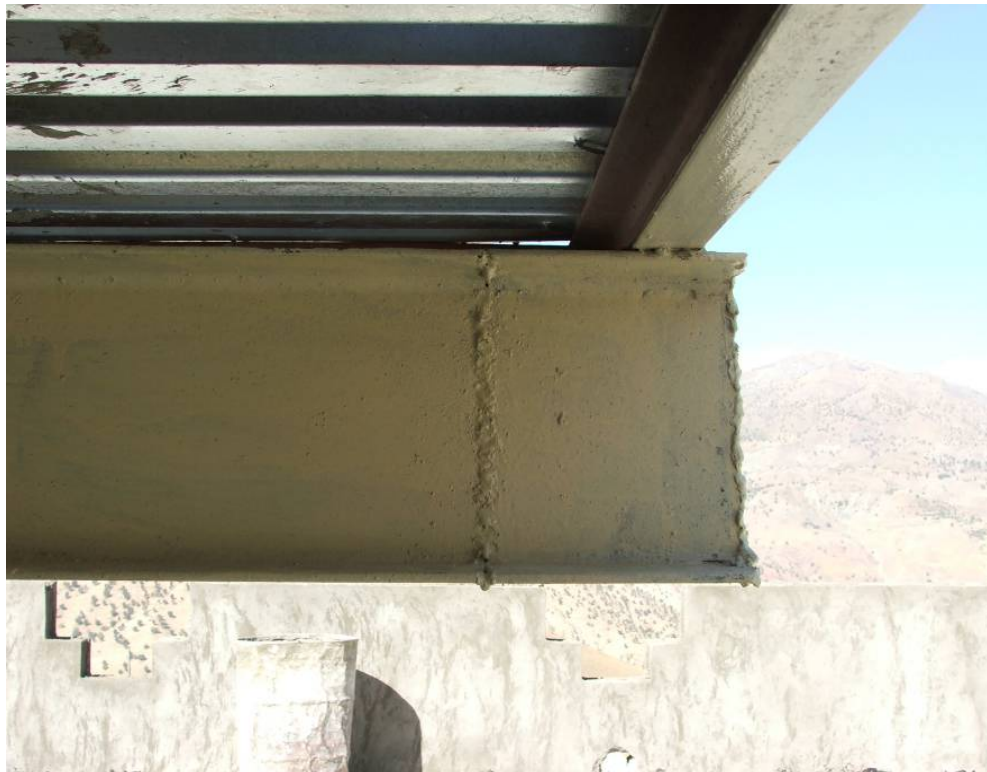
**Site Photo 5. Lateral I-Beam Member – Cut Short and Welded  
(Issawa #604 Border Post)**

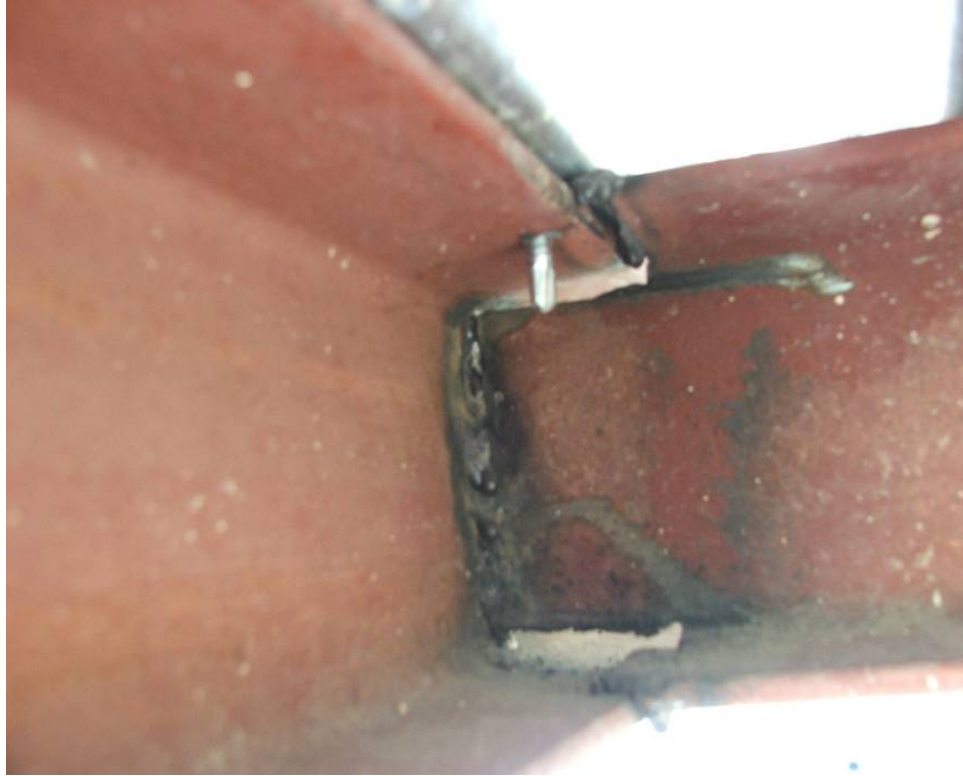
**Site Photo 6. Channel Section to Channel Section Connection  
(Marwa #628 Border Post)**

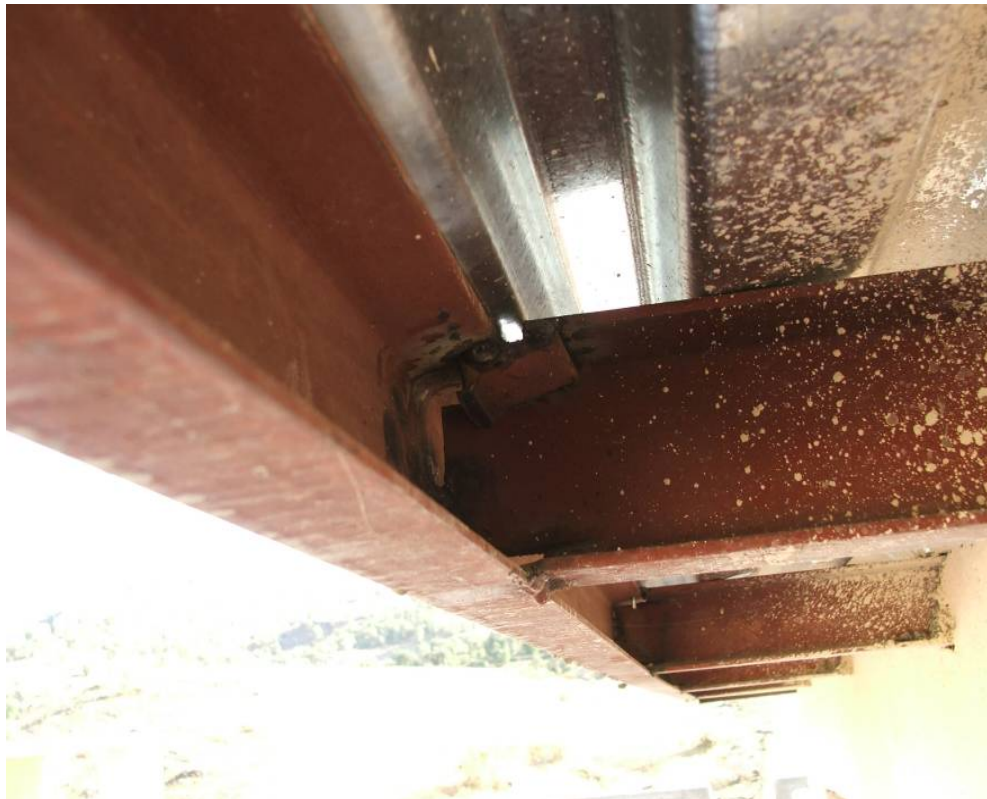
**Site Photo 7. Channel Section to Channel Section Connection  
(Marwa #628 Border Post)**

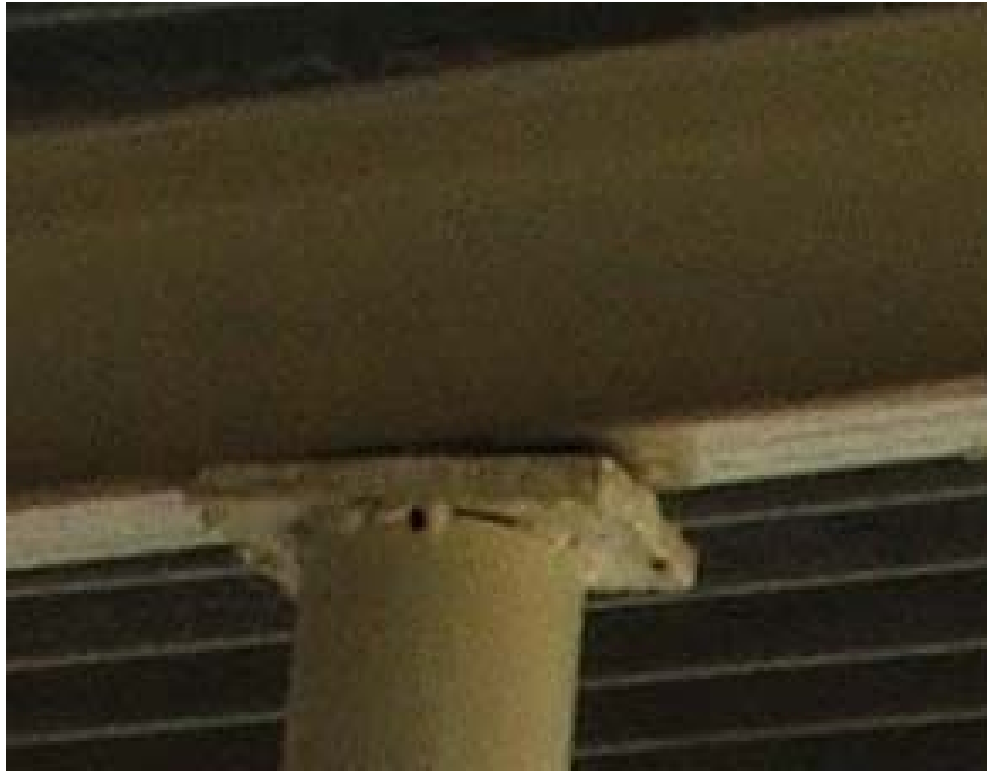
**Site Photo 8. Upper Column Bearing Plate Showing Incomplete Welds  
(Safrah #634 Border Post)**

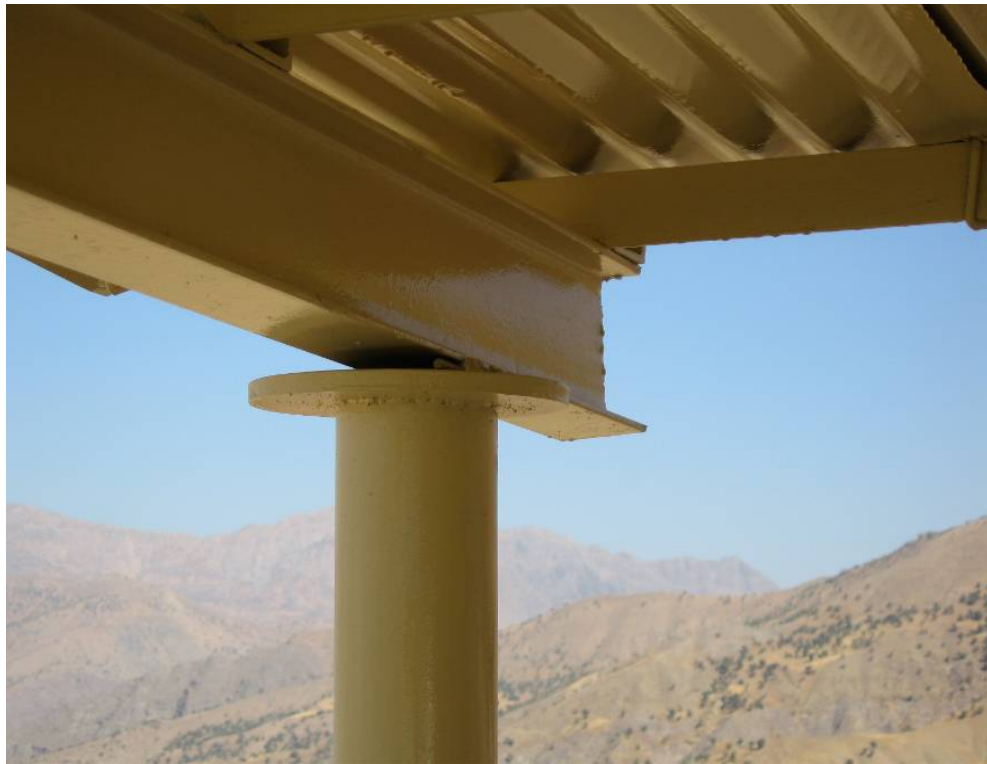
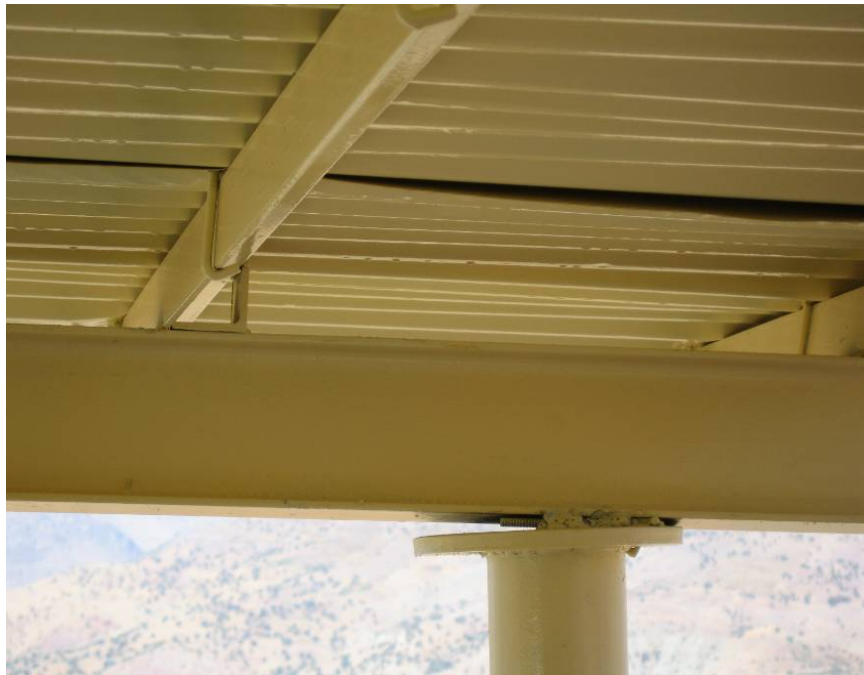
**Site Photo 9. Upper Column Bearing Plate Only Connected On One Edge  
(Issawa #604 Border Post)**

**Site Photo 10. Upper Column Bearing Plate Only Connected On One Edge  
(Issawa #604 Border Post)**

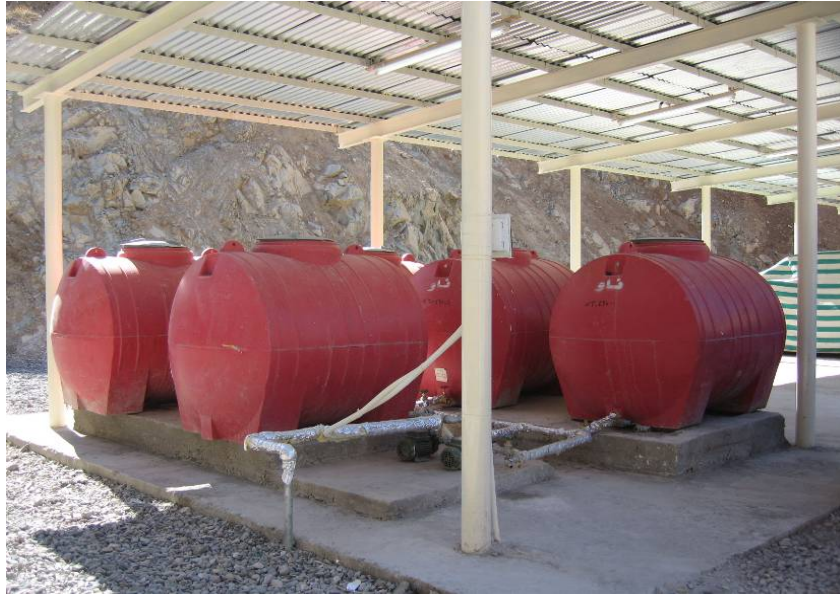
The location of the ground-mounted water storage tanks was not consistent with the design requirements. The ground-mounted tanks were to be located underneath a separate steel framed canopy. During the site visit, we identified that the tanks were located under the automobile parking steel canopy.

**Site Photo 24. Five Ground-Mounted Water Storage Tanks (Safrah #634 Border Post)**

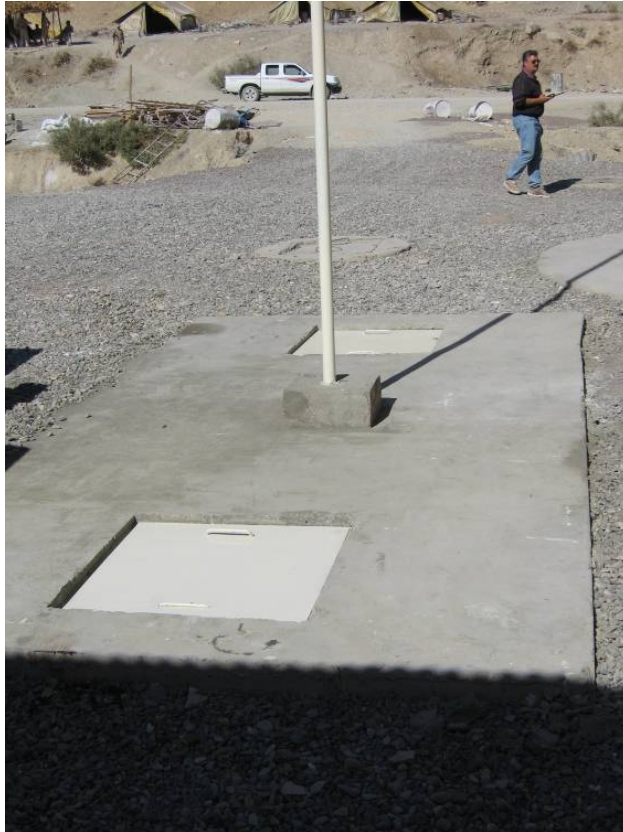
The contract and design required the construction of two septic tanks and four soakaways for collection and disposal of wastewater, including all required associated pipes and fittings. During the site visit, we verified that the construction of two septic tanks and four soakaways was completed. Site Photo 26 shows the top cover surface of one of the septic tank with two access ports and Site Photo 27 shows one of the soakaways. The soakaway access port was made of concrete, appeared to be poorly constructed, and showed signs of deterioration.

**Site Photo 26. Septic Tank (Safrah #634 Border Post)**

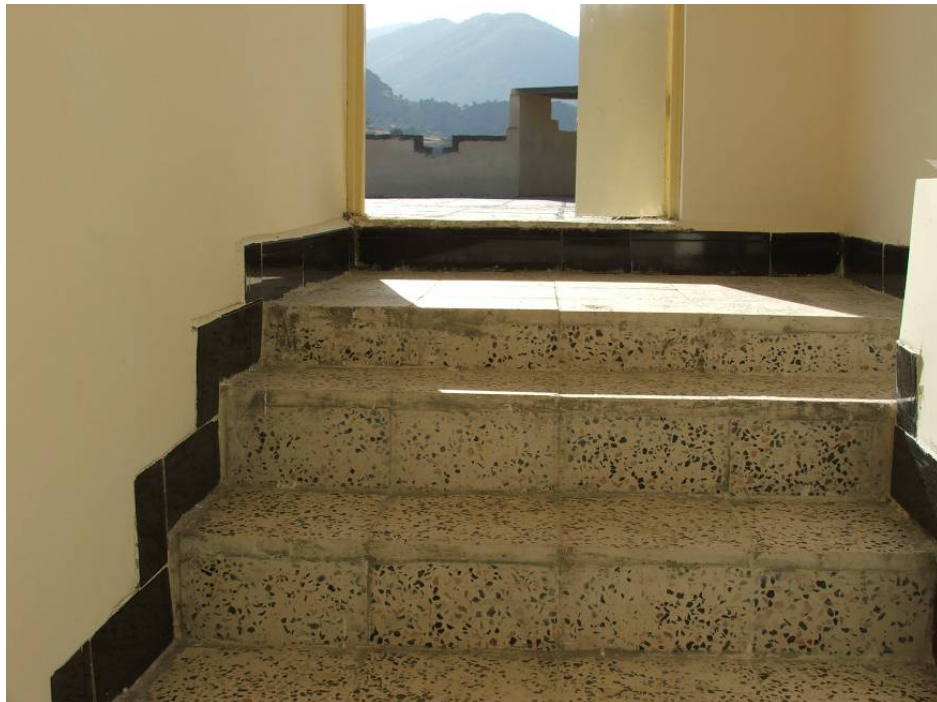
The design required the rise for the steps or the internal stairwell to be 18.7 cm (7.4 in) and the run to be 30 cm (11.8 in). Based on measurements obtained during the site visit, the rise varied between 6 in and 9.5 in, although the run was consistent at 12 in. See Site Photo 32 for an illustration of the interior stairwell steps.

**Site Photo 32. Interior Stairwell Steps (Marwa #628 Border Post)**

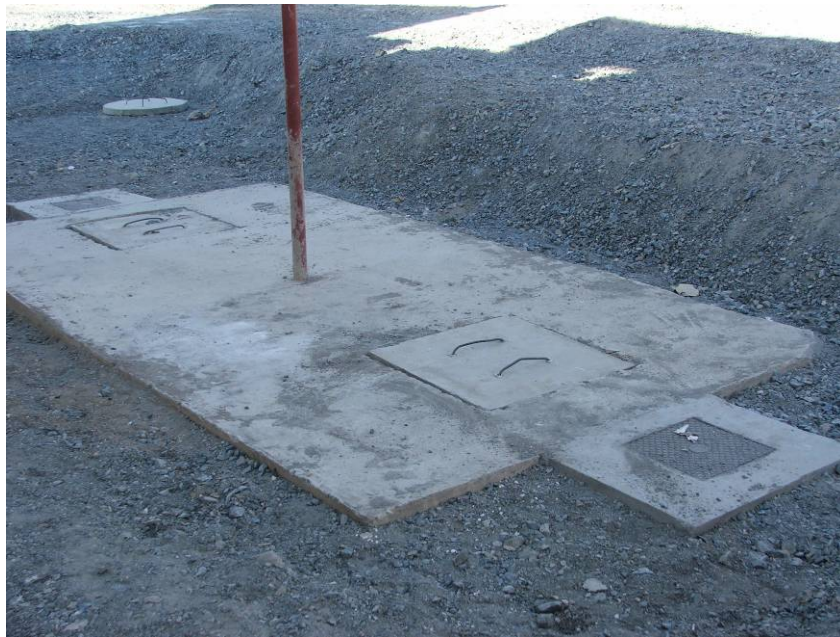
The contract and design required the construction of two septic tanks and four soakaways for collection and disposal of wastewater. In addition, the contract required all associated pipes and fittings for the septic tank and soakaways. The site visit verified that the construction of two septic tanks and four soakaways was completed. For an illustration of the top cover surface of one of the septic tanks with four access ports and two soakaways, see Site Photo 38. The design required two cast iron access ports. The site visit verified four access ports per septic tank, two concrete and two metal.

**Site Photo 38. Septic Tank with Four Access Ports  
(Marwa #628 Border Post)**

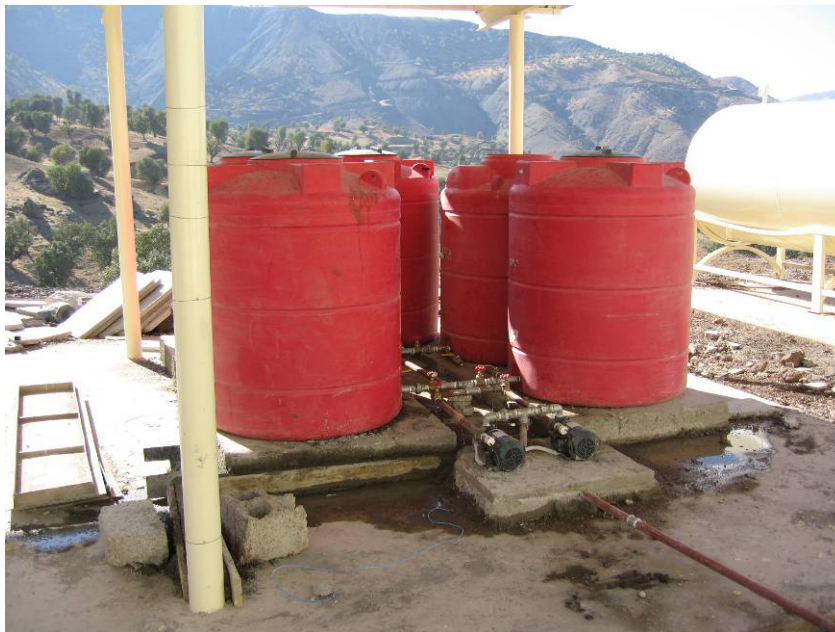
The location of the ground-mounted water storage tanks was not consistent with the design requirements. The ground-mounted tanks were to be located underneath a separate steel framed canopy. During the site visit, the water tanks were located under the automobile parking steel canopy. In addition, the design required anchor bolts to be imbedded in the concrete footing, and the tubular steel columns connected to bearing plates, which would then be bolted to the footing. During the site visit, anchor bolts were not visible.

**Site Photo 47. Ground-Mounted Storage Tanks, Pumps, and Piping  
(Azmic #602 Border Post)**

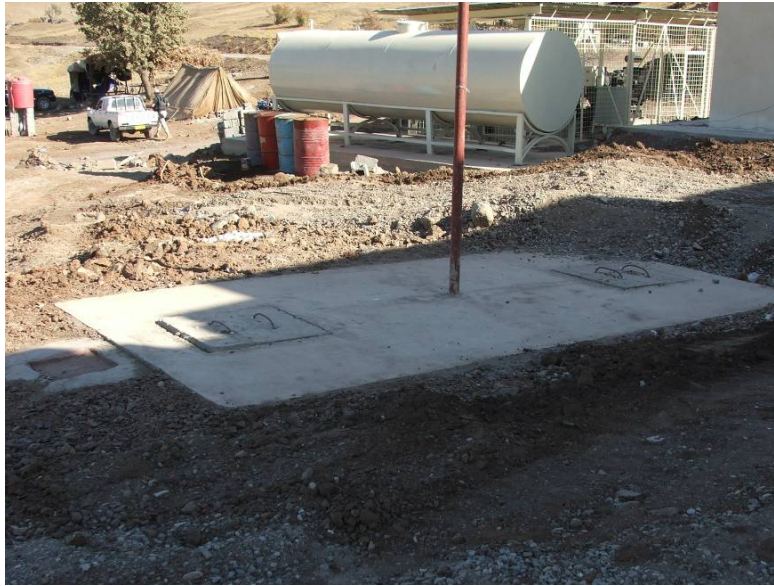
and two soakaways, see Site Photo 48. The design required two cast iron access ports; however, the site visit verified that there were four access ports per septic tank, two concrete and two metal.

**Site Photo 48. Septic Tank and Access Ports  
(Azmick #602 Border Post)**

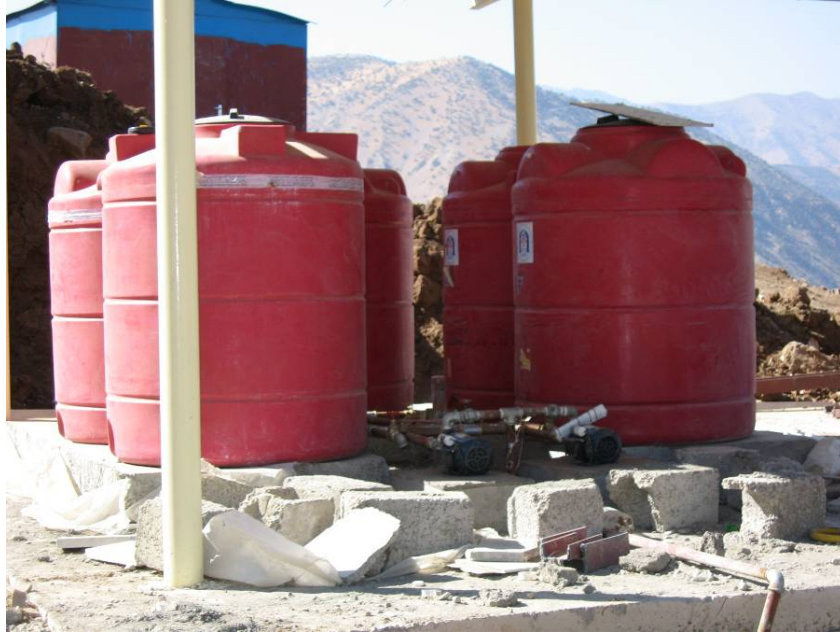
The location of the ground-mounted water storage tanks was not consistent with the design requirements. The ground-mounted tanks were to be located underneath a separate steel framed canopy. During the site visit, the tanks were located under the automobile parking steel canopy.

**Site Photo 56. Ground Mounted Water Tanks (Issawa #604 Border Post)**

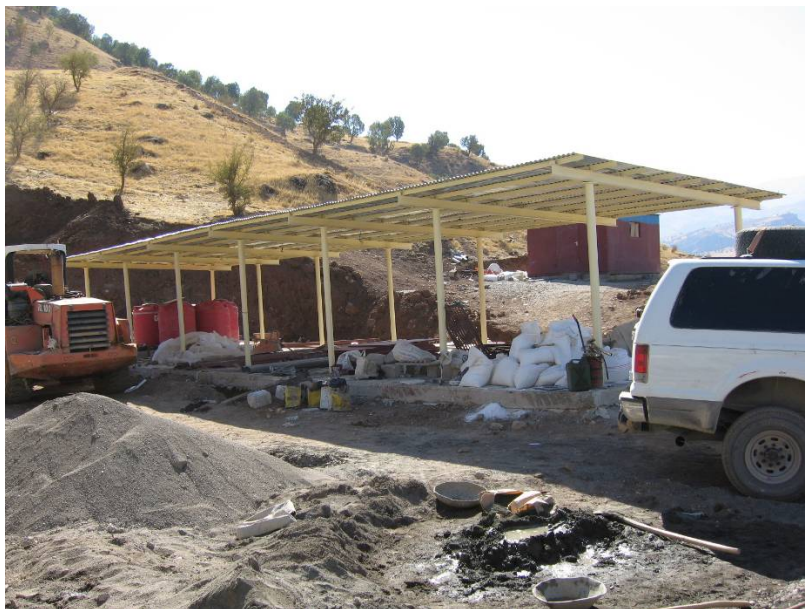
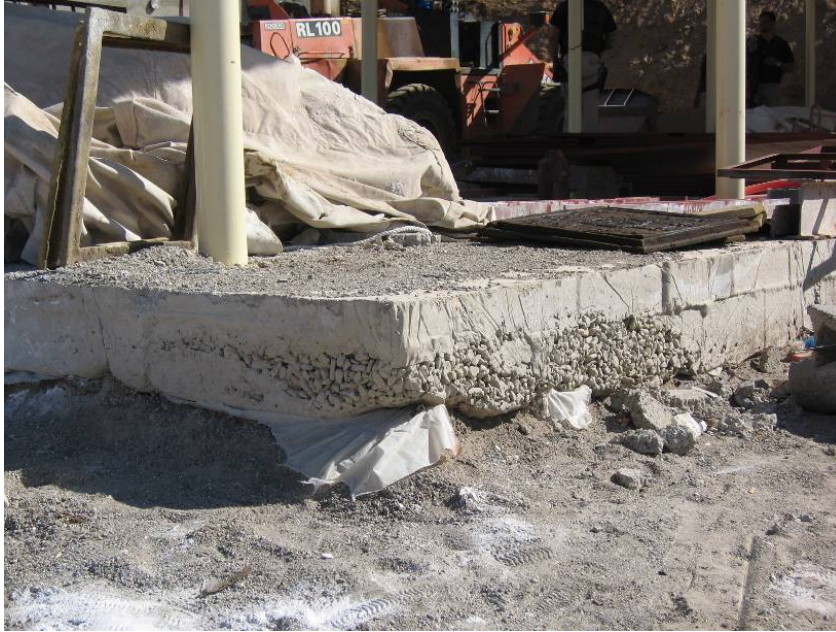
The contract and design required the construction of a covered automobile parking area. The covered automobile parking area was to consist of a reinforced concrete slab with steel framed structure and a corrugated steel canopy. The site visit verified that the automobile parking area was constructed. The side of the concrete pad showed areas of segregated concrete as well as a lack of sub-base to support the concrete pad. For an illustration of the automobile parking area, and the segregated concrete with the lack of a sub-base, see Site Photos 59 and 60, respectively.

**Site Photo 59. Automobile Parking Area (Issawa #604 Border Post)**

**Site Photo 60. Concrete Pad of Automobile Parking Area  
(Issawa #604 Border Post)**
