SEIF SA'AD POLICE STATION
HILLA, IRAQ

SIGIR PA-05-020
MARCH 10, 2006

Special Inspector General for Iraq Reconstruction

Seif Sa'ad Police Station in Hilla, Iraq

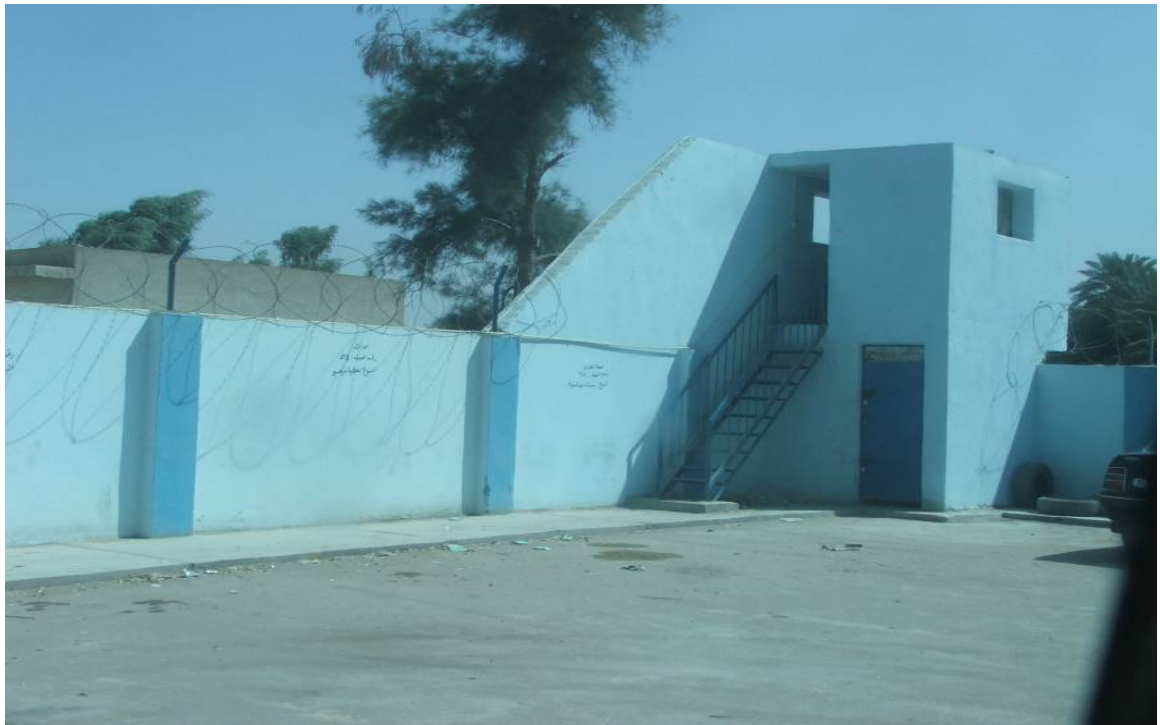
The contract's bill of quantity required new construction, repair, and upgrade (height) of the perimeter wall, construction of two corner guard towers, supply and installation of 550 meters (m) of concertina barbed wire, installation of 20 square meters (m²) of paved parking area, and installation of 20 m² of sidewalks. During our site visit, we observed that the perimeter walls were in place and were painted and two corner guard towers were complete. Concertina barbed wire was located on top of all perimeter walls and on the police station's roof. The parking area was paved with asphalt and concrete and sidewalks were located around the police station and adjacent to the perimeter wall. The work accomplished appeared to be consistent with contract requirements.

Site Photo 1 shows the corner guard tower, perimeter wall, concertina barbed wire, sidewalks, and paved parking area. The second corner guard tower can be seen in Site Photo 2.

Site Photo 1. Guard Tower, Perimeter Wall with Concertina Wire on Top, Paved Parking Area, and Concrete Sidewalk

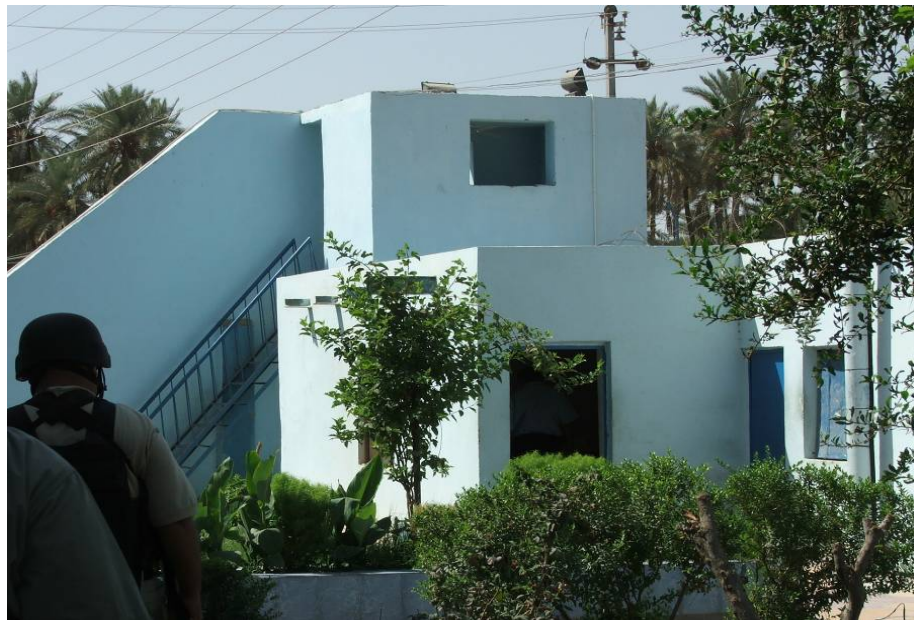
Site Photo 2. Corner Guard Tower (located near Front Entrance)

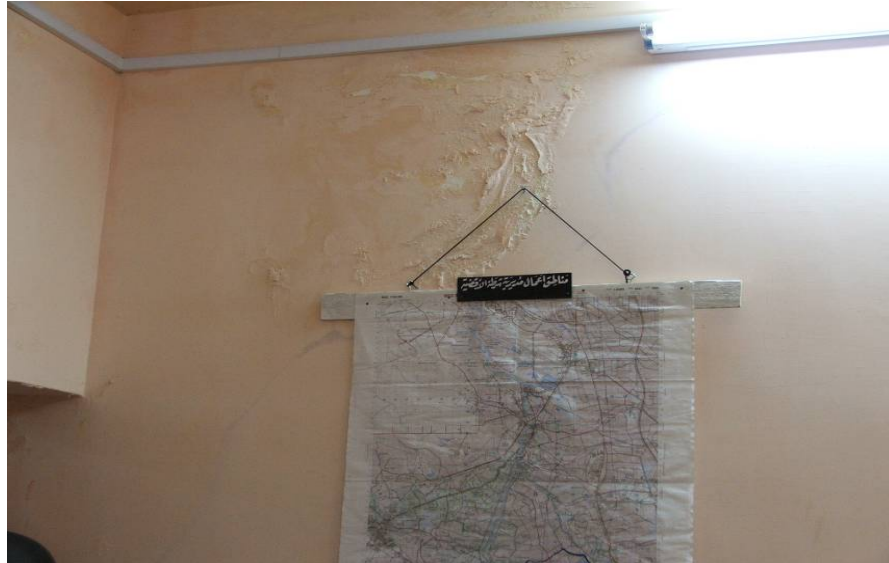
tiles with joints sealed with mastic. During the inspection of a renovated office, the Seif Sa'ad Police Station Chief of Police stated that water had been leaking from the ceiling into this room and an additional office. The walls of both offices had blistering and peeling paint. Inspection of the roof revealed that the roof mounted water tank was overflowing continuously causing water to flow onto the roof. The roof tiles and roof slope appeared to be correct; however, the space between the roof tiles was only partially filled with mastic. Site Photo 3 shows the damaged interior room wall and the tiled roof can be seen in Site Photo 4. Site Photo 5 shows the mastic seal between the roof's concrete tiles.

Site Photo 3. Damaged Interior Room Wall

During our site visit, the roof system appeared to be leaking. The contract included a one-year warranty for work completed. The USACE QAR subsequently contacted the contractor and requested he repair the roof. The USACE QAR advised that the contractor agreed to repair the roof and began work on 5 October 2005.

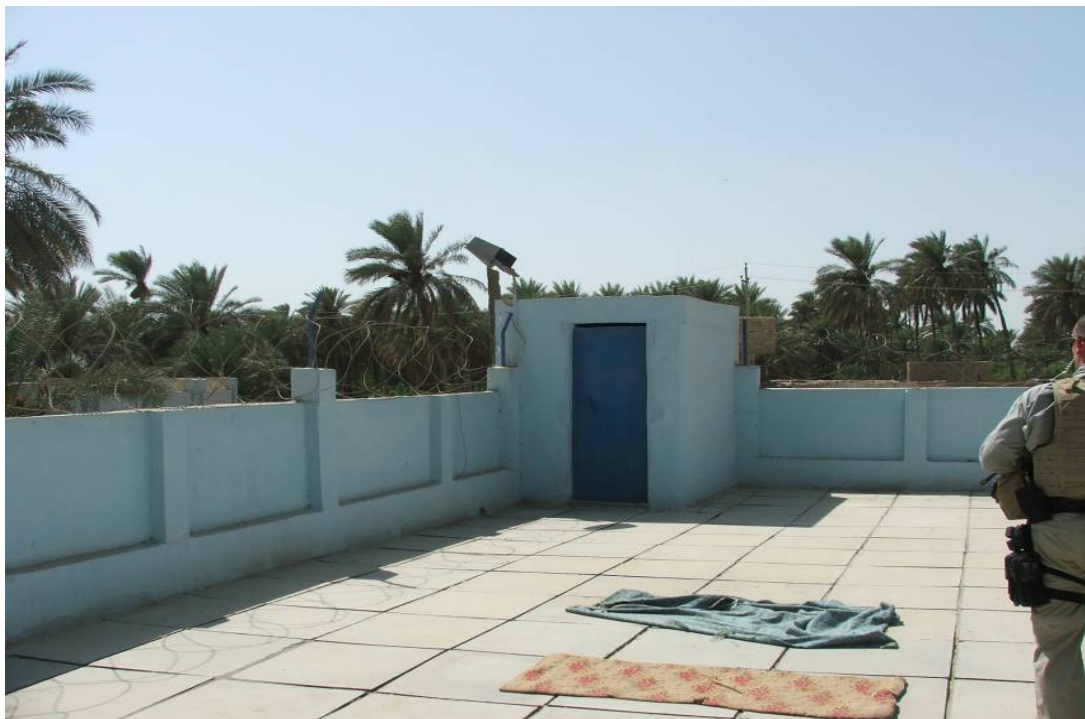
Site Photo 4. Tiled Roof

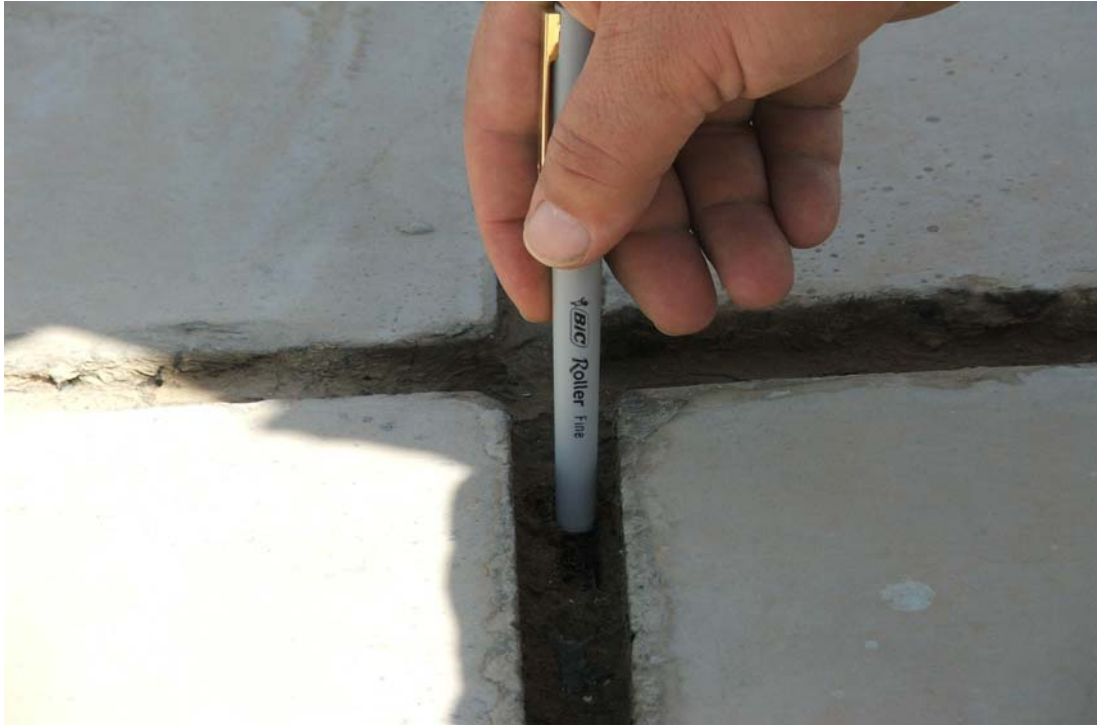
Site Photo 5. Mastic Seal between Concrete Roofing Tiles

The leaking roof and insufficient mastic sealing between the roof tiles were the only exceptions noted during our site visit. The contract required "the Contractor to provide a one-year unlimited warranty for all workmanship and mechanical equipment provided in the renovation of said facility." The USACE QAR, following our site visit, contacted the contractor and he agreed to fulfill his obligation under the warranty clause of the contract. Upon completion of the roof repair, the Seif Sa'ad Police Station renovation will result in an operational police station. This report does not contain any negative findings. Therefore, management comments were not required.

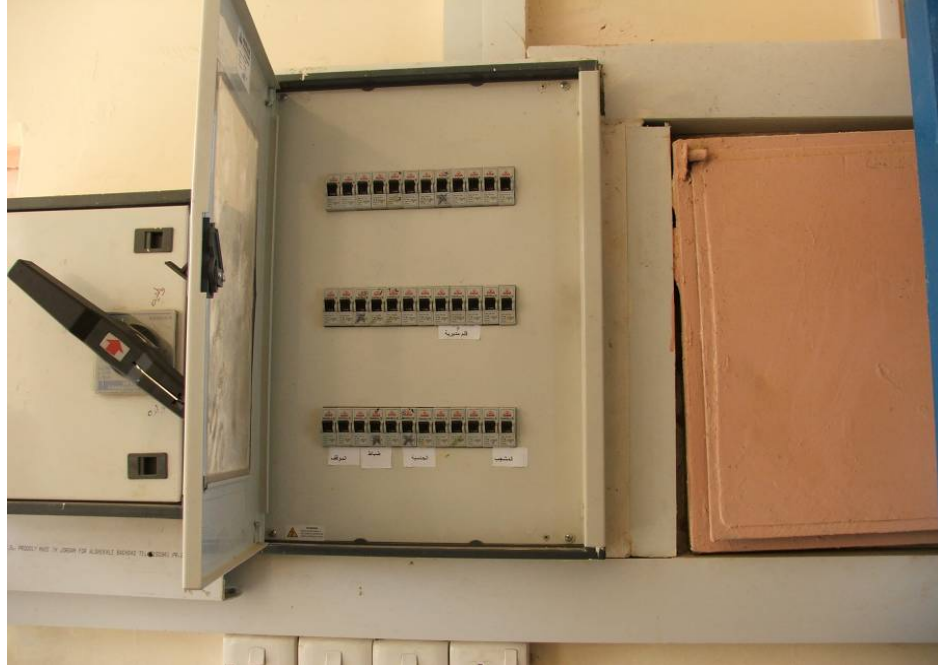
We also observed an installed circuit breaker panel and exterior corner lights. Site Photo 6 shows the circuit breaker panel. The exterior lighting can be seen in Site Photo 7.

Site Photo 6. Circuit Breaker Panel

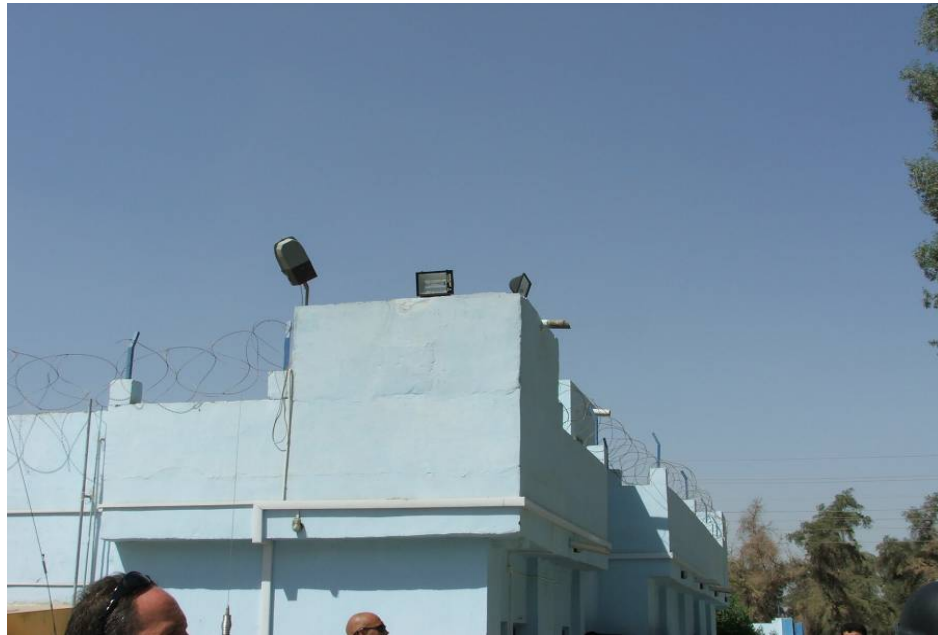
Site Photo 7. Exterior Mounted Lights on Police Station Walls

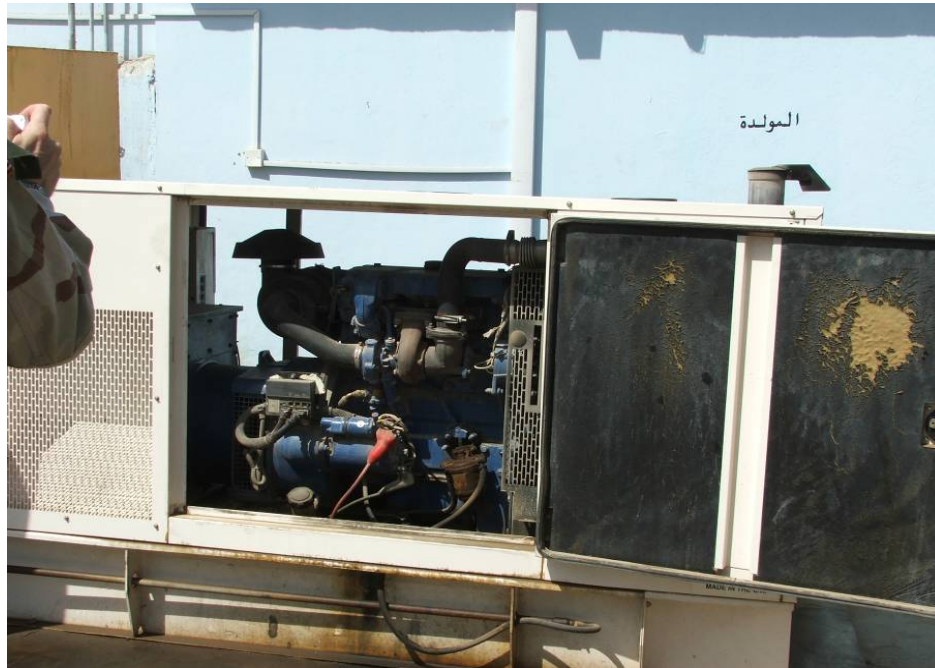
FGWPEP03ED0A24324, Year of Manufacture - 2004, Rated Power - 82.5 kVA, Rated voltage - 400/230 Volt, Rated Frequency - 50 Hz, and Rated Current - 119 A. The fuel lines between the fuel tank and the generator appeared to be leaking. We observed that one side of the fuel tank was propped up to allow fuel flow when fuel levels were low. It appears police station personnel did this after the project was completed. This action changed the alignment of the fuel lines and was responsible for the fuel leak. Site Photo 8 shows the installed 82.5 kVA generator.

Site Photo 8. 82.5 kVA Generator

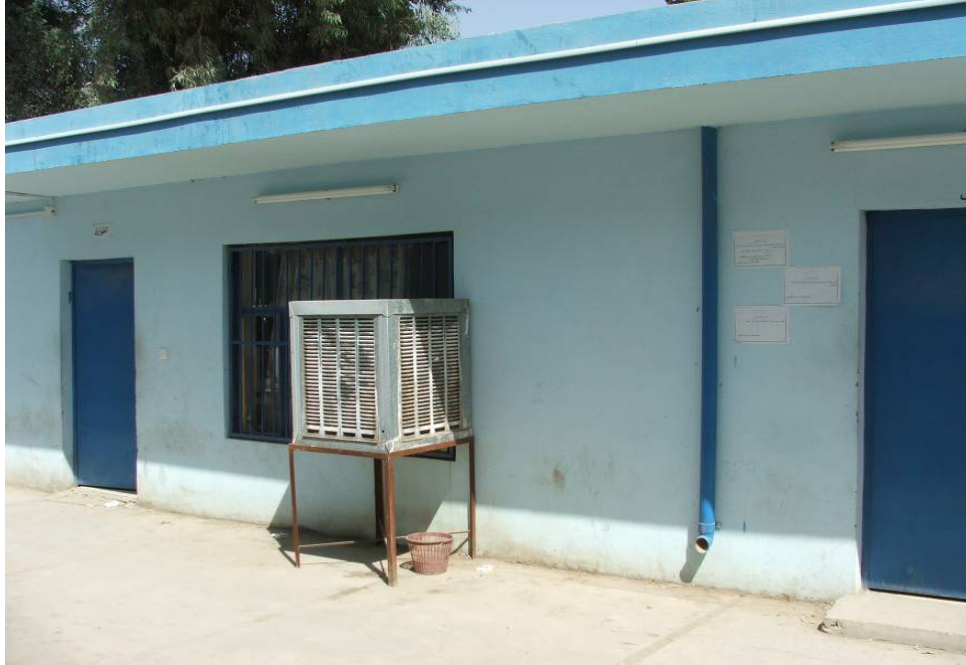
Contract Modification #P0002 required the construction of a two-room 40 m² building for offices and sleeping rooms, and a one-room 20 m² building for the Chief of Police's office. These requirements were combined into a single three-room building. The contract did not specify design requirements for new construction. Design drawings were not prepared and, therefore, construction could not be verified against an approved drawing set. Our site visit did verify the completed construction of a three-room building. The building consisted of the following: stucco and painted exterior walls, doors, windows, electrical systems, and a flat roof. The exterior of the three-room building can be seen in Site Photo 9.

Site Photo 9. Exterior of the Three-Room Building
