MUTHANNA VILLAGE ROADS  
SEGMENT 4  
GOVERNORATE OF  
MUTHANNA, IRAQ

**PROJECT NUMBER SIGIR-PA-06-055**

**JUNE 30, 2006**

SUBJECT: Report on Project Assessment of the Multhanna Village Roads Segment 4,  
Muthanna Governorate, Iraq (Report Number SIGIR-PA-06-055)

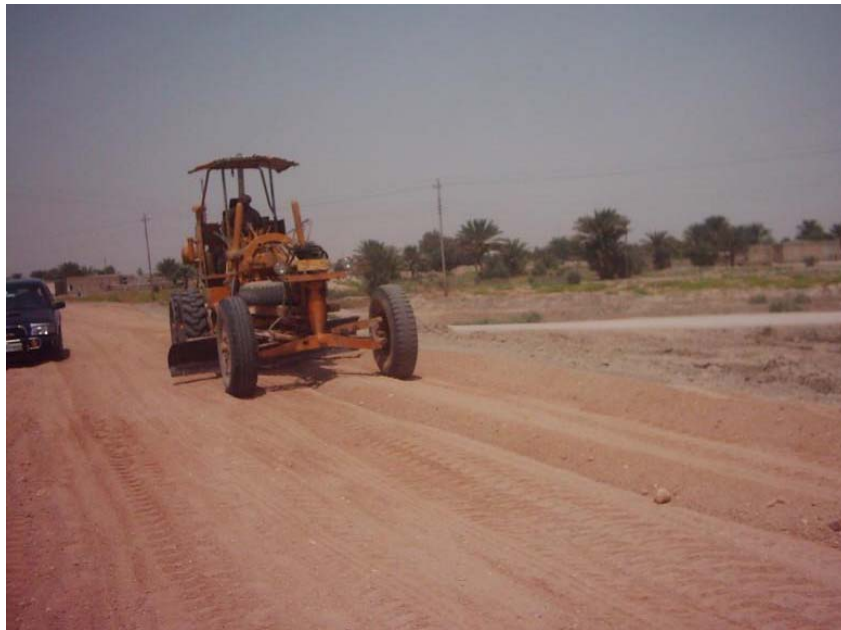
Based on a review of the quality assurance reports and photos, it appeared the contractor used suitable material for constructing the sub-base. The contractor would deliver the material to the roadway, and then spread and level the material with a motor grader as shown in Site Photo 1.

**Site Photo 1. Contractor motor grader leveling the sub-base – Photo provided by USACE**

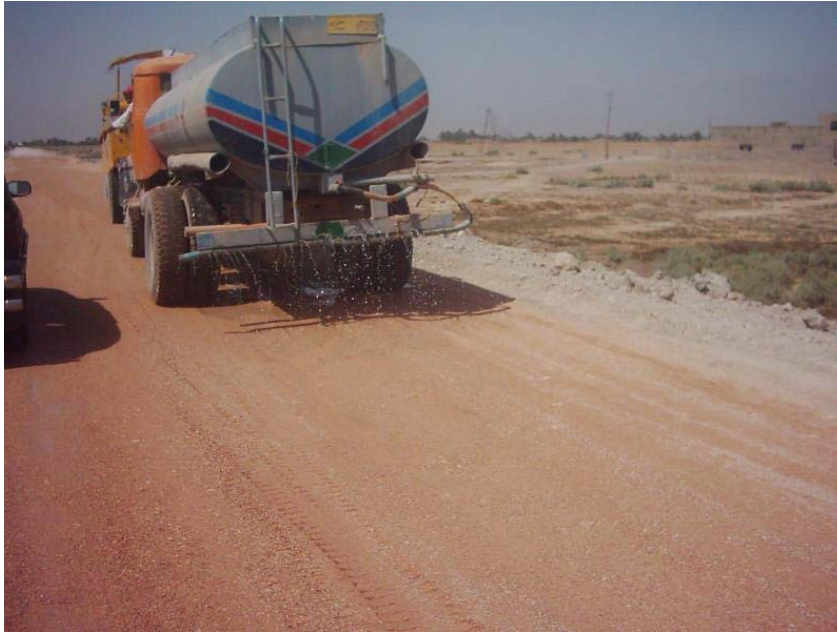
To achieve the compaction requirements stated in the Iraq Standard Specifications for Roads and Bridges, the Contractor added water as shown in Site Photo 2 to spread the sub-base material in order to achieve an optimum moisture content<sup>4</sup> to facilitate proper compaction.

**Site Photo 2. Water distributor adding moisture to the sub-base – Photo provided by USACE**

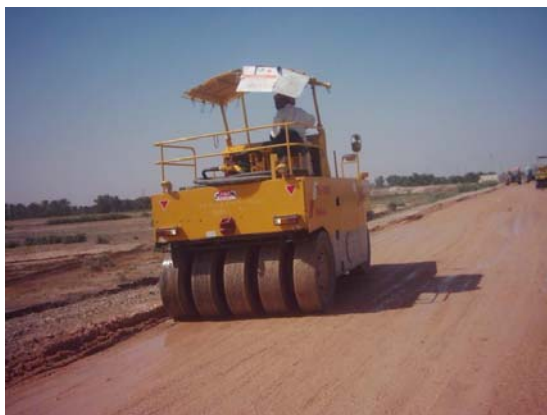
**Site Photo 3. Compacting the sub-base with a pneumatic rubber tired roller – Photo provided by USACE**

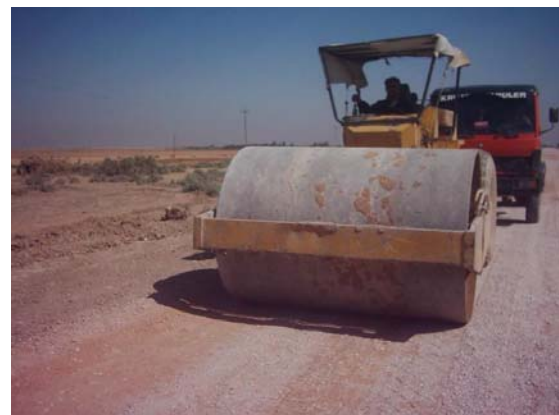
**Site Photo 4. Compacting the sub-base with a steel wheeled roller – Photo provided by USACE**

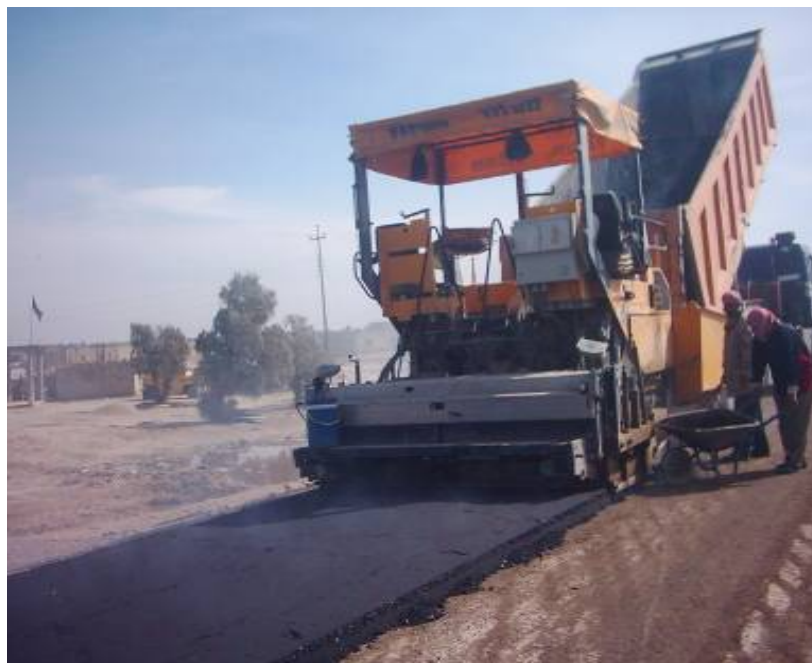
**Site Photo 5. Placing and spreading asphalt concrete pavement –Photo provided by USACE**

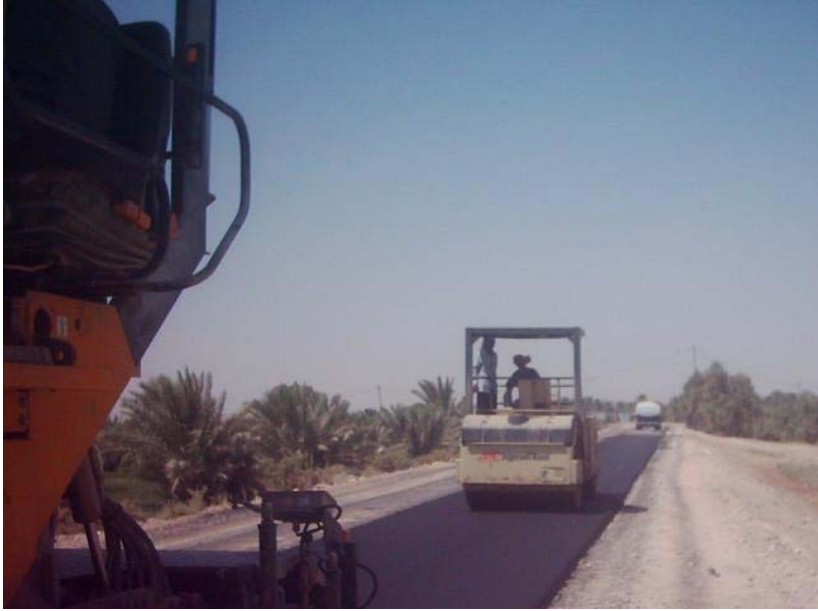
**Site Photo 6. Steel wheel roller behind paver compacting the asphalt concrete layer – Photo provided by USACE**

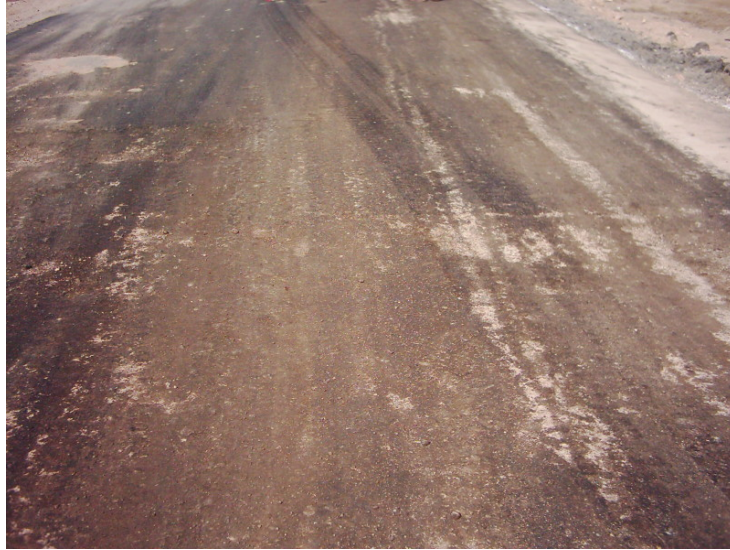
- The prime coat<sup>5</sup> application rate did not meet coverage requirements (not less than 0.5-1.2 liters per square meter) prior to paving between stations 14+500 and 14+650 (Site Photo 7).
- The outside edge of the pavement between stations 9+500 and 10+000 was uneven, resulting in some of the asphalt mix sloughing off from the mat (Site Photo 8).
- The improperly constructed fill to support the base and sub-base layers and the lack of adequate sub-base width in roadway sections between stations 0+000 and 9+5000 (Site Photo 9).

**Site Photo 7. Lack of sufficient prime coat on sub-base prior to paving – Photo provided by USACE**

The QAR’s deficiency log indicated the contractor took corrective action to fix the prime coat problems. According to the USACE RE, the pavement edge problems will not be corrected until the 1.75 m wide shoulders are in place alongside the paved base layer. Once the shoulder work is complete the deficient pavement areas will be repaired to their required widths. In the case of the problems shown in Site Photo 9, the USACE RE reported the road will be repaired when the additional borrow is available to widen the roadway fill structure (Diagram 3) in order to obtain the required section widths for the sub-base, pavement, and shoulders.

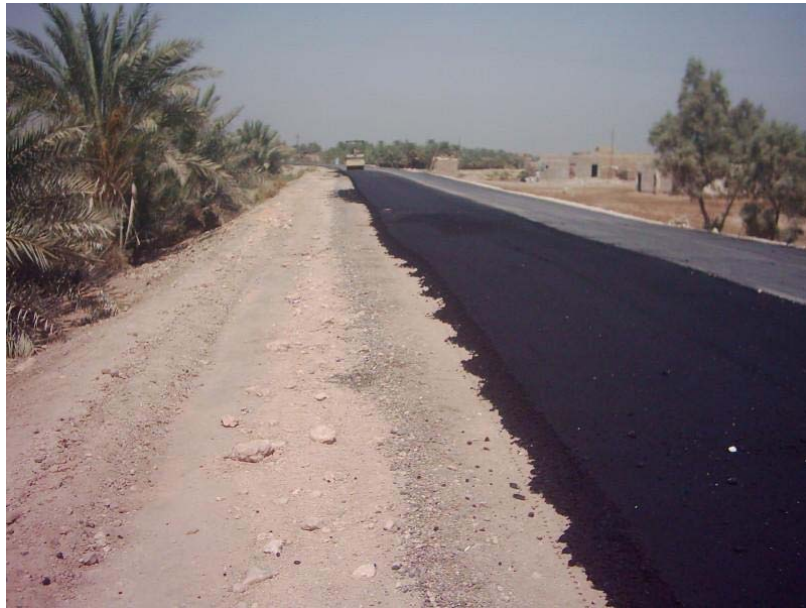
**Site Photo 8 – Asphalt along edge that is “Sloughing Off of the Mat” – Photo provided by USACE**

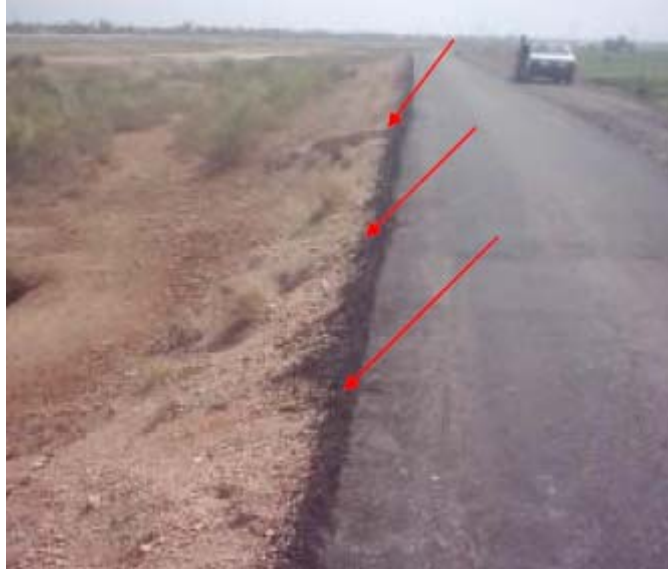
**Site Photo 9. Asphalt mix sloughing off along pavement edge due to poor sub-base and fill construction – Photo provided by USACE**

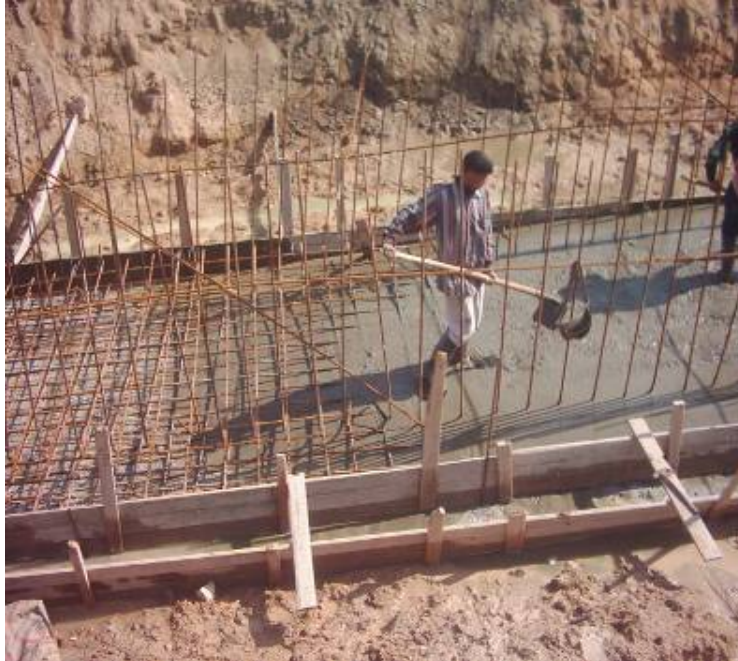
The box culverts, as documented in the QA reports, were constructed as cast-in-place reinforced concrete structures. Site Photo 10 shows the bottom slab for a box culvert under construction at station 19+300. Site Photo 11 shows a similar type box culvert at station 24+745, with the reinforcing steel in place for the top slab prior to concrete placement. In our review of the QA reports and the USACE Iraqi QAR's deficiency logs, we did not find any deficiencies associated with the construction of the box culverts.

**Site Photo 10. Construction of reinforced concrete box culvert foundation – Photo provided by USACE.**

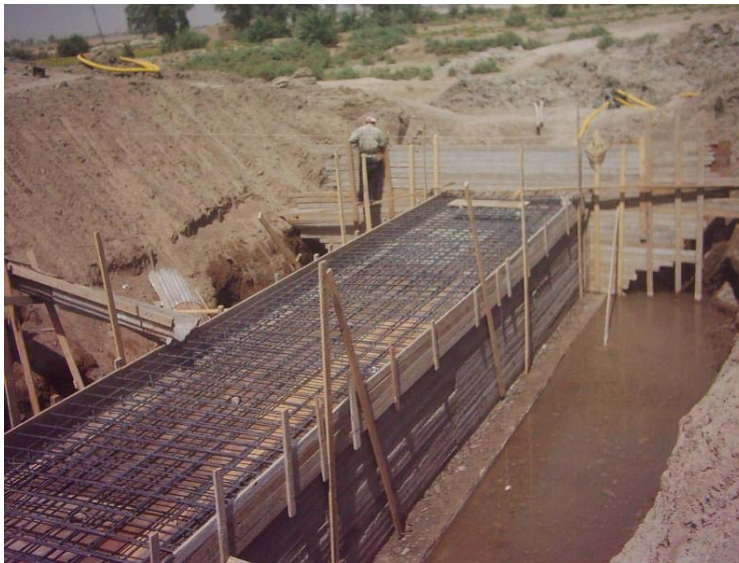
**Site Photo 11. Construction of reinforced concrete box culvert – Photo provided by USACE.**

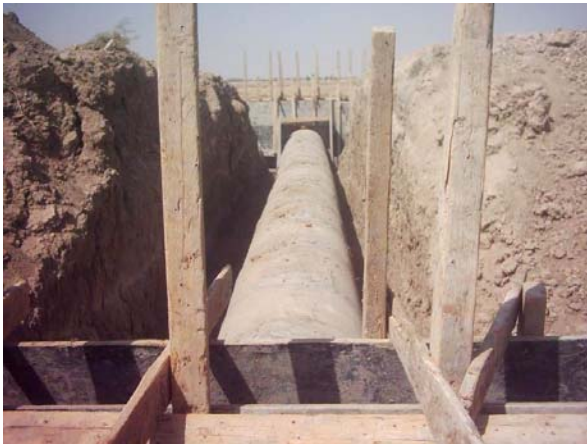
Site Photos 12 and 13 illustrate part of the construction process noted above. Based on the quantities shown in Table 1, over 90% of reinforced concrete pipe construction had been completed on the project as of 12 April 2006. The assessment team reviewed the USACE Iraqi QAR's deficiency logs and found the Iraqi QAR had documented deficiencies associated with the backfilling. In addition, the Iraqi QAR reported a deficiency when the contractor failed to prepare cube samples for concrete compressive strength tests or when the tests did not meet specification standards.

**Site Photo 12. Pipe culvert in trench –  
Photo provided by USACE**

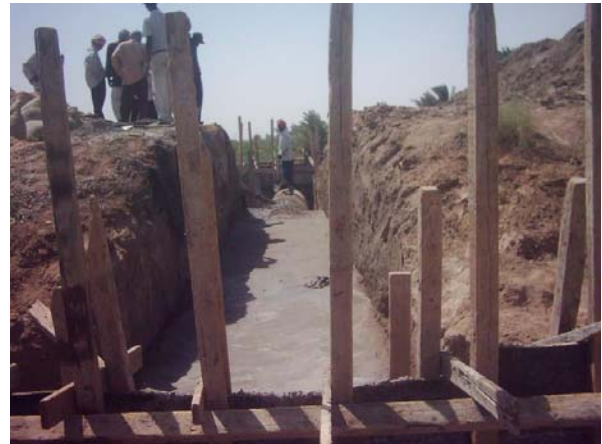
**Site Photo 13. Pipe culvert encased in concrete –  
Photo provided by USACE**
