DAHUK REHABILITATION CENTER
DAHUK, IRAQ

SIGIR PA-06-070
JANUARY 08, 2007

SUBJECT: Report on Project Assessment of the Dahuk Rehabilitation Center, Dahuk,
Iraq (Report Number SIGIR-PA-06-070)

Dahuk Rehabilitation Center Dahuk, Iraq

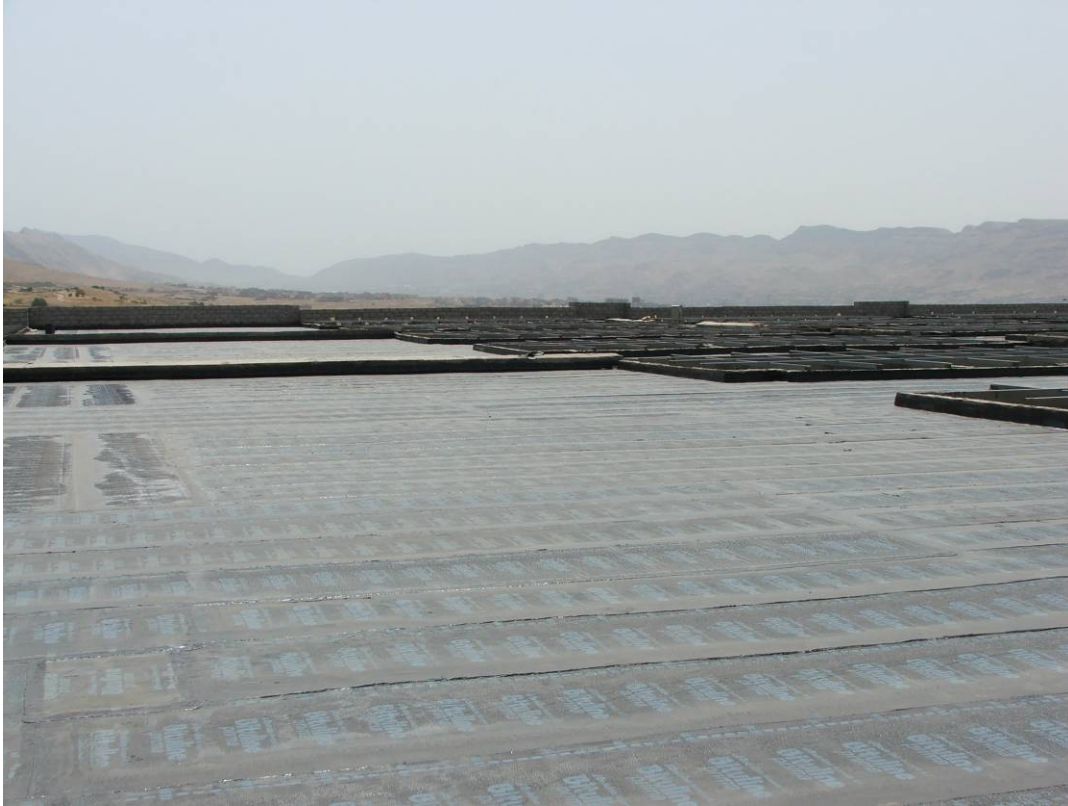
Site Photo 4 is a large scope display of the membrane's adhesiveness to the roof forming a strong membrane surface bond along with even seams. Based on the assessment team's observation, the membrane was properly installed and evenly distributed with straight and parallel seams over the entire roof.

Site Photo 4. Large scale view of bituminous waterproofing membrane.

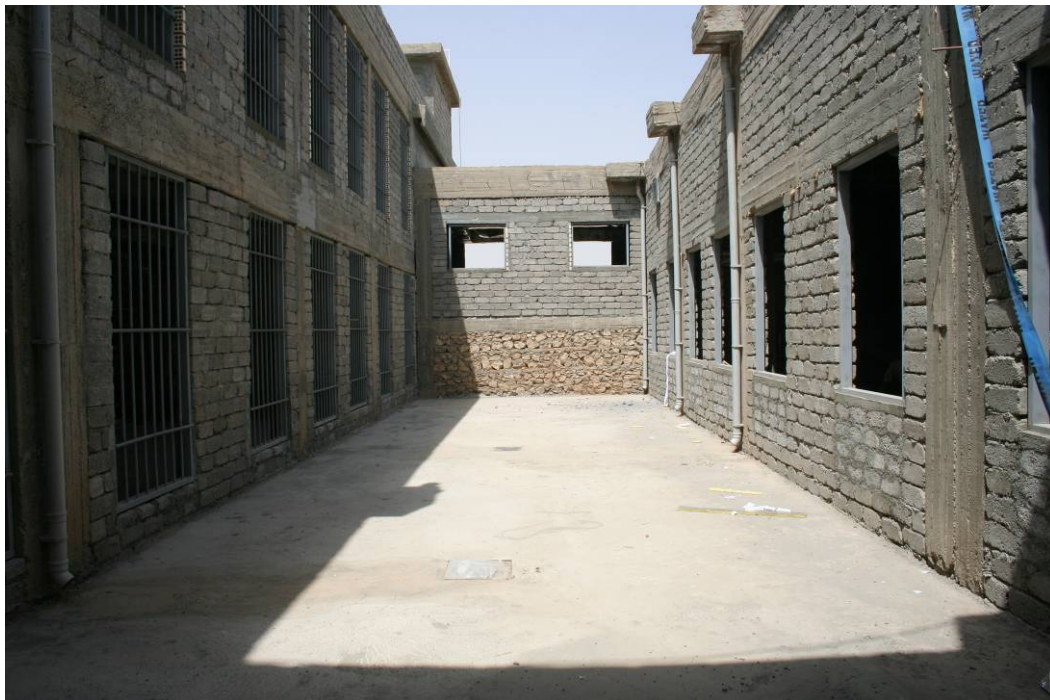
Installation of the pre-fabricated protection bars throughout the facility was the next construction step observed by the assessment team. In Site Photo 6, security protection bars were installed in the large windows on the left side of the picture while the smaller windows on the right side were pending installation.

Site Photo 6. Ground floor installation of security protection bar assemblies.

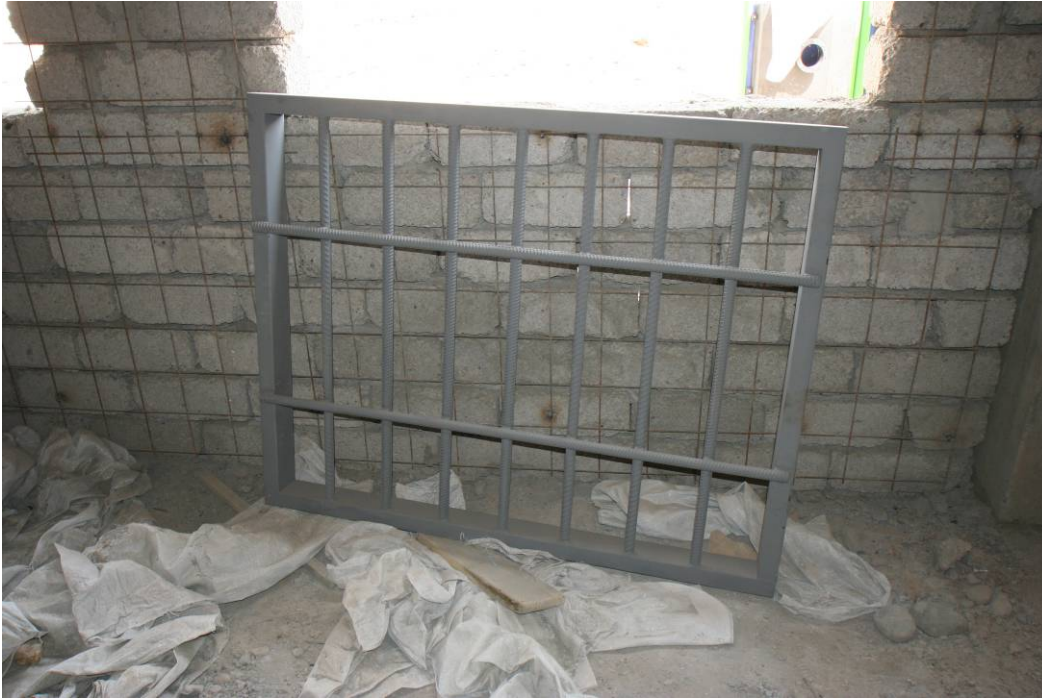
Security protection bar assemblies were manufactured in the shop to fit the various opening sizes throughout the facility. Site Photo 7 shows the inside of a window waiting the installation of a pre-fabricated protection bar assembly. The assessment team observed that security bar spacing was uniform within the frame and the assembly was painted before installation in an effort to reduce future corrosion. In addition, steel reinforcement mesh was installed inside the concrete masonry unit (CMU) wall.

Site Photo 7. Pre-fabricated security protection bar assembly staged for installation.

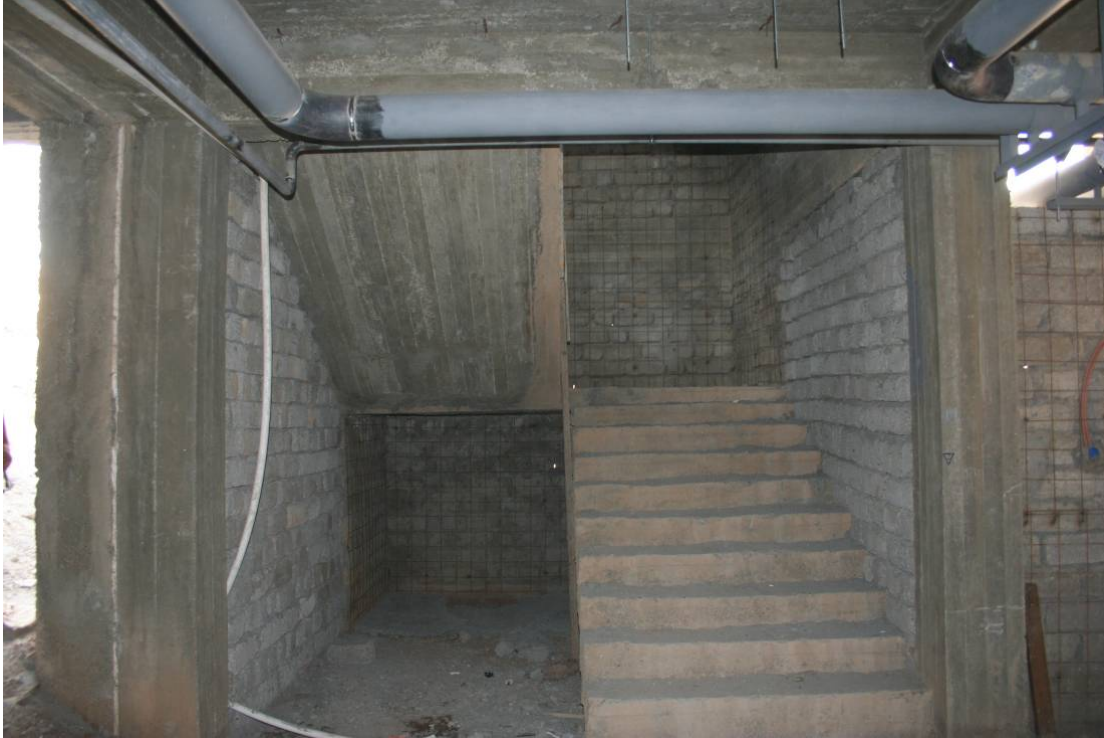
Site Photos 8 and 9 show stairwells in pre-finished condition. Site Photo 8 shows steel reinforcement mesh attached to the exterior of the Concrete Masonry Unit (CMU) wall awaiting application of the finishing layer of concrete. The mesh will improve bonding between the CMU wall and the finish layer while reducing cracking in the finish layer. Site Photos 8 and 9 show that the steps were cast level and square. In addition, the absence of concrete separation or honey-combing attests to the structural integrity of the casting.

Site Photo 8. Pre-finish front view of poured concrete stairs.

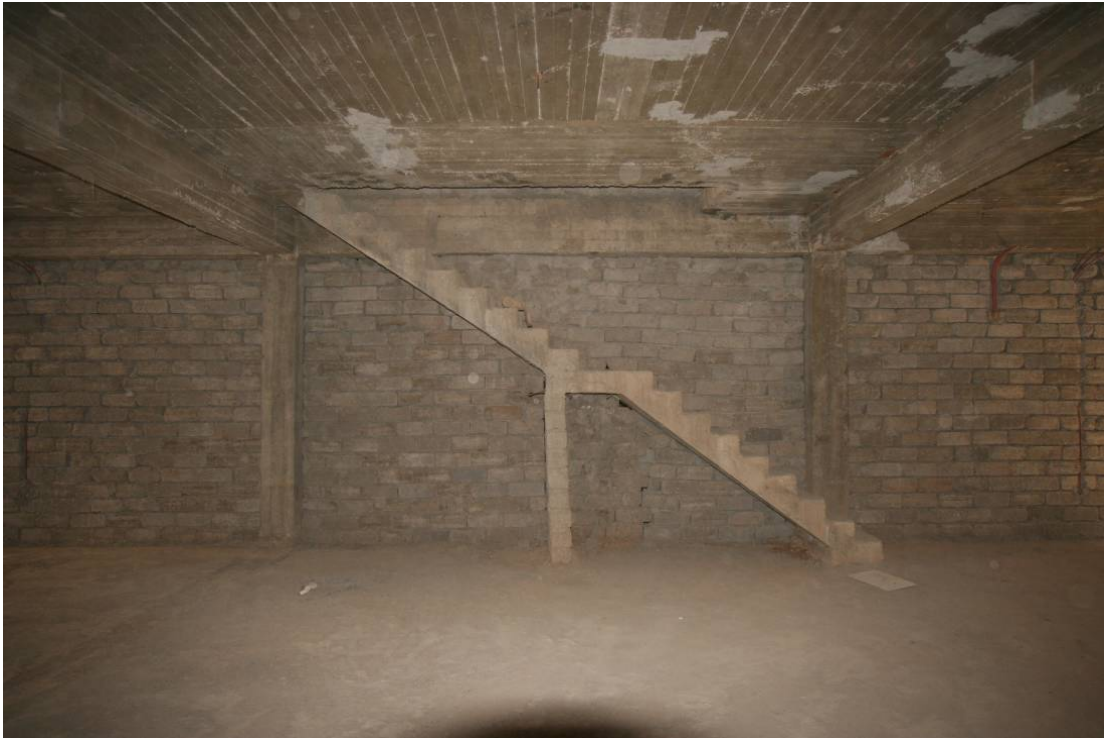
Site Photo 9. Pre-finish side view of poured concrete stairs.

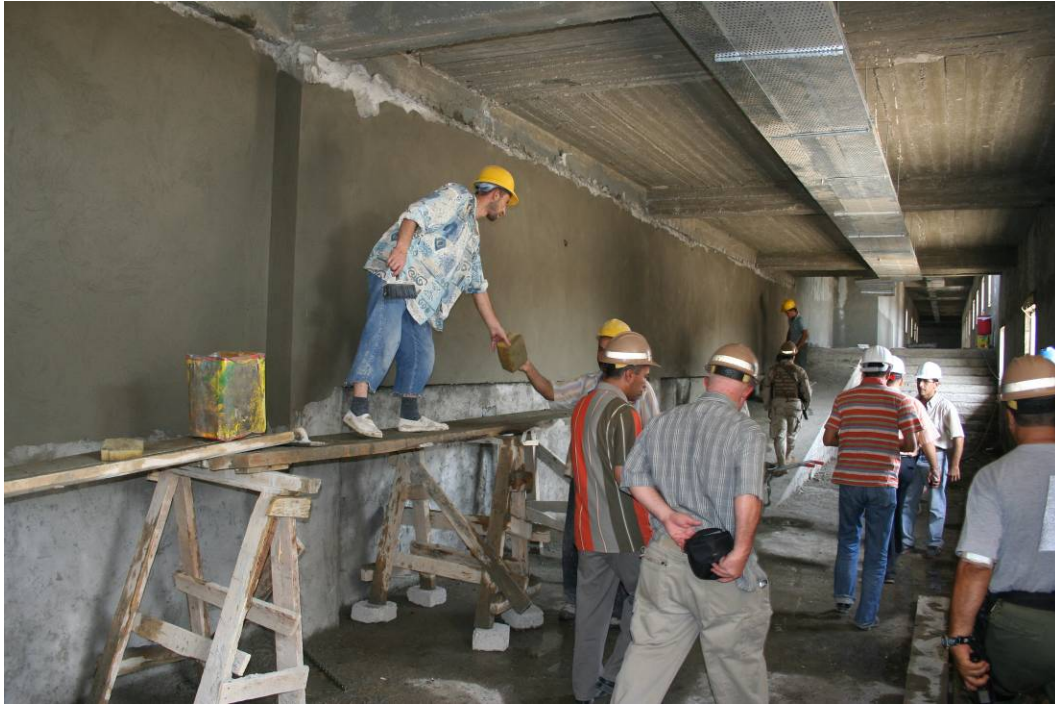
beams. The application of a finish layer of concrete is one of the finishing steps that must be accomplished on the walls of the facility to create a smooth appearance. In Site Photo 10, workers apply a thin coat of concrete or plaster to the wall of the facility. The finished surfaces appeared smooth, uniformly thick, and straight with even corners. Site Photo 11 shows finished interior walls while Site Photo 12 displays a finished external wall (left side of image) and unfinished external wall (right side of image).

Site Photo 10. Workers finish an interior wall with a thin layer of concrete (plaster).

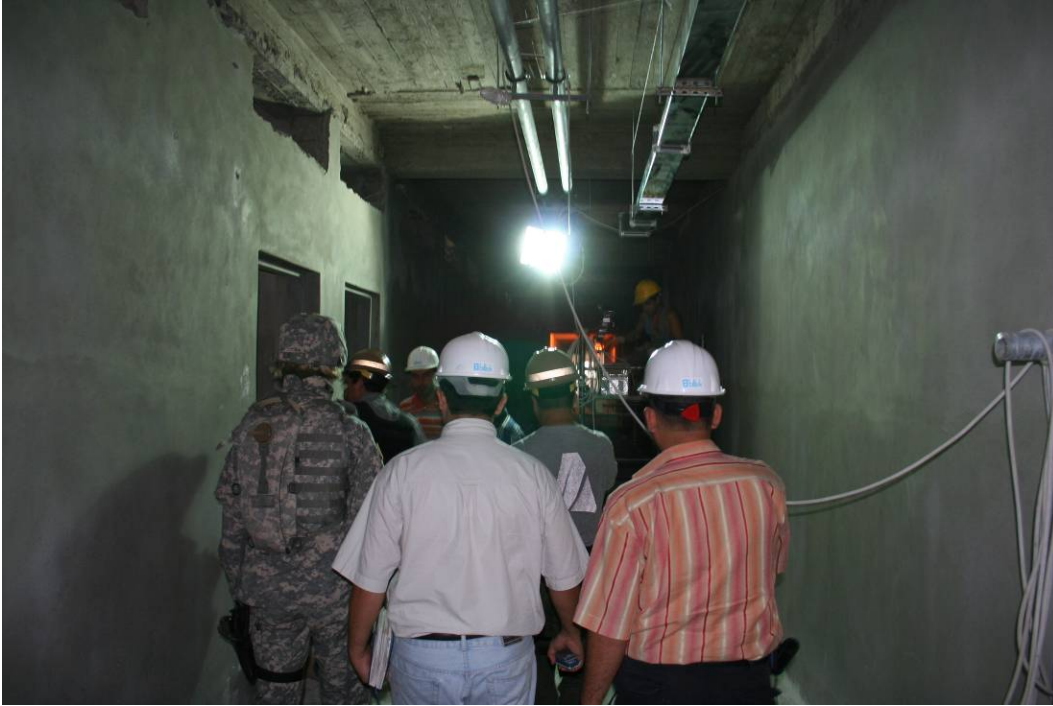
Site Photo 11. Concrete finished interior walls.

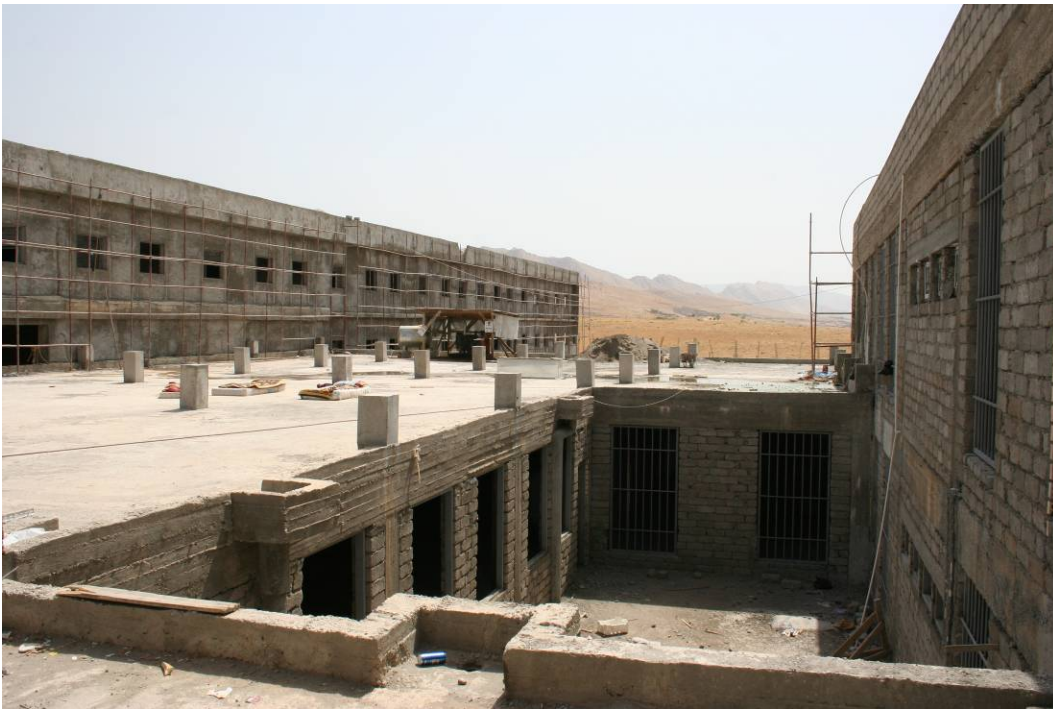
Site Photo 12. Left side of photo shows completed exterior finish work, while right side shows an unfinished wall.

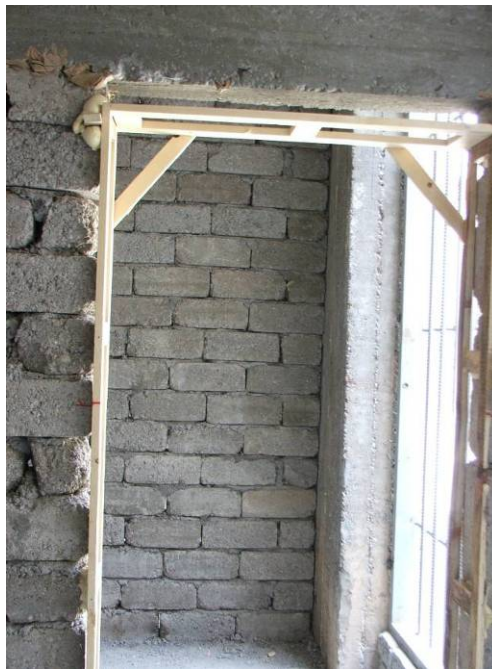
Site Photo 14 shows a wooden frame installed in a doorway. The left side of the photo shows that self-hardening epoxy foam was used to securely position the wooden frame inside the CMU wall opening. Subsequently, the CMU block will be plastered and voids around the frame filled in. The final step will be to install the finished frame and door.

Site Photo 14. “Roughed-in” wooden doorway frame was positioned before finishing CMU wall.

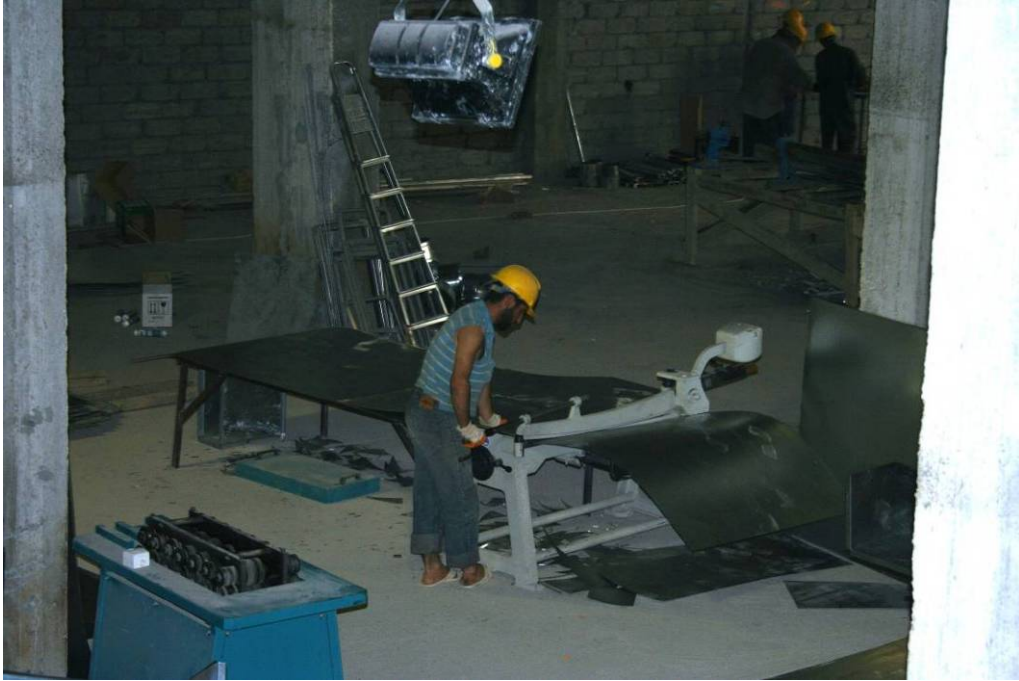
Much like the process to pre-fabricate security protection bar assemblies mentioned earlier in this report, the assessment team found that the contractor established a ductwork fabrication room or shop. The fabrication shop was equipped with proper tools and was large enough to effectively function as the manufacturing center for sheet metal pieces and ductwork used throughout the rehabilitation facility. In Site Photo 15, a worker uses a “sheer bar” to cut sheet metal stock to a proper dimension in order to facilitate shaping in subsequent fabrication steps.

Site Photo 15. Centralized sheet metal shop was used to pre-fabricate ducts and other metal assemblies.

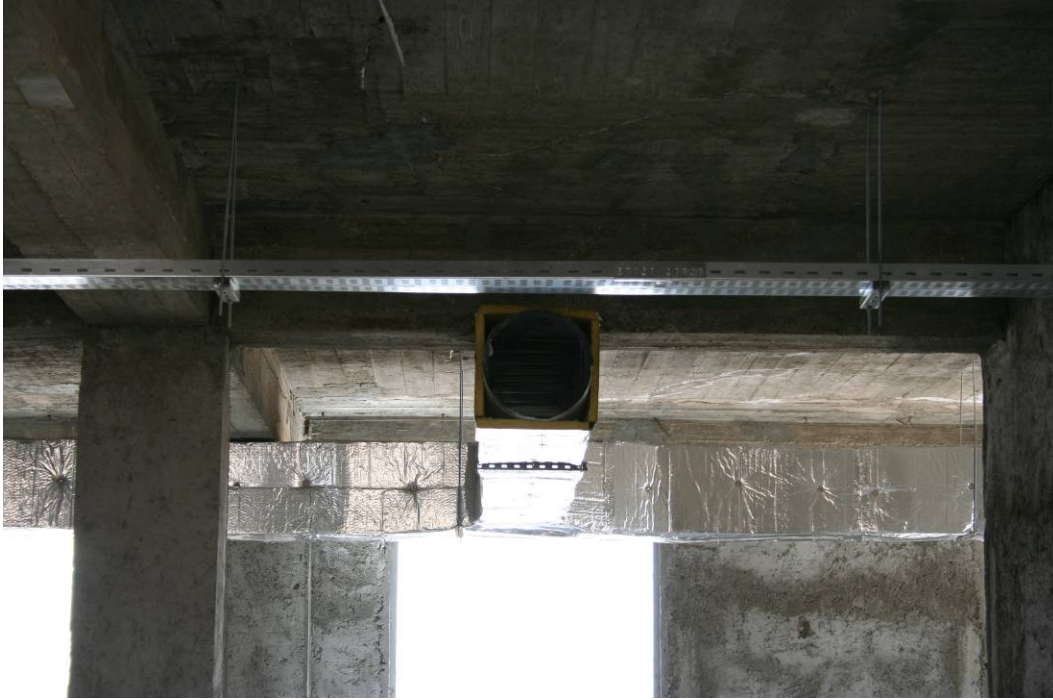
Site Photo 16 shows an insulated duct and cable tray attached to the ceiling in preparation of final construction. During the site assessment, the inspectors observed that the ducts, trays, and pipes were hung with hangers and were attached an equal distance apart and level. In addition, hangers appeared to be made with new materials of sufficient size.

Site Photo 16. Ducts and cable trays throughout the facility appeared professionally installed.

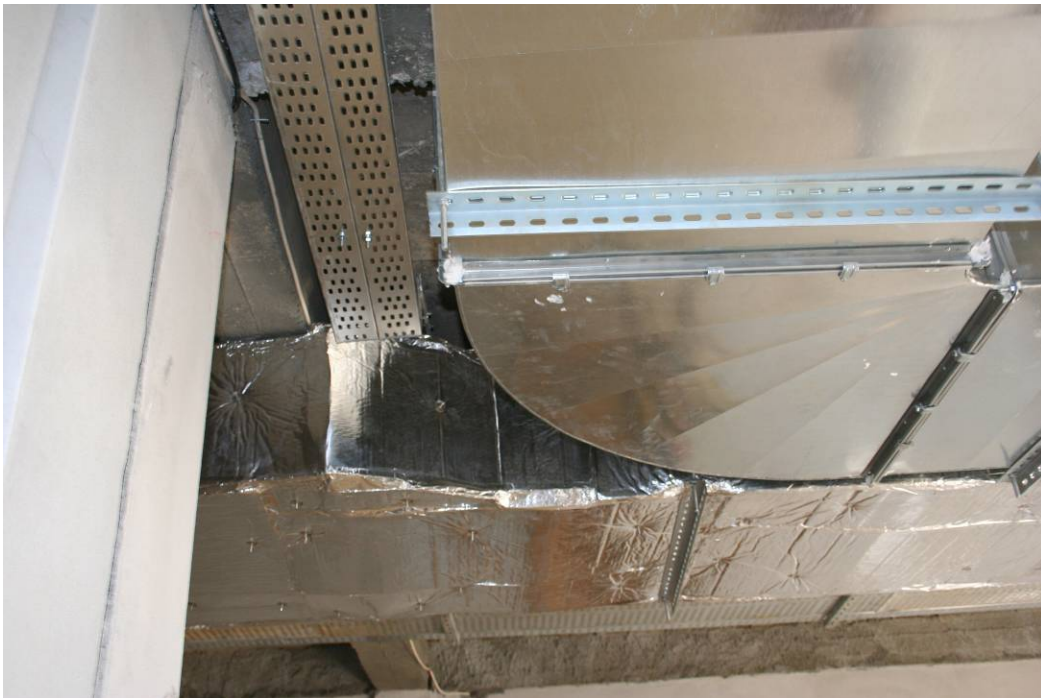
Site Photo 17 shows the professional construction techniques used throughout the facility to install cable trays and ducts. Duct insulation wrap appeared complete and smooth. All cable trays and ductwork observed were level and hung an equal distance from the ceiling.

Site Photo 17. Cable tray and duct work were neatly installed in a confined area.

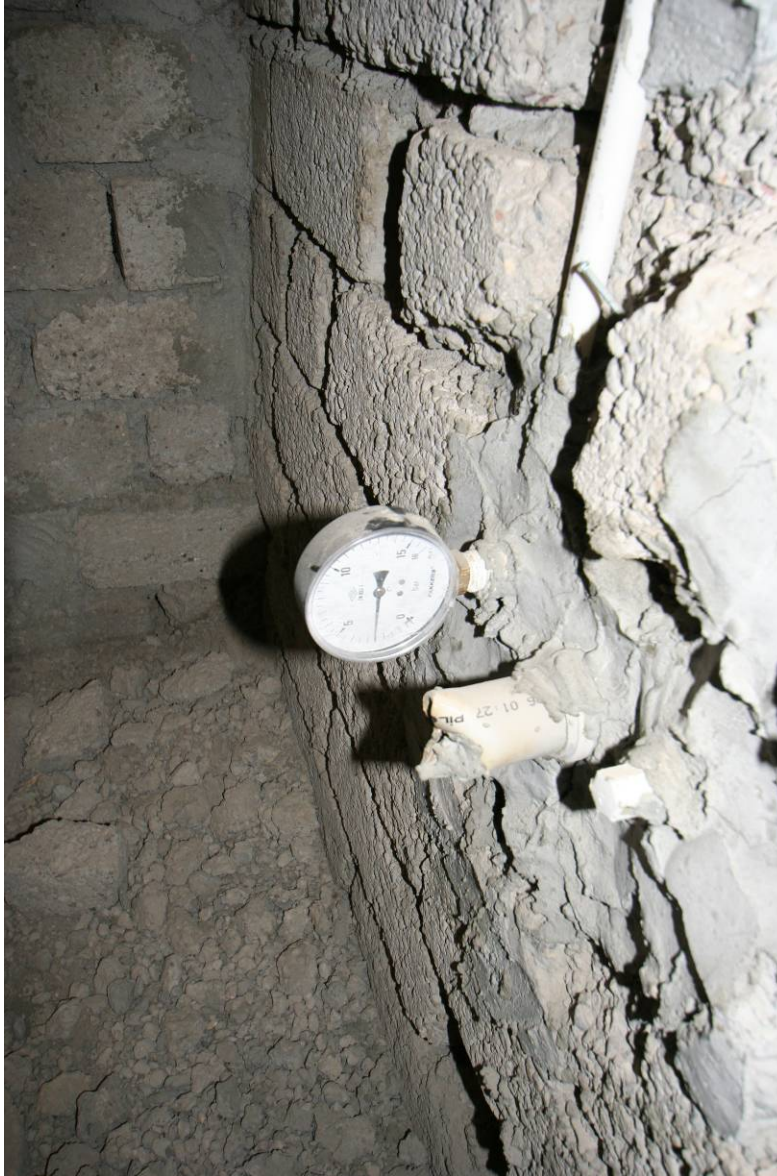
At the time of the assessment team's visit, the installation of the wastewater pipes, rainwater pipes, and domestic water supply system pipes were complete. The contractor was in the process of conducting pressure tests on the domestic water supply system pipes. In Site Photo 18, a pressure meter is attached to a pressurized domestic water line.

Site Photo 18. Domestic water line pressure test was in progress.

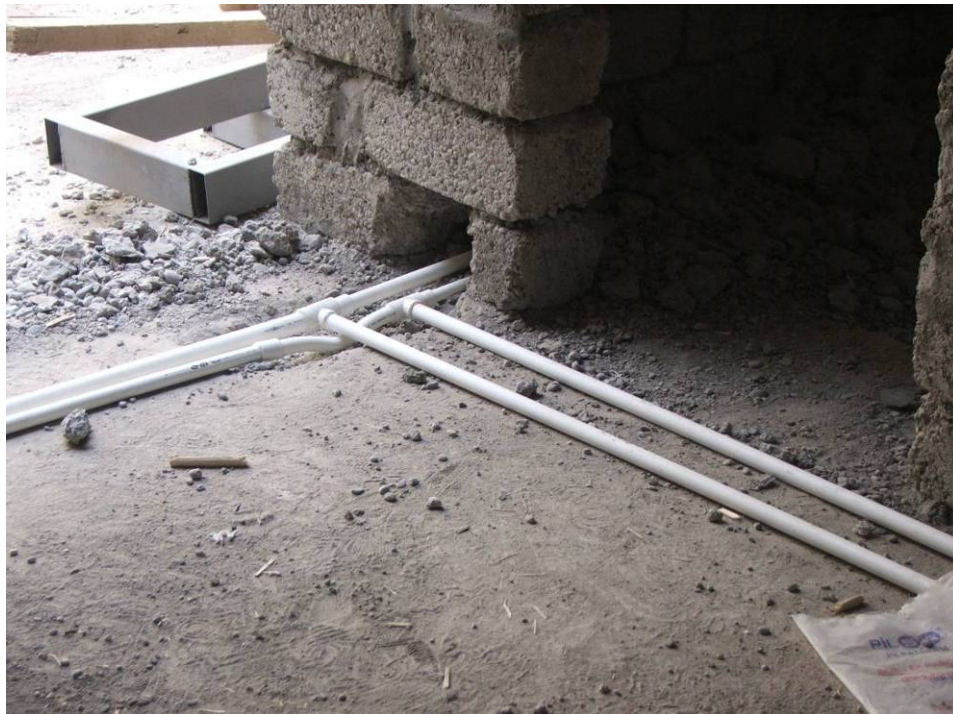
In Site Photos 20 and 21, domestic water piping runs along the floor and wall of a bathroom area waiting successful pressure testing before applicable wall or floor finishing could be completed. The photo shows even installation of clean new PVC piping. In addition, the pipes were fitted cleanly together in a professional manner.

Site Photo 20. PVC pipe run along the floor was pressure tested before installation of floor tile.

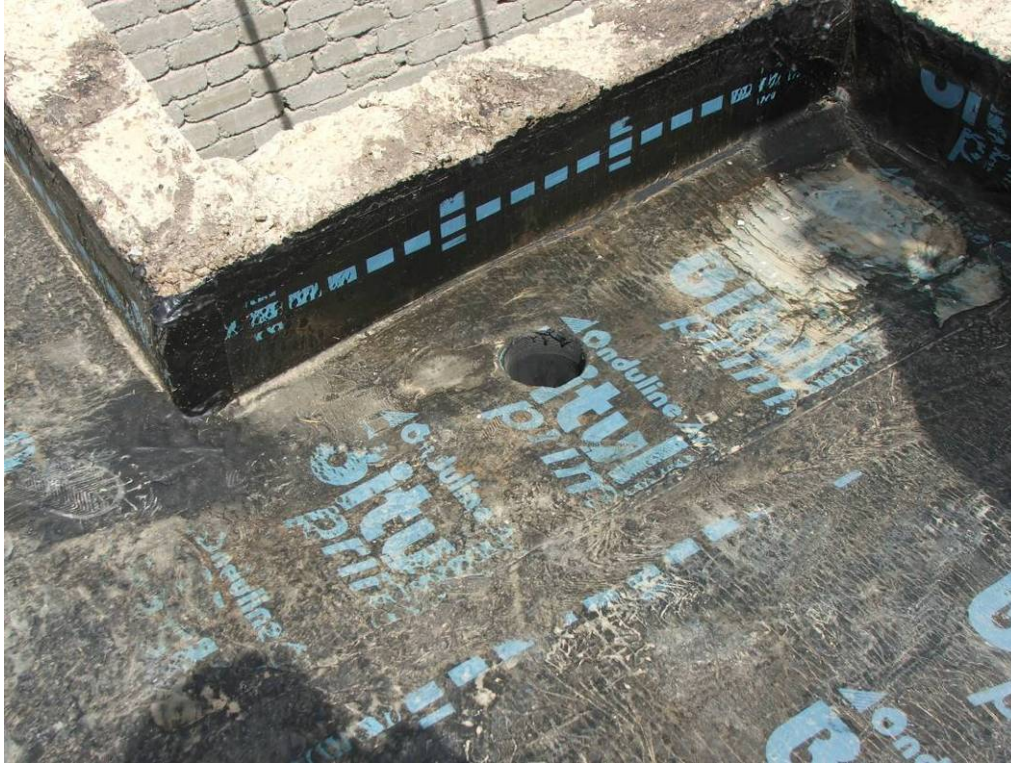
Installation of rainwater piping was completed by the time of the assessment team's site visit. Site Photo 23 shows the basin on the topside of the roof where the rainwater will collect and Site Photo 24 shows the positive connection rainwater piping used to drain the roof. It appeared that the drain pipe was securely attached to the wall.

Site Photo 23. Topside view of rainwater collection basin with drain piping.
