ELECTRICAL SUBSTATION
SUSTAINMENT
BASRAH, IRAQ

SIGIR PA-06-082
SIGIR PA-06-083
SIGIR PA-06-084
SIGIR PA-06-085
SIGIR PA-06-086
JANUARY 10, 2007

SUBJECT: Report on Electrical Substation Sustainment, Basrah Iraq
(Report Numbers SIGIR PA-06-082, 083, 084, 085, and 086)

Electrical Substation Sustainment Basrah, Iraq

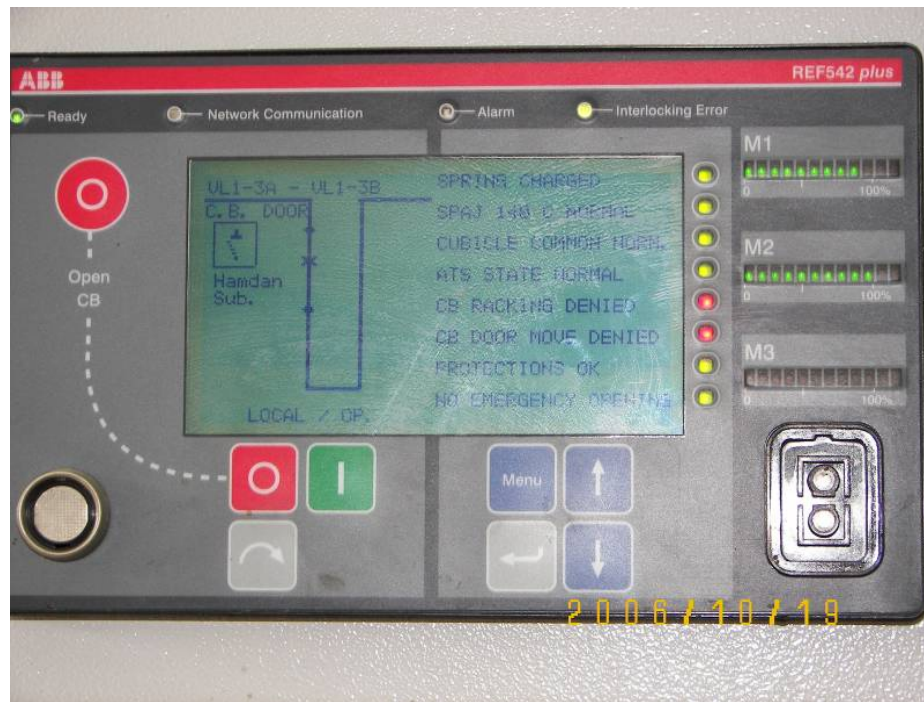
Our site assessment validated that both the Al Seraji and Al Hamdan substations were connected to the power grid and were both operating. The Al Seraji substation had full transmission power connected to the 33/11 kV transformer but only two of the thirteen distribution feeders were energized. SDC engineers stated that the other eleven distribution feeders were not energized because transmission power was not sufficient to operate all thirteen distribution feeders. The Al Hamdan substation had transmission power to only one 33/11 kV transformer, which provided power to energize five of the thirteen distribution feeders. The second transmission line was not energized because an upstream substation was undergoing maintenance.

Site Photo 1 is a panel display showing the closed circuit that is energizing a distribution circuit.

Site Photo 1. Switch panel display illustrating the closed distribution circuit

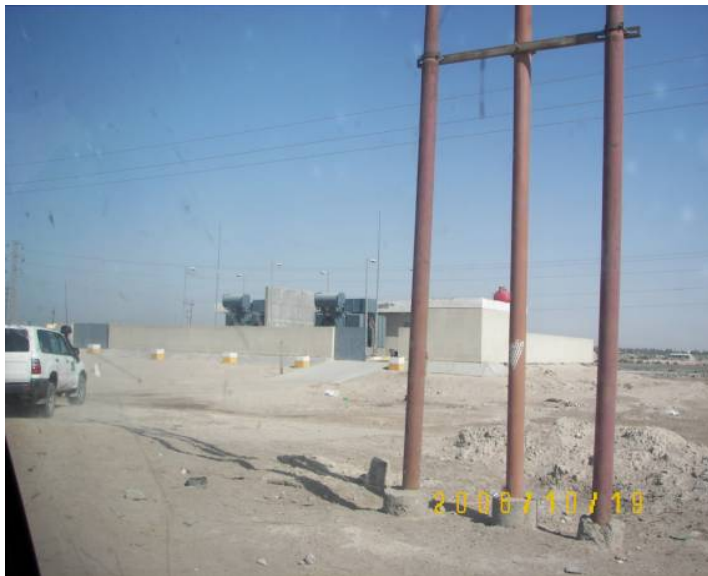
The current sustaining assessment of the Al Seraji and Al Hamdan substations showed that the substation buildings, guardhouses, and perimeter walls remained in good repair. Each substation was secured by security guards and two substation operators, who were present at the time of our visit. Site Photo 2 illustrates the condition of the exterior perimeter of the Al Hamdan substation at the time of our visit. Site Photo 3 illustrates the condition of the interior perimeter walls and transformers at the Al Seraji substation.

Site Photo 2. Al Hamdan substation perimeter walls

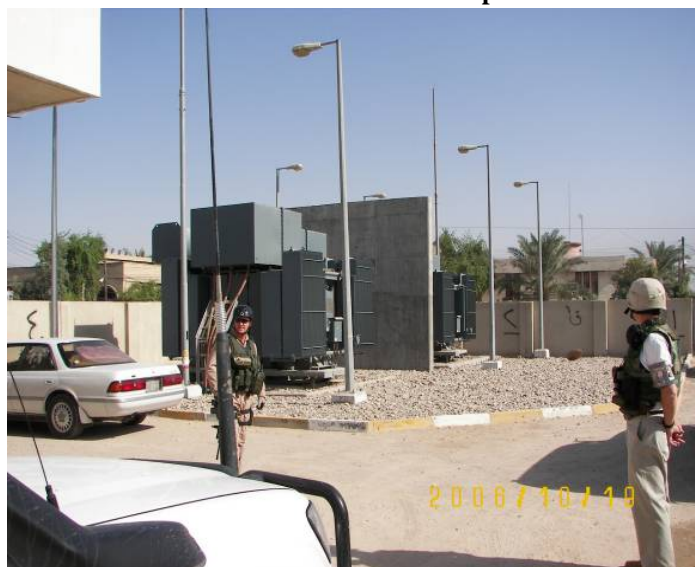
Site Photo 3. Al Seraji substation view of internal walls

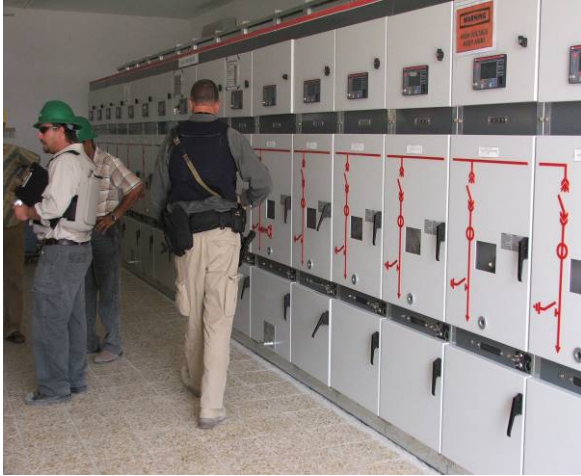
Site Photo4. Al Hamdan substation distribution 11 kV switchgear panels at the time of the initial assessment

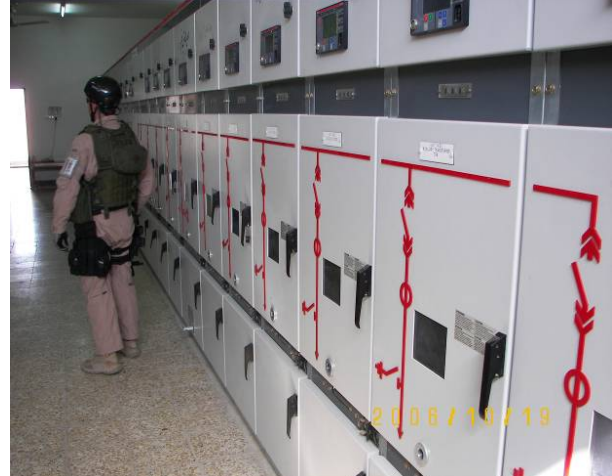
The contract and design required installing 33 kV and 11 kV switchgear in the newly constructed substation buildings. The prior on-site assessment verified the installation of the switchgear; however, it had not yet been energized. The current site assessment validated that the Al Hamdan 11 kV switchgear was operating and providing power to five of the thirteen distribution feeders. The Al Seraji switchgear was also operating and providing power to two of the thirteen distribution feeders. Site Photos 4 through 7 show no significant change in the switchgear condition between the first and second assessments.

Site Photo 5. Al Hamdan substation distribution 11 kV switchgear panels at the time of the second assessment

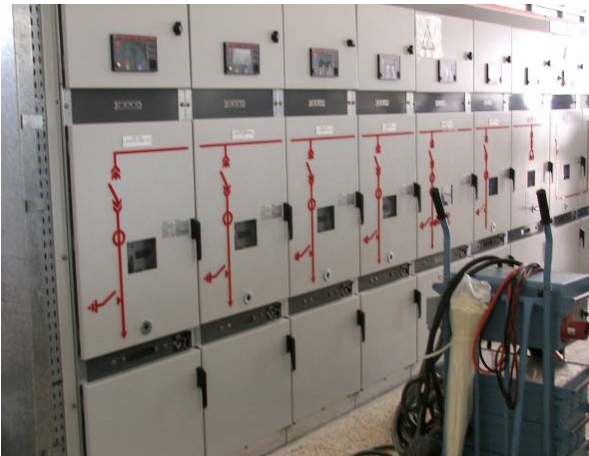
Site Photo 6. Al Seraji substation distribution 11 kV switchgear panels at the time of the initial assessment

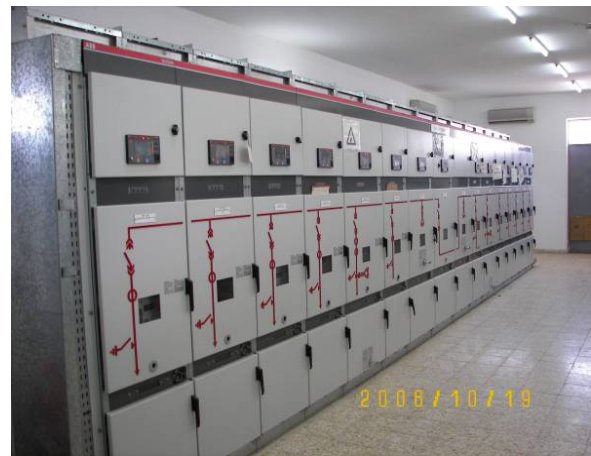
Site Photo 7. Al Seraji substation distribution 11 kV switchgear panels at the time of the second assessment

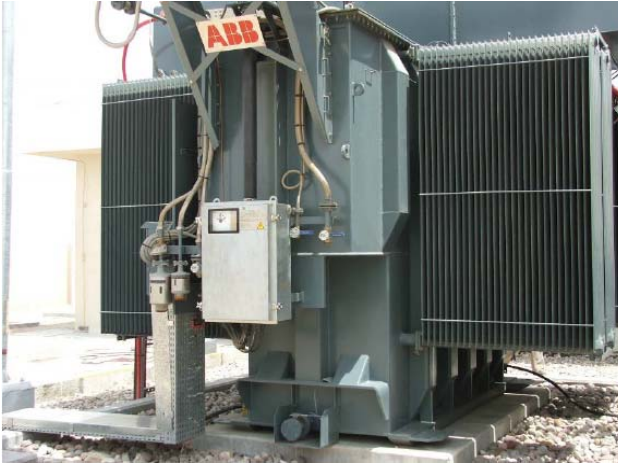
Site Photo 8. Al Hamdan 33/11 kV transformer at the first assessment

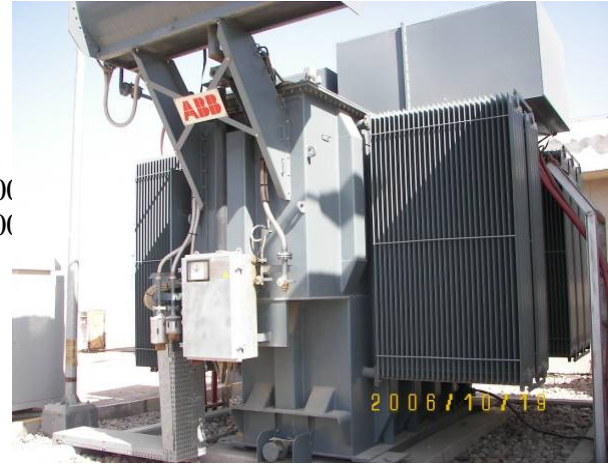
were installed on concrete pads with firewalls. The current assessment confirmed that the transformers remained in good repair and three of the four were operational. The fourth transformer, located at Al Hamdan was connected to the transmission feeder but was not operating because of maintenance being performed at the upstream transmission substation. Site Photos 8 through 11 shows no significant change in the transformers' condition between the first and second assessments.

Site Photo 9. Al Hamdan 33/11kV transformer at the second assessment

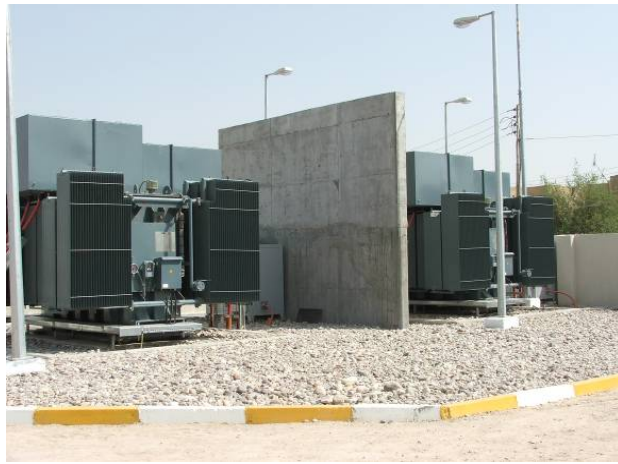
Site Photo 10. Al Seraji 33/11 kV transformer at the first assessment

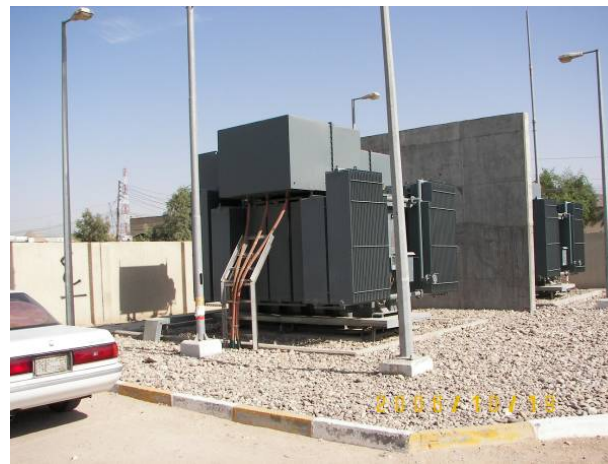
Site Photo 11. Al Seraji 33/11kV transformer at the second assessment

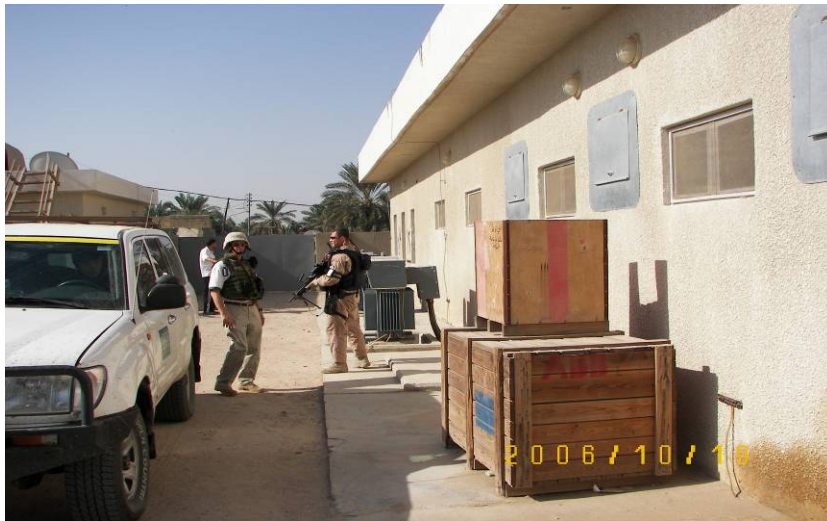
The contractor delivered manuals, drawings, and spare parts required by the contract to each substation. We observed two unopened wooden boxes on the sidewalk perimeter at the Al Seraji substation building during our site visit. During a follow-up discussion, we learned that these boxes probably contained the spare parts delivered by the contractor. The SDC officials responsible for operating the substation said the spare parts are not officially delivered until they are opened and the contents inventoried in the presence of a contractor or government representative. The GRS resident engineer was unaware that the boxes were not opened and agreed to work with the MOE to open them, observe the contents and secure them in the SDC warehouse. Site Photo 12 shows the boxes thought to contain the spare parts delivered to the Al Seraji substation.

Site photo 12. Boxes thought to contain the spare parts delivered to the Al Seraji substation

3. Spare parts, drawings, and operating manuals were provided as required by the contract. However, confusion over the official acceptance process appears to have caused spare parts to be left in unopened boxes next to at least one substation for over one year. Neither the contractor nor the GRS Resident Engineer was notified by SDC that the spare parts boxes had not been opened.
