MINISTRY OF DEFENSE BUILDING  
BAGHDAD, IRAQ

SUSTAINMENT ASSESSMENT

**SIGIR PA-07-102**  
**JULY 17, 2007**

SUBJECT: Report on Sustainment Assessment of the Ministry of Defense Building  
Baghdad, Iraq (Report Number SIGIR PA-07-102)

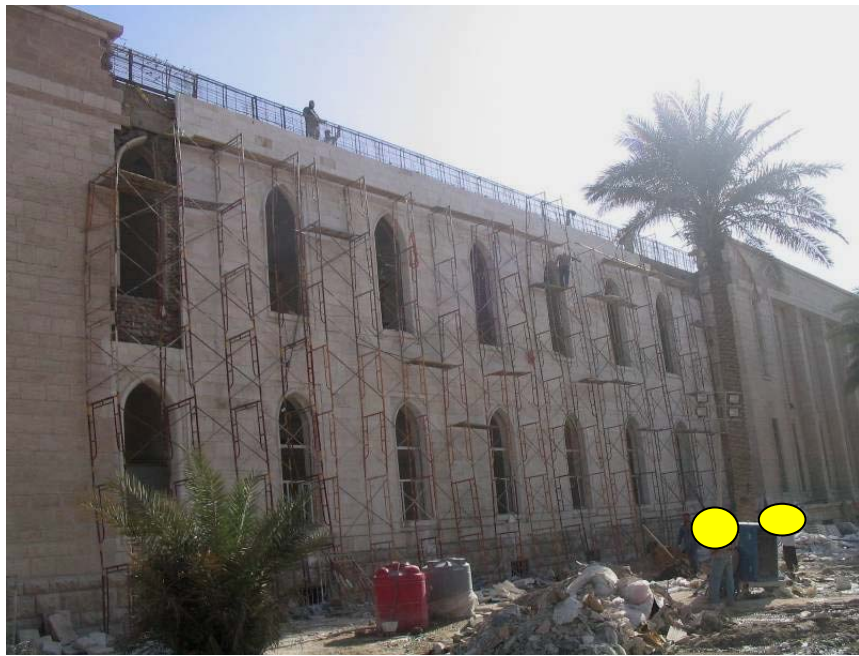
**Site Photo 9. Near completion of the left wing of the MOD HQ building (Photo courtesy of Laguna Construction)**

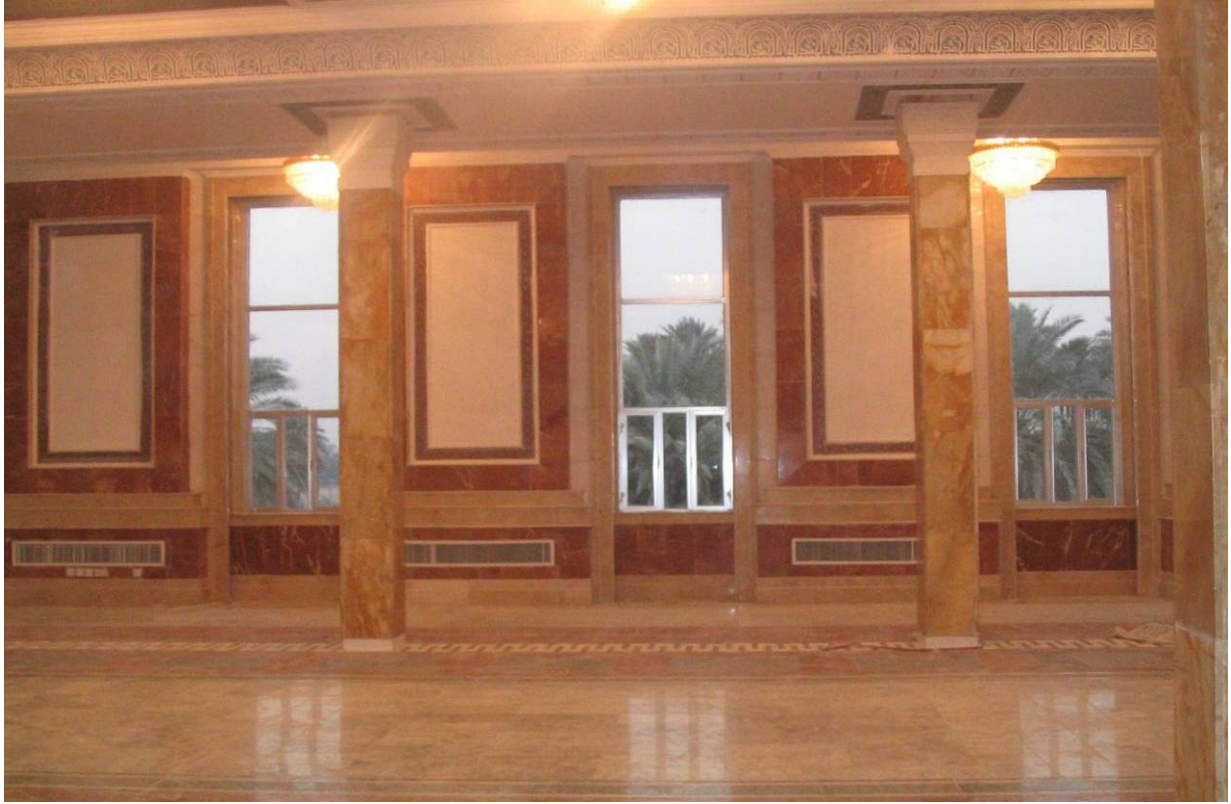
During our site inspection of the MOD HQ building's interior, we observed the contractor's detailed and quality workmanship. Site Photos 16-18 document the aesthetic beauty of the contractor's interior workmanship. According to the contractor, every effort was made to retain the elegance of this former palace<sup>2</sup>. An example of the contractor's attention to even the most minute detail is the ceiling tiles. For the ceilings in the hallways and office areas, any existing ceiling tiles were replaced with exact replicas. The contractor stated the reason for this was the previous ceiling tiles were inscribed with the name of Saddam Hussein; while the new replicas did not have this inscription (Site Photos 19-21).

**Site Photo 16. A finished interior ballroom within the MOD HQ building  
(Photo courtesy of Laguna Construction)**

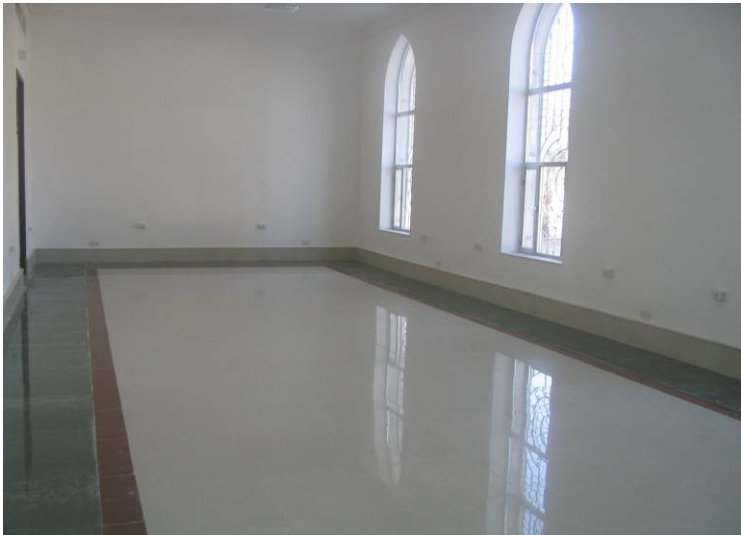
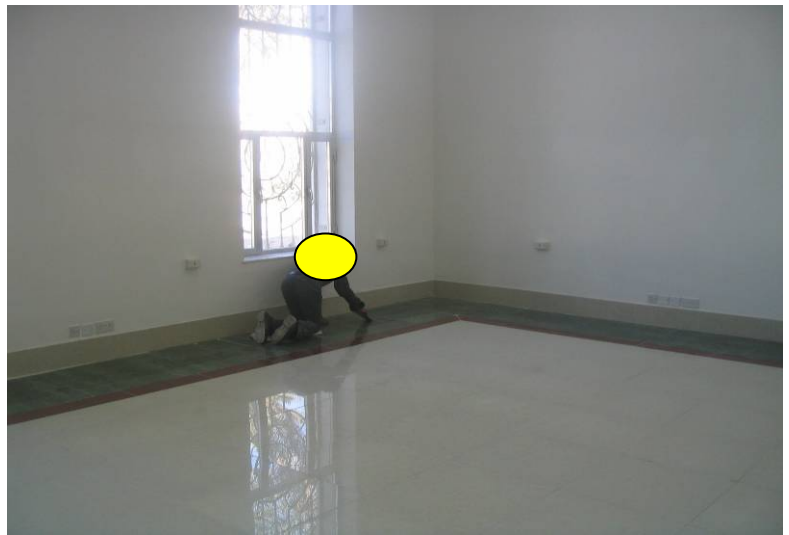
**Site Photos 17 and 18. Quality workmanship done to the interior of the MOD HQ building  
(Photos courtesy of Laguna Construction)**

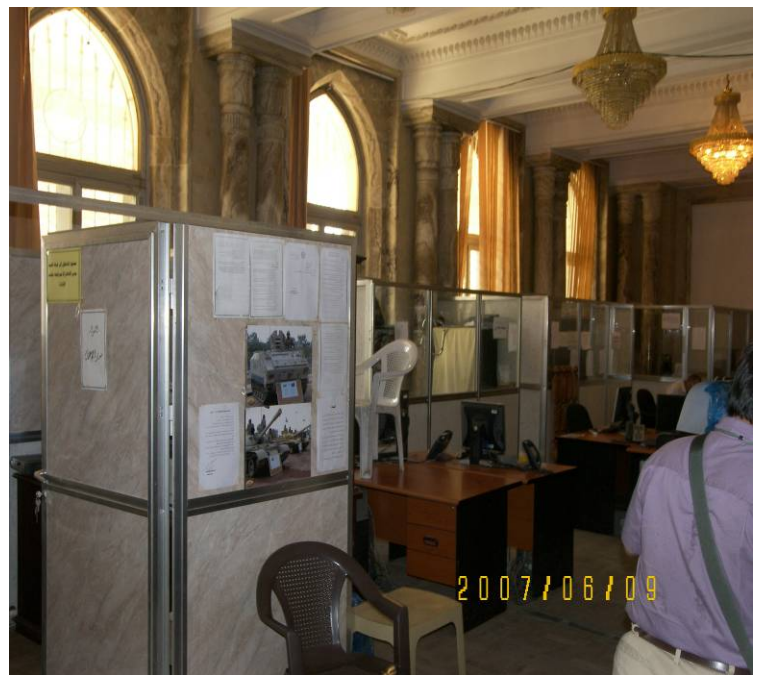
According to the contractor and MOD officials, the current usage of the building far exceeds the original intent of providing working space for approximately 450 MOD personnel. It is currently estimated that more than 3,000 MOD personnel now work in the MOD HQ building on a daily basis. However, accommodations for the additional MOD personnel were made without major disturbance to the contractor's work. For example, large ballrooms were turned into office space through the use of cubicles (Site Photo 22).

**Site Photo 22. Interior ballroom turned into additional office space through the use of cubicles**
