**REPAIR OF THE AL GHAZALIYAH
G-6 SEWAGE LIFT STATION
UNDER THE COMMANDER'S EMERGENCY RESPONSE PROGRAM
BAGHDAD, IRAQ**

**SIGIR PA-07-118.1
APRIL 22, 2008**

SUBJECT: Report on Project Assessment of the Repair of the Al Ghazaliyah G-6
Sewage Lift Station, Baghdad, Iraq (Report Number SIGIR PA-07-118.1)

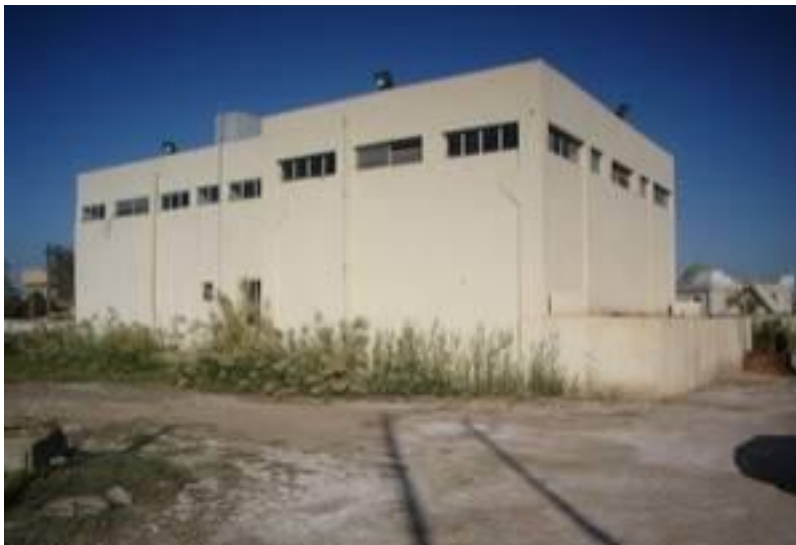
Site Photo 1. Exterior view of the Al Ghazaliyah G-6 sewage lift station

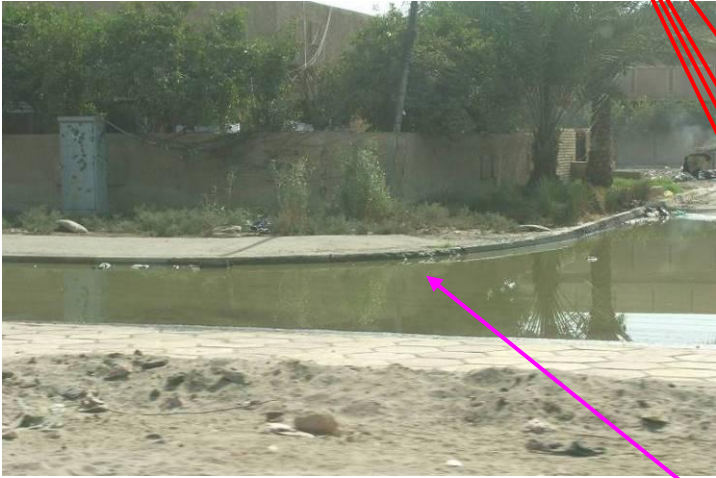
Examples of backed up sewage water throughout the Al Ghazaliyah neighborhood between the two sewage lift stations

Site Photo 2. Street surrounding the Al Ghazaliyah G-7 station

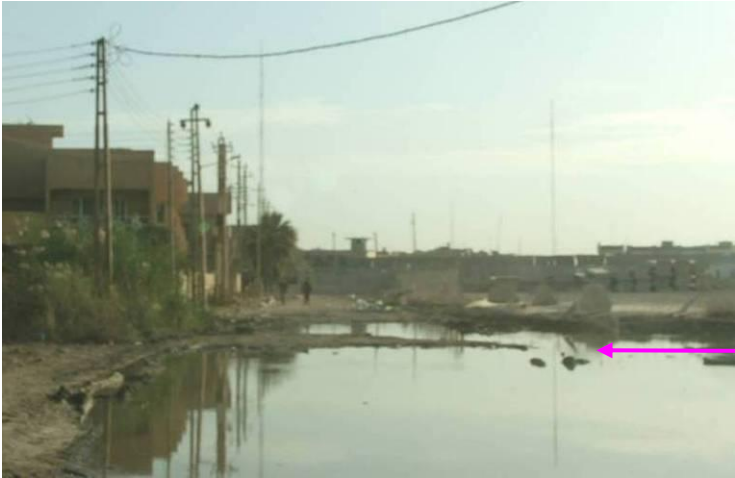
Site Photo 3. Street surrounding the Al Ghazaliyah G-7 station

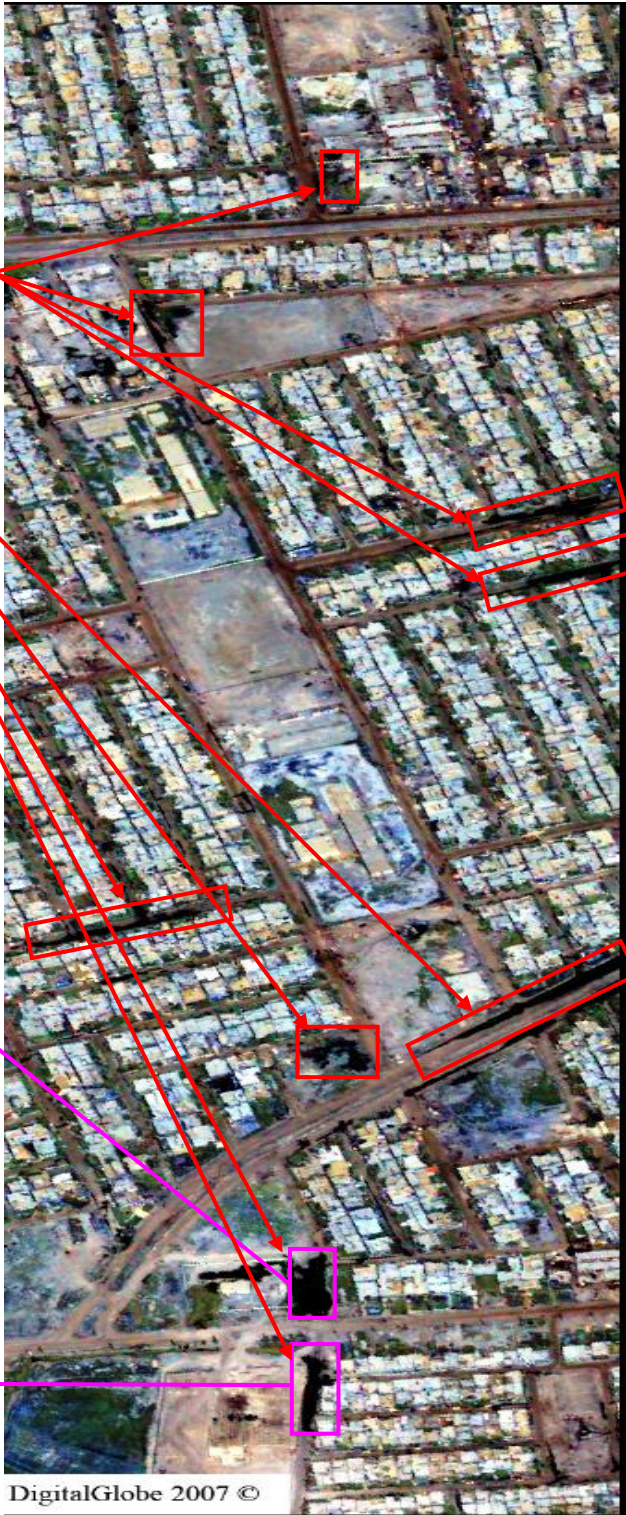
Aerial Image 3. Amount of standing pooled sewage throughout the Al Ghazaliyah neighborhood

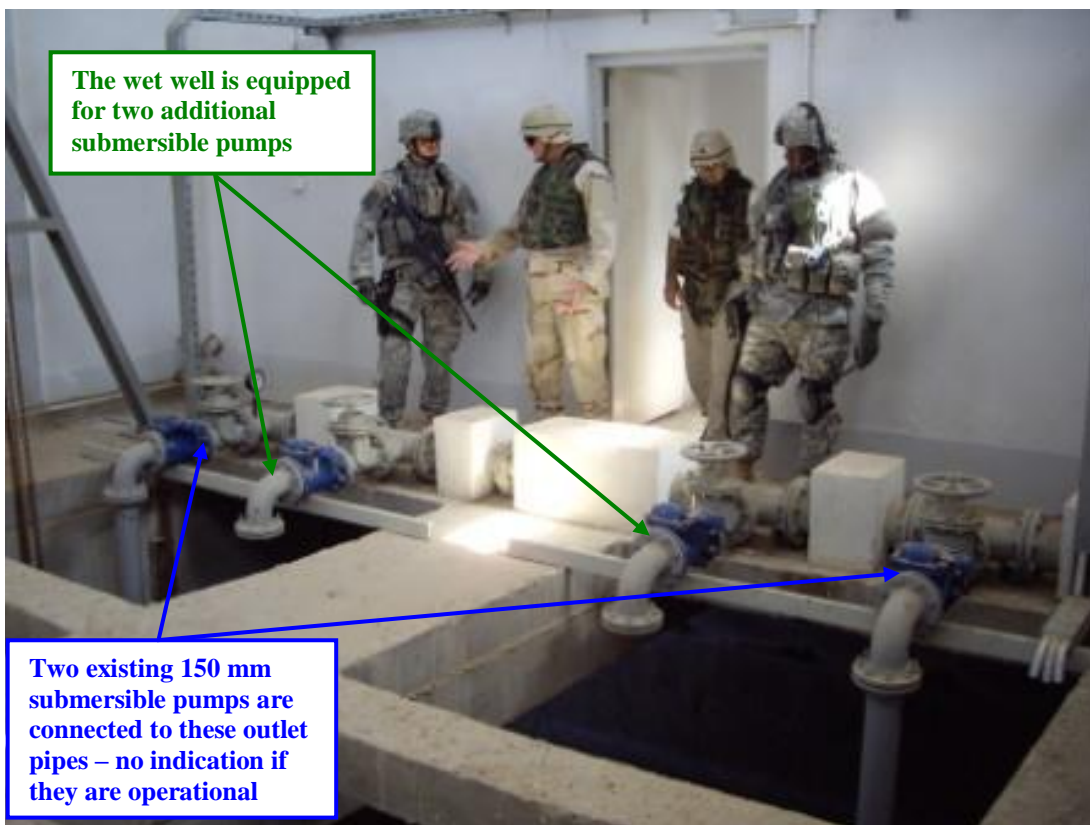
**Site Photo 4. Interior view of Al Ghazaliyah G-6 building
(Photo courtesy of the USACE)**

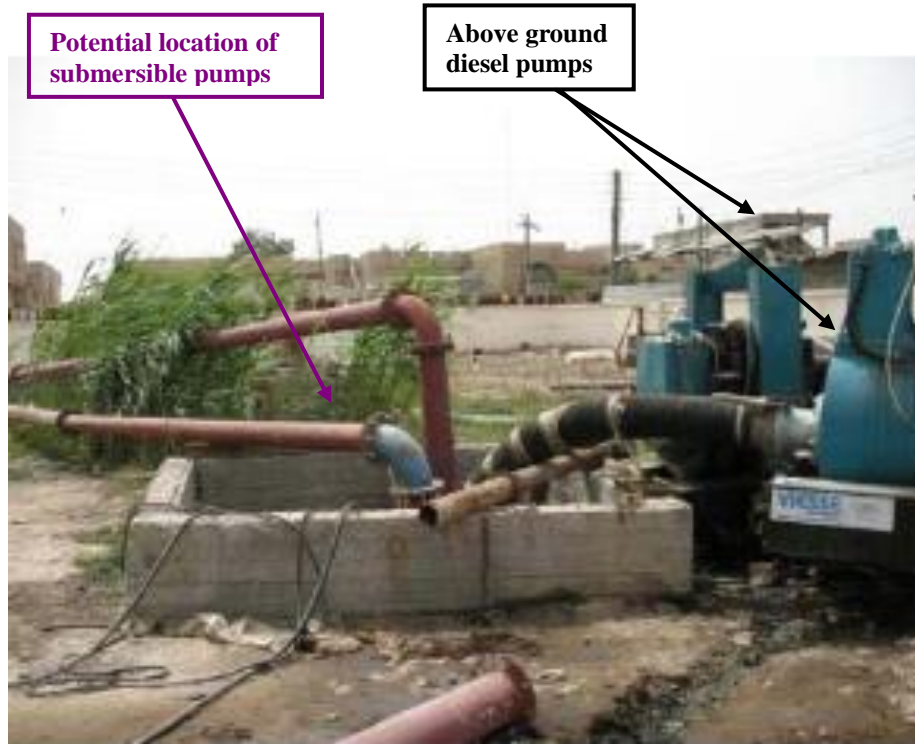
The SOW, when compared to the contractor’s “Engineering Report”, indicates the two submersible pumps will be installed inside the G-6 building. Specifically, the two submersible pumps were to match the existing pumps. However, according to a site visit conducted by the USACE in April 2007, the submersible pumps are located outside the G-6 building (Site Photo 5). A site report was written and stated that “one of the submersible pumps still is not connected electronically to the generator or to the national power, piping connection not completed yet.” The two pumps visible in Site Photo 5 appear to be above-ground diesel pumps, not submersible pumps.

The contract file lacked documentation to explain the need for the above-ground diesel pumps and/or submersible pumps outside the lift station facility. Given the absence of contract file documentation and the SIGIR inspection team’s inability to visit the site because of the security situation, available contract file photographs indicate the pumps were used outside. It is possible they were used to bypass the G-6 facility and pump the sewer water from the manhole in front of the facility to the next one along the line. This would provide short term relief of incoming sewer water to the G-6 facility while the contractor renovated and upgrades the facility. As previously mentioned in the Project Design and Specifications section, the contractor did not provide design drawings to identify the use of the equipment required by the SOW. However, it appeared the original intent was to use the two submersible pumps either to replace or compliment the two existing submersible pumps inside the facility.

Further, based solely upon available contract file documentation, we cannot determine if the submersible pumps were ever delivered or installed. For example, none of the daily QA reports mention the delivery or installation of the submersible pumps; while the daily QC reports are contradictory regarding the delivery and installation of the pumps. For instance, on 14 December 2006 and 16 December 2006, the contractor’s QC daily reports each stated “installing the pump;” while the 17 December 2006 daily QC report stated

Site Photo 5. Manhole outside the G-6 building (Photo courtesy of the USACE)

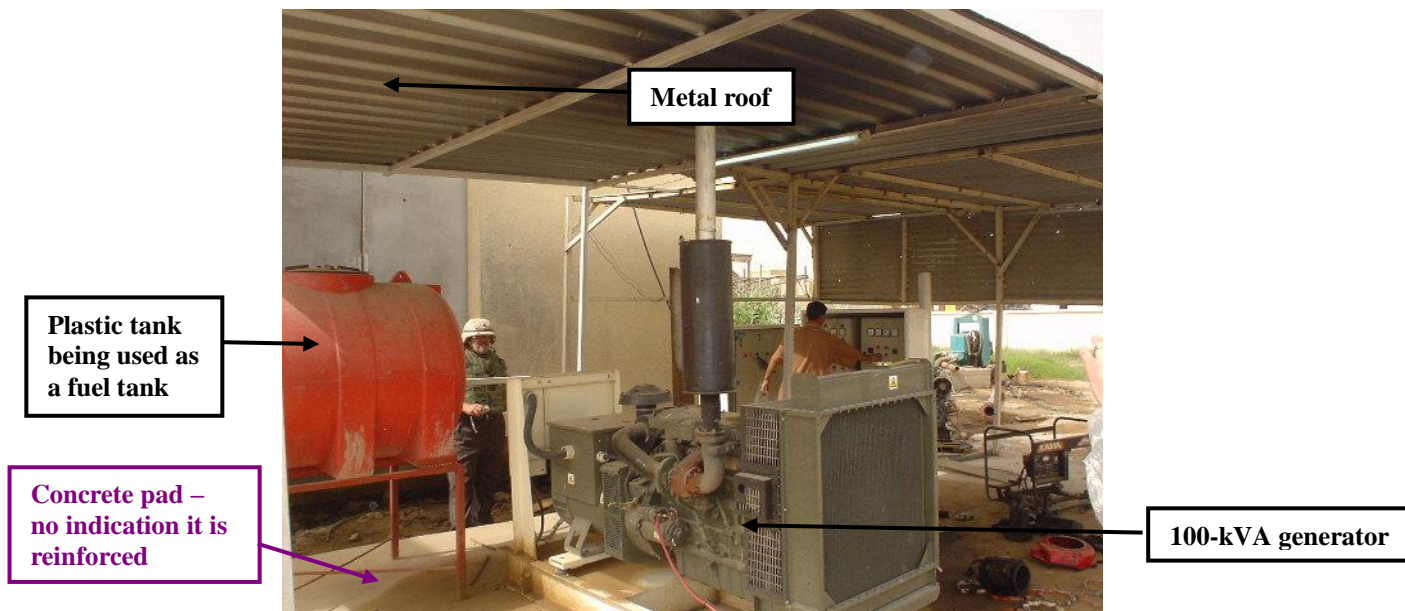
Included in the contract file were photographs documenting the delivery of the 100-kVA generator set (Site Photos 6). However, according to the USACE April 2007 site visit, the “ampere meter of the generator is not working.” In May 2007, a daily QC report stated that the contractor was “fixing the ampere meter of the generator;” however, there is no documentation in the contract file to confirm the ampere meter was fixed or tested.

**Site Photo 6. Contractor provided 100-kVA generator
(Photo courtesy of the USACE)**

Included in the contract file documentation was a photograph verifying the installation of the metal roof (Site Photo 6).

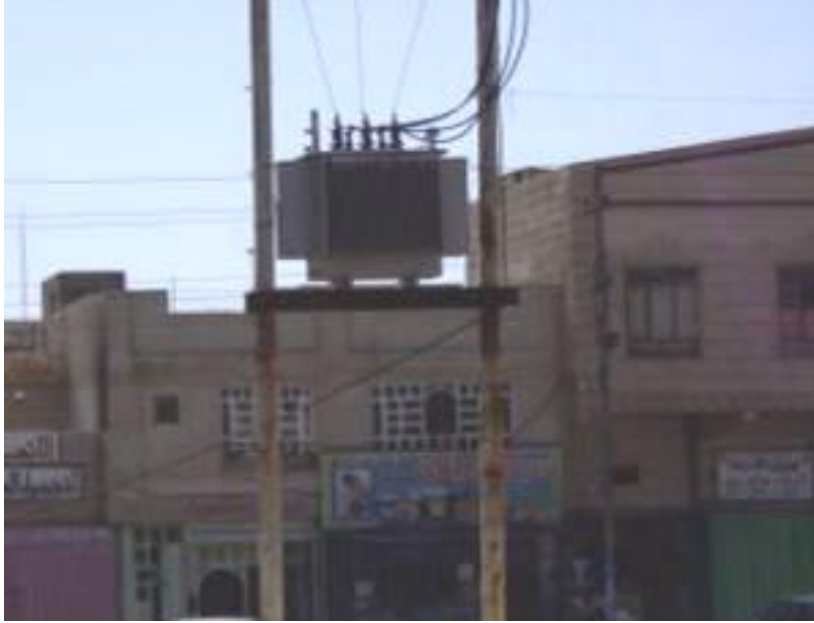
The SOW required the installation of an oil-filled pad-mounted transformer, sized to allow the connection of the facility to the main distribution grid. Photographs in the contract file documents that a pad type transformer was mounted on the electrical pole and connected to the main distribution grid (Site Photo 7).

**Site Photo 7. Transformer appears to be connected to main distribution grid
(Photo courtesy of the USACE)**

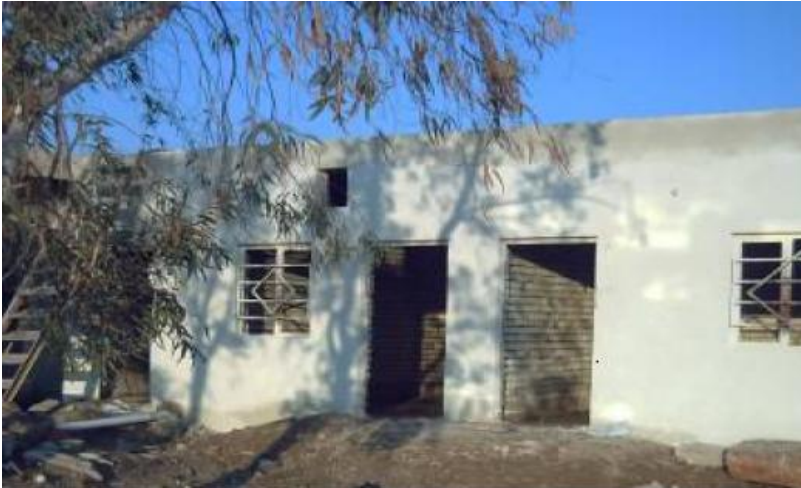
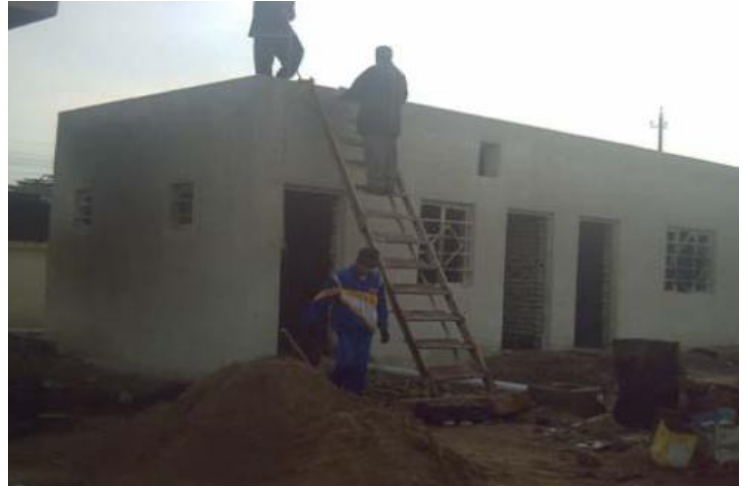
Several of the daily QC reports provided photographic verification of the construction of the facility (Site Photos 8 and 9).

Site Photos 8 and 9. In-progress construction photos of the service building (Photos courtesy of the USACE)

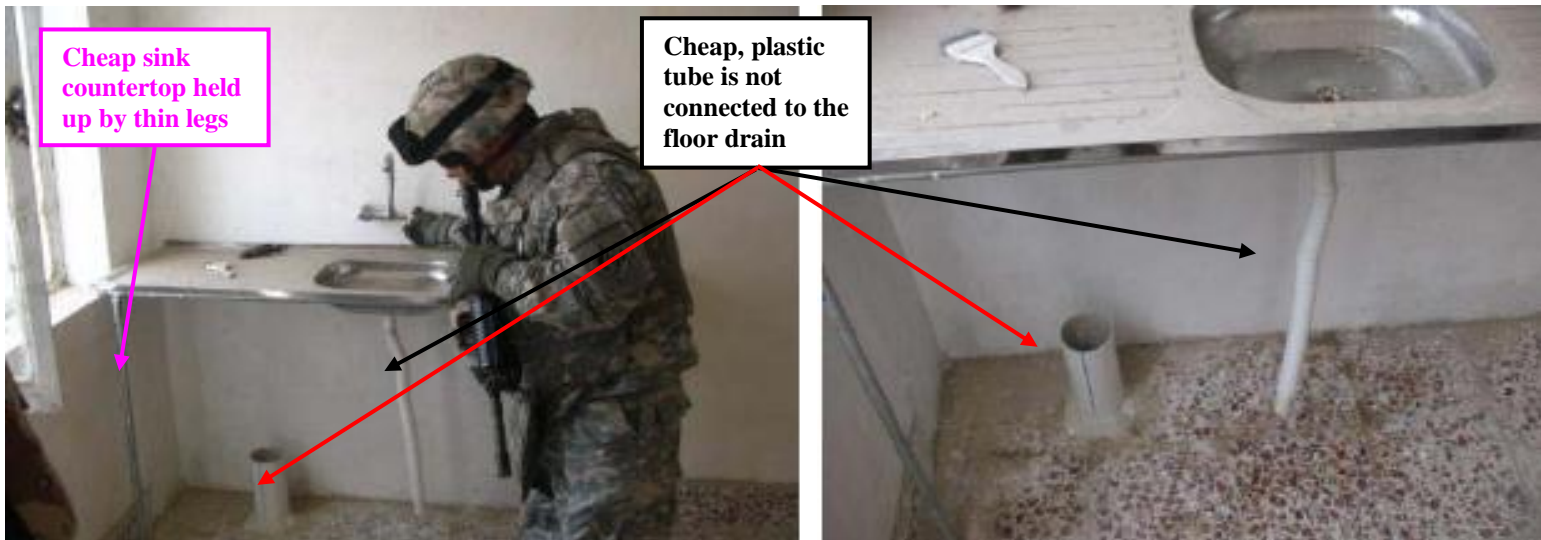
The USACE's April 2007 site visit identified deficiencies within the service building, such as the use of "old" doors and windows and "poor sanitary work" (Site Photos 10 and 11). A subsequent daily QC report confirmed these deficiencies were addressed. However, in some cases, the "fix" did not address the root cause. For example, the contractor created a drain for the sink in the ground far too large and connected it through the use of a plastic tube. The contractor "corrected" the problem by using PVC pipe with two 90 degree angles to connect to the previously created drain (Site Photo 12). The contractor did not use traps, which provide access for cleaning the pipes and prevent odors from the waste pipe from entering the room. In addition, the contractor's fix did not address the large floor drain pipe extending from the floor. Finally, the quality of parts used, such as the sink did not appear suitable for use as a kitchen sink.

Site Photos 10 and 11. Examples of poor construction techniques by the contractor (Photos courtesy of the USACE)

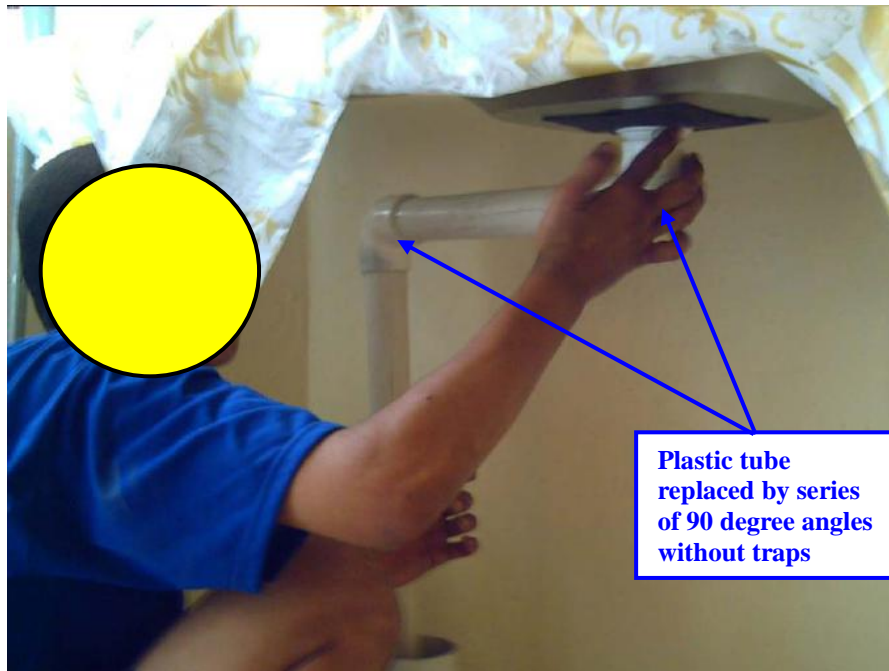
Site Photo 12. Attempt by contractor to “correct” plastic tube problem
(Photo courtesy of the USACE)
