ORPHANAGE AND SENIOR CITIZEN
ASSISTED LIVING CENTER
ERBIL, IRAQ

SUSTAINMENT ASSESSMENT

SIGIR PA-09-178
OCTOBER 21, 2009

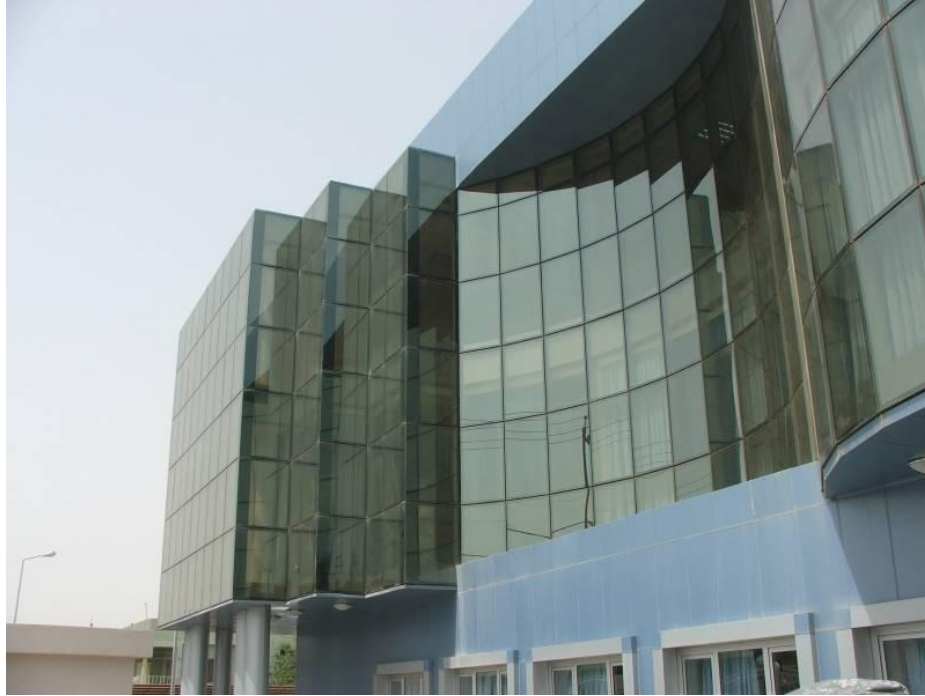
The building was configured around a central rotunda with two wings. The exterior of the administration building consisted of composite aluminum panels with a prominent glass facade. The workmanship of the building's exterior appeared satisfactory.

Site Photo 4. Exterior view of administration building

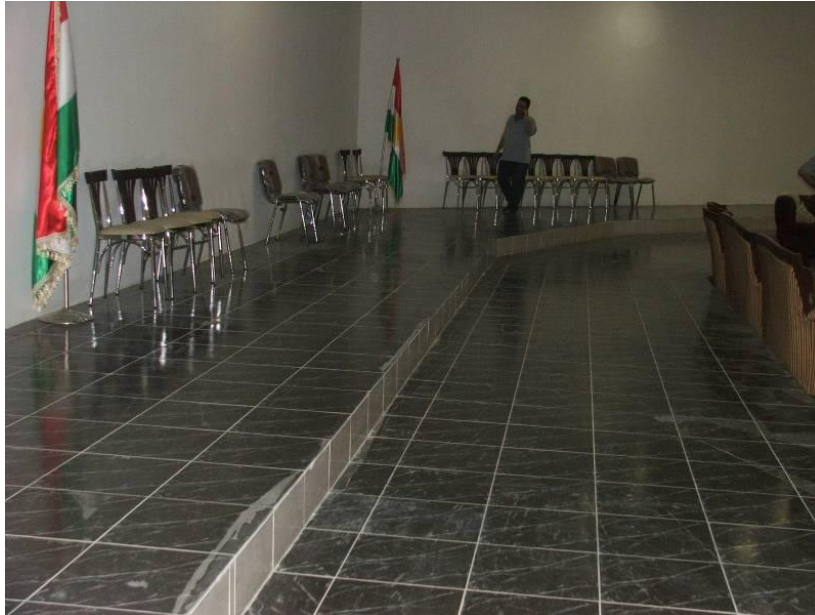
At the time of the inspection, the plastered walls were in good condition with only minor hairline cracking, which is typical in new structures due to initial settlement. The quality of the tile was good, and the placement exhibited quality workmanship.

Site Photo 8. Multi-purpose building auditorium

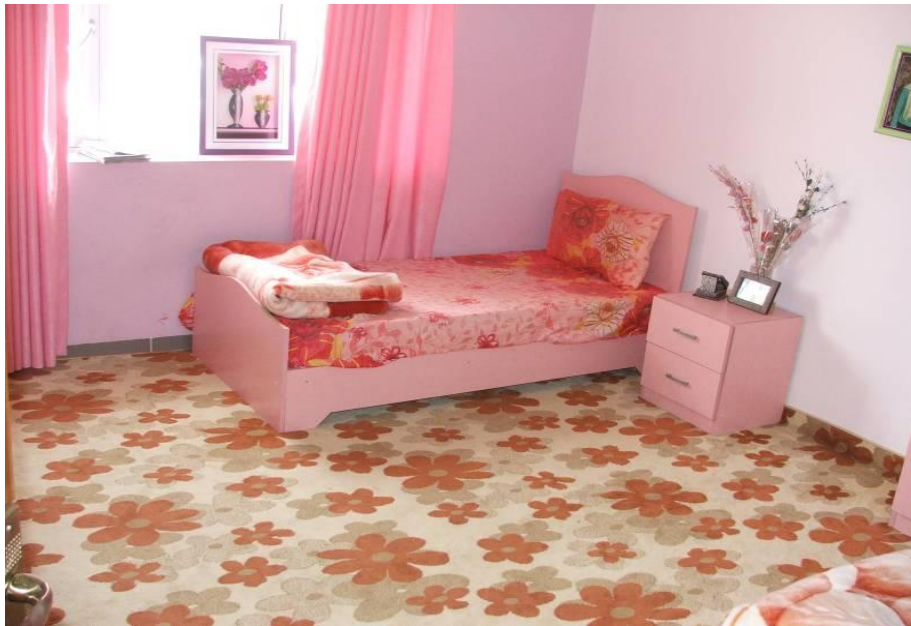
The bedrooms were arranged to accommodate three younger children or two older children. During the assessment, SIGIR noted that the bedrooms were satisfactorily furnished and maintained (Site Photo 13).

Site Photo 13. Female residential house bedroom

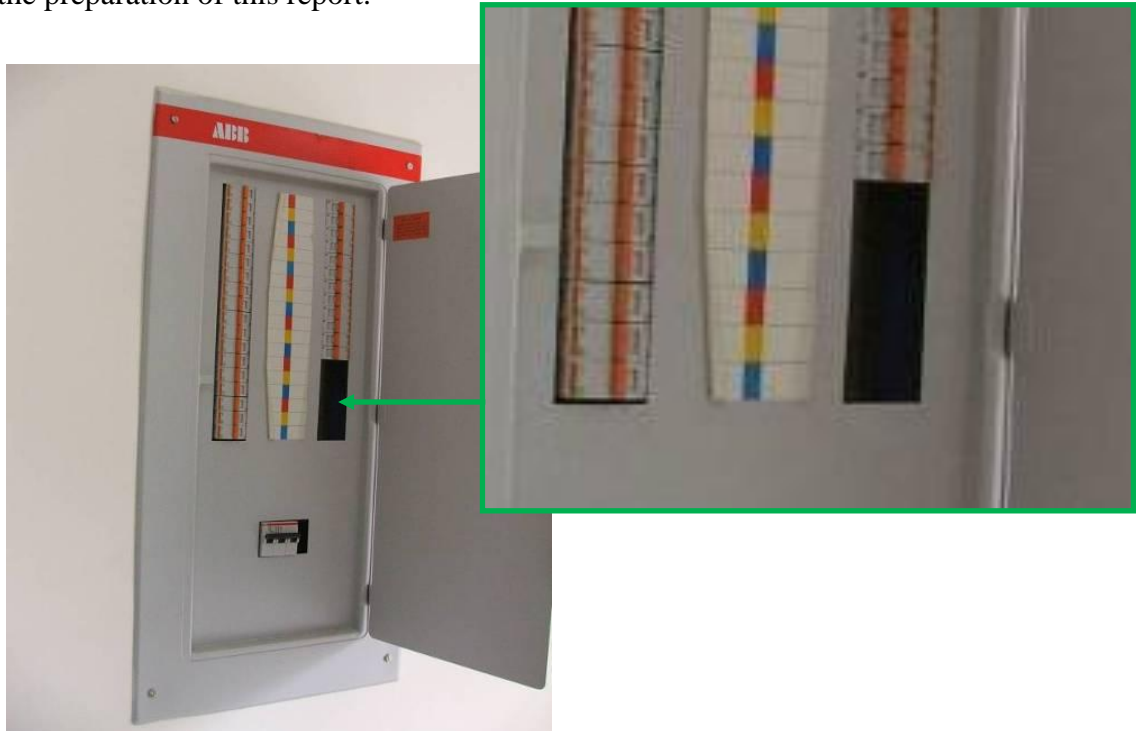
During the site assessment, SIGIR noted the primary circuit breaker panels for each unit in the children's residential houses were located on the exterior of the building. The primary circuit breaker panels were not locked and access was readily available (Site Photo 14). At the time of the site visit, SIGIR noted that there was no barrier in place over the unused panel circuits; however, the Erbil Resident Office rectified the situation prior to the preparation of this report.

Site Photo 14. Primary circuit breaker panel with no barrier

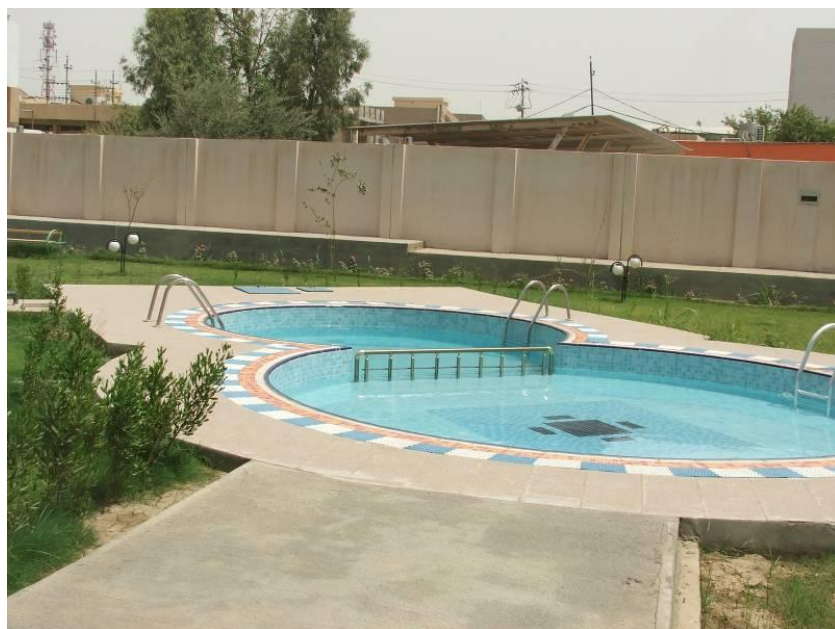
The swimming pool was located on the opposite side of the administration building, away from the dormitories (Site Photo 17). The facility's manager stated that the pool was located there to prevent unauthorized access by the children. Also, the swimming pool was surrounded by a security fence with a gate to limit access by unauthorized individuals.

Site Photo 17. Swimming pool
