**HUMER KWER HEALTH CENTER
SULAYMANIYAH, IRAQ**

SUSTAINMENT ASSESSMENT

**SIGIR PA-09-186
APRIL 20, 2010**

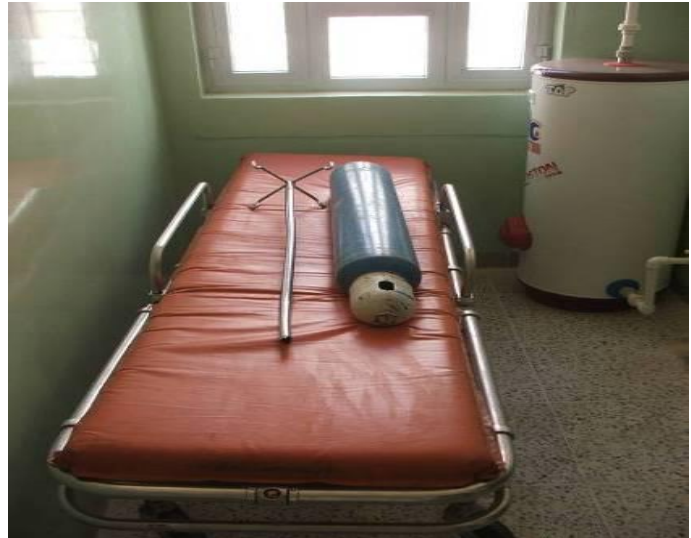
The SIGIR inspection team noted that a pressurized gas cylinder was on a gurney in one of the hallways (Site Photo 12). The cylinder was accessible to the public and was susceptible to tampering. Pressurized gas cylinders should be secured to prevent accidents.

Site Photo 12. Accessible pressurized gas cylinder storage

1. Install handrails on the staircase.
2. Secure the fire extinguishers and the pressurized gas cylinder.
3. Fix the leaking fuel tank.

Response: Concur. The Gulf Region District Resident Office that executed the project reported that the fuel leak was repaired after SIGIR identified the leak during its site visit in August 2009. After SIGIR issued the Humer Kwer Health Center draft report, the Resident Office contacted the contractor and informed him of the additional deficiencies. The contractor agreed to install the hand rails and secure the fire extinguishers and pressurized gas cylinder. The Resident Office reported those deficiencies should be addressed by 16 April 2010.

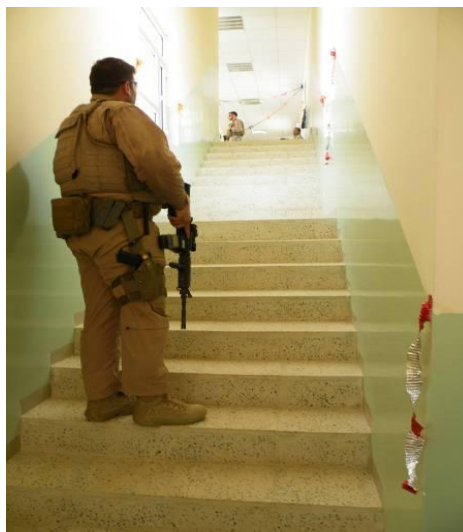
The contractor constructed reinforced concrete stairs to connect the upper and lower levels (Site Photo 13). The steps appeared to be level and even with consistent risers and tread widths. No apparent cracks or signs of settlement or distress were observed. Handrails were not present in the stairway. Handrails could prevent injury in the event of individuals tripping or losing their footing on the steps.

Site Photo 13. Interior stairs connecting upper and lower levels

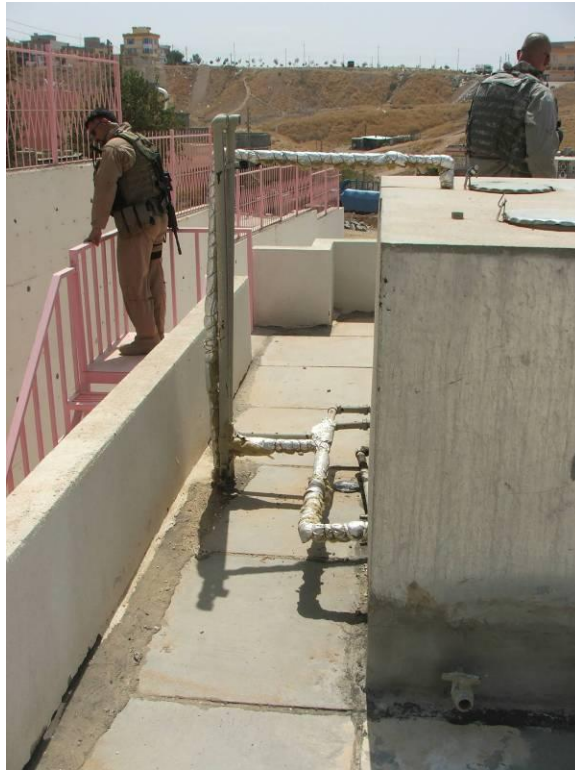
The storage tanks appear relatively small compared to the size of the facility. SIGIR inspection teams have reviewed other Iraqi primary healthcare centers with significantly larger potable water storage tanks. Since usage requirements were not provided and the exact amount of potable water available from the municipal system was not provided, the adequacy of the potable water storage could not be determined.

Site Photo 16. Roof tank and piping

Piping to the tanks appeared to consist of PVC with fiberglass insulating wrap. A GRN KAO representative informed SIGIR that the winter temperatures can fall below freezing, and bursting pipes was an issue on other projects in the region. The insulation on the pipes will provide some measure of protection against freezing. However, since the tank is not insulated, freezing could occur near the various apertures and cause pipe breakage at the tank/pipe interface.
