BP America Production Co.

ATLANTIS

2010 ROV INSPECTION REPORT

Document No: 3800-RPT-60003

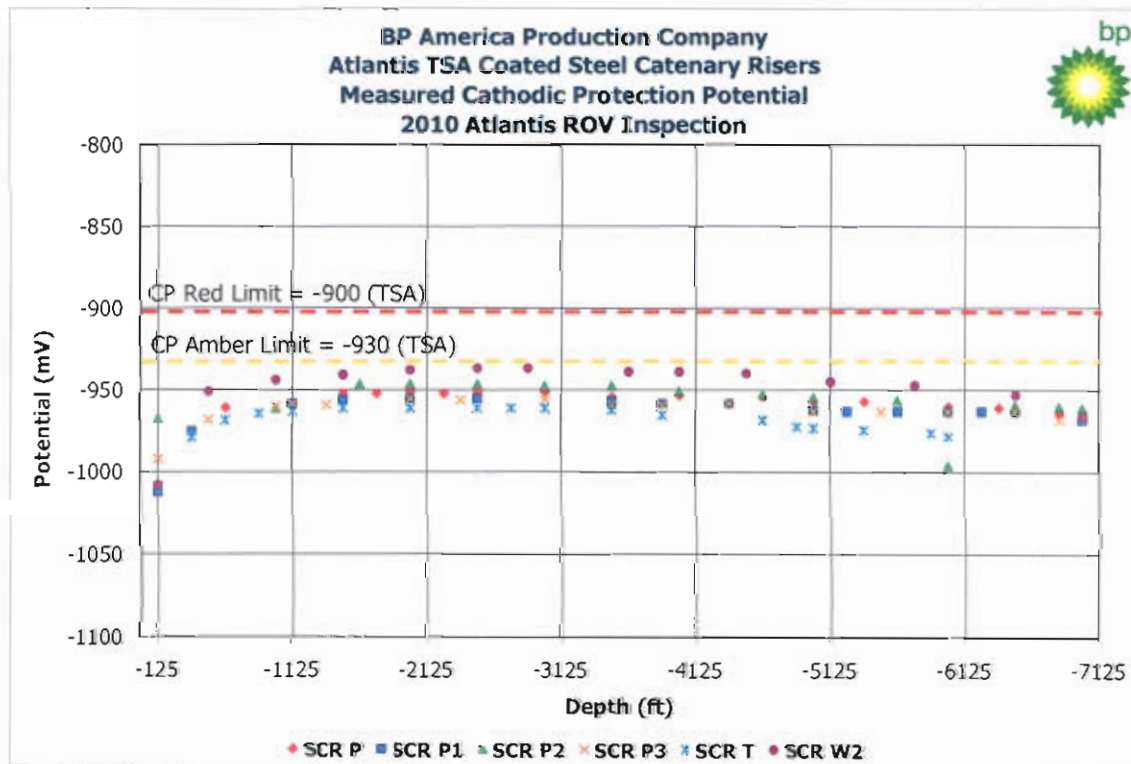
Figure 2.1 – Atlantis Risers Measured CP Potential

A CP survey of straked riser sections was conducted from the riser hang off to beyond the TDP for all straked riser sections; all recorded values are within acceptable limits. A plot of the recorded CP measurement is given in Figure 2.1.

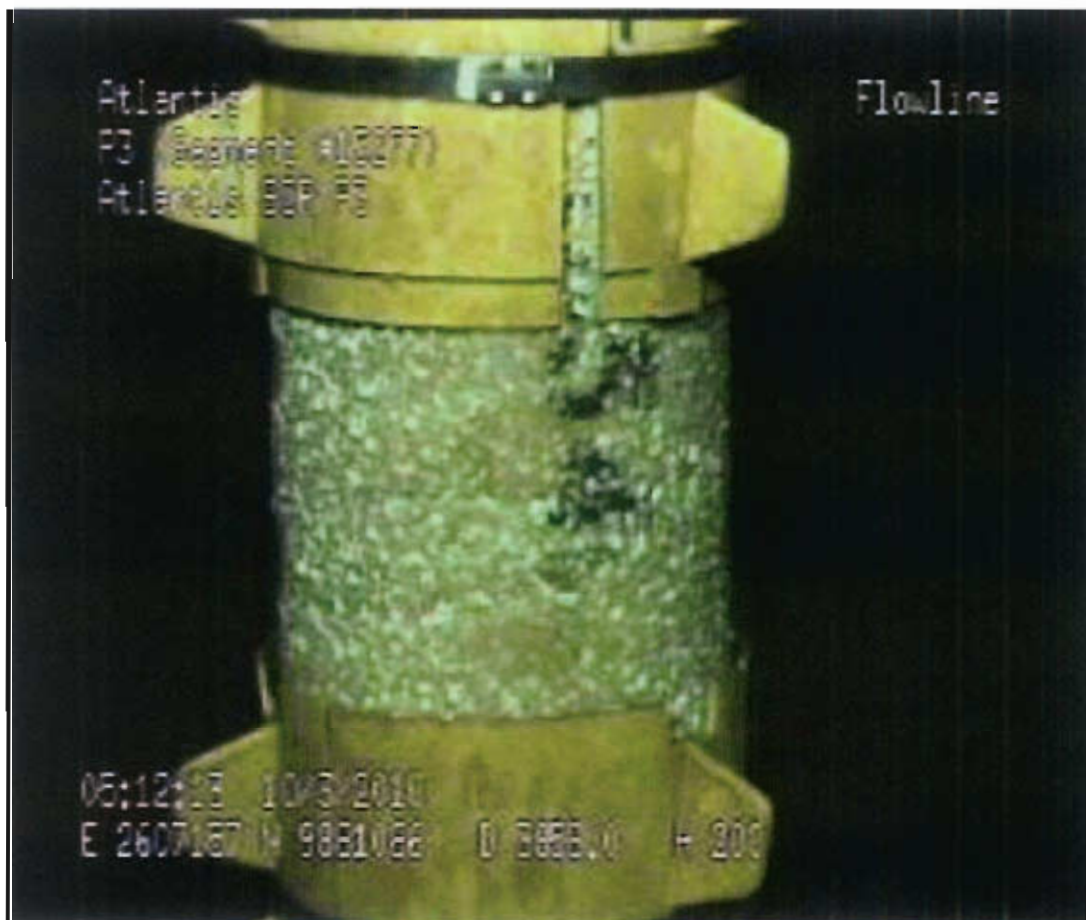
Figure 2.2 – Example TSA Activation on P3 Riser

Numerous areas of TSA activation adjacent to the J lay collars were noted by inspectors as shown in Figure 2.2. In some instances the spent TSA material is reported to bulging through the strake seams. The corrosion protection for this riser system is afforded by a combination sacrificial anode CP system and TSA coating. TSA coating will provide CP protection for this section of the riser by self depletion.

TSA coating systems are generally designed such that the coating material is anodic to the substrate metal. In other words, they corrode preferentially to steel, acting as sacrificial coatings preventing the corrosion of the underlying steel substrate. TSA coating will provide CP protection for these sections of the riser by self depletion until it is completely consumed leaving the sacrificial anode CP system as the only source of protection. Complete depletion of the TSA coating will result to increased CP demand thereby increasing the anode depletion rate. Because measured CP potentials are within acceptable limits, the TSA is undergoing normal and expected polarization, hence pose no integrity threat.

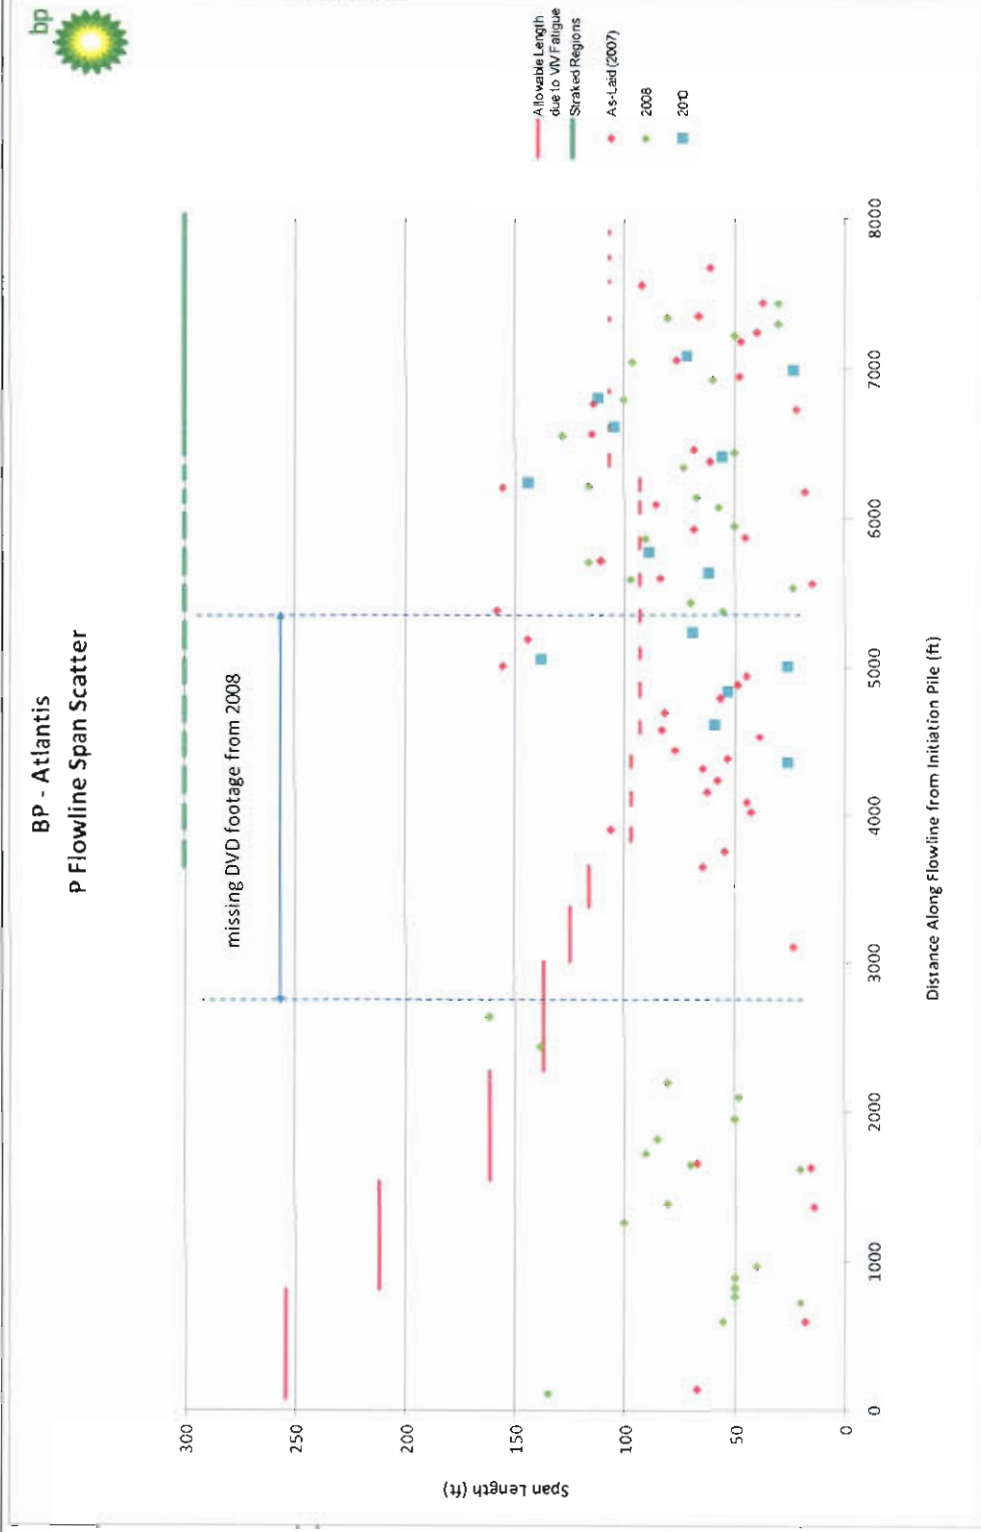
Figure 2.3 – Span Length Assessment for P Flowline

Free span lengths on all DC1 flowlines were measured by recording the span start and end locations. No spans were found on the DC1 flowlines to be above the approved limit within unstraked areas for VIV [21] as shown in Table 2.1. One span on the W2 flowline, as noted in Figure 2.8, is reported to be longer than the maximum length recorded and analyzed from the as laid survey in 2008. Plots of measured span length for the P, P1, P2, P3, T and W2 flowlines are shown in Figure 2.3 through Figure 2.8 respectively.

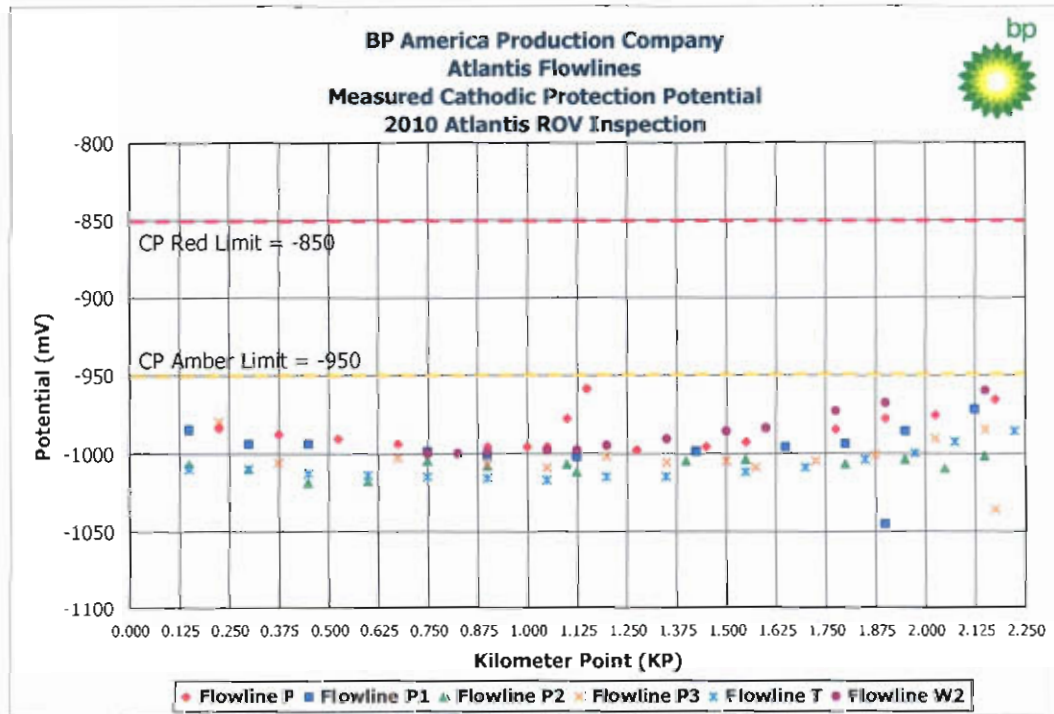
Figure 2.9 – Atlantis Flowlines Measured CP Potential

A CP survey of the DC1 flowlines was conducted from the TDP's to the PLET's. A plot of the recorded CP measurements for all of the DC1 flowlines is given in Figure 2.9. All recorded CP measurements are within acceptable limits.

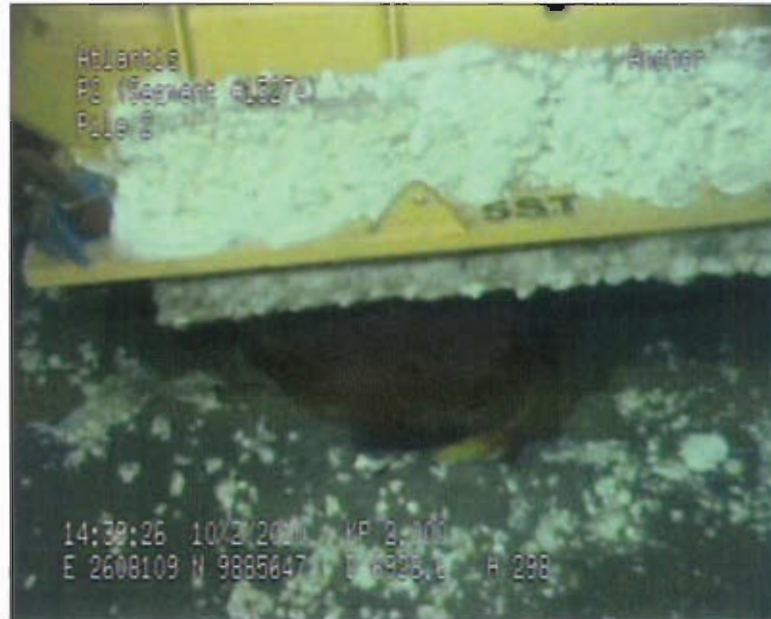
The hold back anchor piles on P, P1, P2, P3 and T flowlines have indications of soil scouring. An example figure is shown below The P2 SCR east devil's claw pile, showing a 0.5ft gap as seen in Figure 2.10. The chains and the flowline yokes are also noted to be taut. Anomaly 3800-ANM-60035 [15] has been raised to conduct a detailed assessment of the above observations.

**Figure 2.10 - P2 SCR Pile for Devil's Claw Connector from East Soil Scoured
Approximate 0.5ft**

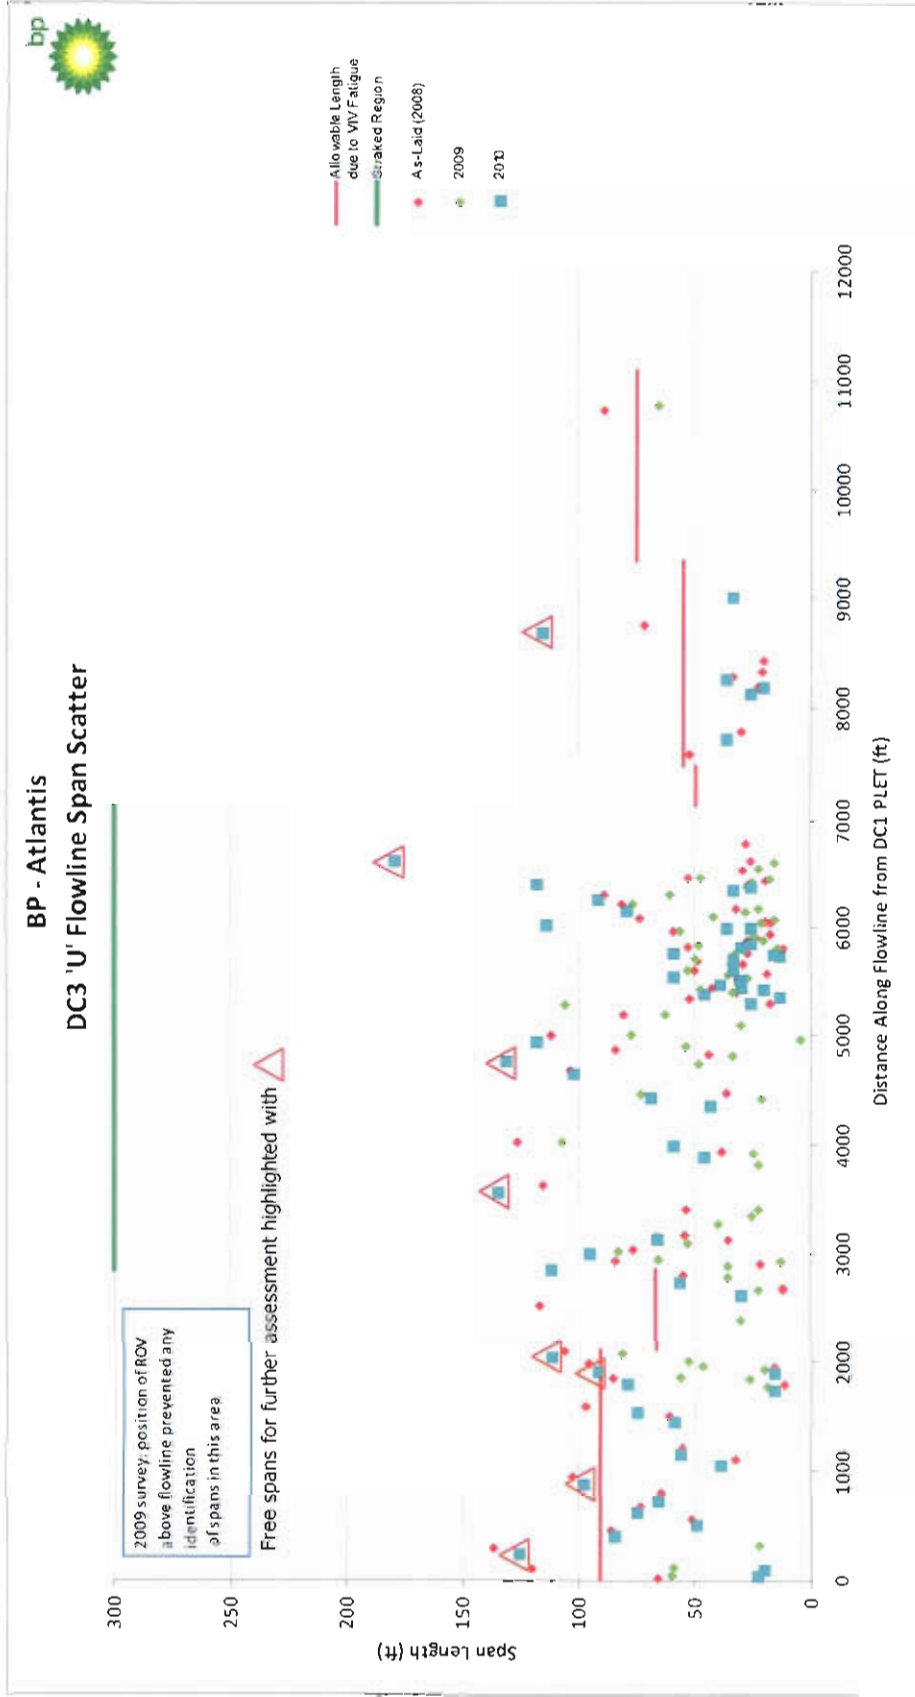
Figure 2.11 – Span Length Assessment for DC3-U Flowline

Free span lengths on DC3 U flowline was measured by recording the span start and end locations. Five spans were found on the DC3 U flowline to be above the approved limit within unstraked areas for VIV [21]. Three spans on the DC3 U flowline are reported to be longer than the maximum length recorded and analyzed from the as laid survey. The plot of measured span length for the DC3 U flowline is shown in Figure 2.11 with the spans for further assessment highlighted.

Further assessment of the reported spans on DC3 U flowline is recommended, per anomaly 3800-ANM-60005 [5]. The review should confirm the reported lengths based on the cross profiler data which is being assessed as part of the anomaly closeout process.

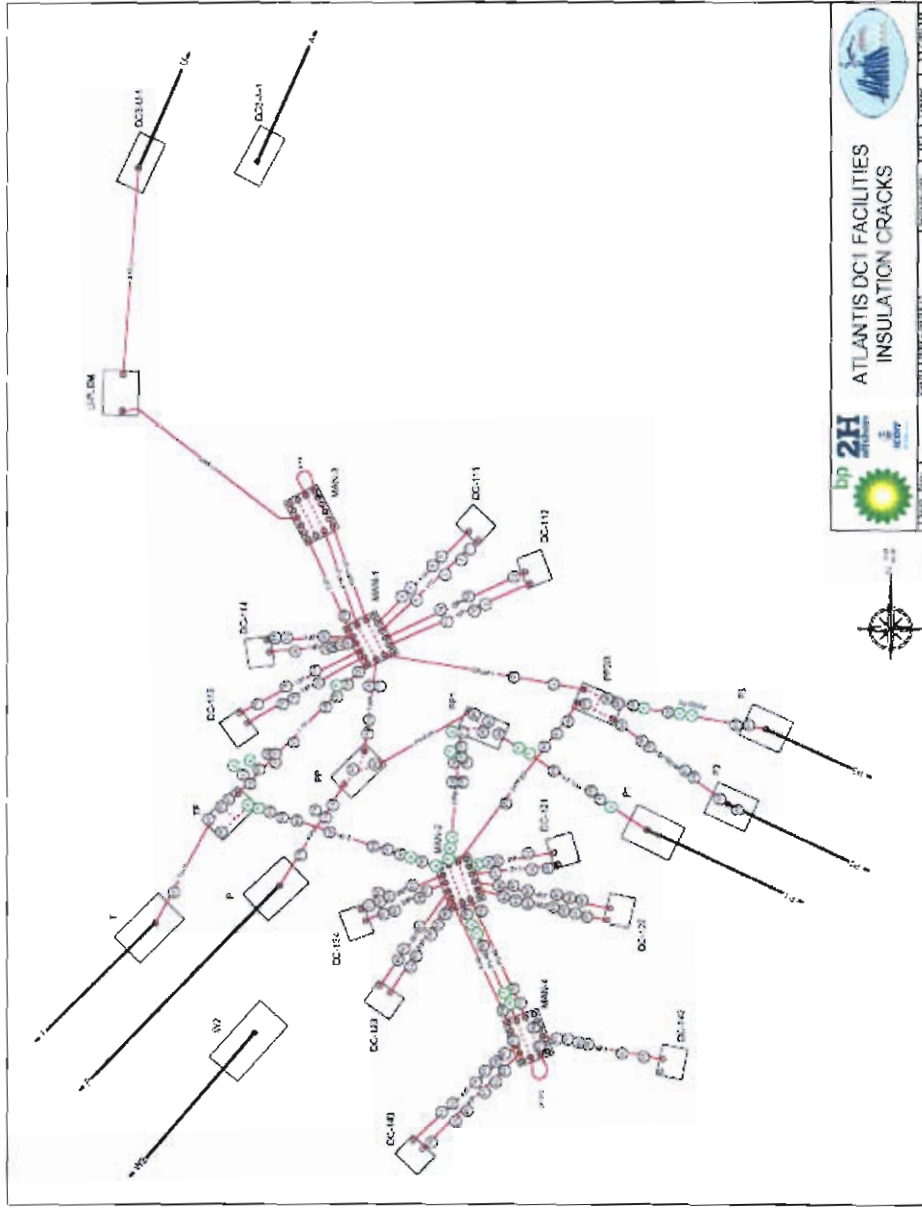
Figure A.1 – Atlantis DC1 Coating Defects – New Observations in Green

All flowline jumpers were inspected except PP2/3-P3 as required by the inspection workscope [2]. The insulation on all DC1 well jumpers was found with numerous coating cracks. The insulation coating defects were first noted in the 2008 inspection [16]. There were multiple new insulation defects observed on the flowline jumpers which are given in Table 2.9 and documented in the defect register [13]. The defect observation locations are given in Appendix A. The Flow Assurance Team is recommended to review the insulation coating defects on well and flowline jumpers for thermal integrity. The current plan is to remove all DC1 jumpers and manifolds affected in 2012 therefore no remedial action is needed.
