National Transportation Safety Board
Washington, D.C. 20594

Aircraft Accident Brief

Accident Number:	CHI01MA006
Aircraft and Registration:	Bombardier CL-600-2B16 (CL-604), C-FTBZ
Location:	Mid-Continent Airport, Wichita, Kansas
Date:	October 10, 2000
Adopted On:	April 14, 2004

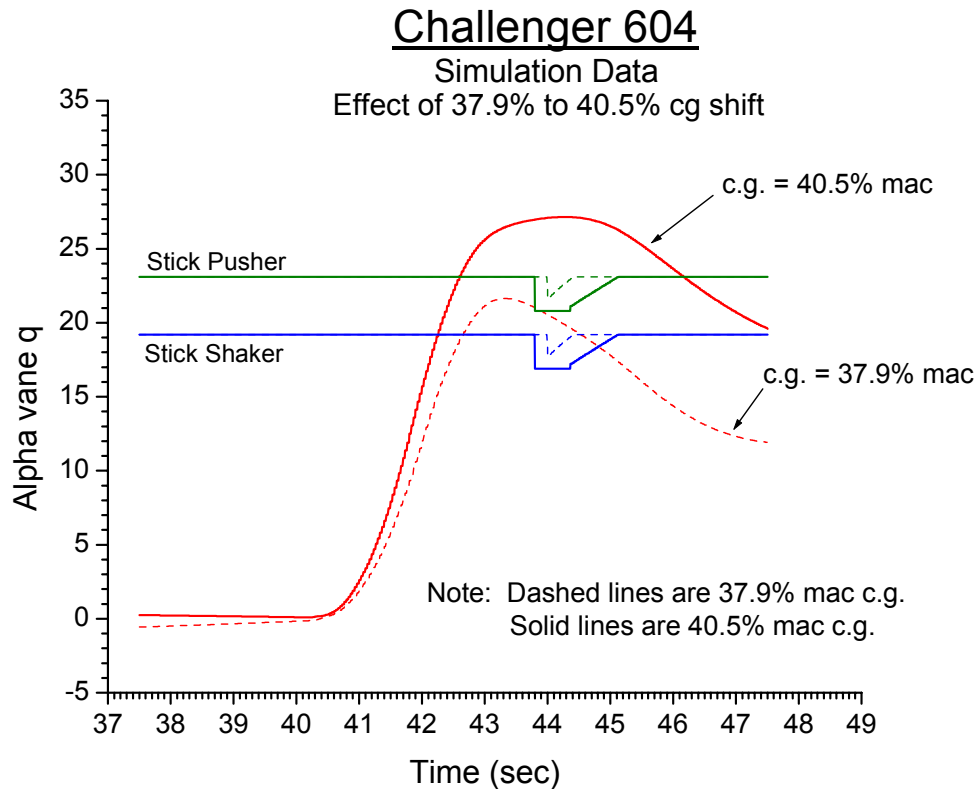
Figure 3. C.g. Sensitivity and Stick Shaker/Pusher Threshold Values

Based on FDR data, flight data of the PF's previous takeoffs, and postaccident fuel migration and shift calculations, it is evident that the pilot's pitch control, combined with unanticipated aft c.g. (fuel) shift during acceleration, resulted in an excessive rotation rate and an unexpected and faster pitch rate after liftoff, which caused the airplane to stall. The FAA and Transport Canada issued ADs after the accident addressing the issue of fuel migration (lowering the aft c.g. limit) and the potential for exceeding the airplane's aft c.g. limit during acceleration or climb.
