**Federal Aviation
Administration**

ADVISORY CIRCULAR

43-16A

**ALERT
NUMBER
409**

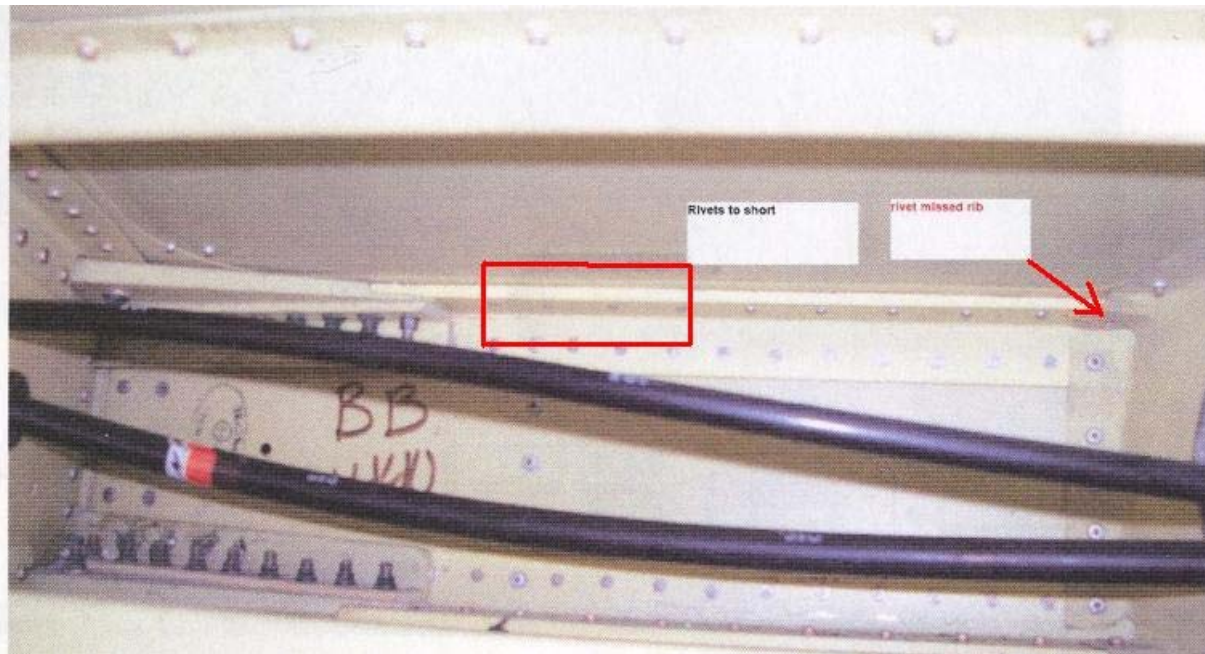
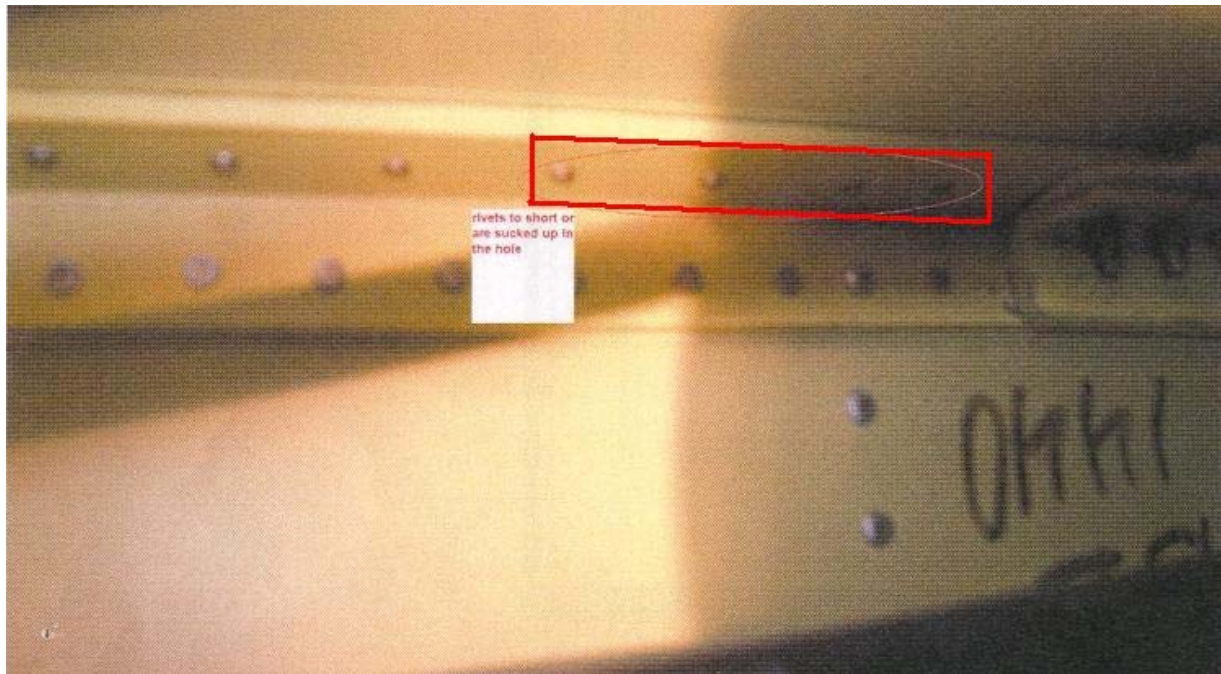
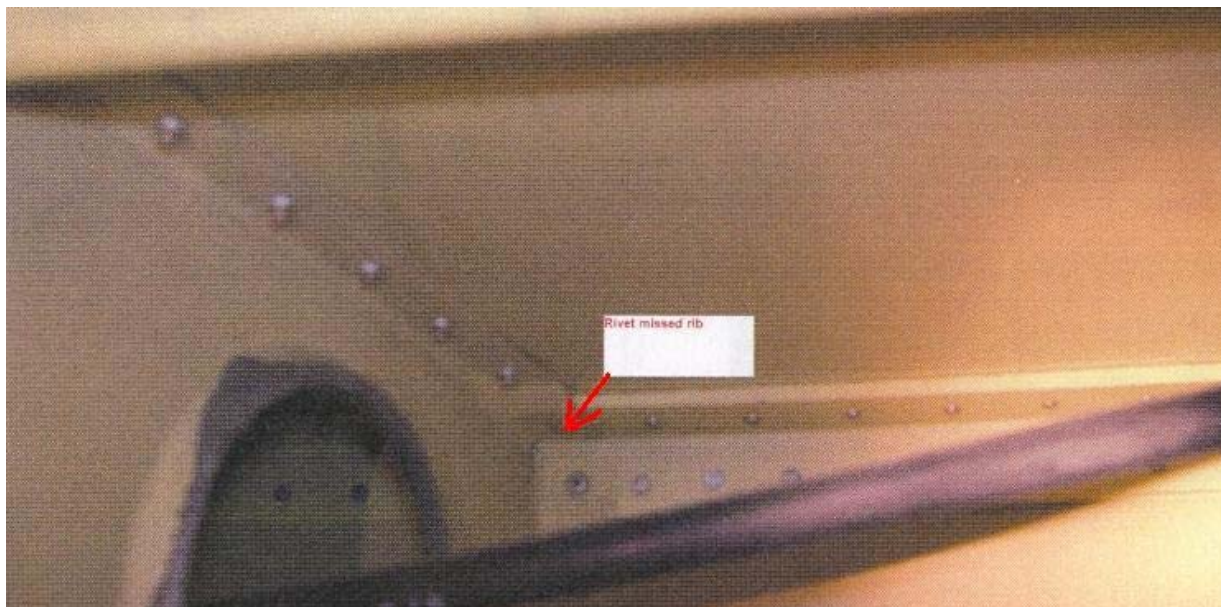
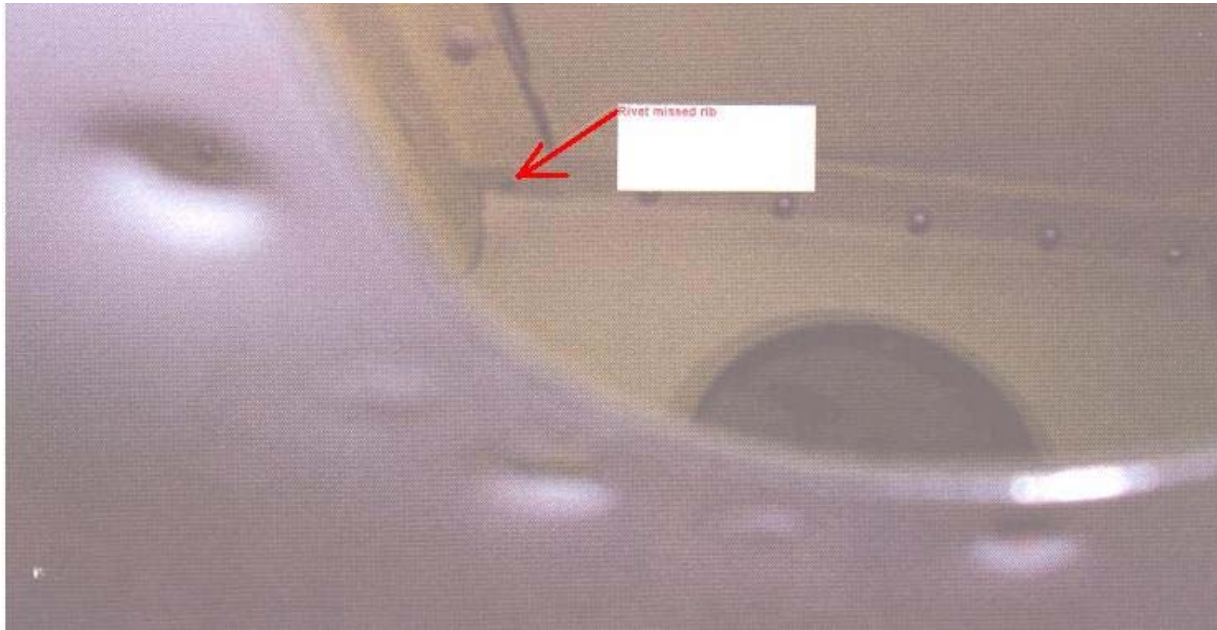
Beechcraft: B200; Bad Rivet Installation in Stabilizer Spar; ATA 5510

A submitter working on this corporate aircraft writes, "After complying with Service Bulletin 55-3835 'Installation of Empennage Inspection Access Panels' and the 'Horizontal and Vertical Stabilizer' inspection, we found the horizontal stabilizer forward spar and ribs not riveted correctly from the factory. Many rivets that go through the forward spar are too short, and where the rib and forward spar come together, the rivet misses the rib. We have found this same problem on other aircraft we have inspected."

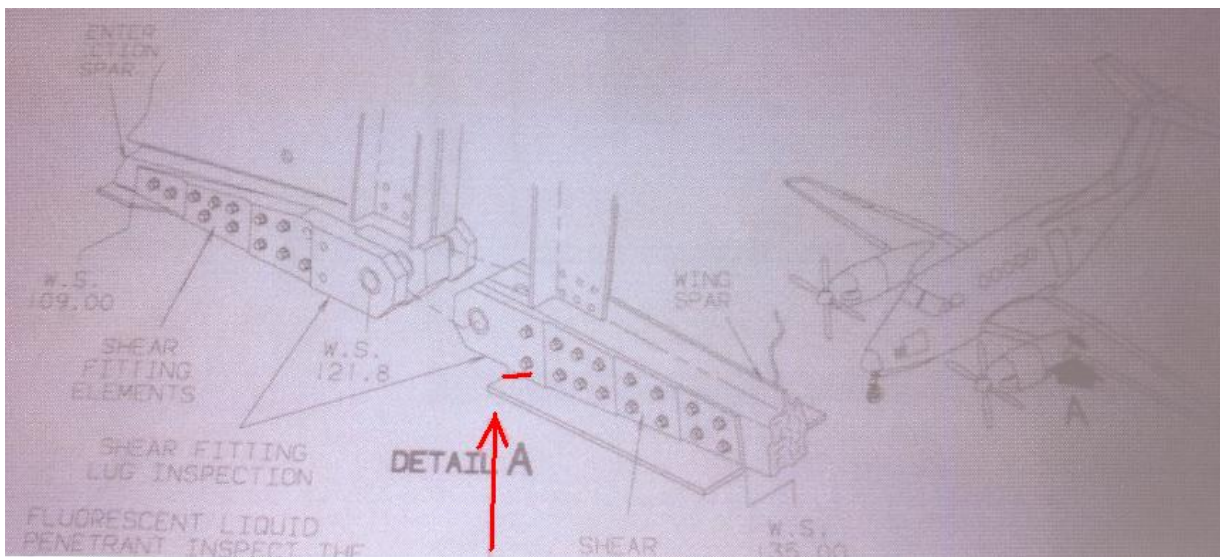
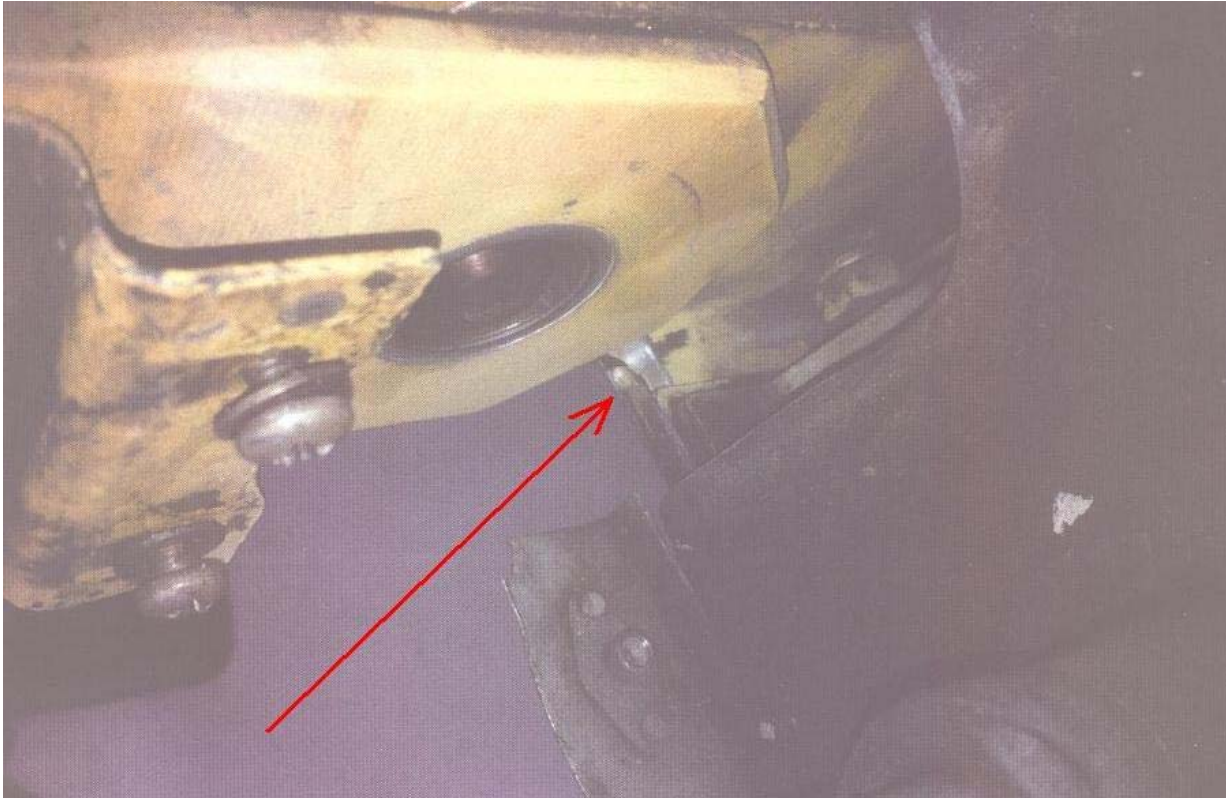
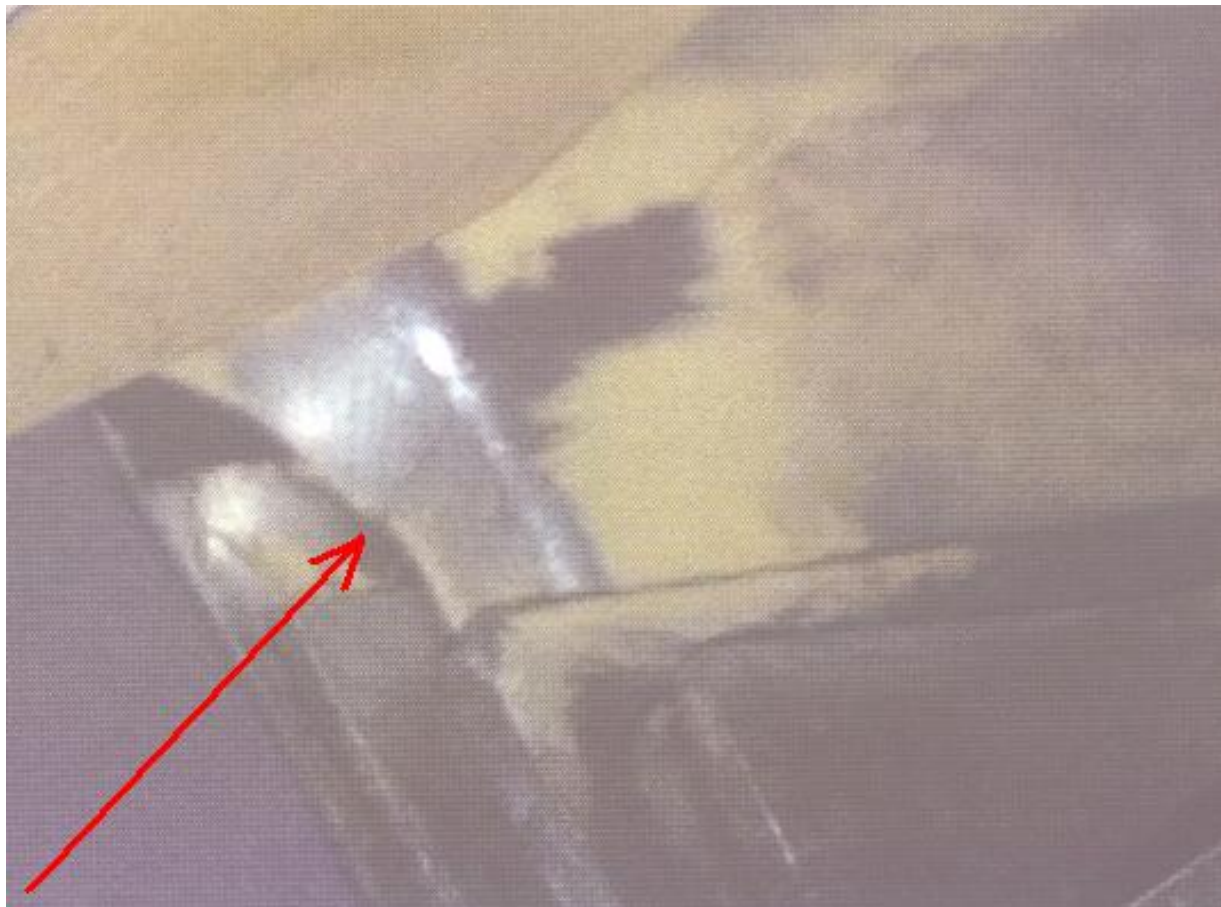
Beechcraft: 200; Cracked Spar Shear Fitting; ATA 5740

"While accomplishing a wing bolt inspection," says this unidentified technician, "the L/H lower wing spar attach shear fitting was found cracked (P/N 1011100731). This crack is approximately 0.75 inches long and is located in the forward flange area."

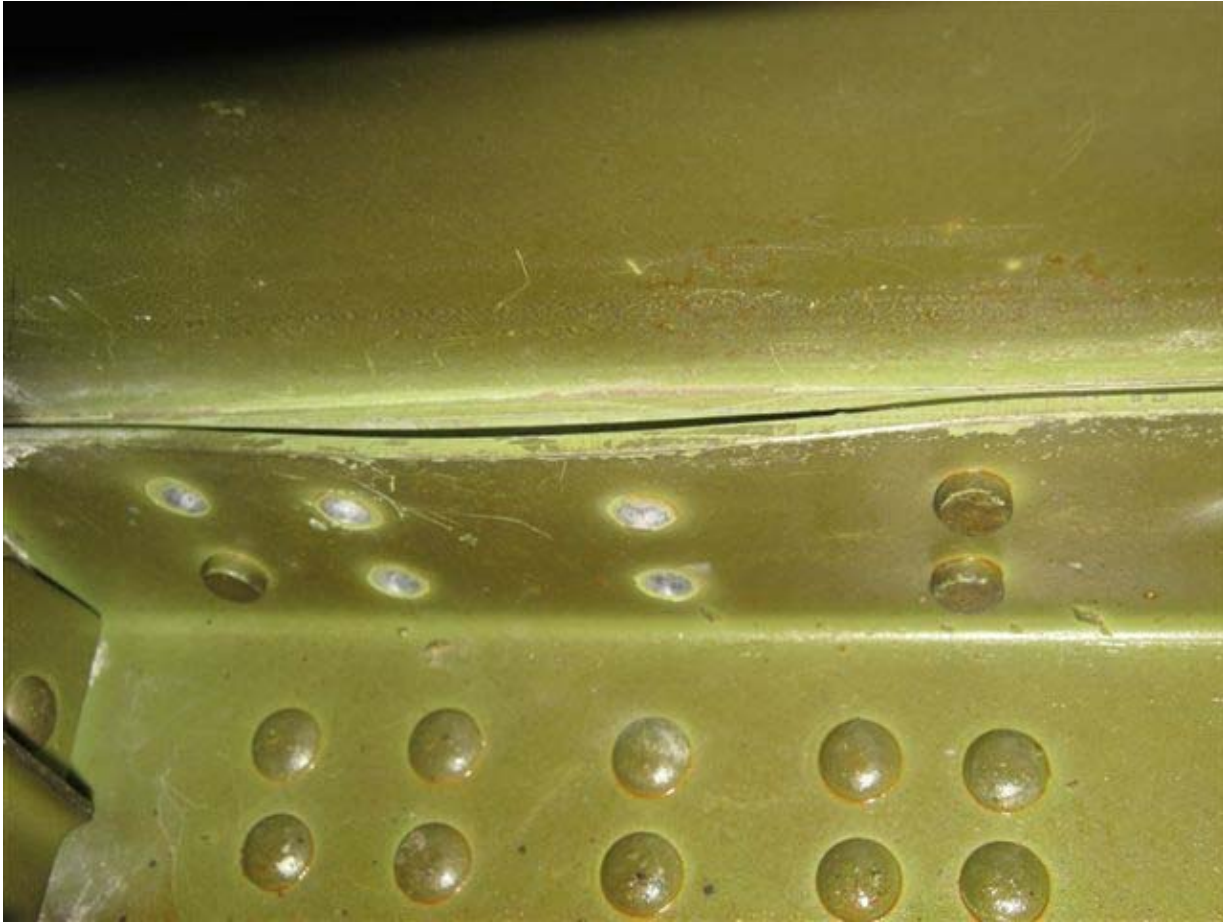
CASA: C212-200; Wing Spar Corrosion; ATA 5711

An Air Carrier technician says, "The left wing, upper forward spar's aft horizontal leg is exfoliated at (approximately) Wing Station 3496. *(There is)* probable exfoliation at WS 2130 to 2450, and at WS 2900 to 3000."

(Nice photo—but it leaves me scared to see what is in between...powder and flakes—Ed.)

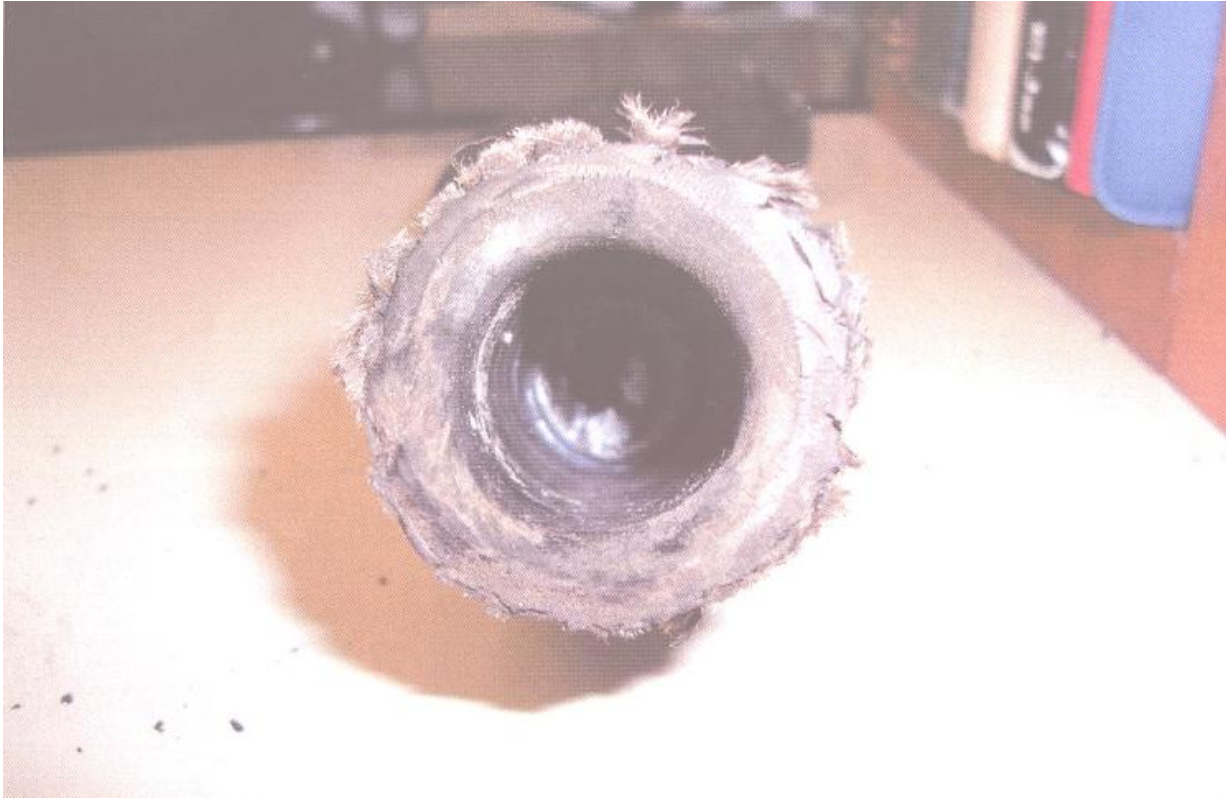
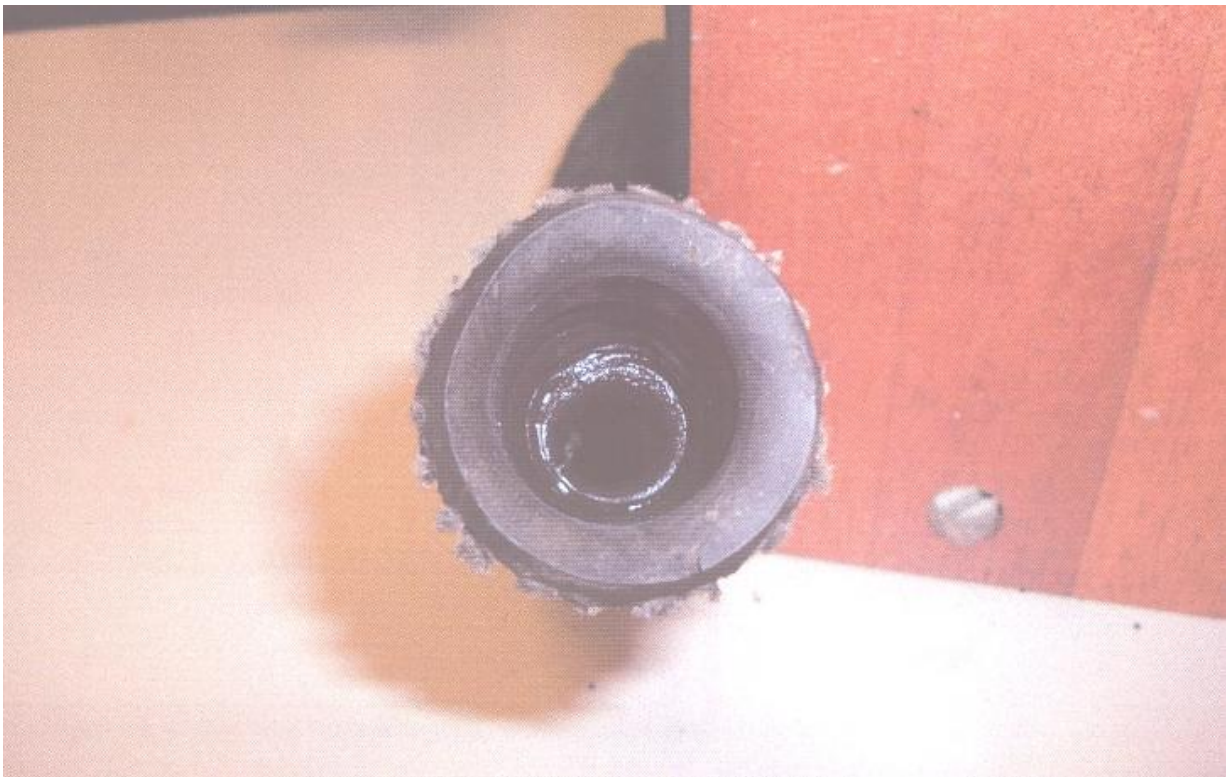
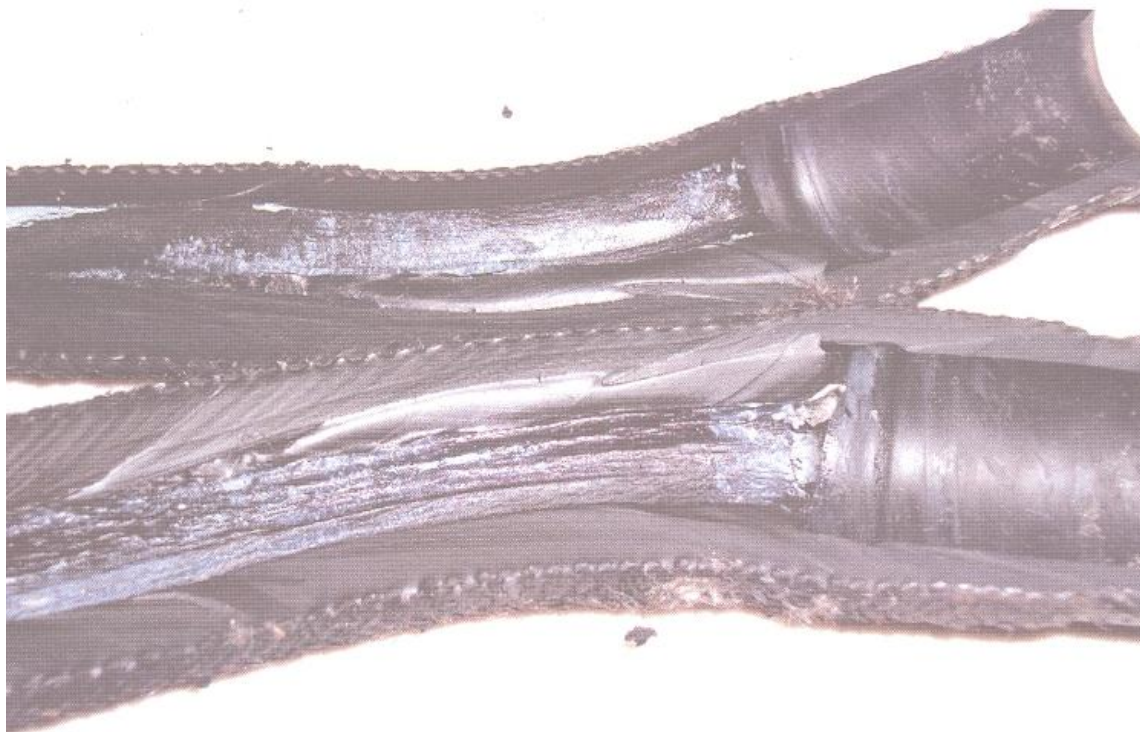
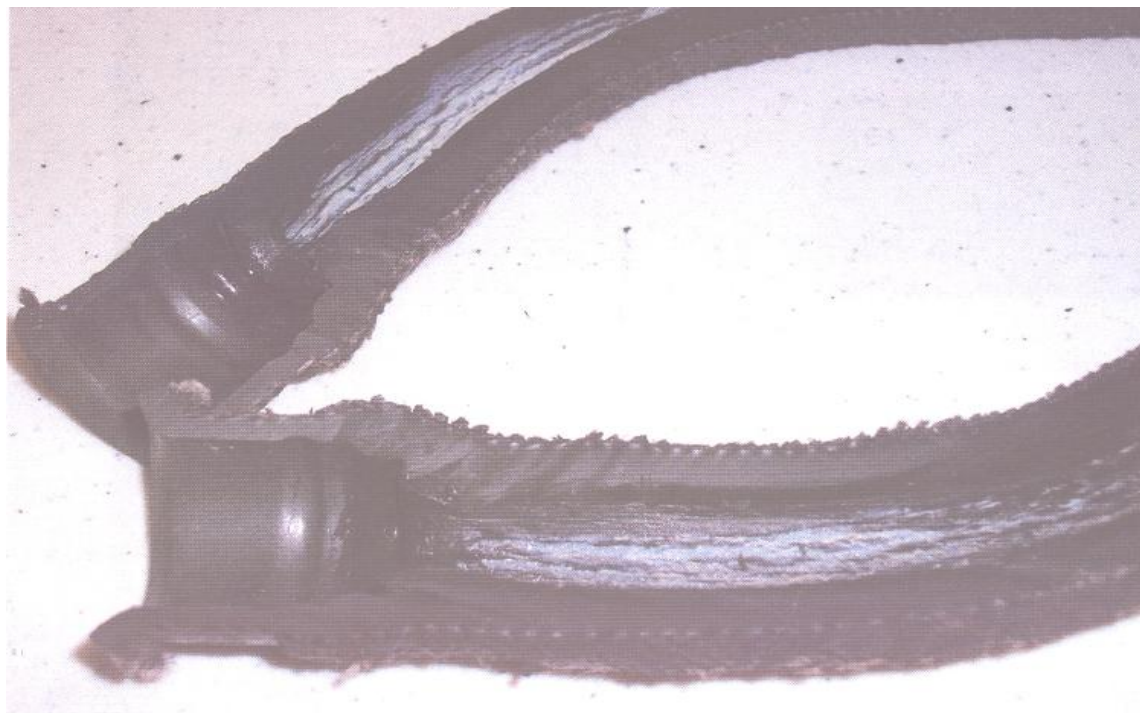
Cessna: 208B; Collapsed Engine Vent Line; ATA 7261

A general aviation submission states, "In compliance with a fleet campaign directive, and during an engine inspection, a mechanic checking the vent line of the overboard breather found the rubber section swollen internally. Left unchecked, an obstruction would cause the Pratt & Whitney PT6-114 engine of this (*aircraft*) to start consuming large amounts of engine oil—compromising the engine bearing seals and resulting in expensive engine repairs. The fleet campaign directive mentioned above was generated by this Caravan operator to address the condition of these aging hose sections. Operators of older Caravans would be wise to check their aircraft for similar defects."

(P/N S5114. Indeed—some other operators too have found this defect. See last month's Alerts edition—Ed.)

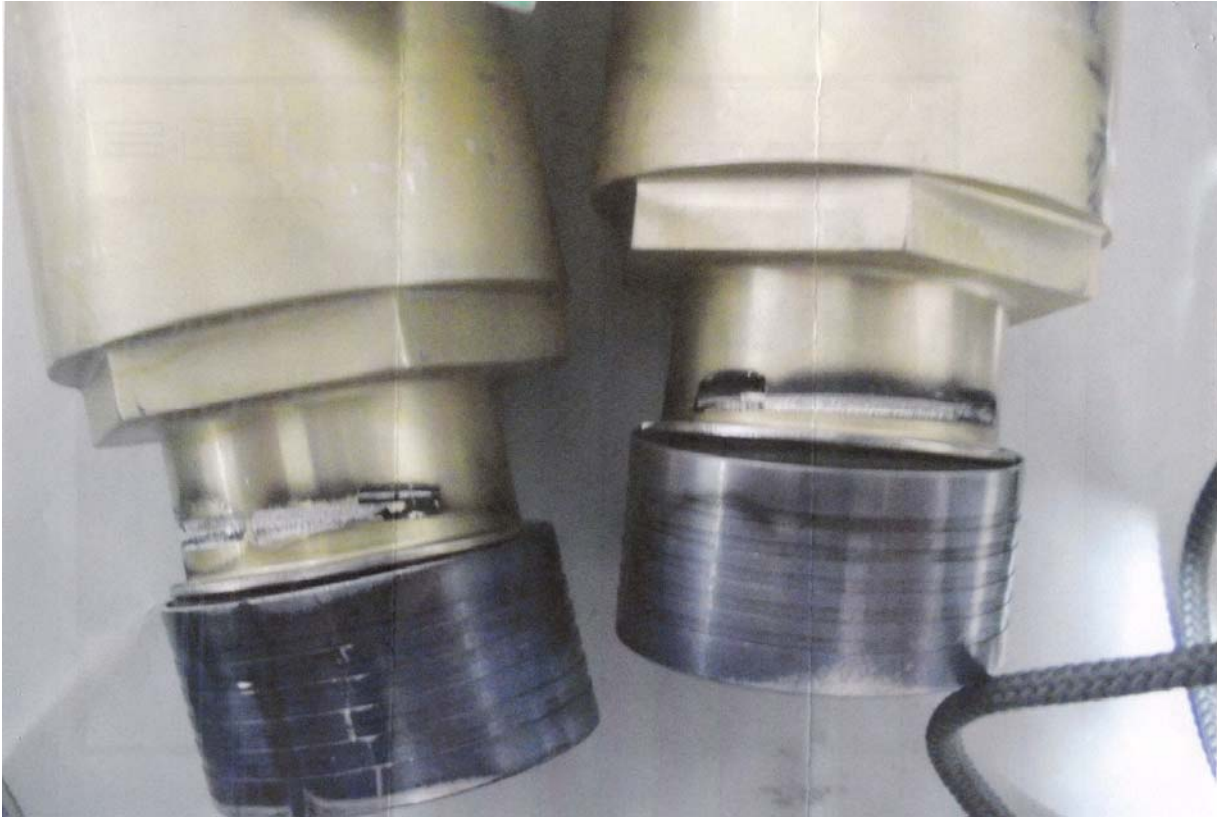
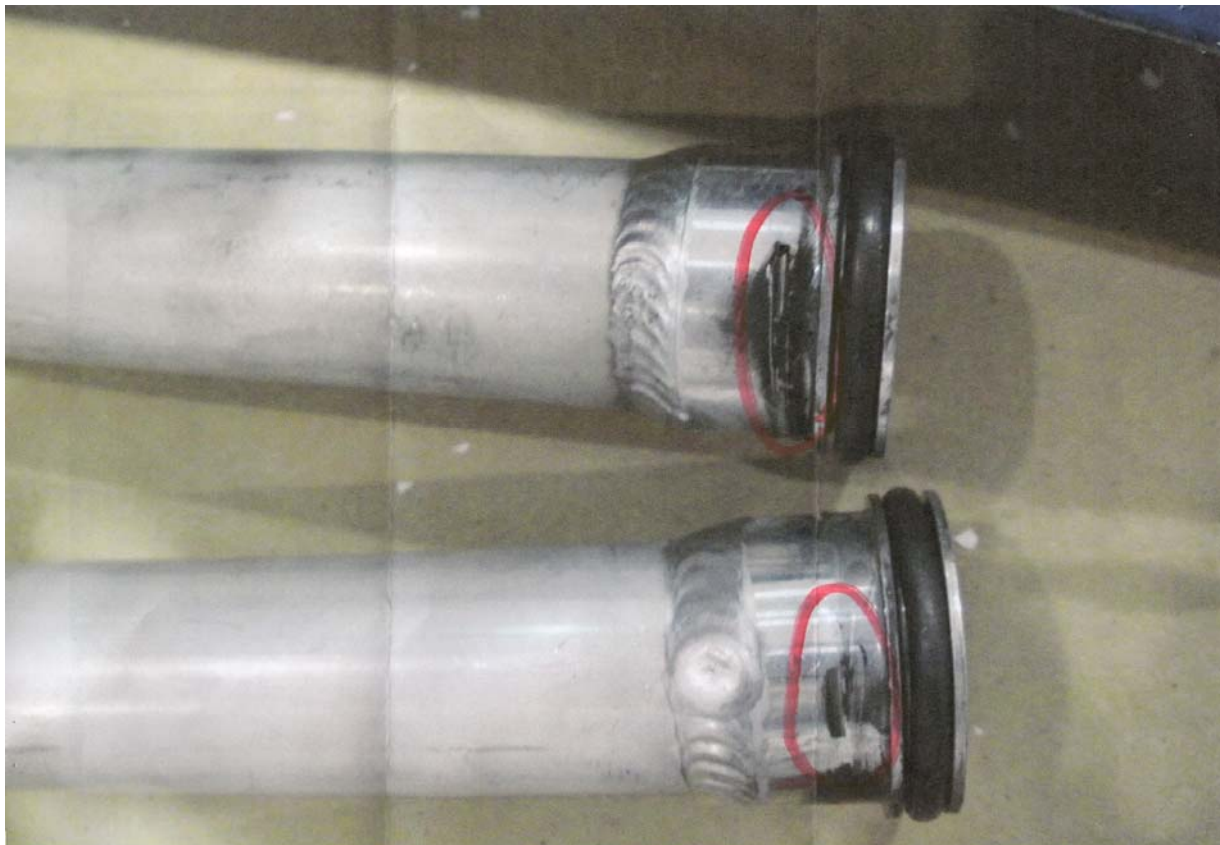
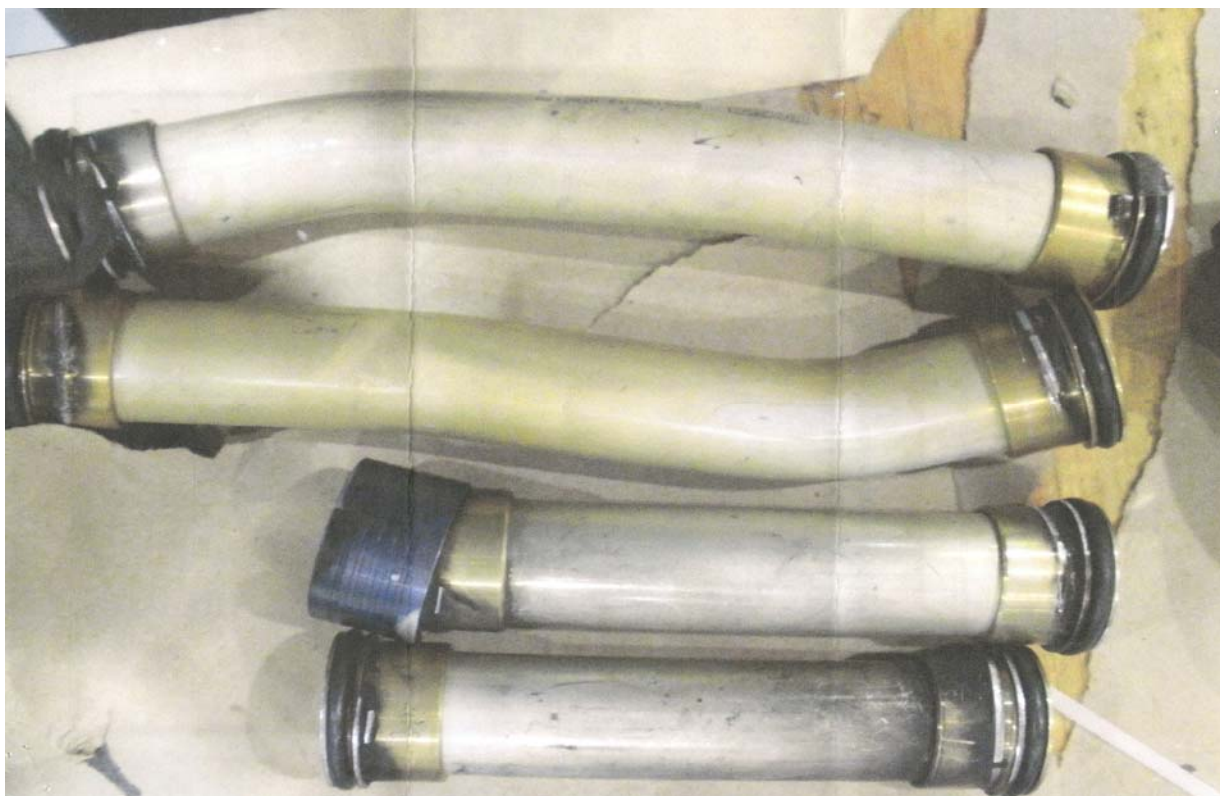
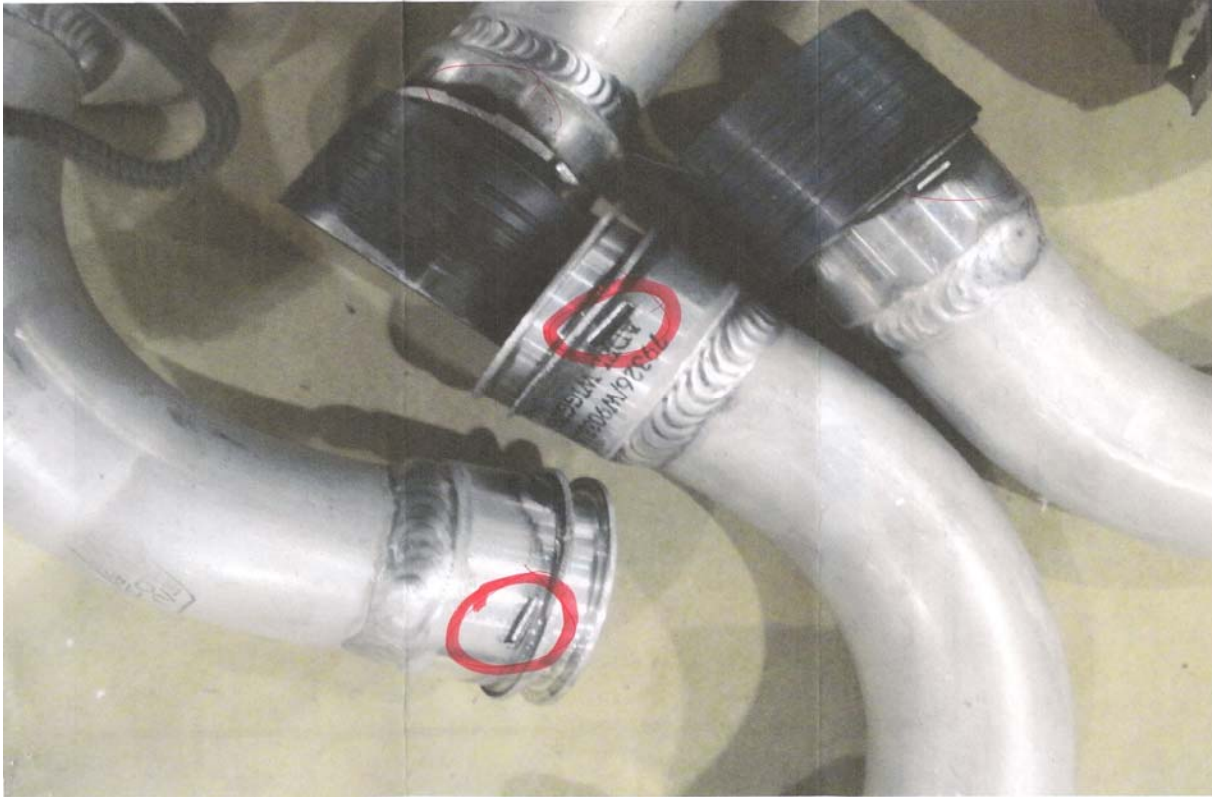
Cessna: C680; Chafed Jet-pump tubes; ATA 2810

"Extensive fretting damage (*was found*) on the primary jet-pump fittings—and the attaching line fittings where the Wiggins clamps (*W991-18DE*) are installed," writes a repair station mechanic. "Damage occurs to adjacent plumbing—P/N's 6926100-123, 6926100-13 (*and -14, -15, -76*). Damage has been found on Cessna 680 models during tank inspection 28-10-00-201. This condition is dangerous and unairworthy." (*Primary Jet-Pump P/N: 9914682-1.*)

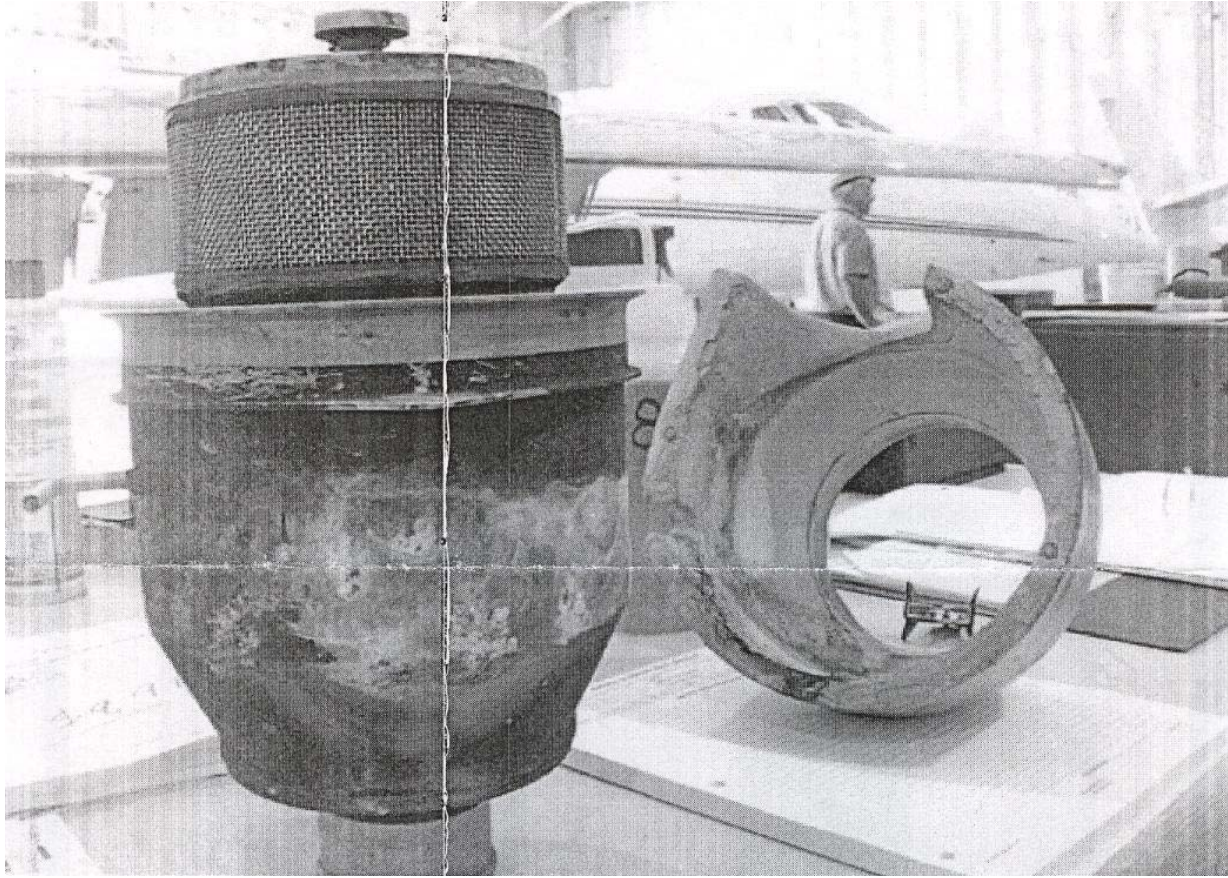
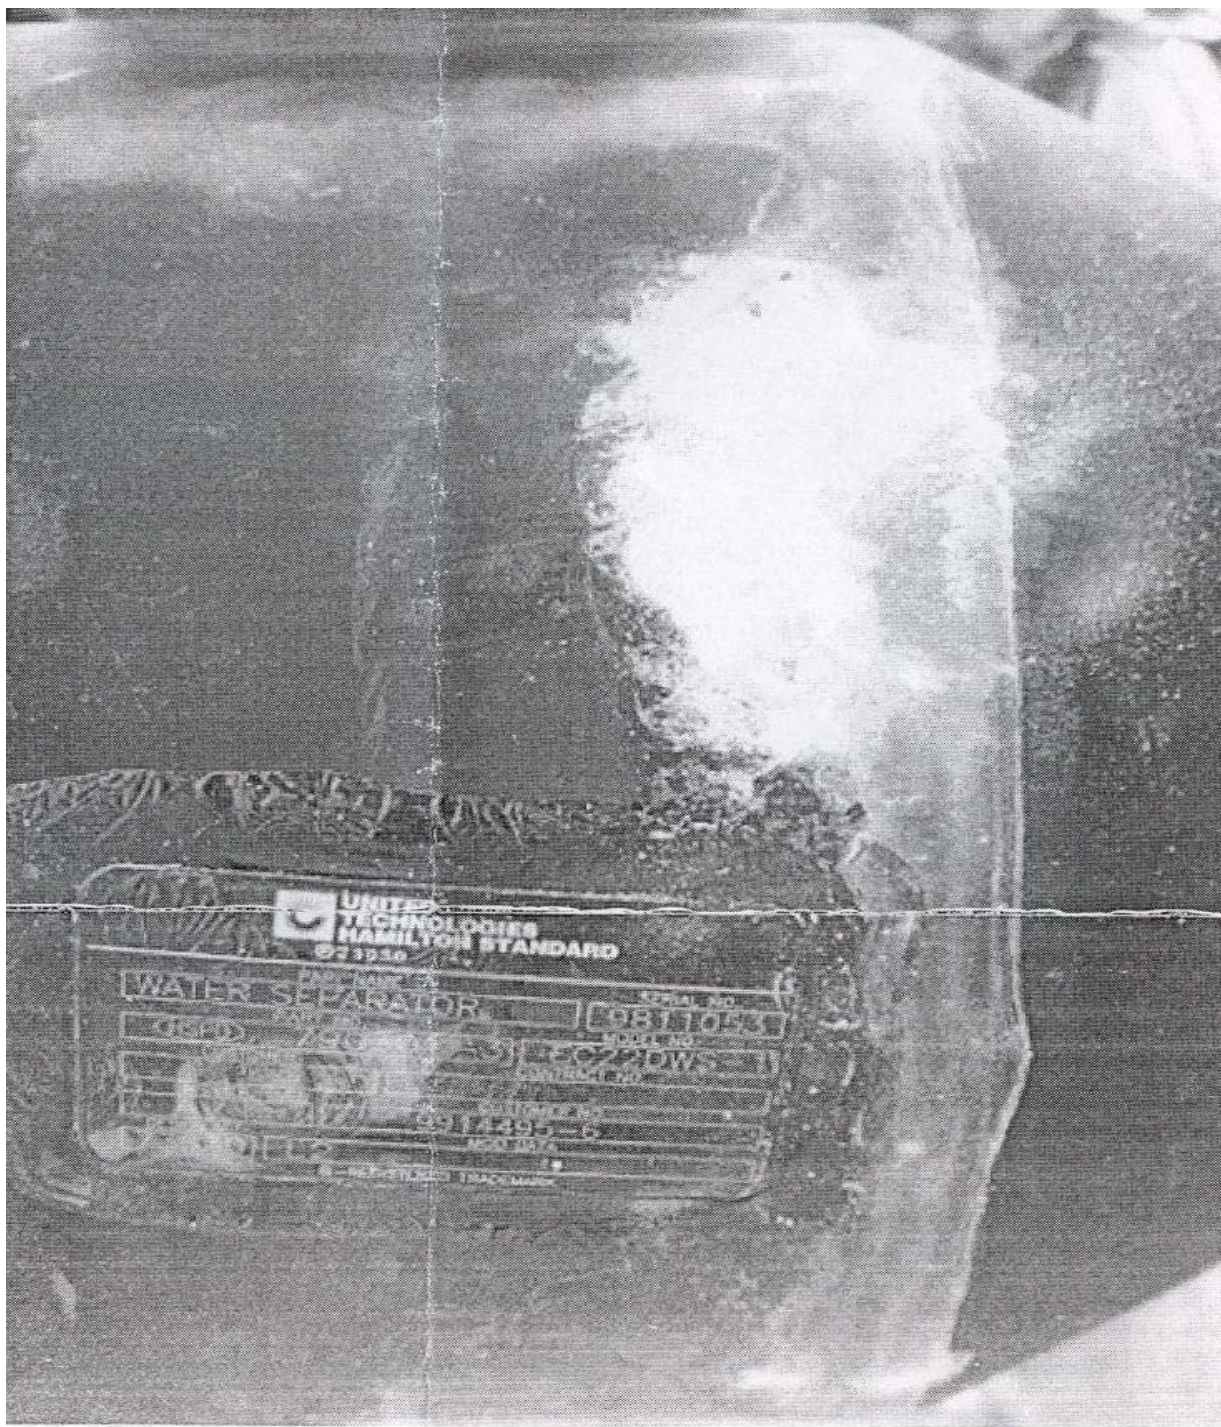
Cessna: CE-750; Water-separator Corrosion: ATA 2170

A repair station mechanic states, "Both the L/H and R/H water separators have corrosion under the insulation (P/N 5715526-8). This is an area not normally looked at during the water sock cleaning/restoration." (*Reference United Technologies, Hamilton Standard; model EC22DWS-1; P/N 79030103.*)

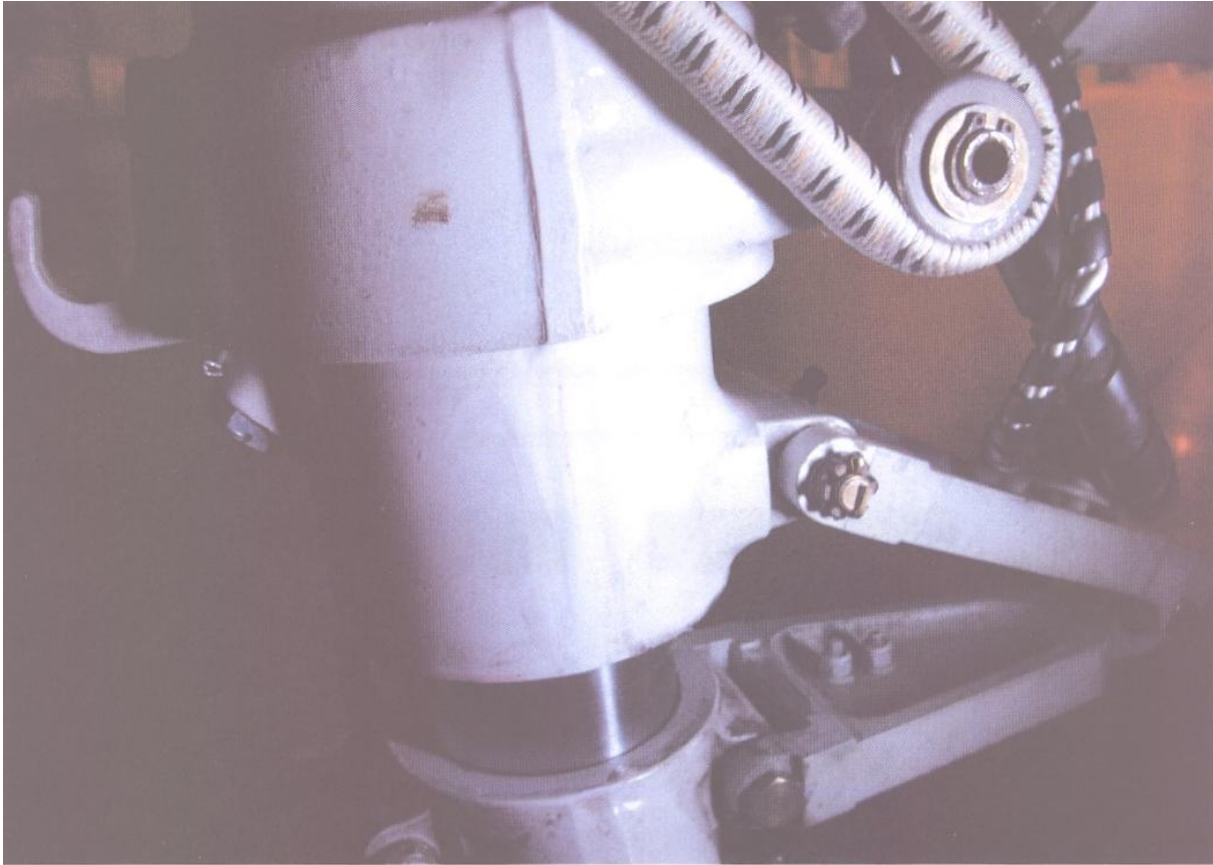
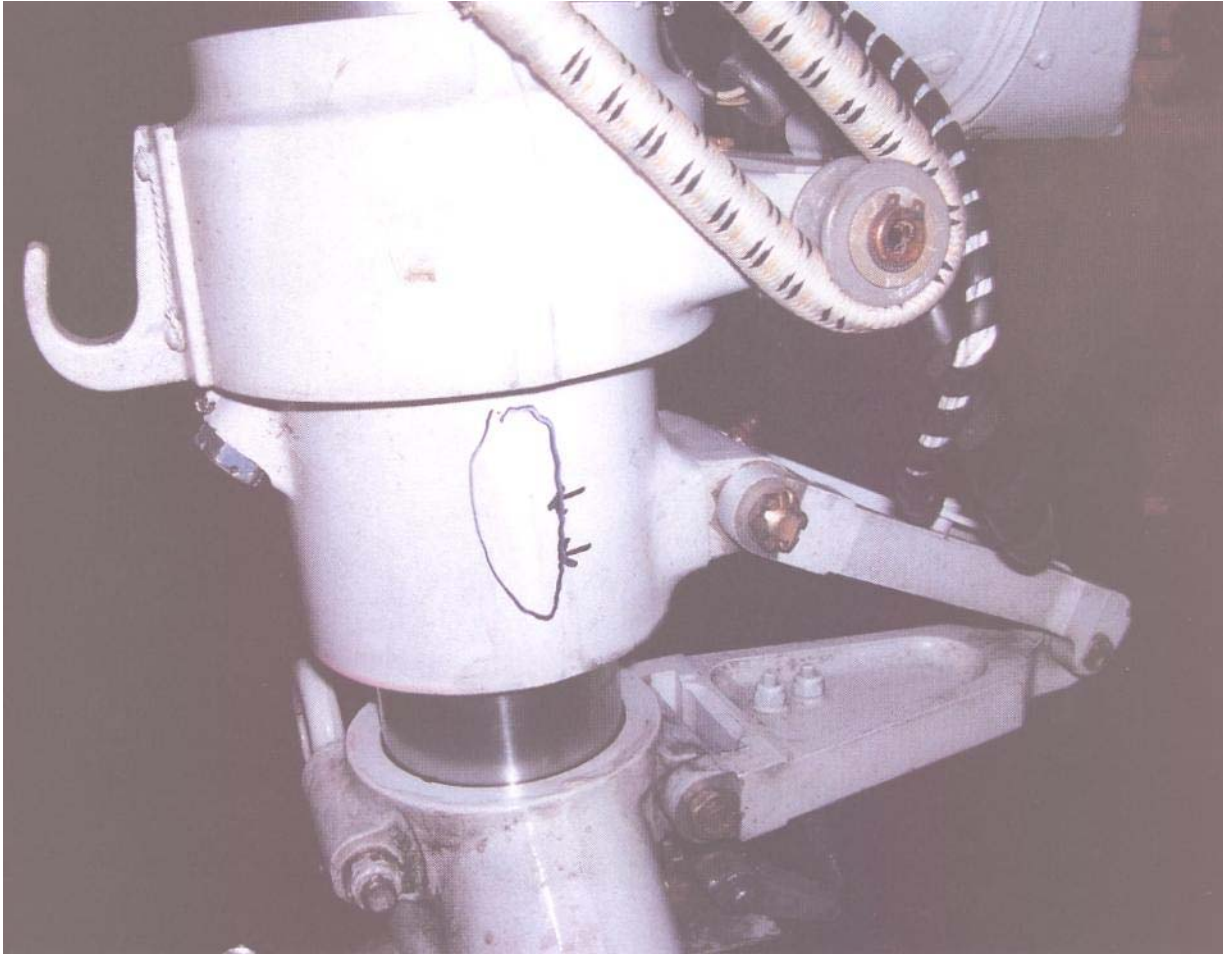
Gulfstream: 690B; Cracked Main Gear Strut; ATA 3213

"The left main gear strut was flat," writes a technician. "(We) tried to service (*the strut*), but when we applied nitrogen pressure hydraulic fluid came out of a three inch crack in the strut body and bearing assembly...." (P/N: ES12394.)

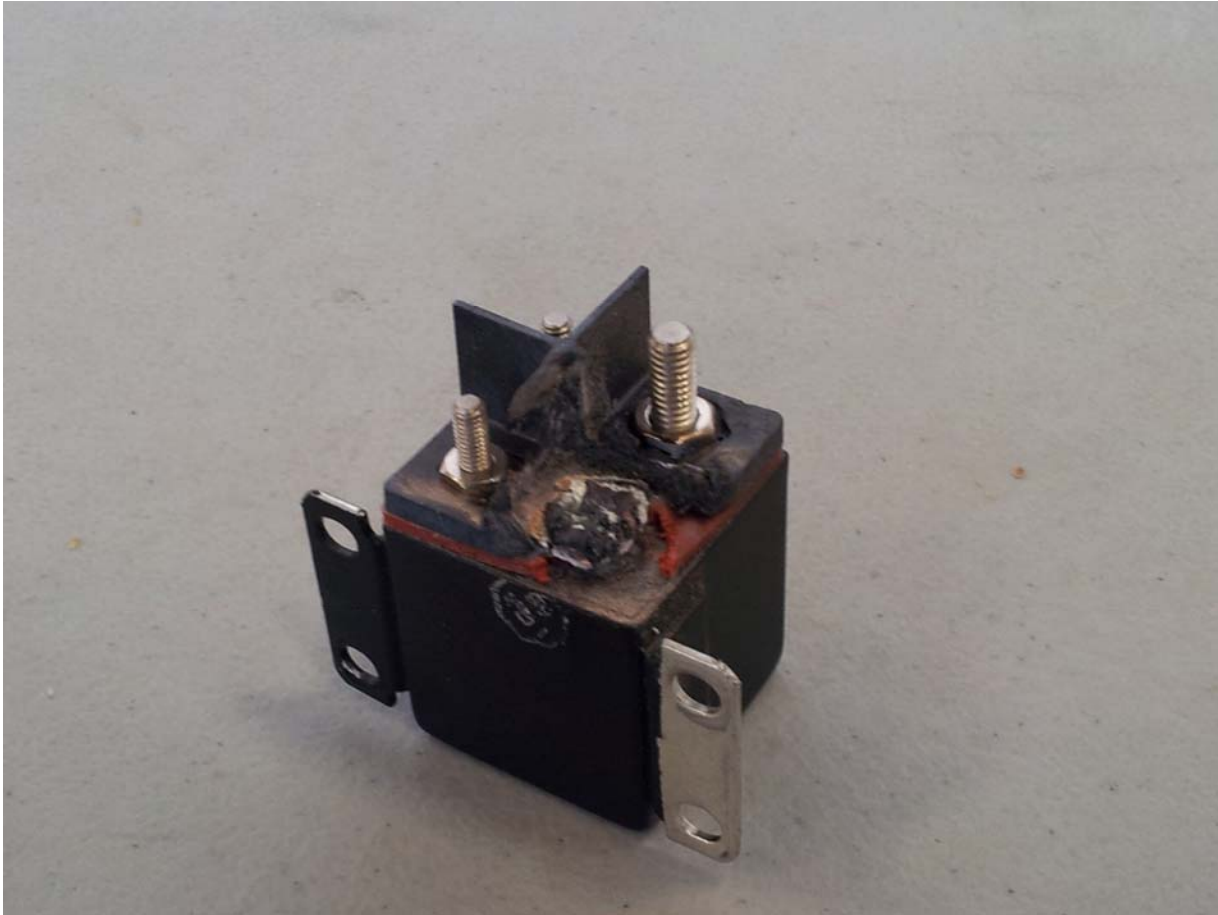
Piaggio: P180; Burned Wiper Relay; ATA 3040

"Windshield anti-ice was found with inoperative sections during a 'B' check," says a technician. "(I) found relays K59 and K6—with power terminals connecting wiring to the windshield—arced and burned, causing complete separation of the terminal from the relay. This condition could also possibly cause smoke in the cockpit."

(Relay P/N: M520J5N.)
