**Federal Aviation
Administration**

ADVISORY CIRCULAR

43-16A

**ALERT
NUMBER
409**

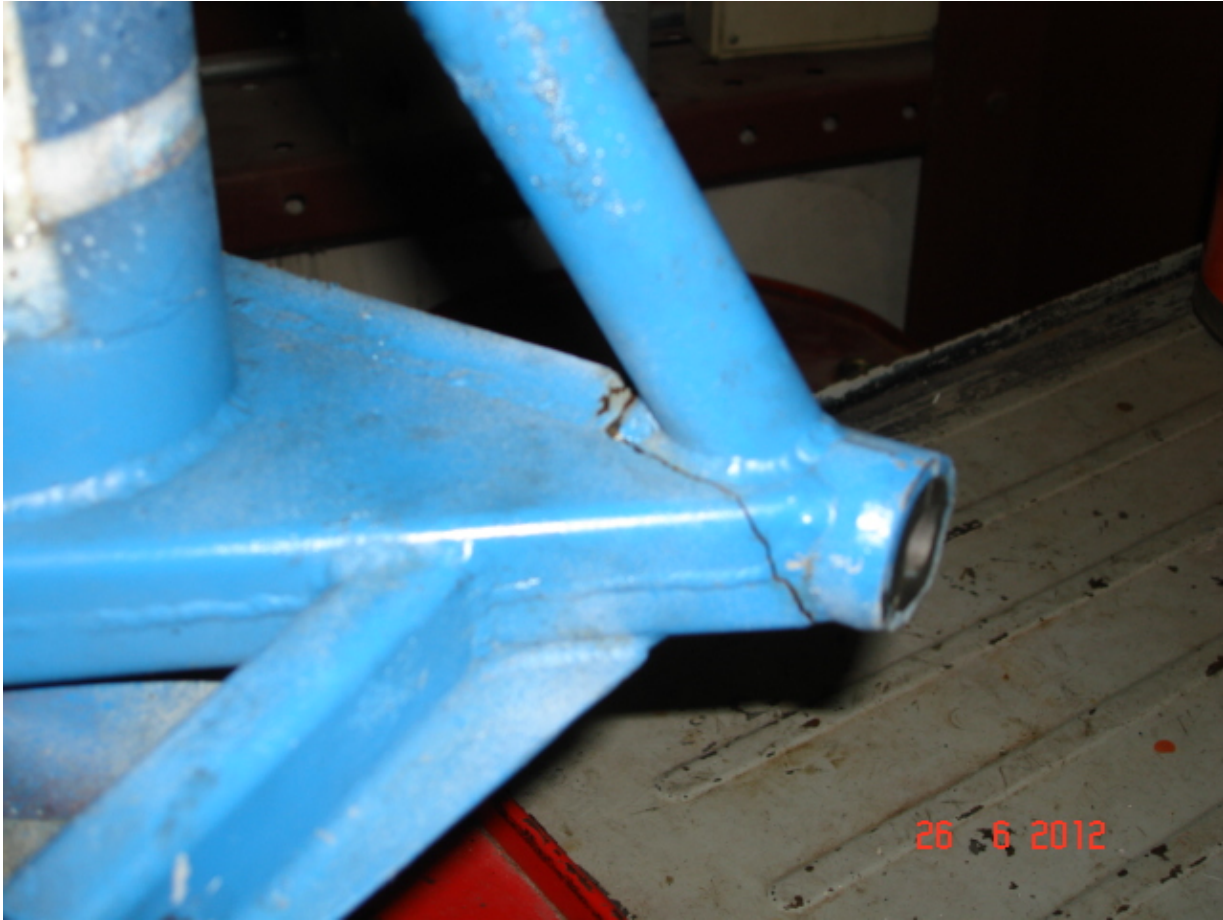
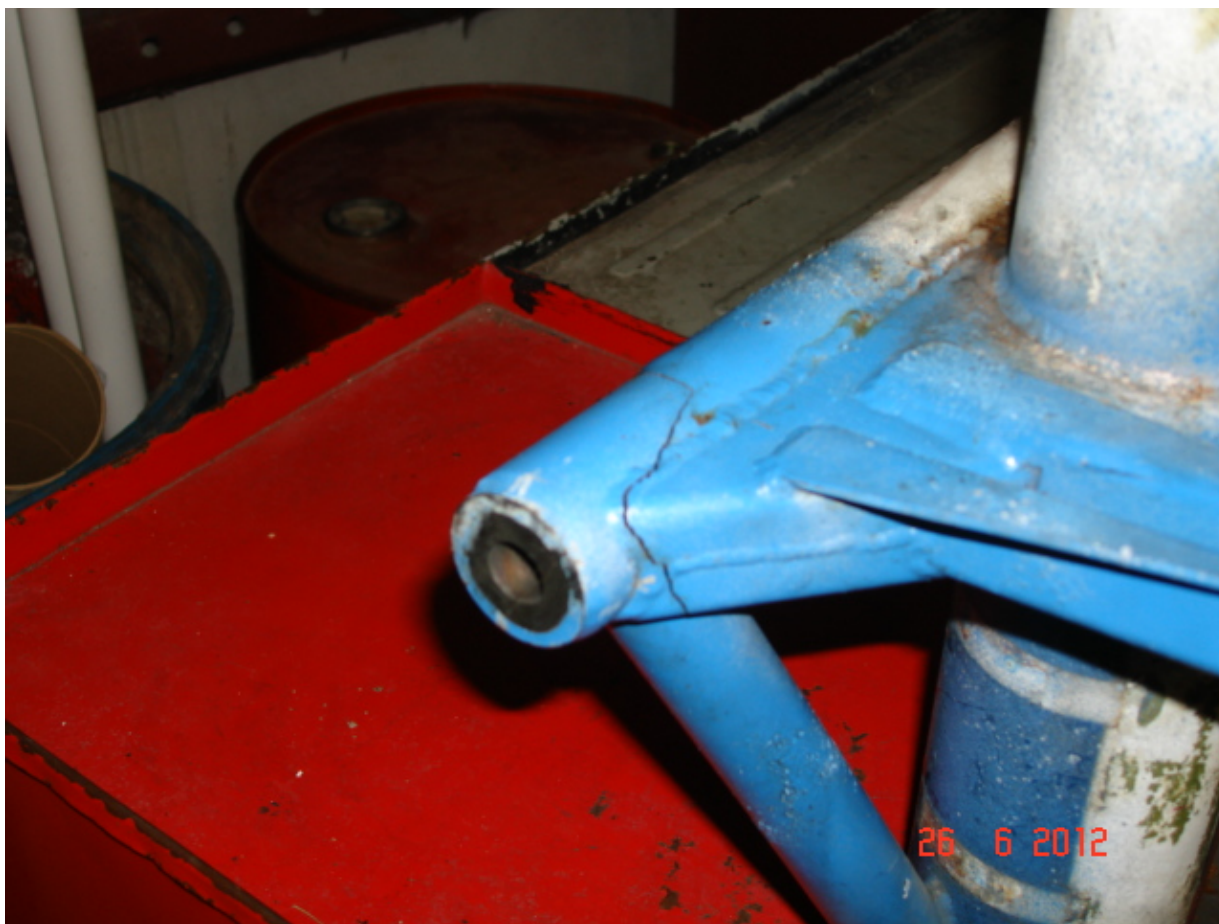
Piper: PA34-200; Cracked Nose Gear Trunnion; ATA 3222

A repair station mechanic states, "*(During)* an Annual inspection, *(I)* found the right pivot point of the nose gear trunnion cracked *(at the point...)* where the trunnion is welded to the pivot bolt housing." *(Trunnion P/N: 9572300. This part is referenced at least four times in the SDRS database.)*

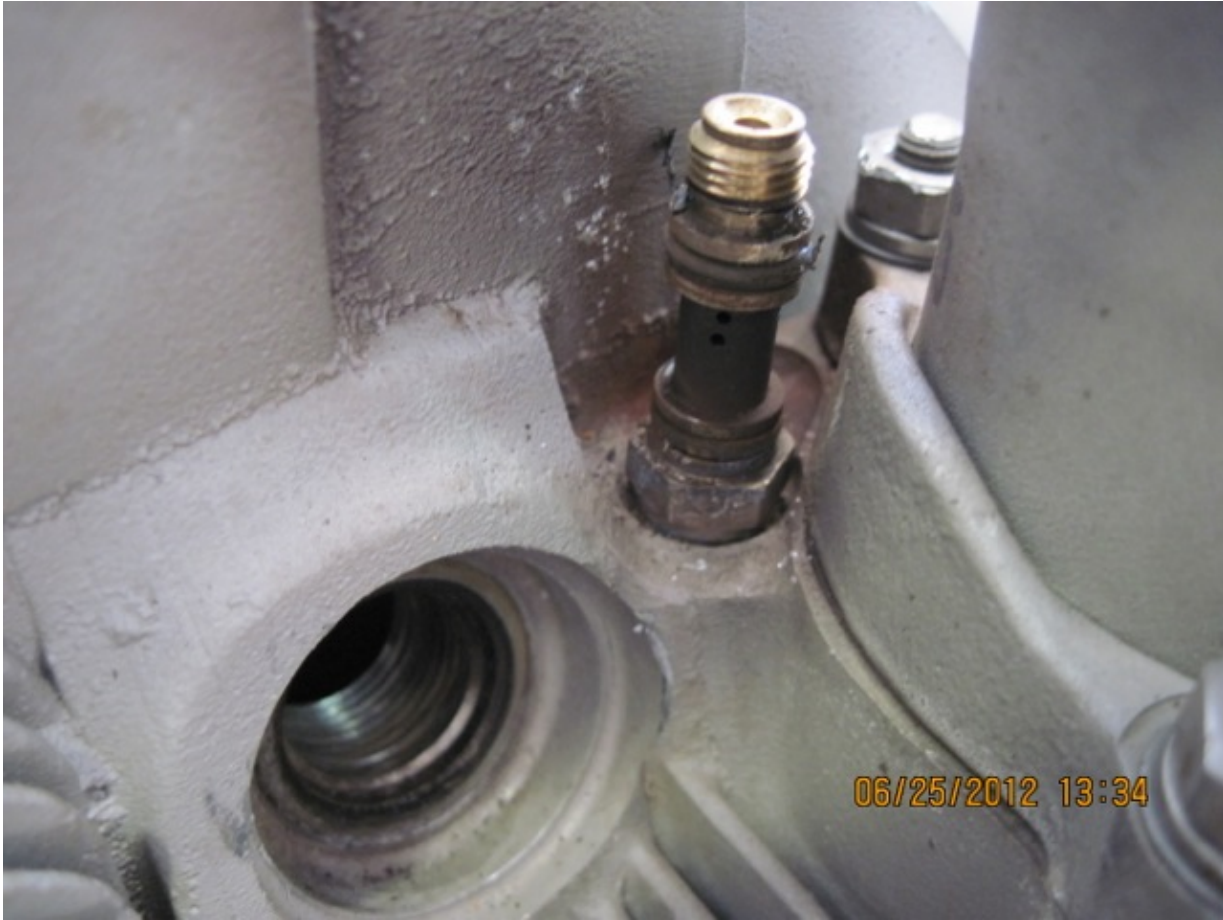
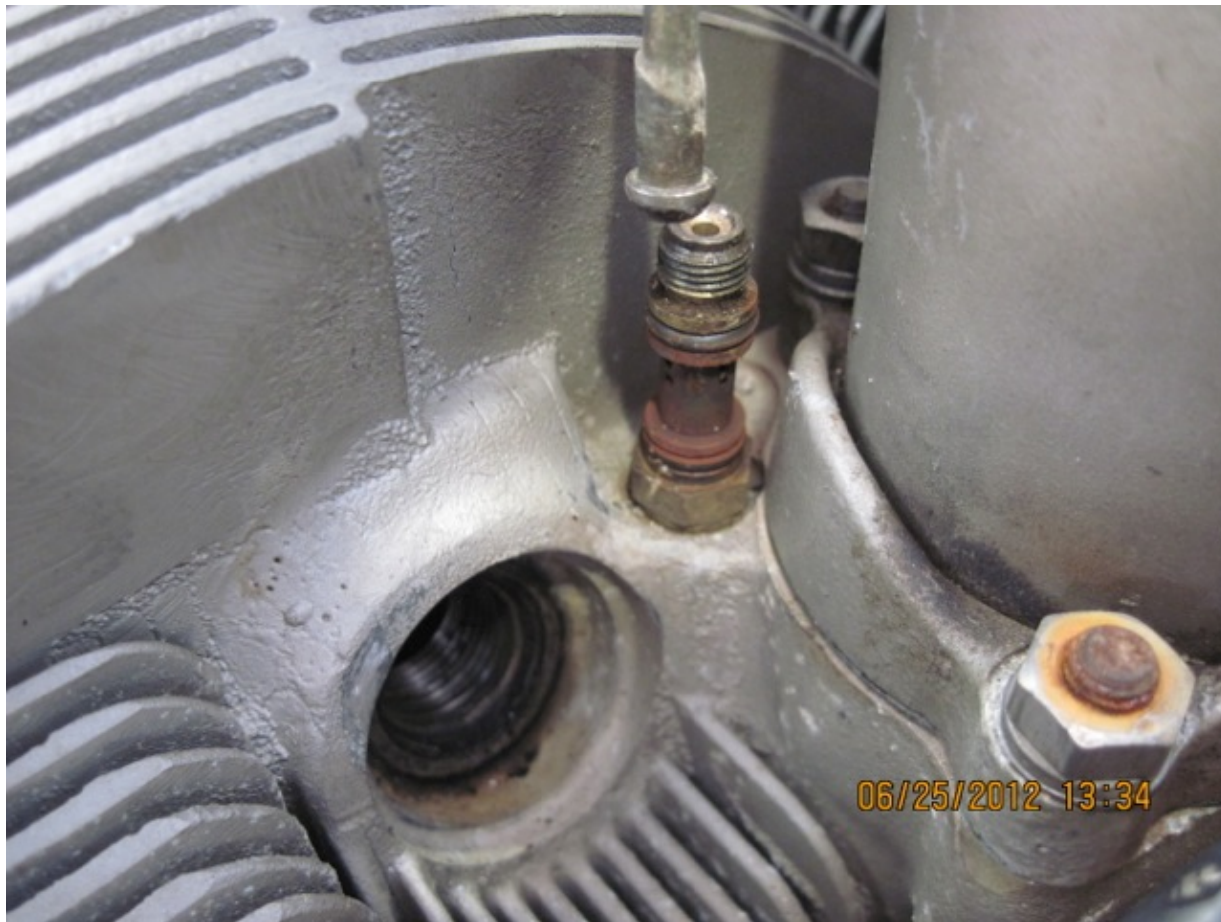
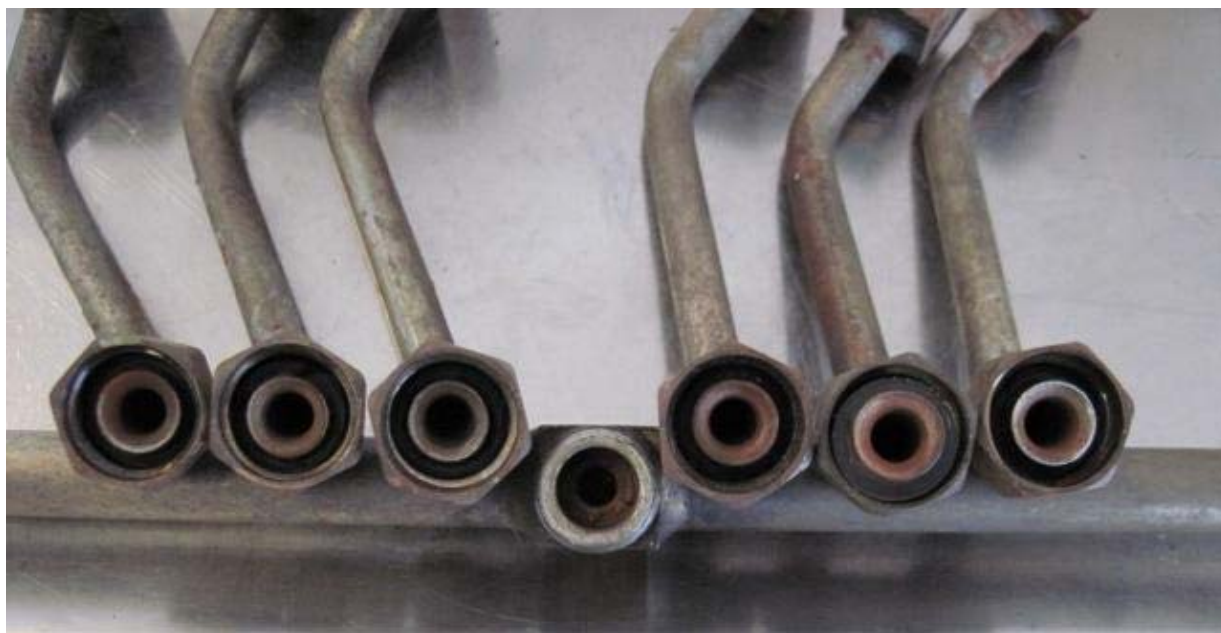
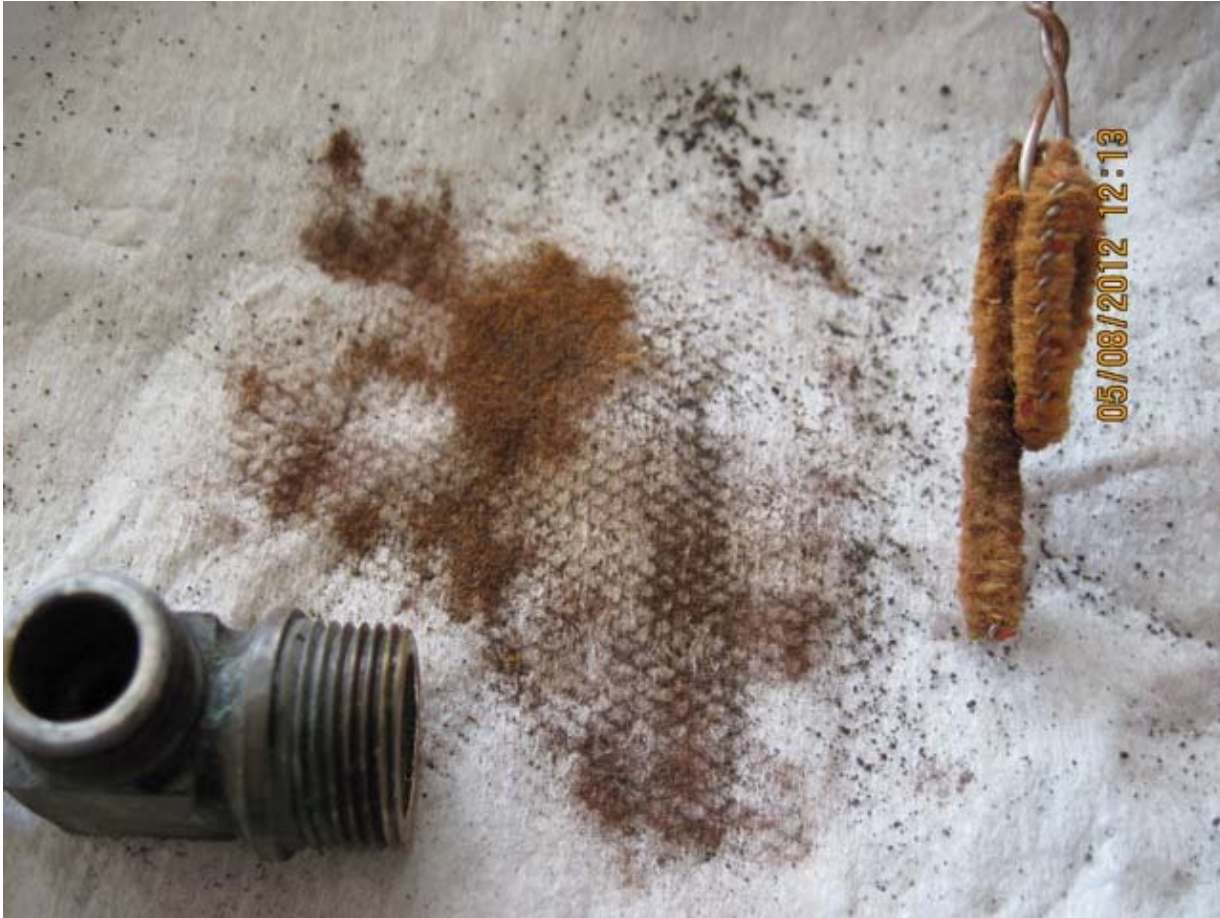
Continental: IO55N; Corroded Fuel Injector Nozzles/Lines; ATA 7310

A mechanic writes, "(I am...) finding the upper deck line rusting internally on Tornado Alley turbo equipped aircraft. This rust consists of both large and small particles that is easily dislodged. Aircraft that have this condition exhibit rust stains on and around the fuel injectors—(*observed*) when the injectors are removed for cleaning. This rust could accumulate and possibly clog the fuel injector air passages over time. I have noticed this (*defect*) on two different aircraft equipped with the STC (*Supplemental Type Certificates*) SA10588SC and SE10589SC."
