Collision of Two Washington Metropolitan Area Transit
Authority Metrorail Trains Near Fort Totten Station
Washington, D.C.
June 22, 2009

Railroad Accident Report

NTSB/RAR-10/02
PB2010-916302

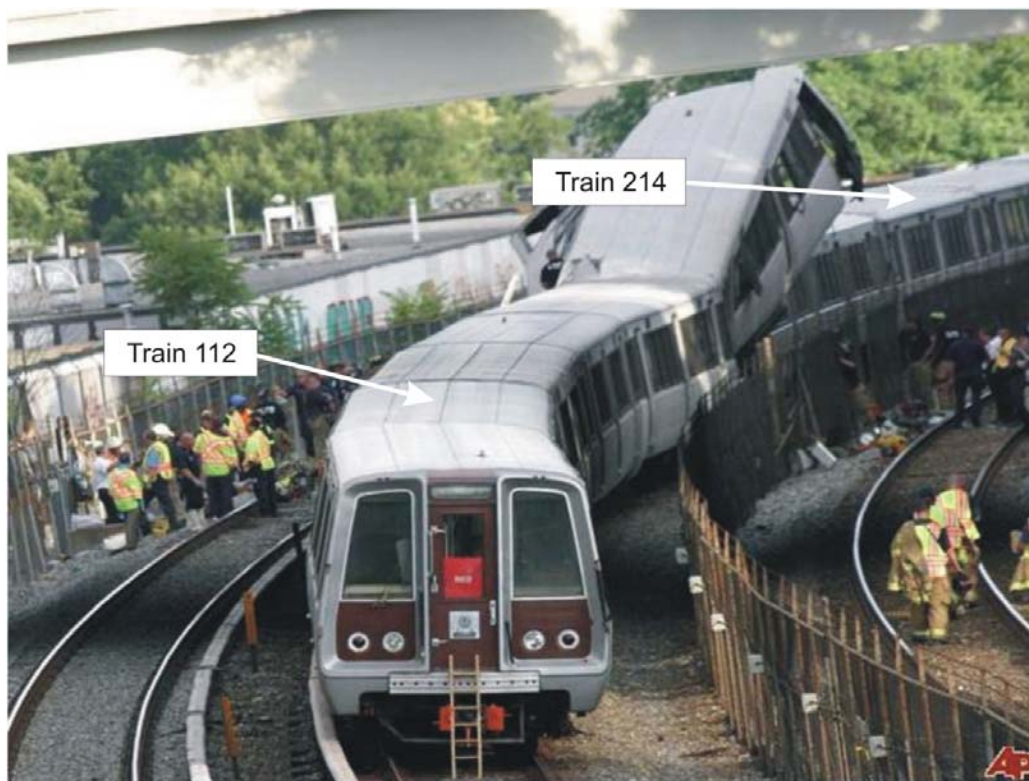
Figure 1. Lead car of striking train (train 112) has overridden last car of struck train (train 214), which has telescoped into lead car of train 112.

The accident occurred on a segment of curved track and resulted in the derailment of the first car and the lead axle of the second car of the striking train. The lead car also sustained catastrophic carbody intrusion damage (telescoping) and loss of occupant survival space to a distance of about 63 feet (about 84 percent of its total length). The rear car of the struck train did not sustain extensive damage and did not derail. None of the other cars on the two trains derailed or sustained major damage. Damage to the train equipment was estimated to be \$12 million.

Most of the damage from the collision was sustained by the lead car of train 112. Both cars came to rest upright and substantially aligned with the track. The lead and second cars of the striking train derailed; these were the only cars on either train to do so. The other railcars of each train were wedged together but were otherwise substantially undamaged and did not lose any occupant survival space. No evidence of fire was apparent in any of the railcars, nor was there evidence of release of a hazardous material such as battery acid.

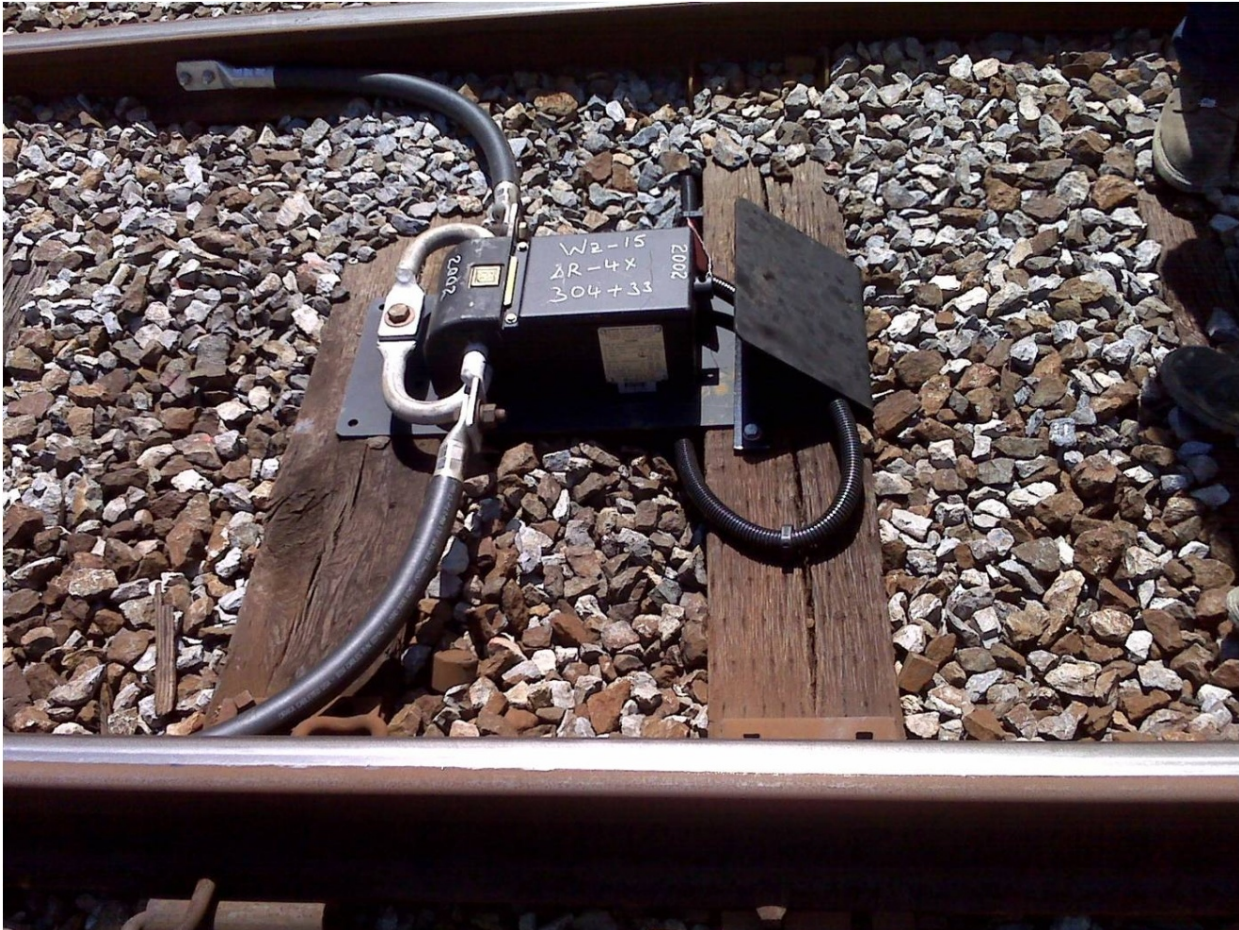
Figure 8. Impedance bond for track circuit B2-304.

Track occupancy detection is accomplished as follows: At each end of each track circuit, an impedance bond is mounted between the rails. (See figure 8.) The impedance bond at one end of the block acts as a transmitter; the one at the other end acts as a receiver.⁵⁰ Track circuits are typically arranged for the normal direction of traffic so that a train entering a track circuit will pass over the receiver end of a track circuit before traversing the transmitter end.

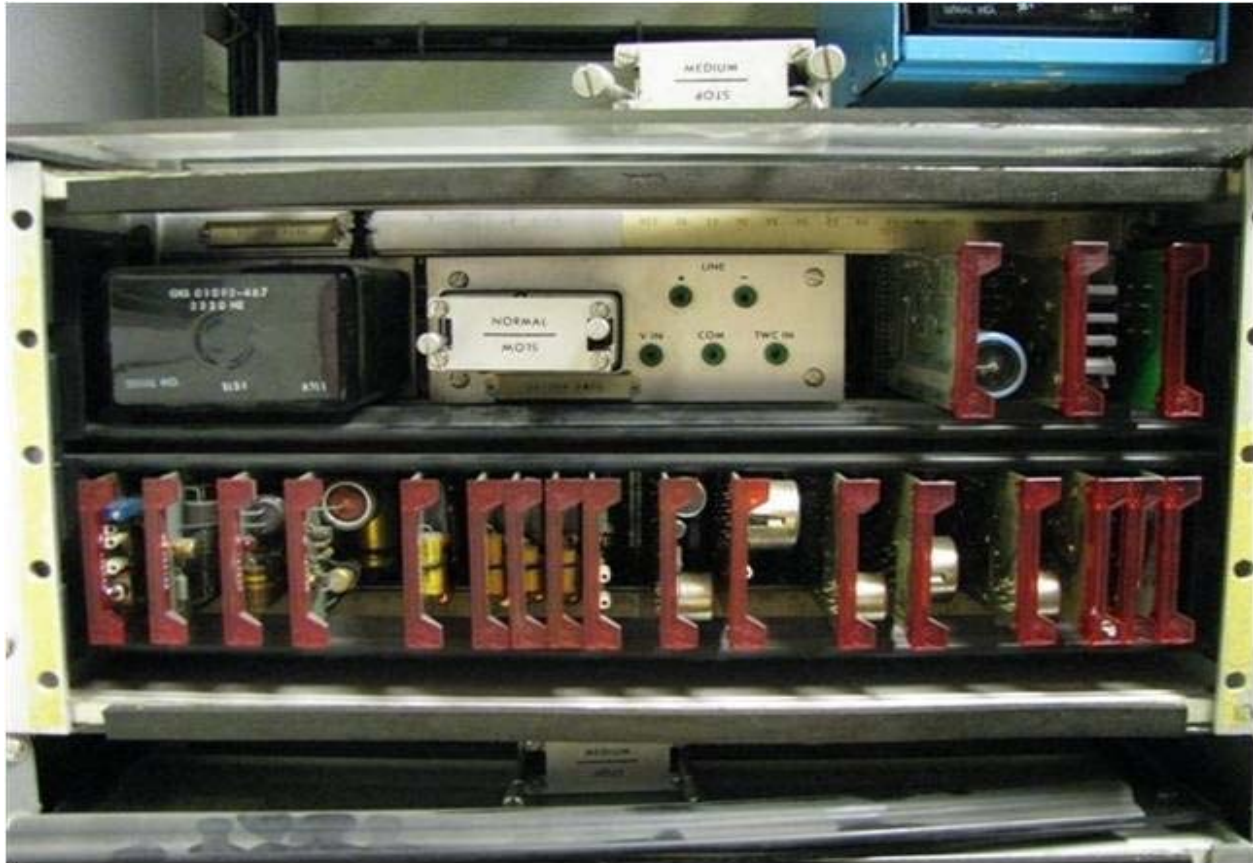
Figure 9. Typical track circuit module.

a track circuit receiver module in the train control room. (See figure 9.) The track circuit receiver module filters, amplifies, and checks the level of the signal it receives from the impedance bond. If the signal meets the amplitude and modulation requirements for that track circuit, the module energizes the coil of a track relay. The energized coil causes the relay armature to “pick up,” or rise, thus completing the track circuit. A track relay in the “up,” or raised, position indicates to the ATC system that the block of track is unoccupied.

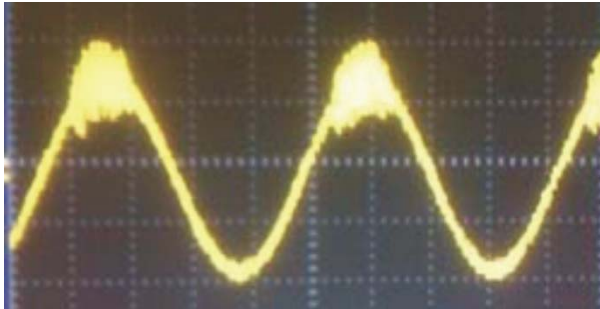
Oscillation type 3: The thickened portions of the waveform are all in the same region (usually at a positive or negative peak), indicating local (internal) oscillations. The track circuit may be at risk for the parasitic oscillation failure mode.

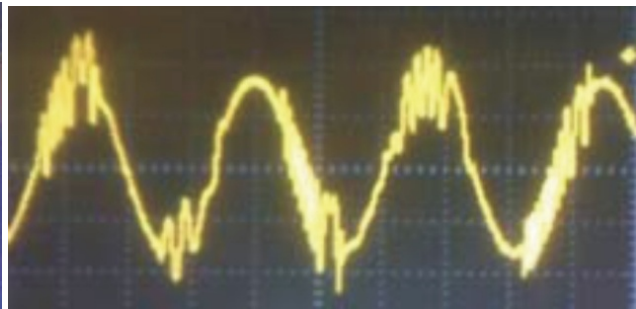
identified as having type 4 oscillation like that found at Fort Totten used GRS impedance bonds and GRS track circuit modules.

Oscillation type 4: The thickened portions of the waveform are irregular (they appear at different angles/locations of the waveform), indicating that they are coming from another transmitter, via the power distribution and rack structures, and are superimposed on the preamplifier of the shared track circuit transmitter. These are external oscillations that could mimic a valid track circuit signal and result in a loss of train detection.

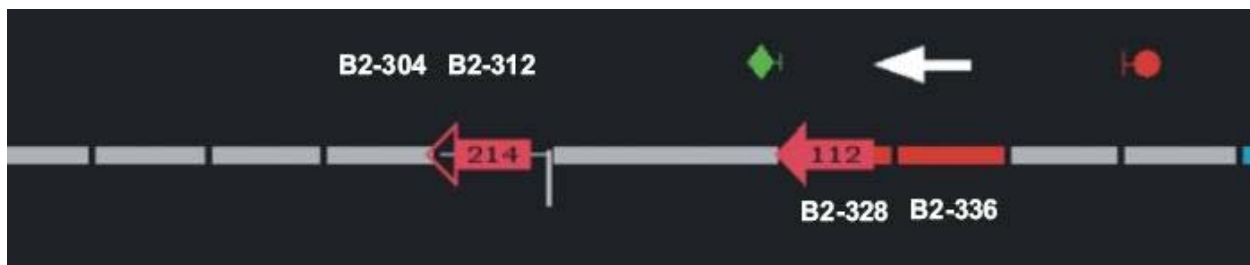
4:57:19 p.m. Train 214 is depicted as occupying a single track circuit (B2-312) that is shown as a non-reporting block (a track circuit that reports as vacant when Advanced Information Management system computer algorithms determine that it should be occupied). Track circuit B2-304 displays as an unoccupied, normally reporting block. Performance data indicated that train 214 was stopped at this time and that the front of train 214 was actually at chain marker 307+00, corresponding to track circuit B2-304. The front of train 112 was at chain marker 335+69, corresponding to track circuit B2-328. Track circuit B2-304 displays as a normally reporting, unoccupied block even though performance data indicated that train 214 was fully within that track circuit. Performance data also indicated that at this time train 112 had begun receiving speed commands of 55 mph.

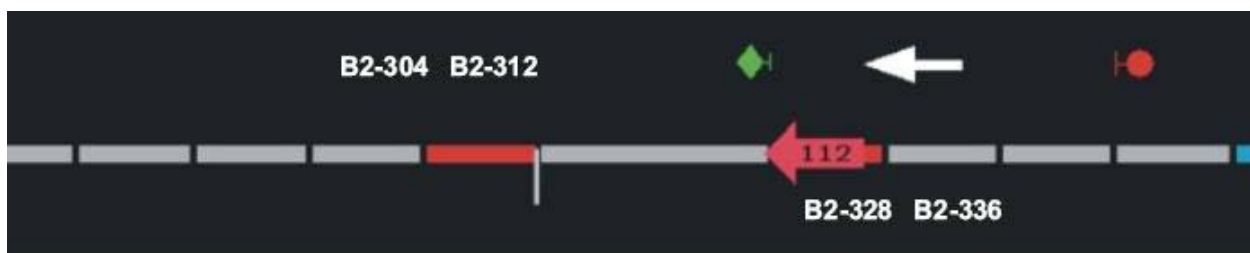
4:57:38 p.m. Track circuit B2-304 displays as unoccupied even though performance data indicated that the front of train 214 was at chain marker 307+00, corresponding to track circuit B2-304. Track circuit B2-312 is now displaying as an occupied, normally reporting block. The tag for train 214 has been dropped from the display as a result of preprogrammed Advanced Information Management system algorithms designed to eliminate false train indications. The front of train 112 was at chain marker 330+15, corresponding to track circuit B2-328.

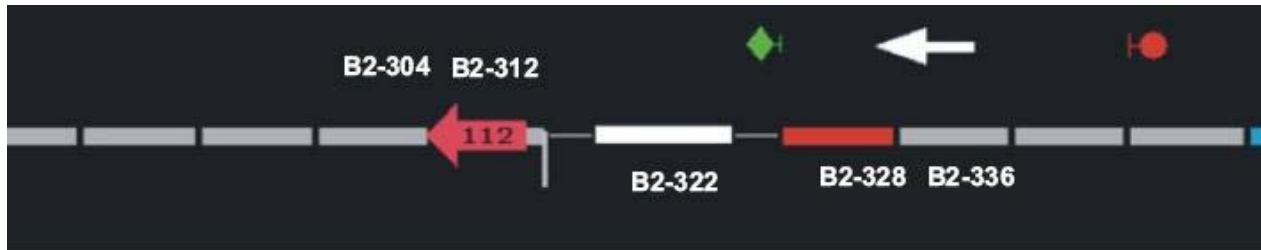
4:57:39 p.m. Train 214 is gone from the display. Train 112 is displayed as occupying a single track circuit (B2-312), which is now reporting as an unoccupied block. At this time, performance data indicated that the front of train 214 was at chain marker 307+00, corresponding to track circuit B2-304. The front of train 112 was at chain marker 329+52, corresponding to track circuit B2-328. Track circuit B2-328 is displayed as an occupied block. The intervening track circuit (B2-322) is displayed as an unoccupied, non-reporting block. Track circuit B2-304 is displayed as unoccupied even though all of train 214 is occupying that track circuit.
