# National Transportation Safety Board

## Aircraft Accident Brief

Accident Number:	CHI01MA011
Operator/Flight Number:	N/A
Aircraft and Registration:	Cessna 335, N8354N
Location:	Hillsboro, Missouri
Date:	October 16, 2000

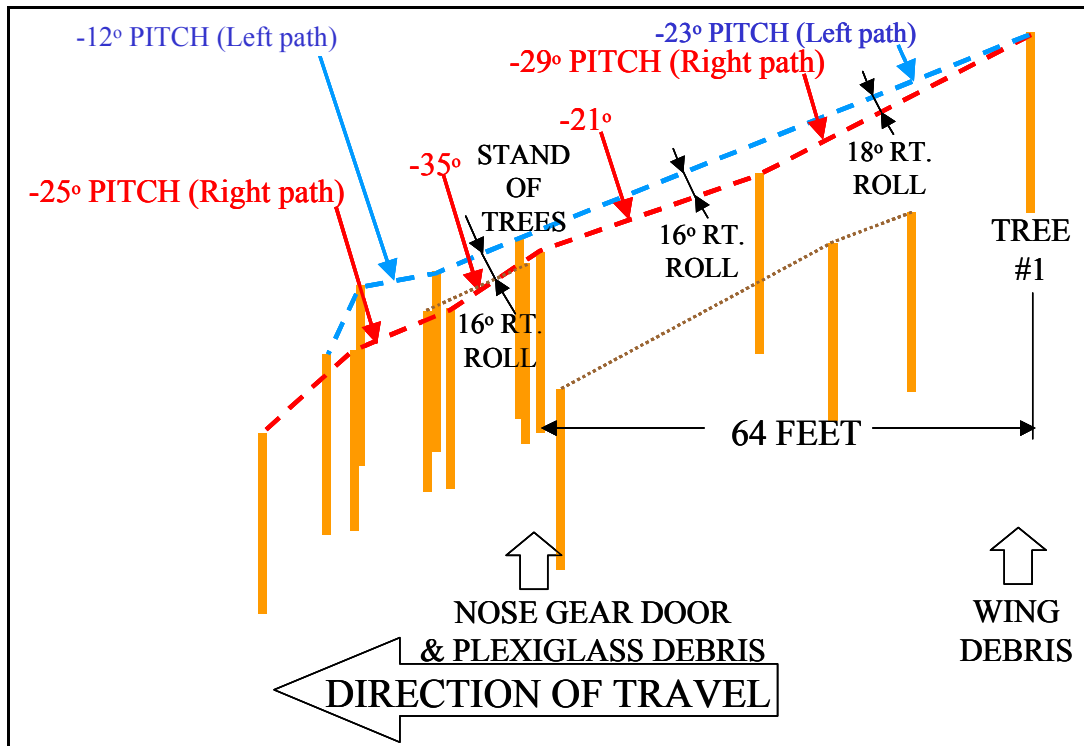
A laser-based measuring device was used to document the accident site. Data from the laser survey were used to create a three-dimensional model of the airplane's flightpath through the trees. The model and the inspection of the accident site revealed that the airplane was in a 16° to 18° right-wing-down attitude during its entry into the trees. (See figure 1.)

No evidence of an in-flight fire or in-flight structural failure was noted. All of the examined fracture surfaces exhibited evidence of overload failure.

**Figure 1.** Diagram showing the side-view of the broken tree tops, construction lines that connect the trees along the direction of travel, and attitude lines with respect to a horizontal plane. Each vertical line represents the base and top of a remaining tree.

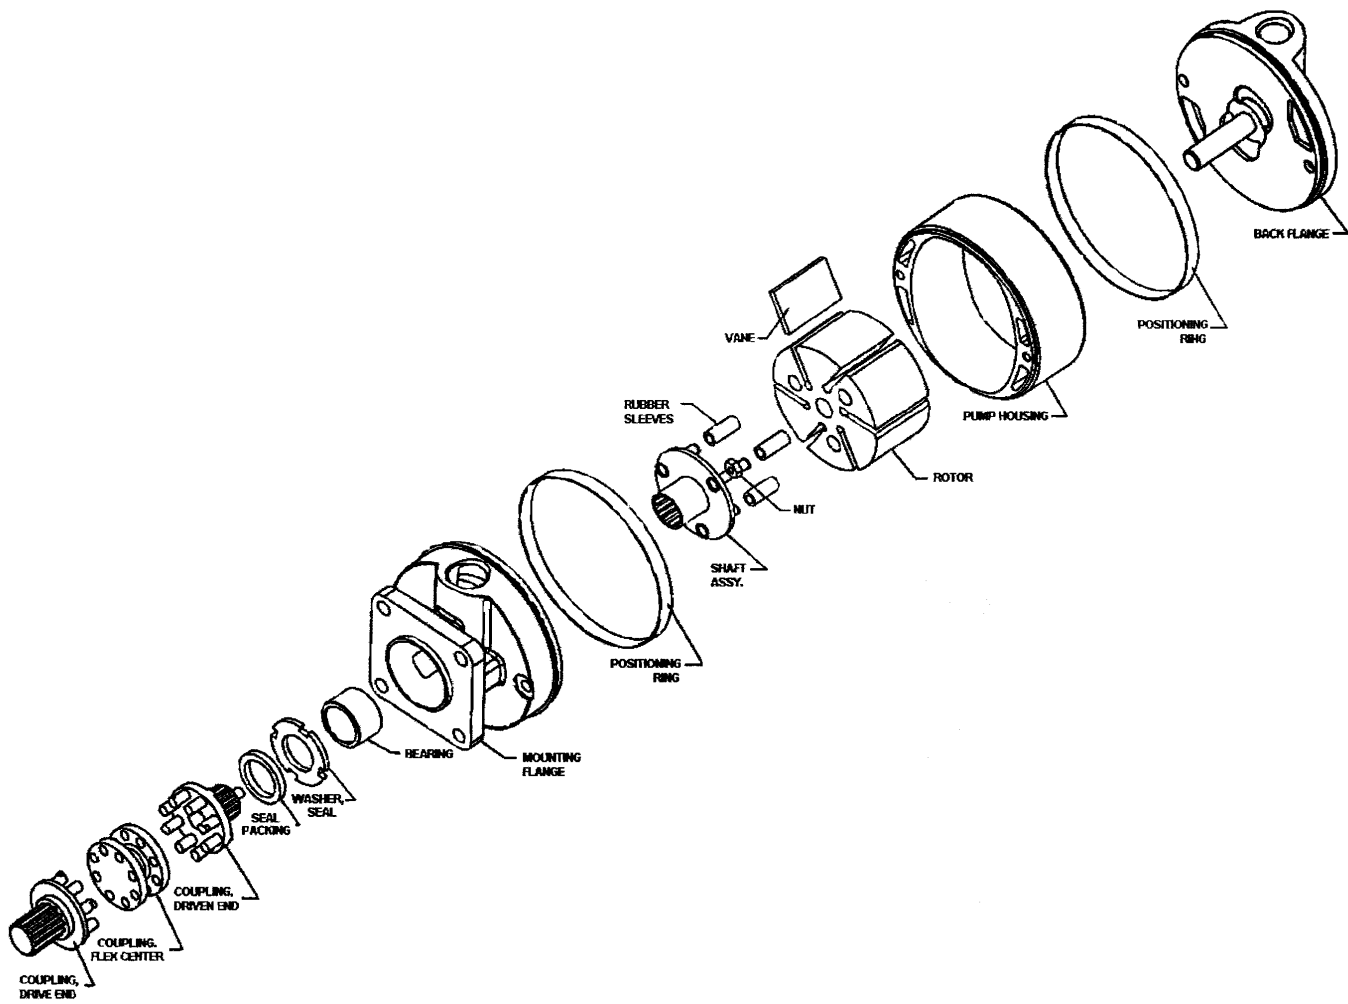
Three pieces of the left engine vacuum pump were found: the mounting flange/pump base, which remained attached to the engine accessory case; the pump housing; and the pump housing back flange. (See figure 2 for a diagram of a Cessna 335 vacuum pump.) Fragments of rotor pieces, between 1 and 2 inches long, were recovered.

Figure 2. Diagram of a Cessna 335 vacuum pump.

The pieces contained short scratches and gouges in the direction of rotor rotation and other scuff marks and scratches in random directions.

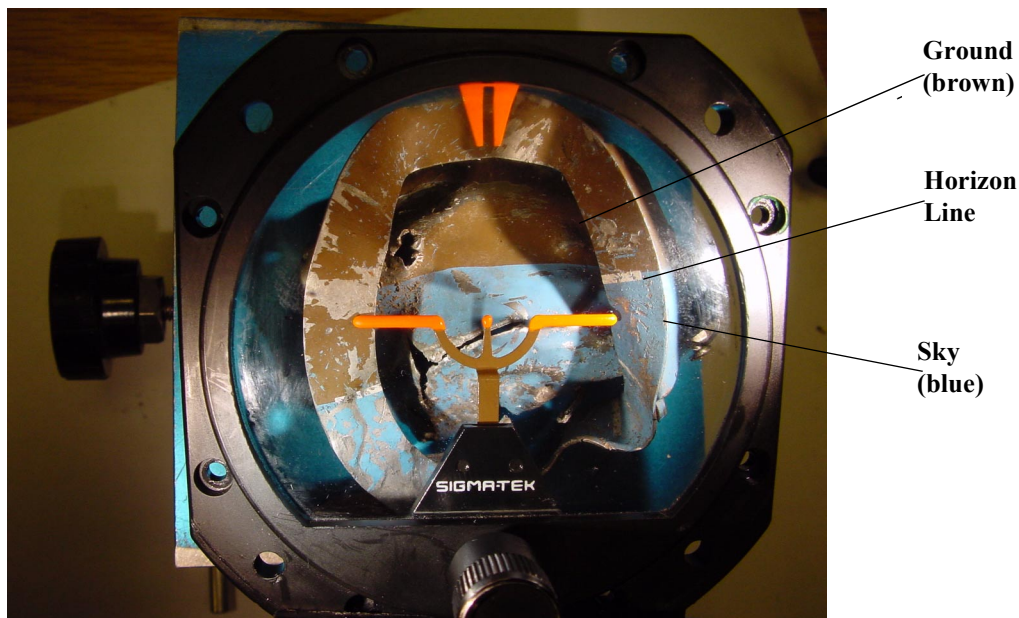
Damage on the facial roll ring resembled the shape of the triangular airplane support housing and the roll index that had been fixed to the instrument case. The relative positions of the damage resembling the triangular support and roll index were on the top and bottom of the ring, respectively, when it was placed at an inverted display of attitude. The face of the instrument was placed behind that of an exemplar instrument and, using the damage on the roll ring for alignment, the marks were within  $2^\circ$  of a wings-level inverted attitude. (See figure 4.)

**Figure 4.** Photograph showing the face of the accident airplane's primary attitude indicator behind that of an exemplar instrument.

On the basis of the examination of the left-side (primary) attitude indicator, it was determined that the rotor was most likely spinning, but not at a high enough rpm to keep the display erect (the wreckage fragments of the left-side attitude indicator clearly aligned in an inverted attitude), indicating that this attitude indicator was not displaying properly at the time of impact. Although the pilot reported that his primary attitude indicator had failed and examination of the attitude indicator supported that such a failure had occurred, the investigation could not determine the cause of the failure in that instrument.

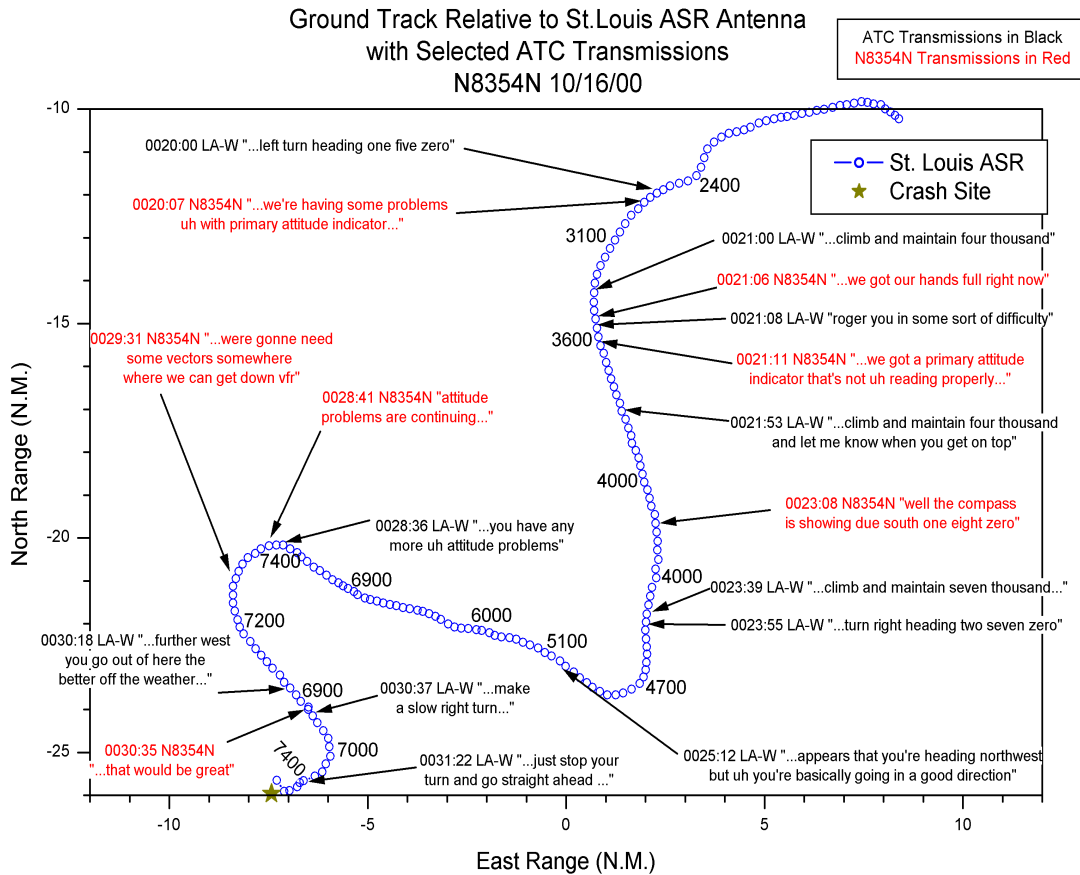
**Figure 5.** Ground track of the accident airplane's last 12 minutes of flight.

Following the LW controller's instruction to make a slow right turn at 1930:37, the airplane began turning to the right. Calculations reveal that, during the turn, the airplane descended to about 6,800 feet while maintaining an airspeed of about 150 knots. The airplane then descended to about 6,500 feet and then climbed at over 3,000 feet per minute (fpm) for the next several seconds. The airspeed was calculated to be about 120 knots during the climb, with a bank angle of approximately 25°. At 1931:31, the airplane reached its maximum altitude of 7,700 feet.
