Subj: COLLAPSED STORM CULVERT UNDER A/C PARKING APRON, MARINE CORPS AIR
STATION, NEW RIVER, NC

Encl: (1) Sketch SK-C-170-84

LANTDIV, NAVFAC-ENGCOM, NORVA
TEMPORARY CULVERT RECOMMENDATIONS

26 JUNE 84, RLT
 SK-C-170-84

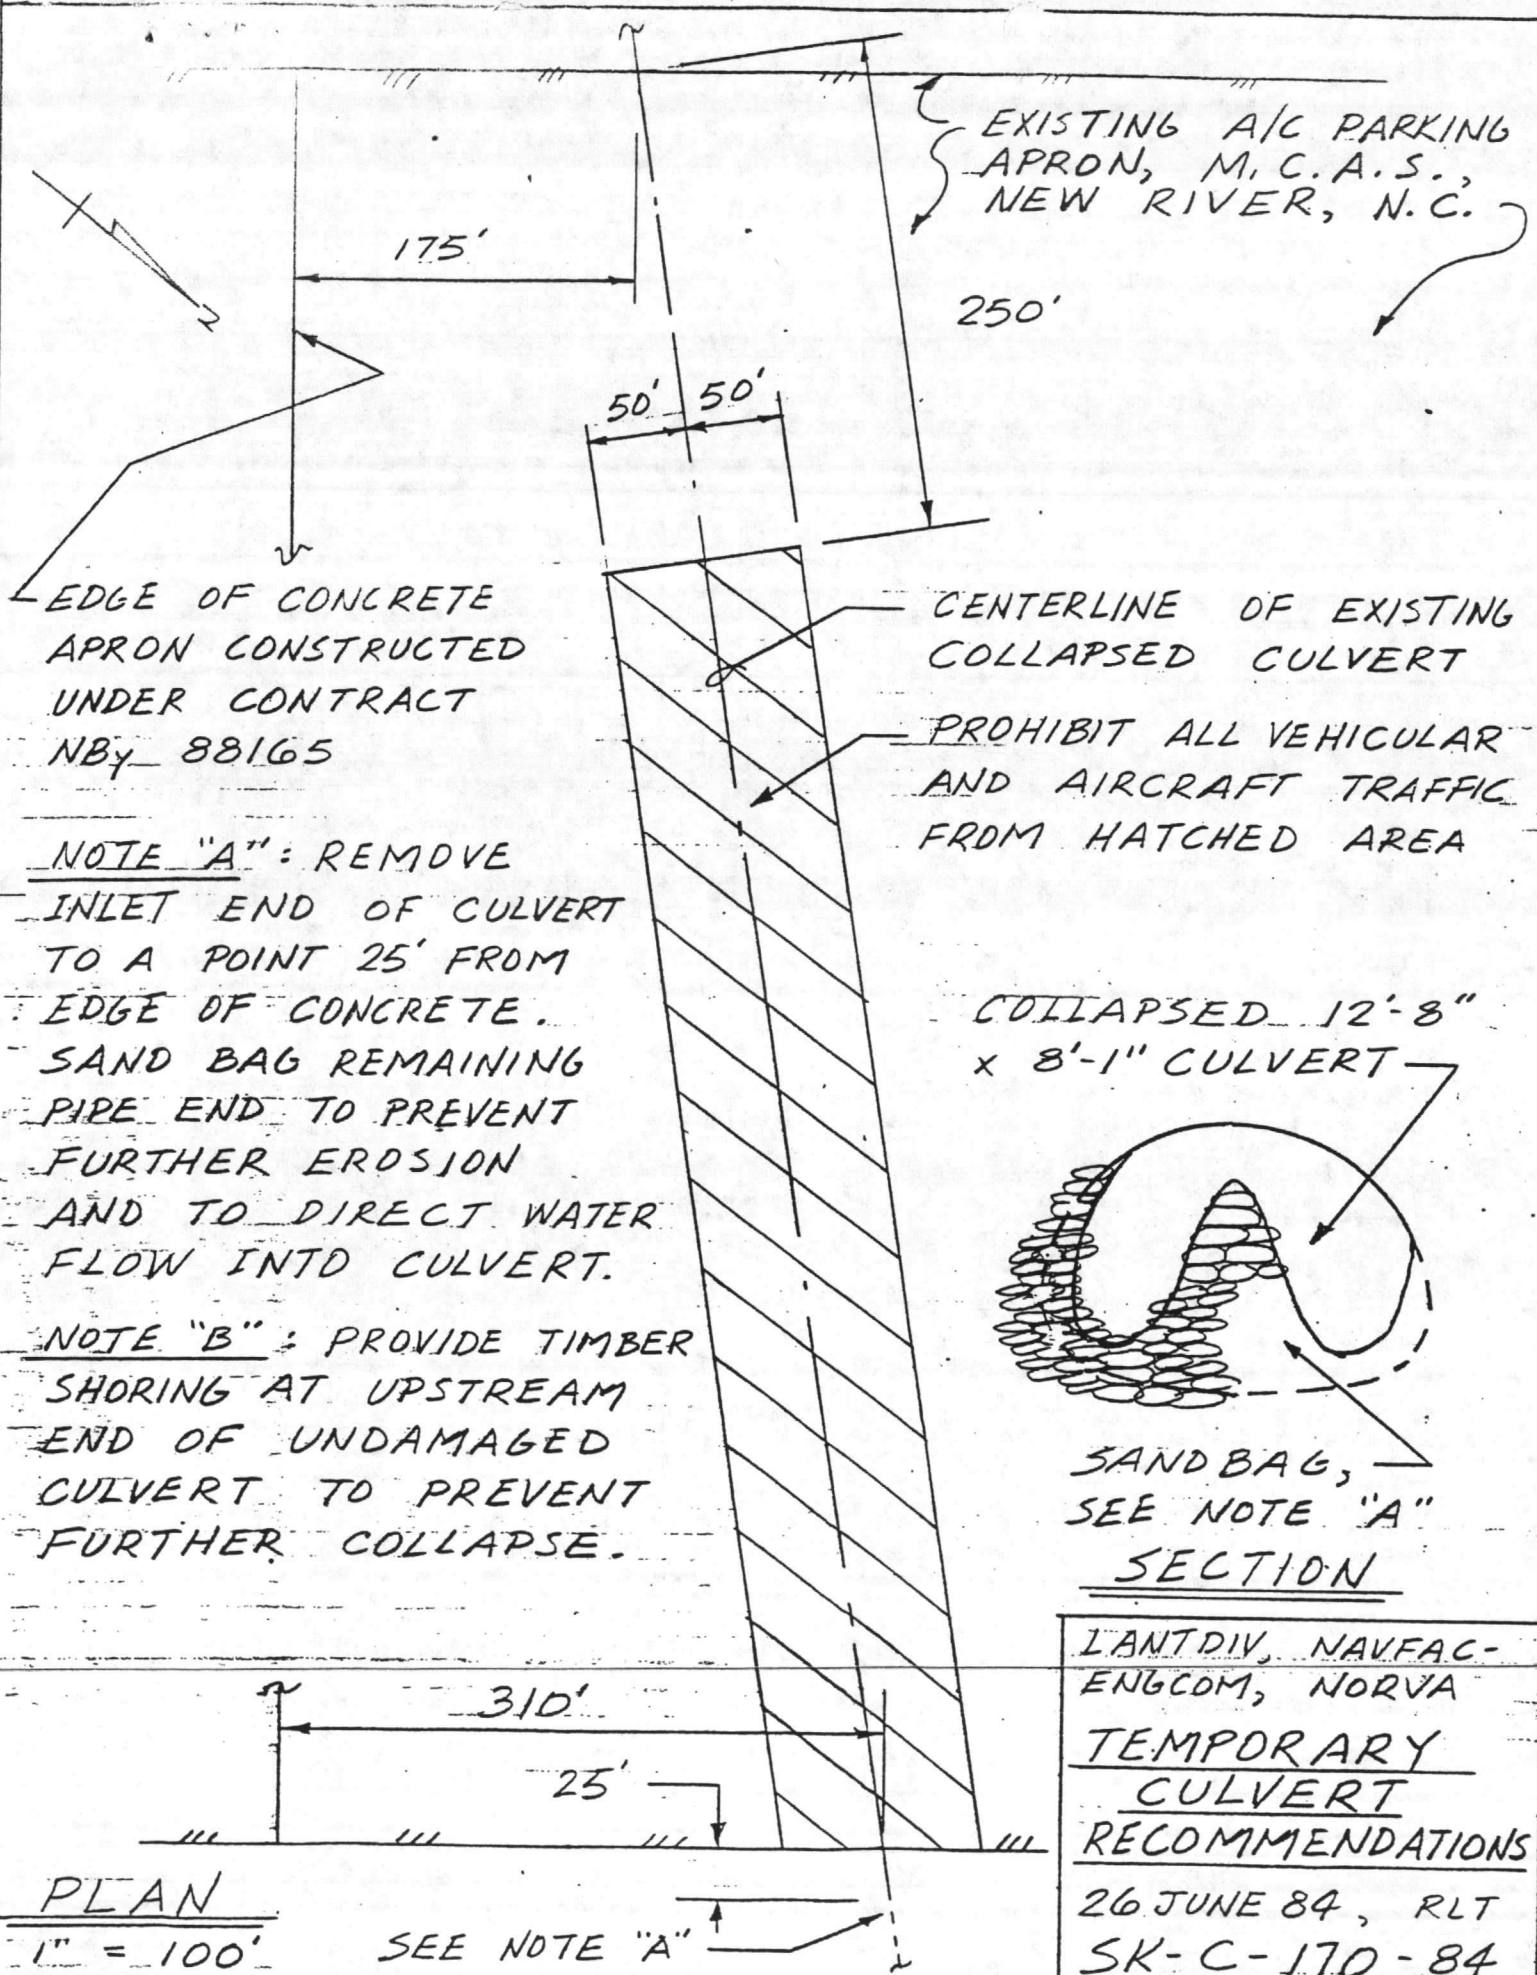
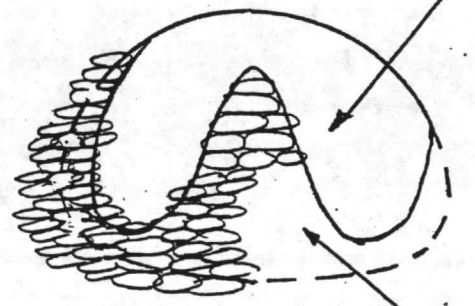
2. The 12'-8" x 8'-1" Armco multi-plate pipe arch culvert has collapsed from the bottom up, in the middle, forming a horseshoe shape. See section on enclosed Sketch SK-C-170-84. It was the consensus of opinion that the failure was caused by the build-up of hydrostatic pressure collapsing the multi-plate pipe arch at its weakest point; the bottom center seam. Approximately 700 LF of culvert is damaged and will have to be replaced, beginning at the inlet end of the culvert. Approximately 610 LF of the damaged culvert lies under the 6" unreinforced concrete A/C parking apron. As of 22 June no visible fractures or subsidence of the pavement was detectable. A profile, elevations at 50' intervals, was taken and plotted on the original construction grading plan with no significant differences. The earth shoulder at the northerly side of the apron has subsided approximately 4 feet. A void area exists under the pavement approximately 3 feet deep by 30 feet wide centered over the culvert. The void exists as far under the pavement as visible. Approximately 390 LF of the culvert at the outlet end was undamaged. Top and bottom flowline elevations were taken in the undamaged culvert and plotted on the original profile. Differences were minor and considered to be within construction tolerances. Replacement of damaged culvert will require demolition and new construction of 6" unreinforced concrete of approximately 45 feet wide by 635 feet long, with exact requirements determined by design and construction requirements. Existing joint pattern is a consideration as culvert is diagonal across parking apron.

CENTERLINE OF EXISTING COLLAPSED CULVERT

PROHIBIT ALL VEHICULAR AND AIRCRAFT TRAFFIC FROM HATCHED AREA

COLLAPSED 12'-8" x 8'-1" CULVERT

3. Sketch SK-C-170-84 depicts recommendations that should be immediately implemented to prevent vehicular or aircraft accidents and damage to the undamaged portion of the culvert. These recommendations were verbally given to Mr. Rouse and Mr. Baker on 22 June.

NOTE "A": REMOVE INLET END OF CULVERT TO A POINT 25' FROM EDGE OF CONCRETE. SAND BAG REMAINING PIPE END TO PREVENT FURTHER ERDSION AND TO DIRECT WATER FLOW INTO CULVERT.

NOTE "B": PROVIDE TIMBER SHORING AT UPSTREAM END OF UNDAMAGED CULVERT TO PREVENT FURTHER COLLAPSE.
