Inspection / Investigation Report No. 11287051

U.S. Department of Transportation
Pipeline and Hazardous Materials Safety Administration
Office of Hazardous Materials Enforcement

Type of Inspection: ACCIDENT/FAILURE INVESTIGATION **Result:** NO FURTHER ACTION

DOT Requested Analysis
of
Failed SCUBA Cylinder/Valve Assembly

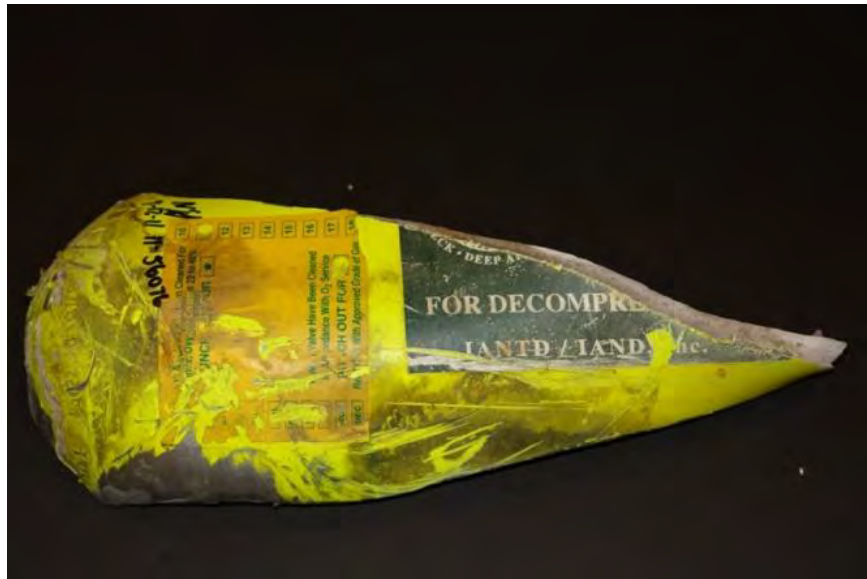
The smaller fragment from the cylinder measured approximately 30 cm by 15 cm, and is seen in **Figure 1**. This fragment contained a portion of the upper part of the cylinder proximate to the threaded opening. The fragment was clearly fractured by a catastrophic overload failure. In the portion near the cylinder opening, the fracture transitioned into a melted/eroded area where the material appeared to have eroded or “flowed” from the interior surface of the cylinder. The erosion was most extensive at the fracture where the cylinder wall was very thin, almost terminating into a sharp edge, with increasing thickness towards the non-eroded area. The flow patterns suggest that the eroded material flowed out of the crack formed in the cylinder wall, as well as out of the valve opening. The remaining cylinder interior surface was otherwise unremarkable. The curvature of the fragment was measured using a spherometer, and resulted in a reading of up to 200 mm near a portion of the interior fracture surface, compared to the original radius of curvature of 57 mm.

Figure 1. Smaller portion of high pressure gas cylinder

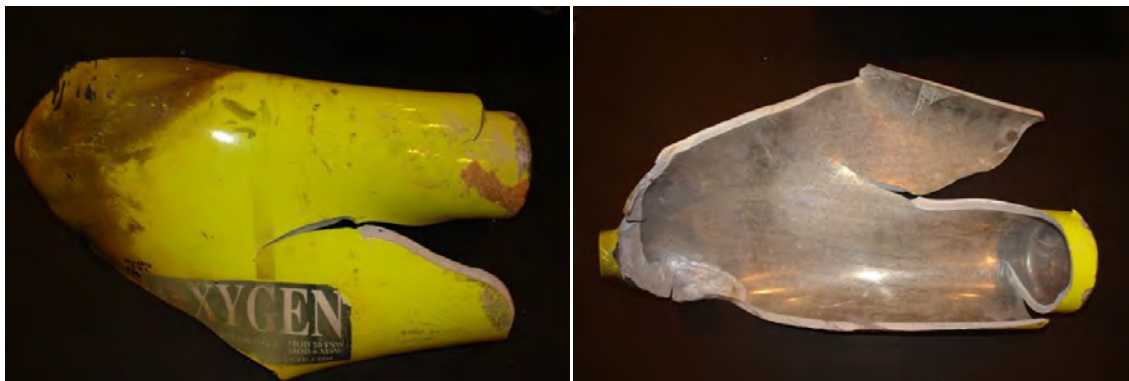
The larger fragment of the high pressure gas cylinder, seen in **Figure 4**, contained the bottom, neck, and valve opening portions.

Figure 4. Larger portion of high pressure gas cylinder

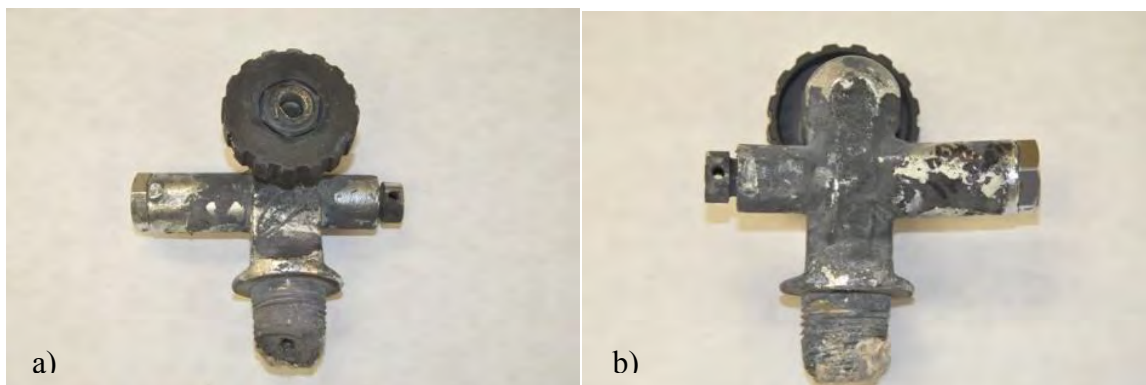
A label stamped into the body indicated the incident cylinder valve was manufactured by Genesis and contained a 32.6 MPa (5000 psi, 30 lb/hr) CG-1 type rupture disk. A pressure regulator adaptor was present in the opening containing a fractured outlet. A metal particle filter was evident in the opening. The rubber hand valve closure knob was present, but separated from the valve, as seen in **Figure 5**.

Figure 5. View of cylinder valve, a) front, b) back

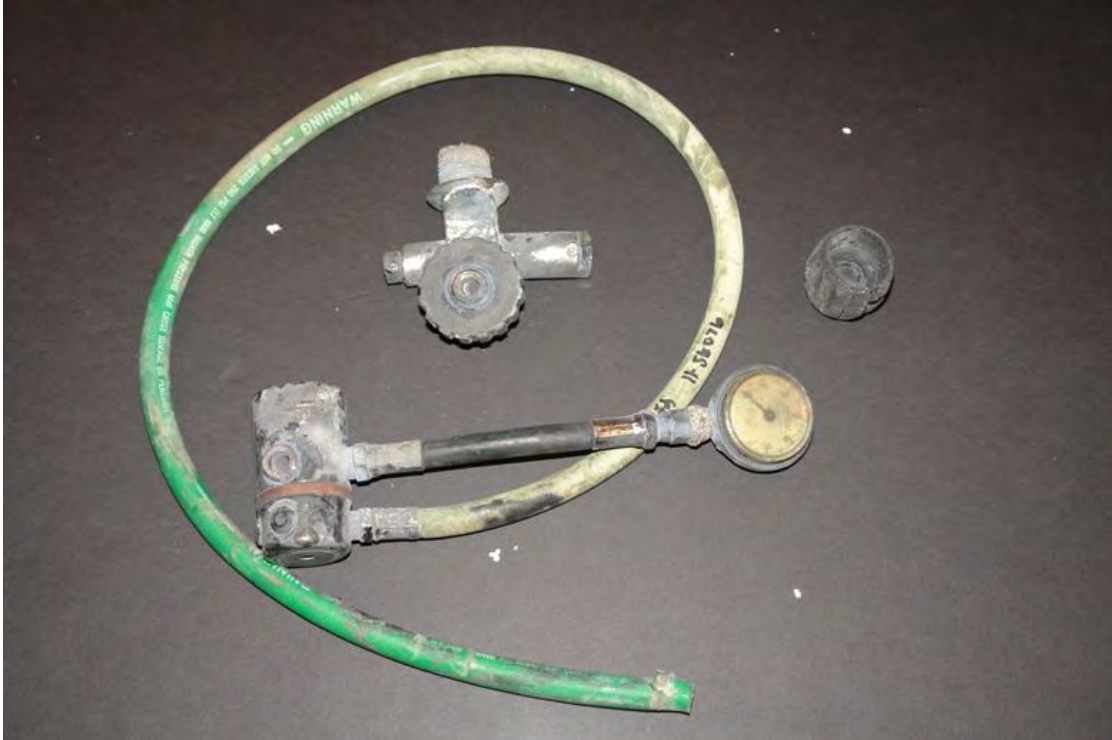
- A black pressure line with dial gage on high pressure side of regulator; dial gage face is heat affected and the gage is illegible.
- A length of green pressure line stating “WARNING Do not exceed 250 psi (17 bar) high pressure may cause damage or personal injury”; no manufacturer was identified.

Figure 6. Cylinder valve, cylinder valve adapter, regulator and regulator assembly.

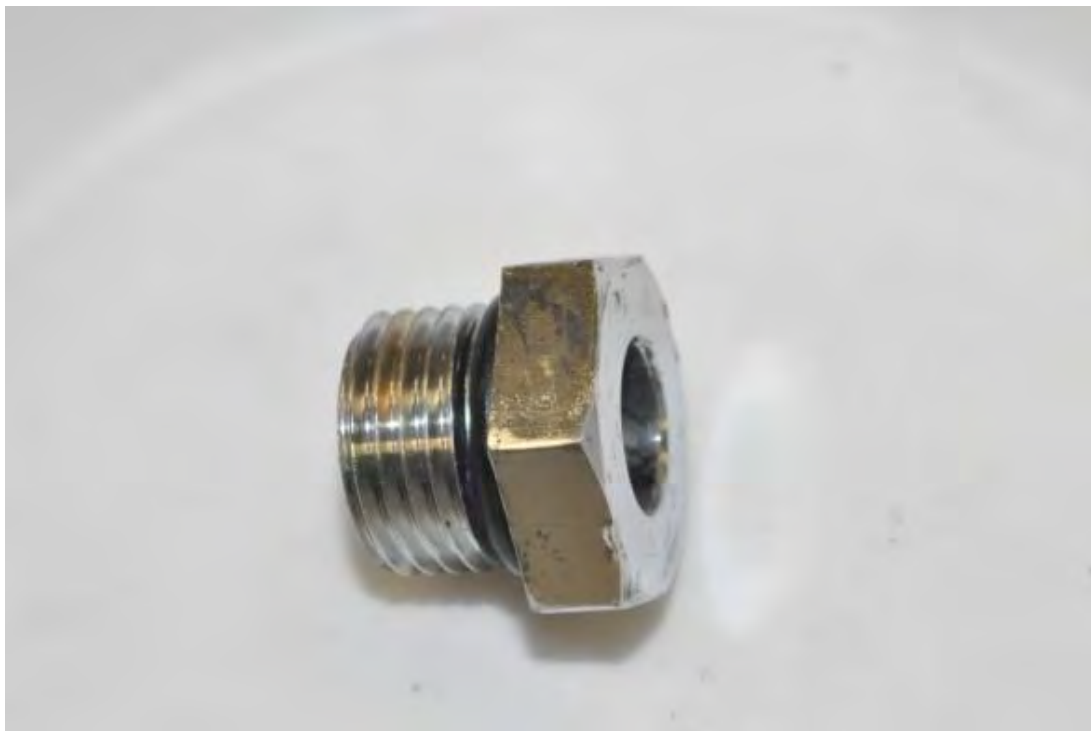
RTI began the disassembly process of the incident valve by removing the gland nut, shown in **Figure 15**, with a torque wrench fitted with an appropriately sized socket in order to measure the installation torque. The gland nut was found to be threaded into the valve body approximately finger tight as measurements showed zero installation torque. The nut made four and one sixth turns before clearing the valve body. An intact O-ring similar to that found in the exemplar remained in its intended position on the gland nut.

Figure 15. View of the incident cylinder valve gland nut showing the presence of the intact O-ring.

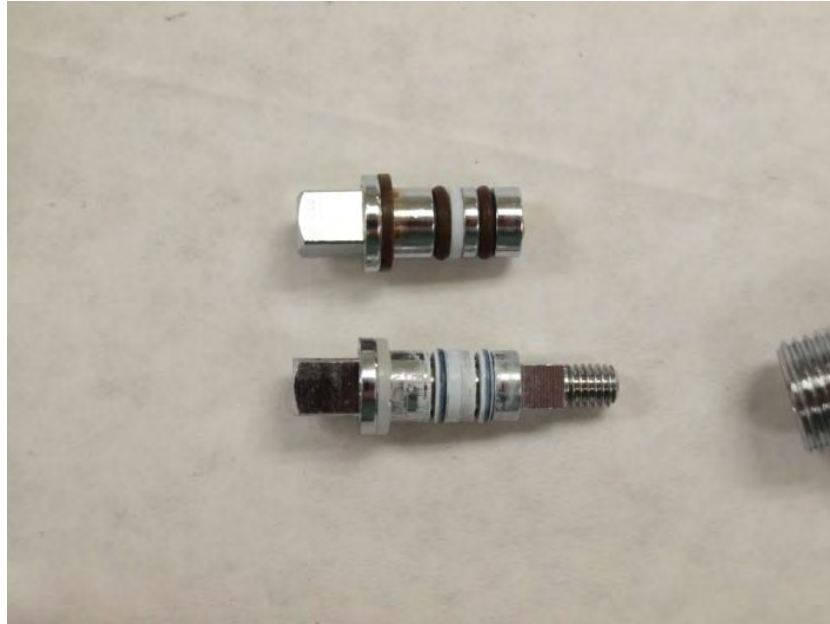
stem, the valve seat body, the plastic valve seat, and the interior of the valve stem portion of the valve body were further notable in that they were free of any apparent damage, heat effects, or discoloration as might be expected to result from fire or explosion.

Figure 16. View of the incident valve stem (top) as compared to the exemplar valve stem.

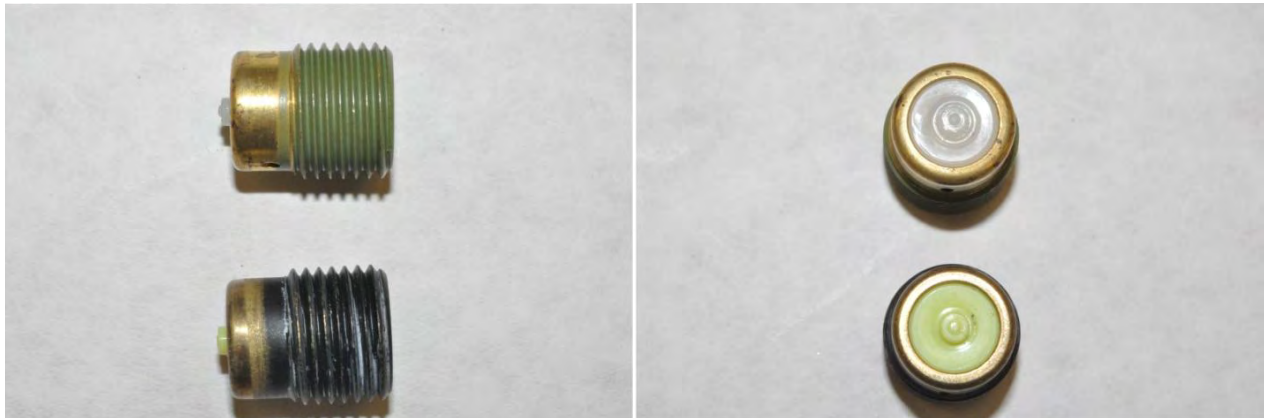
Figure 17. View of the incident valve seat body (green with white valve seat, upper) as compared to the exemplar valve seat body (black with yellow valve seat, lower).

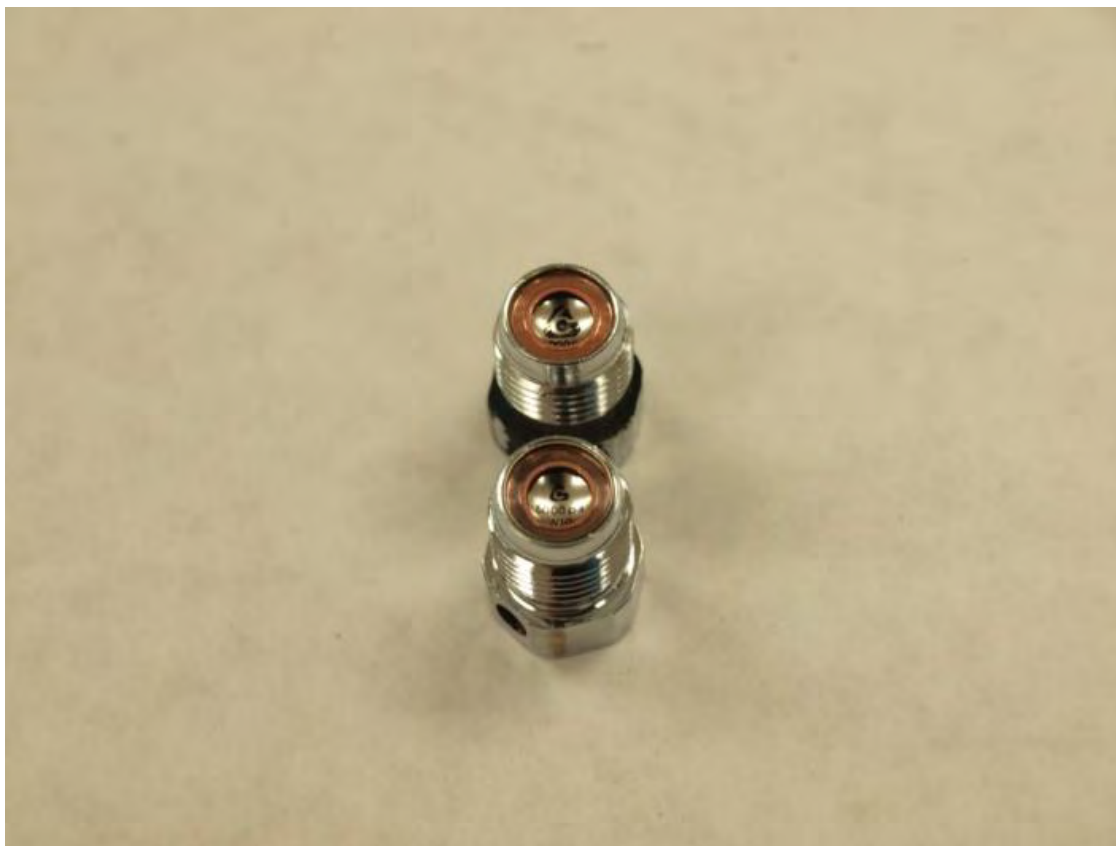
Figure 18. View of the incident burst disk assembly (upper) as compared to the exemplar burst disk assembly (lower).

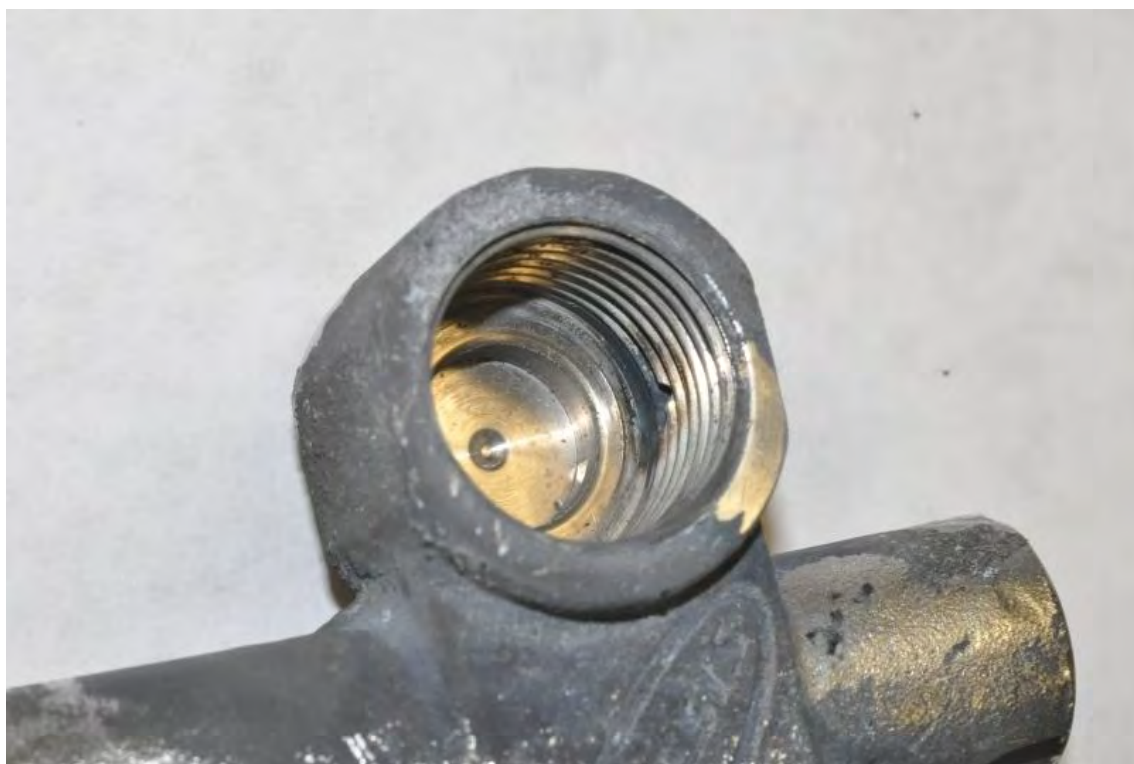
Figure 19. View of the incident valve high pressure regulator port showing discoloration sooting around the vent.

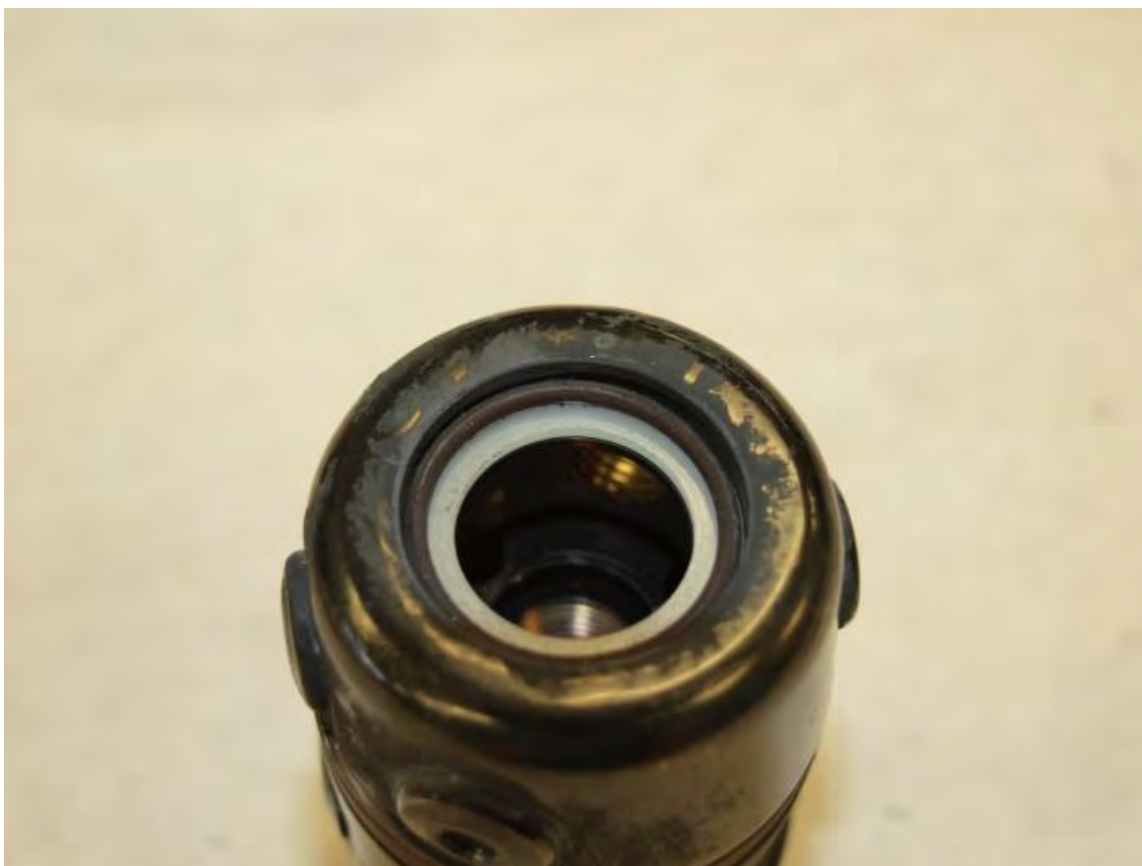
Figure 22. View into the low pressure portion of the incident regulator showing the O-ring and washer.

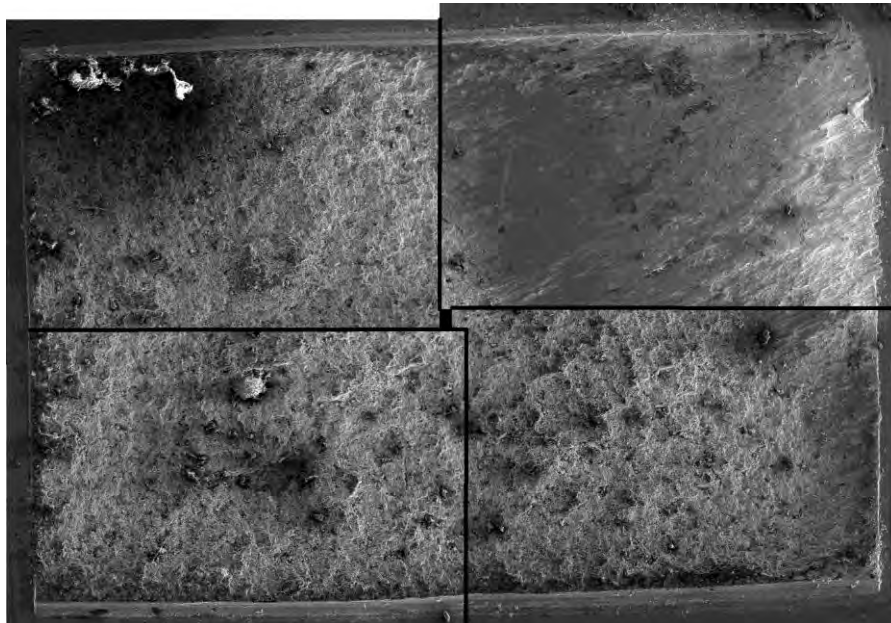
Figure 23. Composite SEM micrograph of incident valve stem fracture surface.

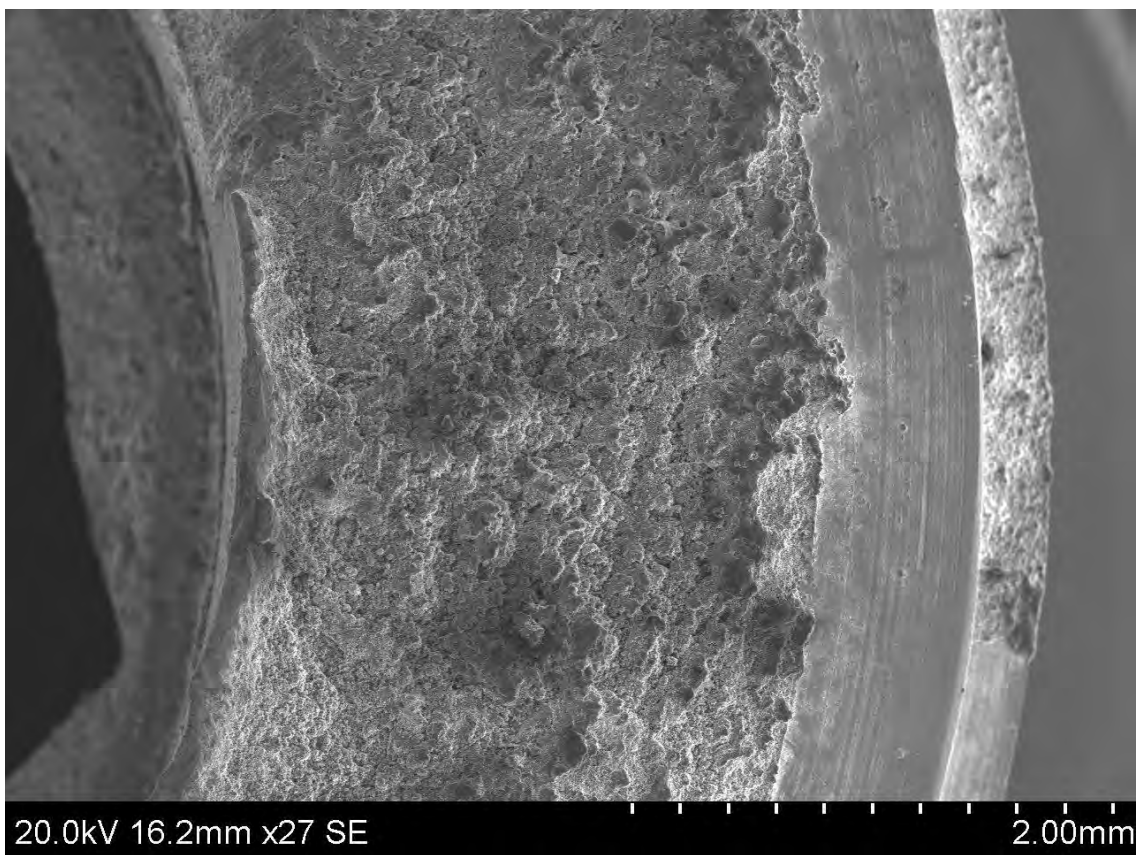
Figure 24. SEM micrograph of pressure regulator adapter fracture surface.

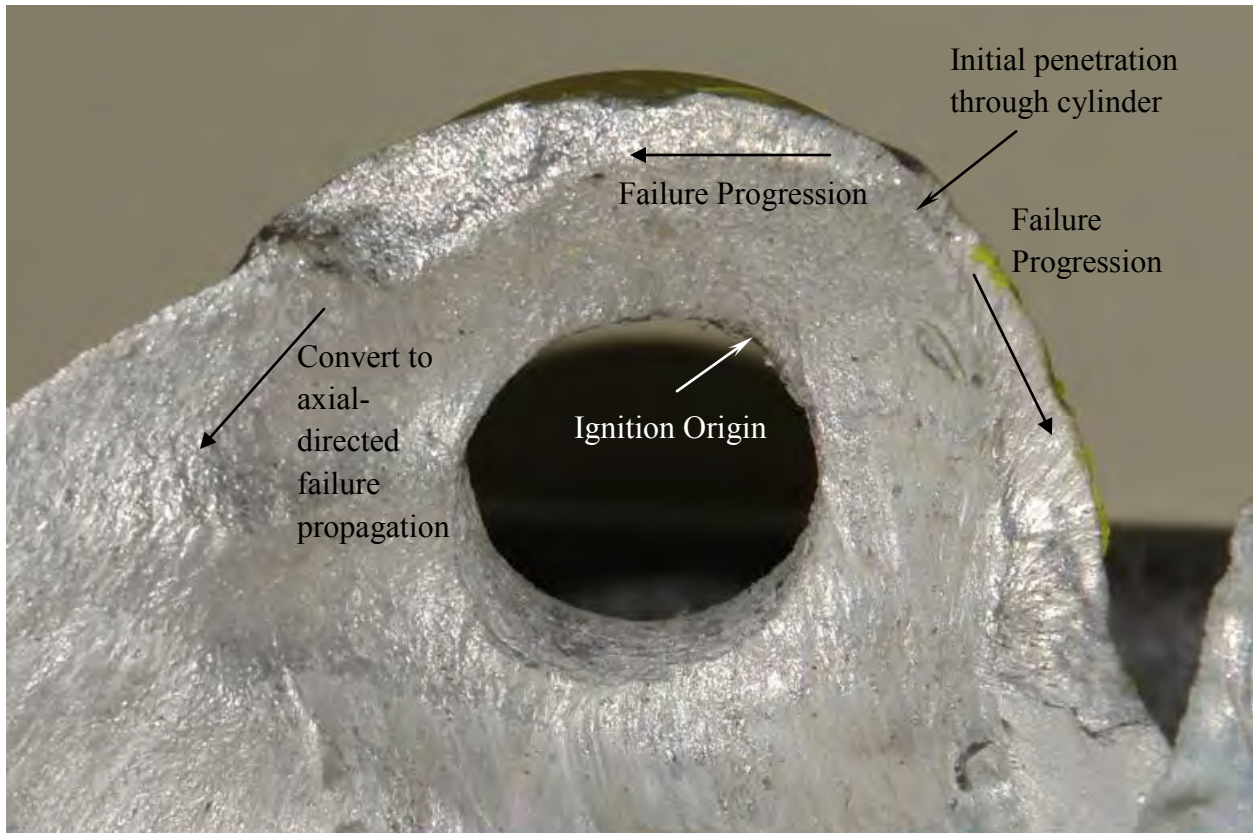
Figure 34. View showing the threaded neck opening region of the incident cylinder from the interior.

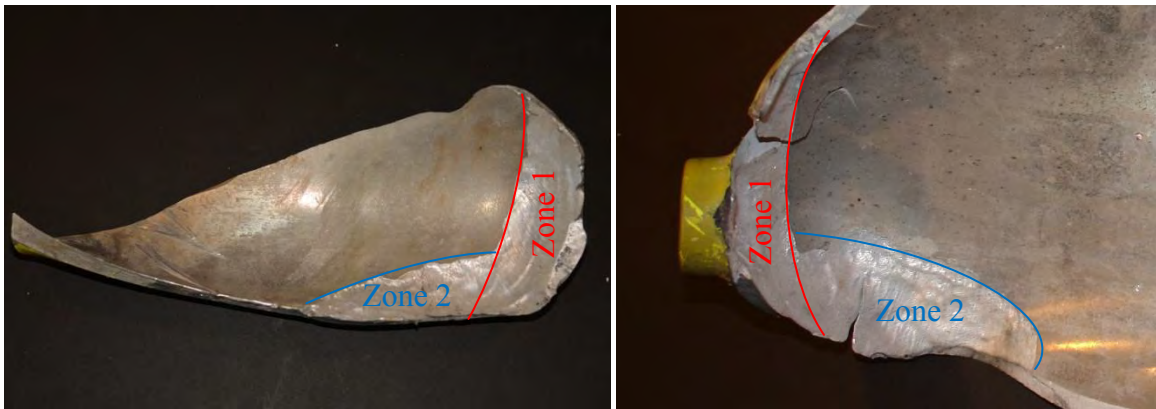
Figure 39. View of interior surface showing the two distinct burn zones.
