June 21, 2004

SUBJECT: DRESDEN NUCLEAR POWER PLANT, UNIT 3
NRC SPECIAL INSPECTION REPORT 05000249/2004009

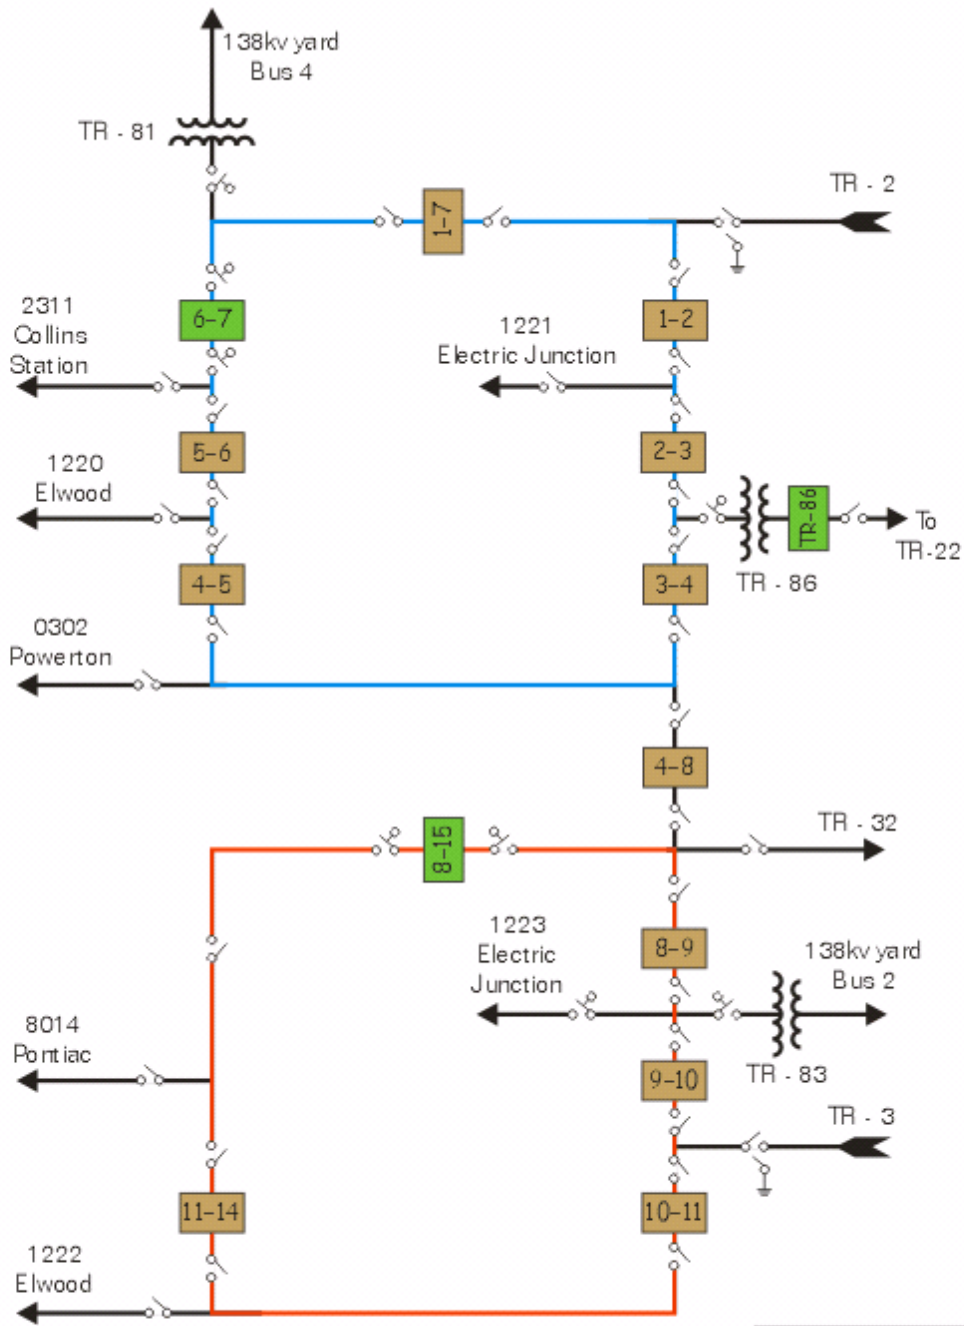
262LN003-001	
345 kV	
Switchyard	
Ref. 12E-2183	
Date: 11.03	Revision: 02

The inspection team noted that in order to support the post maintenance testing of Line 1223, which occurred on May 5, 2004, Switchyard Breakers 8-9 and 9-10 were required to be opened (See Attachment 3 to this report for an offsite switchyard diagram). In April 2004, EED personnel determined and advised licensee operations personnel of the risks associated with two possible Unit 3 switchyard configuration scenarios based on EED reliability and risk studies, as required by EED procedures. Exelon Energy Delivery reliability studies assumed a line fault and subsequent line protective relay actuation, concurrent with a LBB relay actuation. When a LBB relay actuated, the breaker which did not open on a line fault protective relay actuation was isolated by the opening of all adjacent breakers.
