B-908 Aircraft Accident

STRUCTURES INVESTIGATION REPORT
CONCERNING ACCIDENT TO CIVIL AIR TRANSPORT
C-46 DM, B-908, NEAR TAICHUNG, TAIWAN,
ON JUNE 20, 1964

LABORATORY EXAMINATION OF ELEVATOR TRIM TAB CABLE FRACTURES

LABORATORY EXAMINATION
OF RIGHT AILERON DOWN CABLE FRACTURE

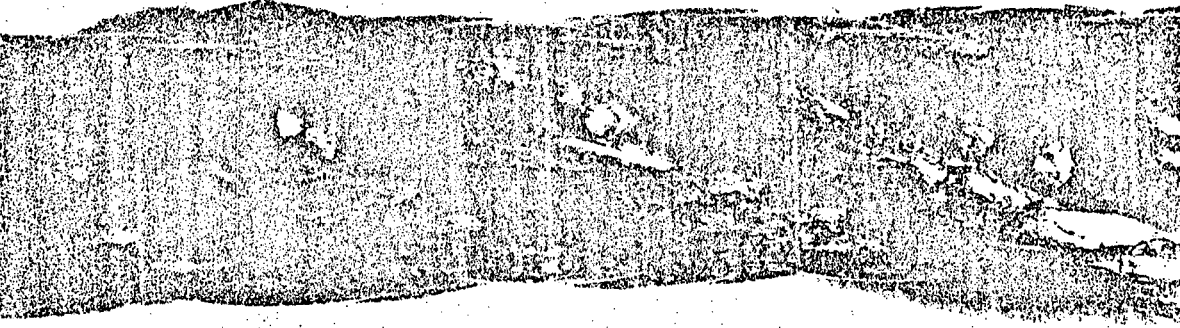
Fig. I - 3
X-15

Approximately 3/4" from the main fracture there are two damaged areas resembling wear on the outside of the cable almost opposite one another (approximately 160 degrees apart). These damaged areas are shown in Figures I-3 and I-4. Before the cable was unraveled for detailed examination, broken wire ends were visible in the more severely damaged area, Figure I-3. About 15 degrees from the damaged area shown in Figure I-4, at the damaged area end farthest from the main cable fracture there were some wires pulled up, as shown in Figure I-5.

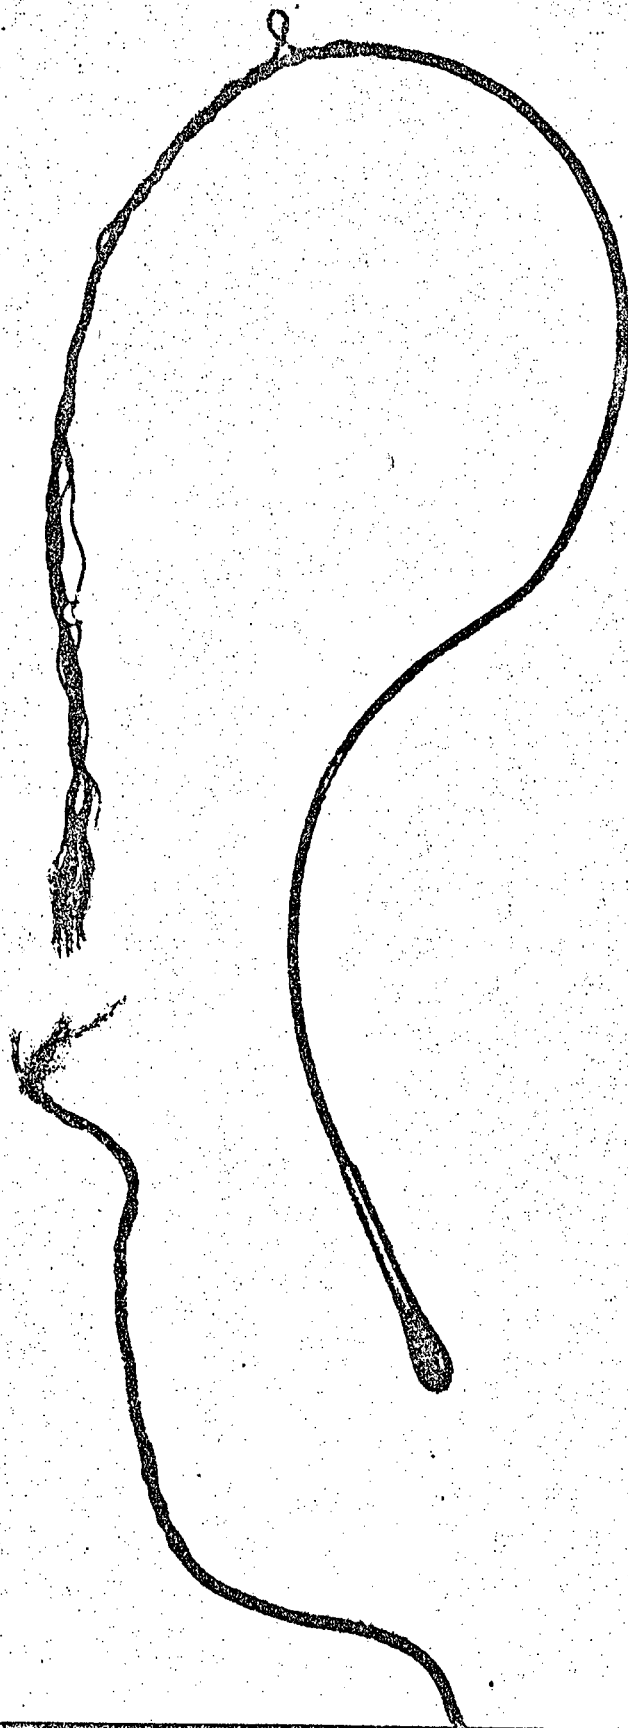
Fig. II-1
X 1/3

Figure II-1 shows the two pieces of right aileron down cable removed from the wreckage for laboratory examination, with the two frayed ends of the fracture area positioned adjacent to each other. This cable is 3/16" diameter 7 x 19 construction. The Engineering and Manufacturing Branch of the Federal Aviation Agency at Atlanta, Georgia, has advised that this is the proper diameter for the aileron down cable assembly, P/N 20-530-1212.
