SIGIR PA-08-138 July 25, 2008

SUBJECT: Report on Construction of the Kahn Bani Sa'ad Correctional Facility, Kahn Bani Sa'ad, Iraq (Report Number SIGIR PA-08-138)

Kahn Bani Sa'ad Correctional Facility, Kahn Bani Sa'ad, Iraq

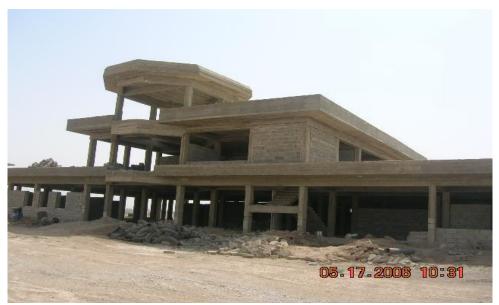
Site Photo 1. Status of construction at the time of Parsons' termination (Courtesy of the USACE)

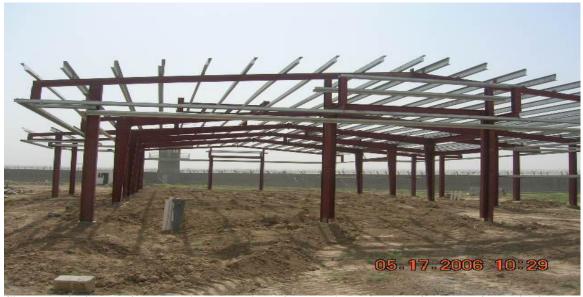
Site Photo 2. Status of construction at the time of Parsons' termination (Courtesy of the USACE)

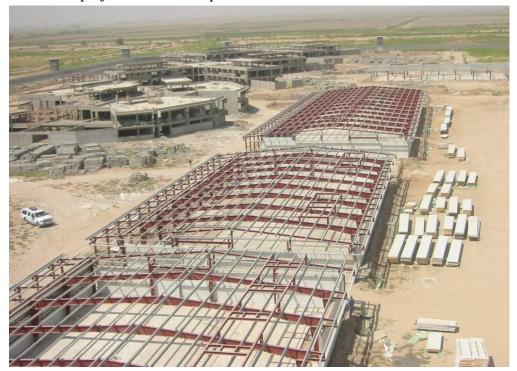
Site Photo 3. Status of project at the end of the bridge contract (Courtesy of the USACE)

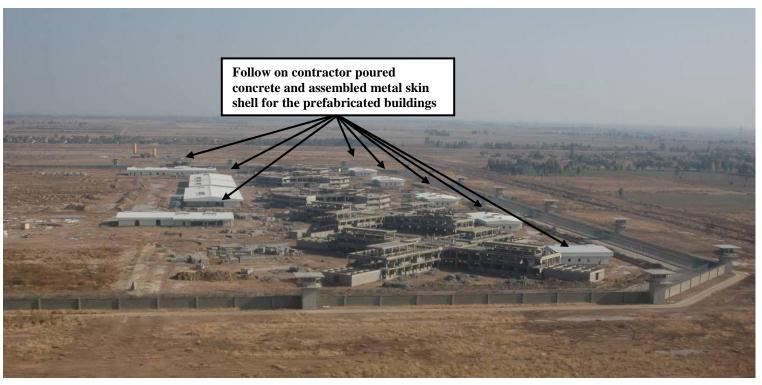
Site Photo 4. Status of construction at the time of the follow-on contractor's termination (Courtesy of the USACE)

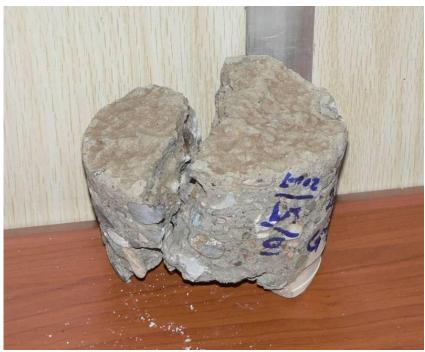
- 1. Ground floor columns were tested with a Schmidt hammer devise (measures the elastic properties or strength of concrete or rock) and many columns showed low strength, which were tested further using an ultrasonic device and again showed low strength.
- 2. First floor slab two concrete cores were extracted from the first floor slab. Both cores were cracked and broke into pieces indicating extremely low strength (Site Photo 5). The thickness of the cores was less than 100 millimeters (mm), which is less than the design thickness of 150-mm.

Site Photo 5. Concrete core sample that cracked, indicating extremely low strength (Courtesy of the USACE)

- 1. The structural concrete of the Administration Building is in good condition and no additional work is necessary.
- 2. Demolish Medium Security Building No. 07/03 part B completely. The existing concrete strength is in very poor condition and needs to be replaced completely.

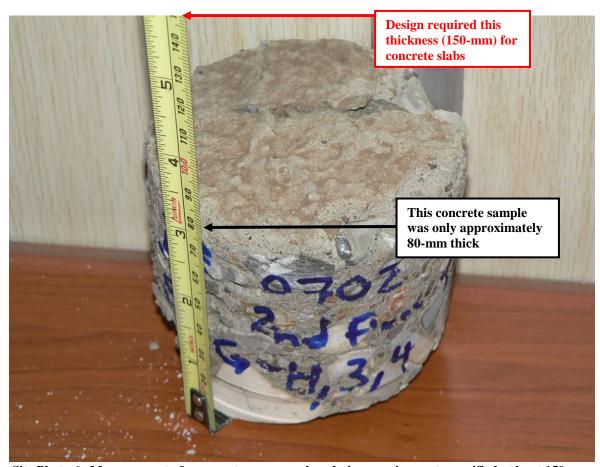
- 1. Ground floor columns Using a Schmidt hammer device, very few columns showed low strength. Further study and redesign calculation is required for a final decision about the appropriate remedial measures to be taken.
- 2. First floor slab the thickness of the concrete cores was at least 150-mm, and in some cases, higher than the required design strength.
- 3. First floor columns the strength of the columns was higher than the required design.
- 4. Second floor slab the thickness of the two selected concrete cores was less than 100-mm, which is less than the design thickness of 150-mm (Site Photo 6).

Site Photo 6. Measurement of a concrete core sample – design requirements specified at least 150-mm thickness; however, this sample was approximately 80-mm (Courtesy of the USACE)

- 3. Demolish the roof slab part B of Medium Security Buildings Nos. 07/02 and 07/01 completely. The existing concrete is in very poor condition and needs to be replaced completely.

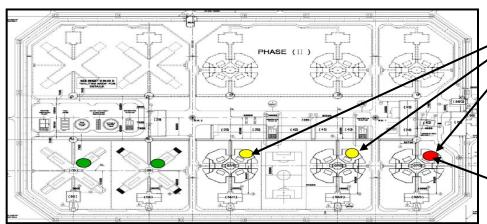
SIGIR used the structural assessment report to identify the areas where structural issues were present. Specifically, the locations where the thickness of the concrete floor slabs

was significantly less than required by the contract designs (Figure 2 and Site Photos 7 and 8).

Figure 2. Locations of low concrete strength

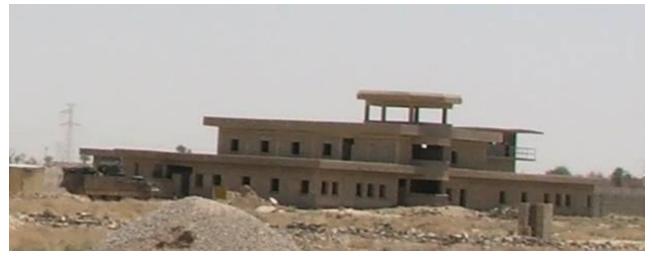
SIGIR found no evidence that the GoI took any corrective action with regards to the structural assessment's findings that specific concrete slabs were not the design-required thickness. For example, SIGIR inspected the still standing medium security building that the structural assessment recommended be demolished (Site Photo 9). In addition, SIGIR inspected the two remaining medium security buildings to determine if any corrective action was taken. Specifically, the structural assessment found the concrete strength of the roof slabs in both buildings to be in "very poor condition" and in need of replacement. SIGIR confirmed the roof slabs were not corrected (Site Photos 10 and 11). Consequently, the three medium security buildings continue to pose significant structural concerns for the GoI.

Site Photo 9. Still standing medium security building that the structural assessment recommended be demolished

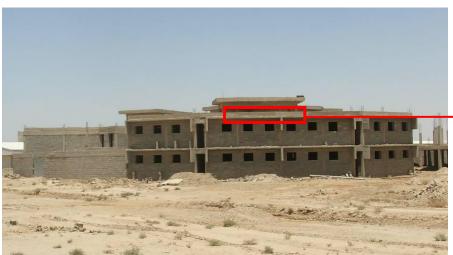
Site Photo 10. Medium security building that structural assessment recommended replacing

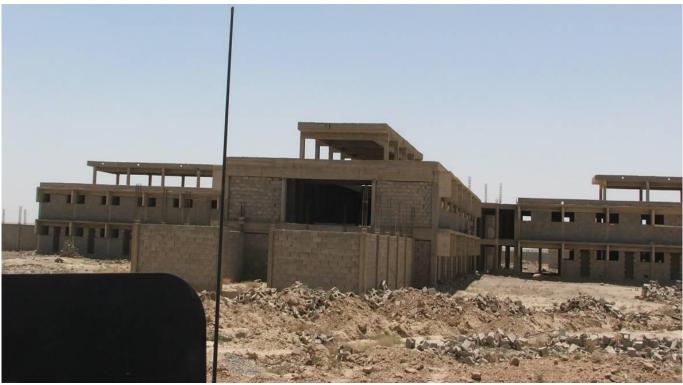
Due to time constraints, SIGIR could not inspect all buildings diagnosed with a lack of reinforcement bar, low strength of concrete blocks, and poor quality construction. SIGIR toured the maximum security building (Site Photo 12) and observed that the assessment's recommendation to demolish all un-reinforced walls and reconstruct with appropriate reinforcement was not accomplished.

Site Photo 12. Exterior view of the maximum security building - no corrective action had been taken by the GoI

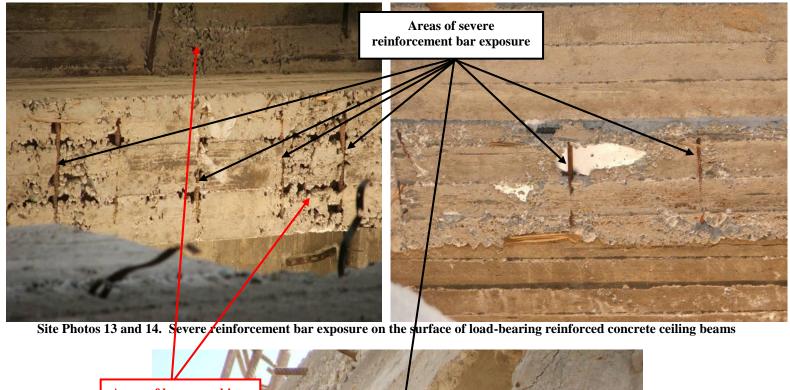
- areas of severe reinforcement bar exposure on the surface of the load-bearing reinforced concrete ceiling beams (Site Photos 13 and 14)
- areas of severe concrete segregation and honeycombing (Site Photo 15)
- potentially dangerous building columns (Site Photos 16-18)
- poor quality brick workmanship (Site Photo 19)

Areas of honeycombing, voids, and segregation

Site Photo 15. Example of severe concrete segregation and honeycombing

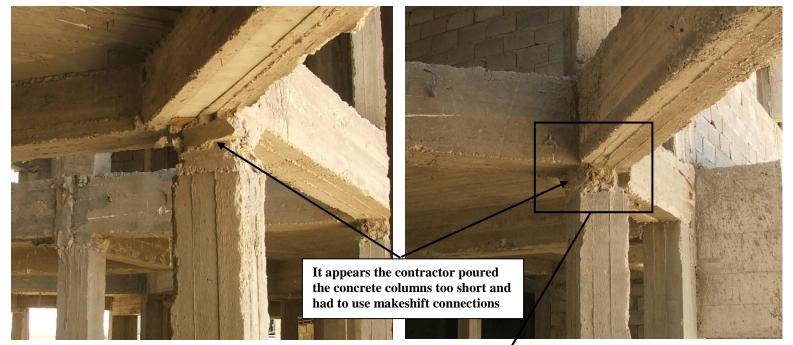
Site Photos 16 and 17. Dangerously constructed building columns

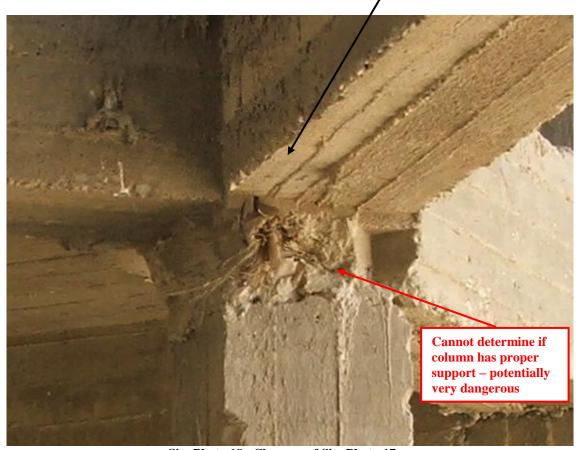
Site Photo 18. Close-up of Site Photo 17

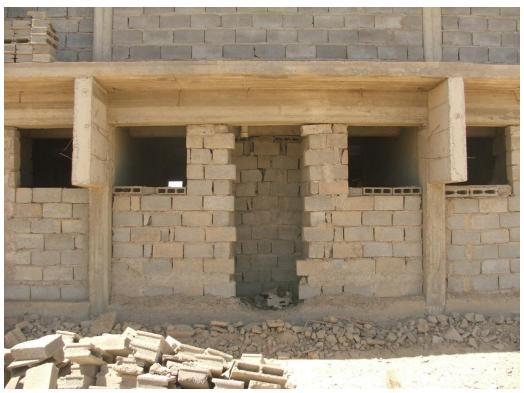
Site Photo 19. Example of poor block laying

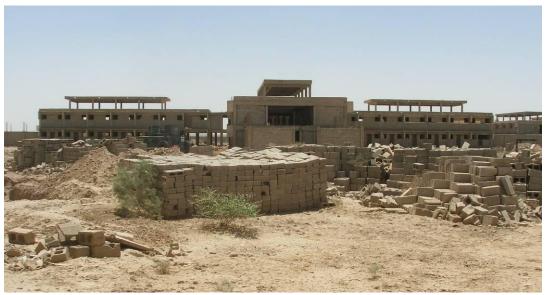
SIGIR toured the entire KBS Correctional Facility site in search of the materials reportedly left on site when the contract was terminated. Numerous cement blocks (Site Photo 21) and bundles of chain link fencing were located (Site Photo 22). In SIGIR's opinion, the majority of the \$1.2 million in materials listed by the contractor as abandoned was either not delivered to the site or removed after the contract was terminated.

Site Photo 21. Concrete blocks still on site at the KBS Correctional Facility

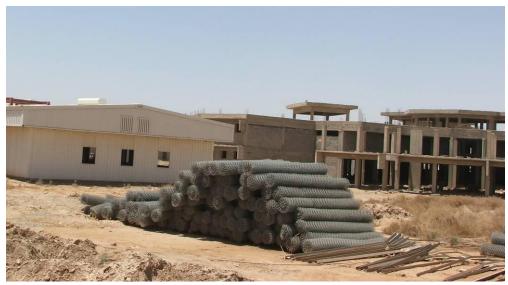
Site Photo 22. Pieces of chain link fence still at the KBS Correctional Facility site

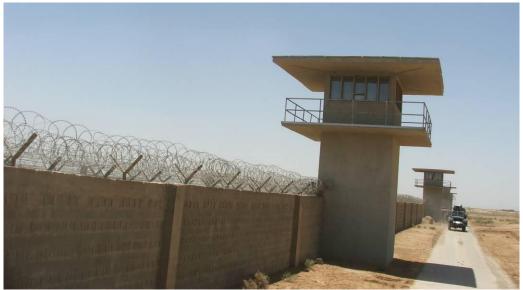
SIGIR requested an interior and exterior perimeter tour in order to determine the adequacy of the security fence and guard towers. The security fence encompasses the entire facility site with no observed gaps, holes, or disturbances. The security fence employed a two phase approach – exterior and interior. The exterior fence consisted of a concrete block base approximately 3 meters (m) high (Site Photo 23); while inside the exterior fence perimeter is two sets of chain link fence with razor wire (Site Photo 24). The first set of chain link fence provides an additional deterrent to the concrete fence (by

SIGIR observed equally spaced guard/watch towers around the entire facility. The towers appeared to be approximately 7-m high and more than adequate to provide an adequate view of any approaching vehicles or people. Aside from minor vandalism (i.e. broken windows), the guard towers appeared to be in good working condition.

Site Photo 23. Exterior security fence and guard towers

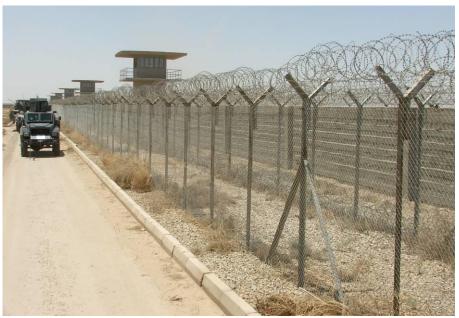
adding additional height), and the second set of chain link fence, approximately 4-m from the first fence, is another restraint.

Site Photo 24. Interior fence

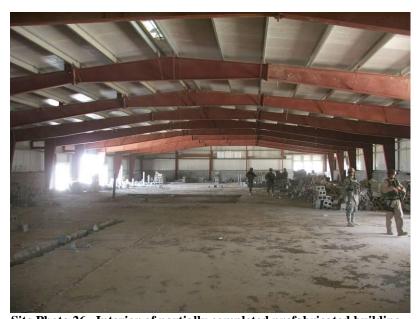
SIGIR observed several partially completed prefabricated buildings at the facility (Site Photo 25). SIGIR inspected one building and found the concrete foundation had been

poured, the steel superstructure constructed, and metal skin attached. The partially completed buildings appeared to be adequately constructed (Site Photo 26).

Site Photo 26. Interior of partially completed prefabricated building
