**4TH BRIGADE, 10TH INFANTRY DIVISION
IRAQI ARMY HEADQUARTERS BARRACKS
MISSAN PROVINCE, IRAQ**

SUSTAINMENT ASSESSMENT

**SIGIR PA-08-164
JULY 20, 2009**

Summary of Report: PA-08-164

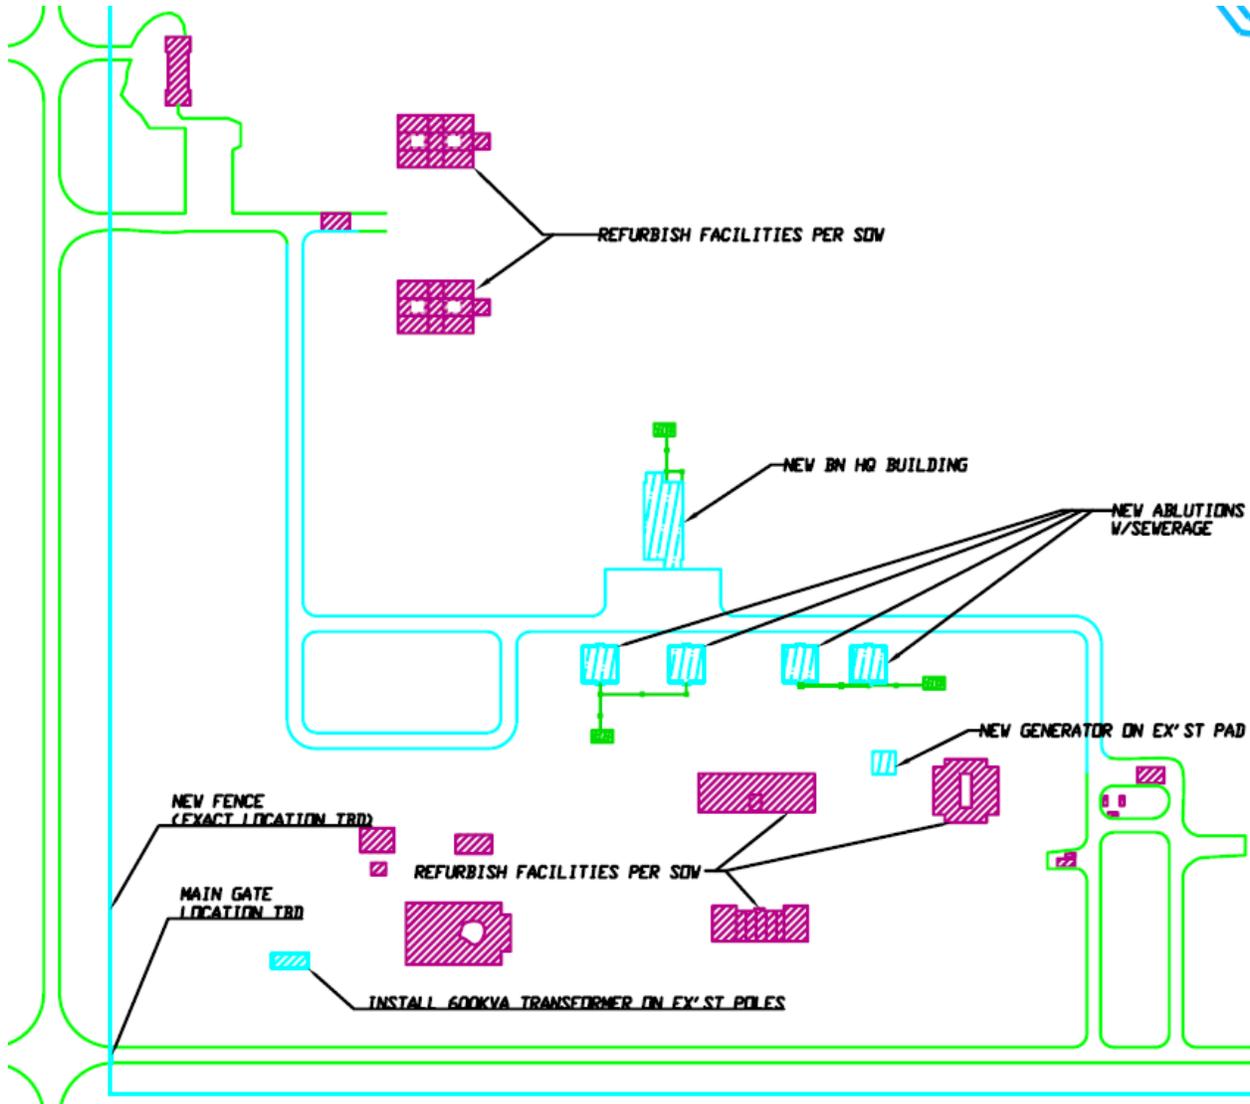
The project documentation provided by GRS did not include detailed construction drawings or design calculations for the project. SIGIR obtained and reviewed some Government Furnished Drawings (GFDs) provided to the contractor: the GFDs included a site location map (Figure 1), a rough site layout, general notes, septic tank details, and roadway cross-section details. A list of the GFDs provided to the contractor was included in the SOW.

The project documentation clearly identifies specific drawings that were to be supplied to the contractor for use during construction. The GFDs provided to SIGIR were determined to be adequate to outline the scope of the project for the contractor but were not adequate to construct the project. SIGIR requested additional contractor-furnished drawings from both GRD and GRS, but neither was able to locate the design drawings. The lack of available design drawings limited the ability of SIGIR to determine the adequacy of the project's design. However, the detailed list of specifications provided in the SOW did provide GRS with a limited basis for requiring the contractor to meet some minimum standards during the construction of this project.

Figure 1. Government Furnished Design C-001 site plan showing the existing and proposed buildings

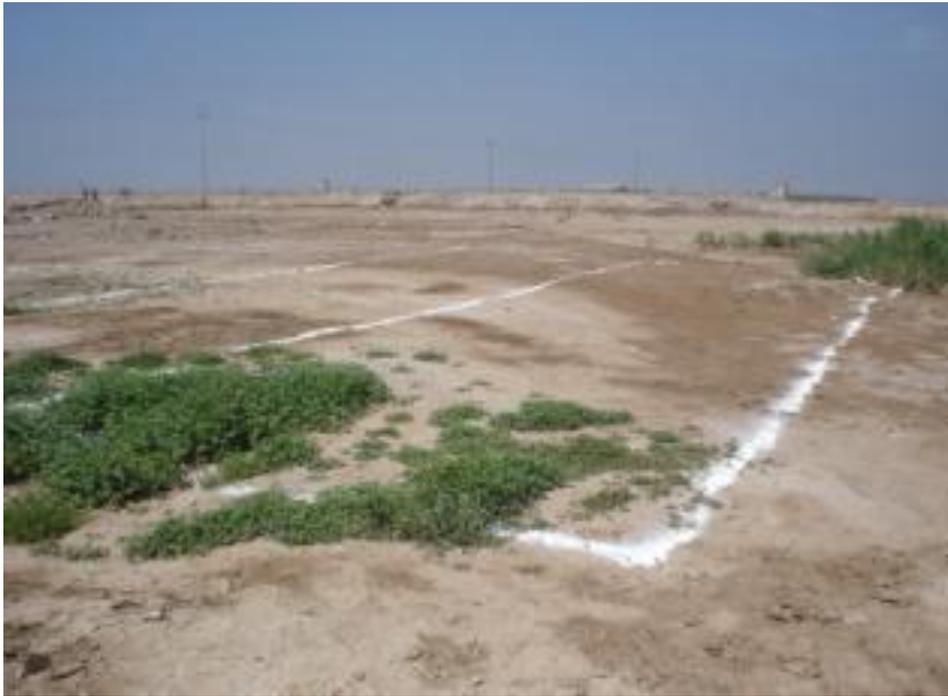
Before the contractor began new construction at the 4th Brigade 10th Infantry Division project, the contractor cleared the area and outlined the future locations of the buildings (Site Photo 1). Site Photo 2 shows the construction of two latrine buildings.

Site Photo 1. Future building location (Courtesy of GRS)

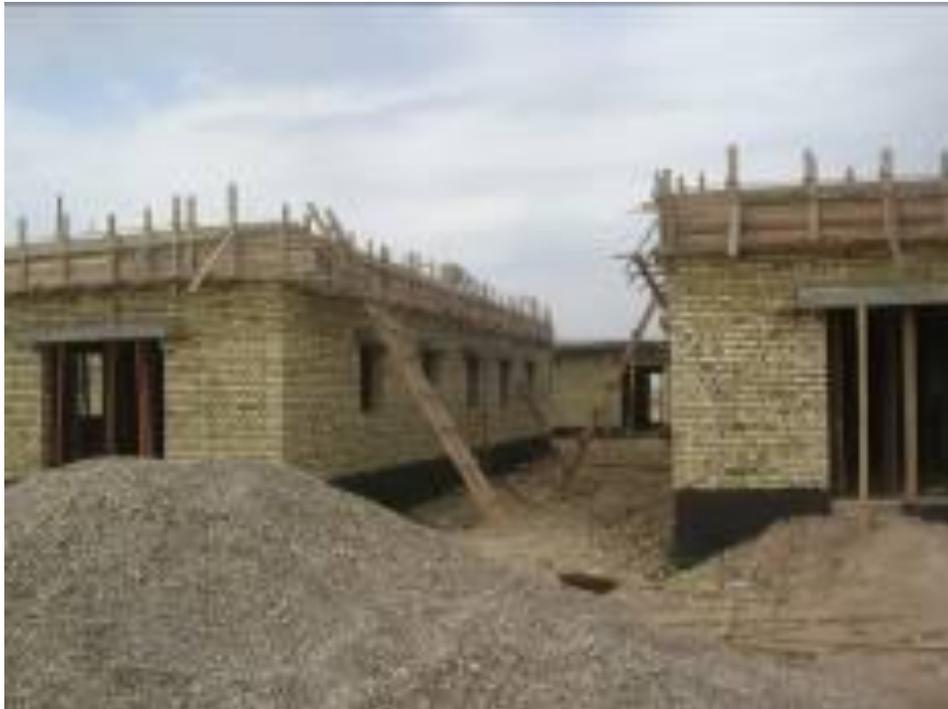
Site Photo 2. Latrine buildings (Courtesy of GRS)

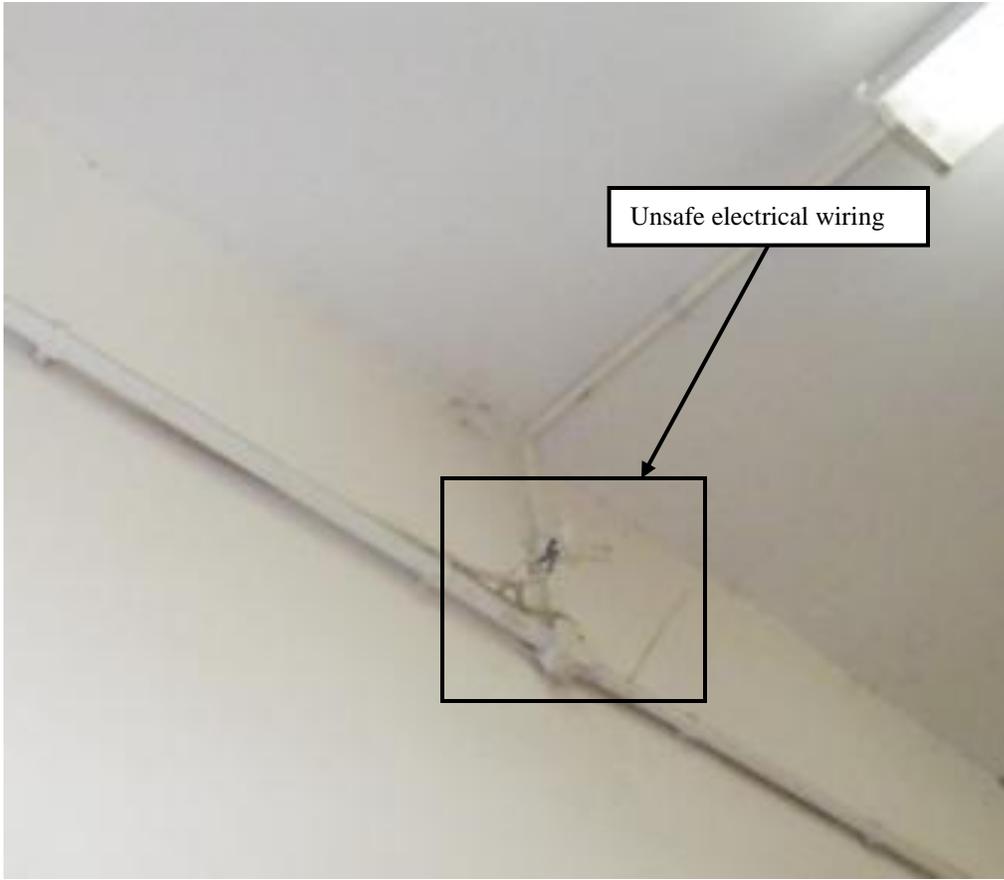
The building construction used typical Iraqi techniques for brick or block walls with a mortar/plaster/paint finish. The building exterior had areas of sandstone cladding (covering of one material with another) and areas of mortar/plaster/paint finish. The flooring was mostly terrazzo tile and a few offices were carpeted. The electrical system appeared to be well constructed, but had poor-quality fixtures. SIGIR noted unsafe electrical connections (Site Photo 3). The heating, ventilation, and air-conditioning system (HVAC) consisted of individual split units, which on-site personnel reported to be working. SIGIR found one room in which the tile flooring had significantly settled. This appeared to be the only major defect in the building. The remainder of the building appeared to be well maintained; however, wall tiles behind the stove and preparation tables in the battalion headquarters kitchen area were missing (Site Photo 4).

Site Photo 3. Unsafe electrical wiring

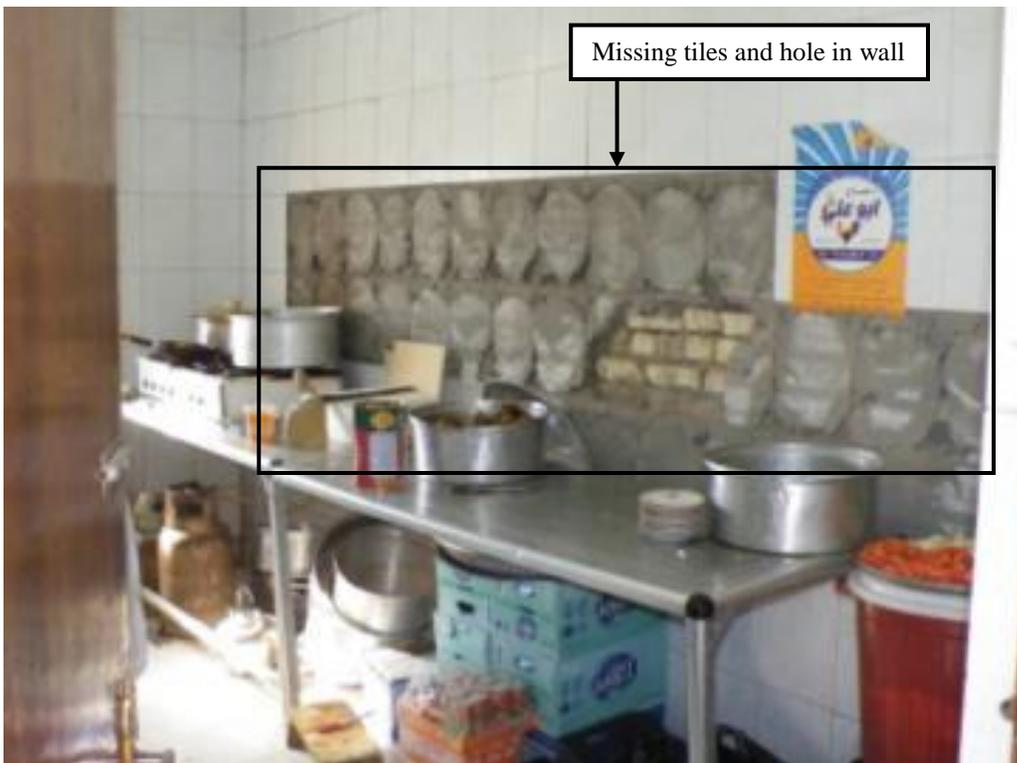
Site Photo 4. Damaged kitchen wall and tiles

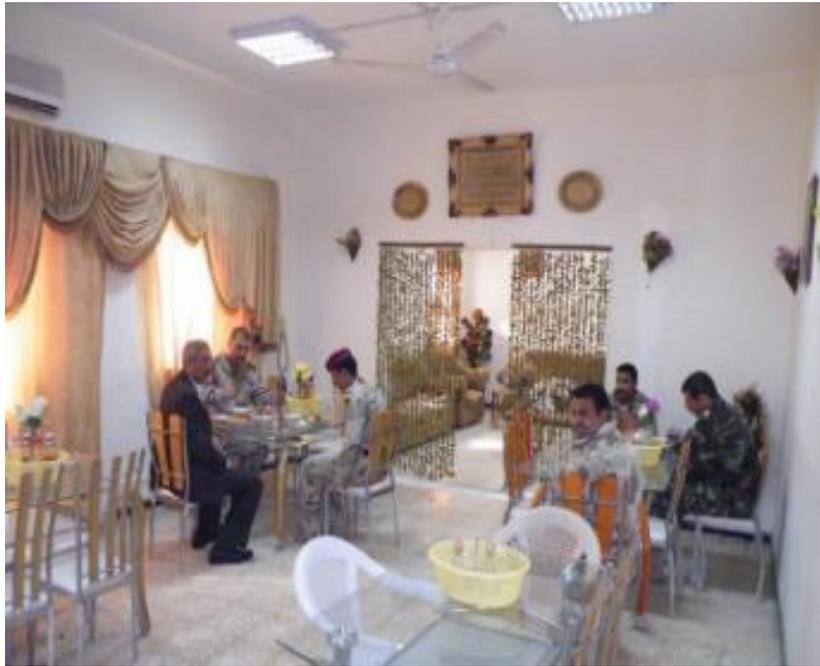
Because the contract did not provide for furnishings, GRS personnel were not sure if the furnishings were transferred from another facility or purchased by the Government of Iraq. The commander's office and the dining area furnishings appeared functional, but not very durable (Site Photo 5).

Site Photo 5. Commander's dining area

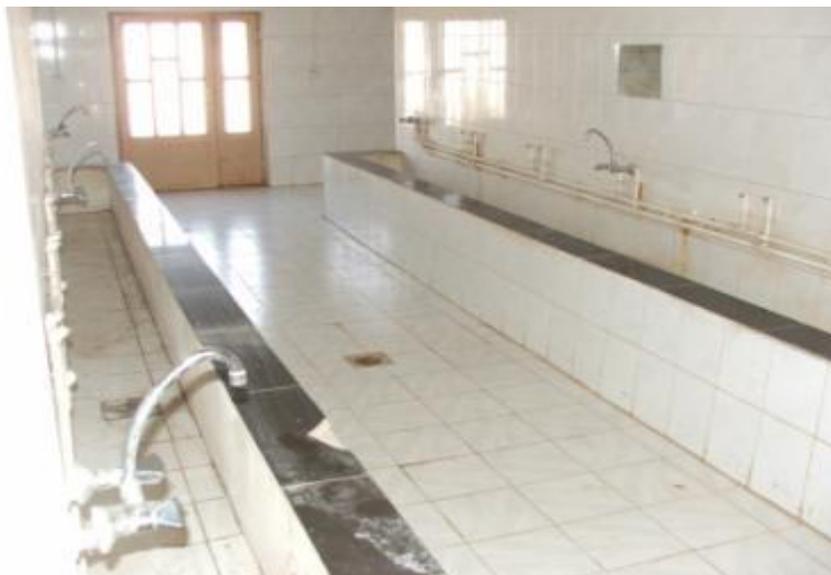
The SOW stated that the contractor was to construct four 12 x 12.4 m latrine buildings. The facilities would contain 20 water closets, 20 showers, and 28 faucets for hand washing. Site Photo 6 shows the hand-washing area. The restrooms were functional; however, SIGIR observed cracks in the tile, missing and broken faucets, and a lack of housekeeping evident by the level of cleanliness observed.

Site Photo 6. Hand-washing station

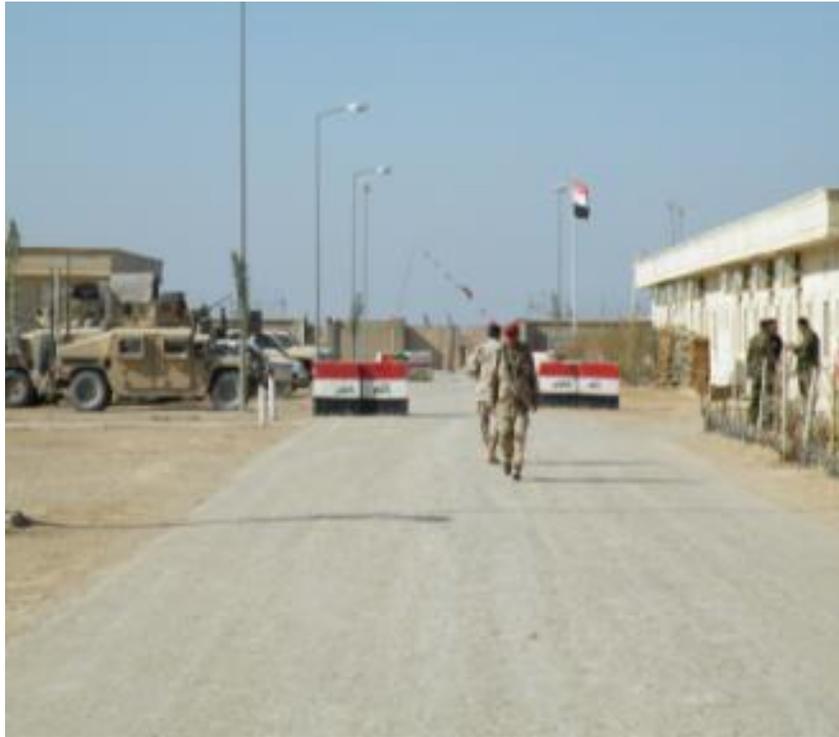
The contractor was required to construct a 7 m-wide aggregate roadway to connect the new construction with the existing roads. SIGIR observed that the project had paved roadways between the buildings connecting to the main entrance (Site Photo 7). Also, the security lights were to be mounted on 4 m-high poles. During the site visit, SIGIR observed mounted security lights around the perimeter wall.

Site Photo 7. Paved road

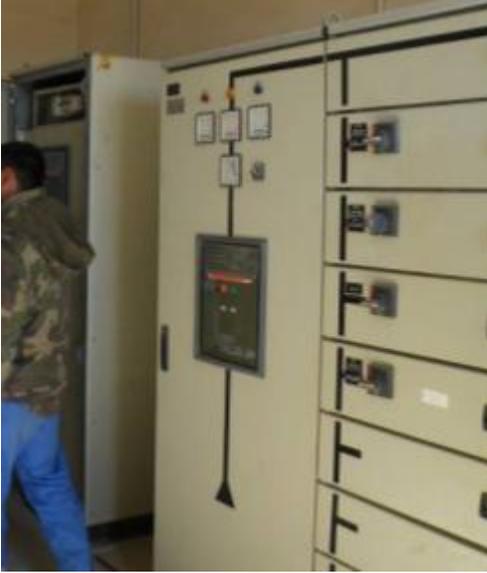
During the site assessment, SIGIR observed the electrical building, which contained several control panels and an automatic transfer switch (Site Photo 8). Two generators were in a separate covered shed that was secured with chain-link fencing (Site Photo 9). On-site personnel stated that the electrical grid was used and the automatic transfer switch was working properly. At the time of the site assessment, the generators were not operating. The generators appeared to have new filters, but the exterior was covered with excessive dust. SIGIR could not verify that any maintenance had been performed on the generators; however, on-site personnel stated that the generators were operational.

Site Photo 8. Electrical control panels

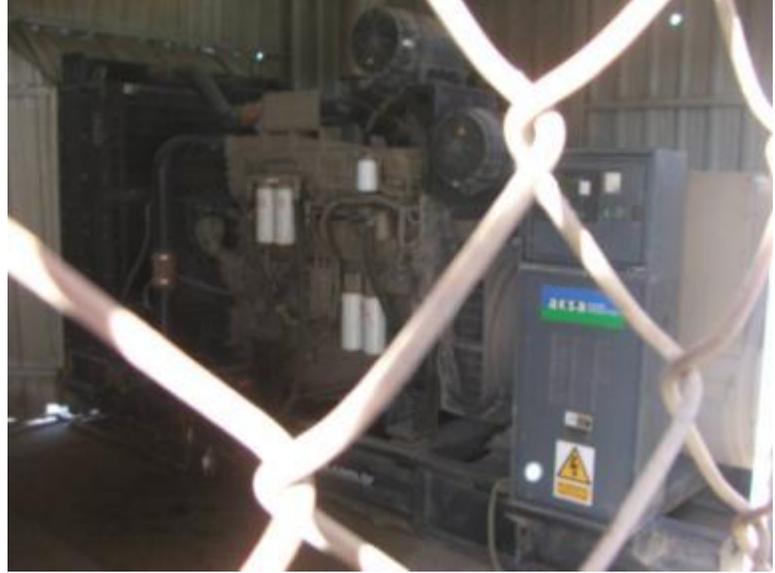
Site Photo 9. Generators

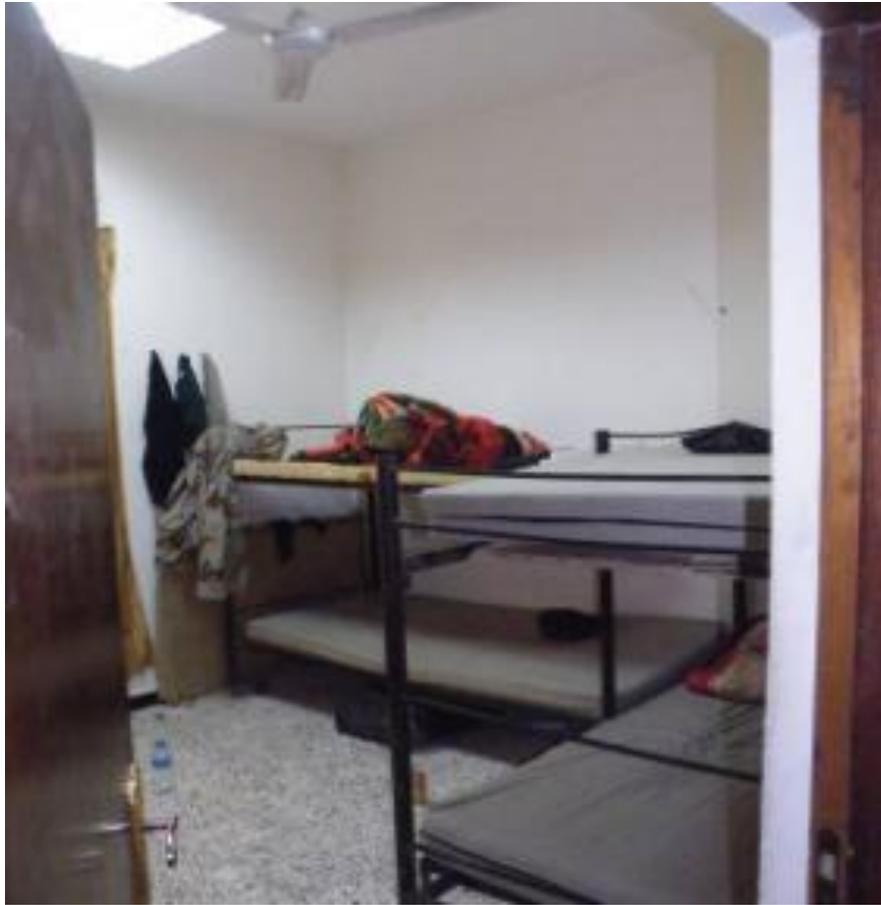
The barracks and office buildings included multiple buildings with sleeping, hand-washing, or storage areas. Barracks building construction used typical Iraqi techniques for brick/block walls with mortar/plaster/paint or tile finish. Also, the exterior consists of areas with sandstone cladding and mortar/plaster/paint finish. The barracks and office buildings had terrazzo tile flooring, and the ceiling was painted concrete with fluorescent lighting. The electrical systems appeared to be well constructed, but poor-quality fixtures were used. The HVAC system consisted of individual split units, which on-site Iraqi personnel stated were working. The sleeping rooms consisted of metal bunks or simple floor mats (Site Photo 10). The faucet fixture quality was poor, and some of the faucets were removed. One of the storage areas was converted into a convenience store to serve the soldiers (Site Photo 11).

Site Photo 10. Sleeping room

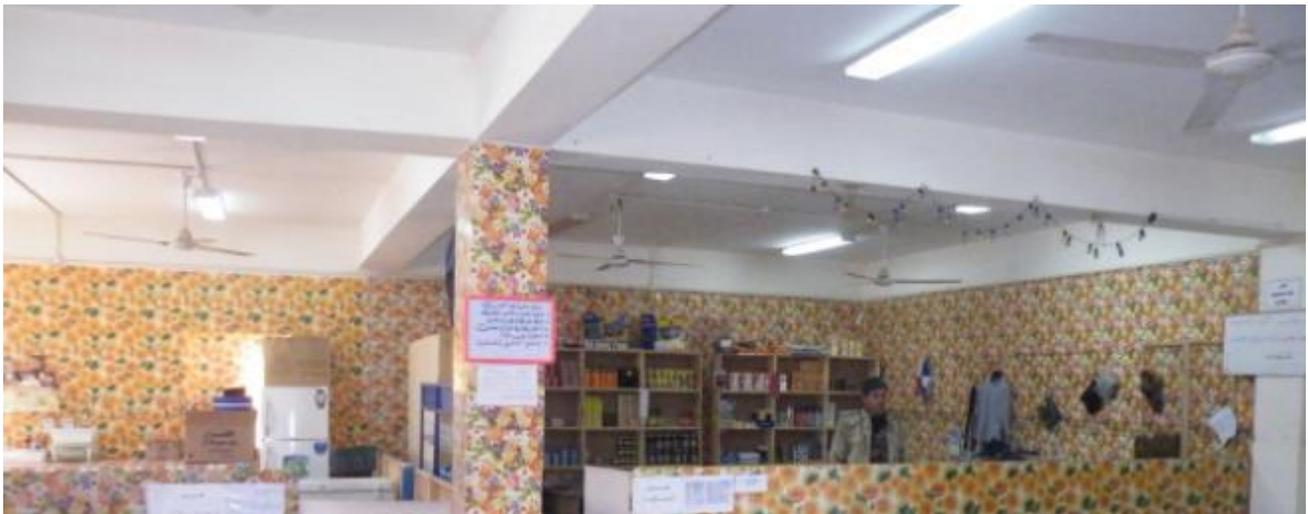
Site Photo 11. Room converted into convenience store

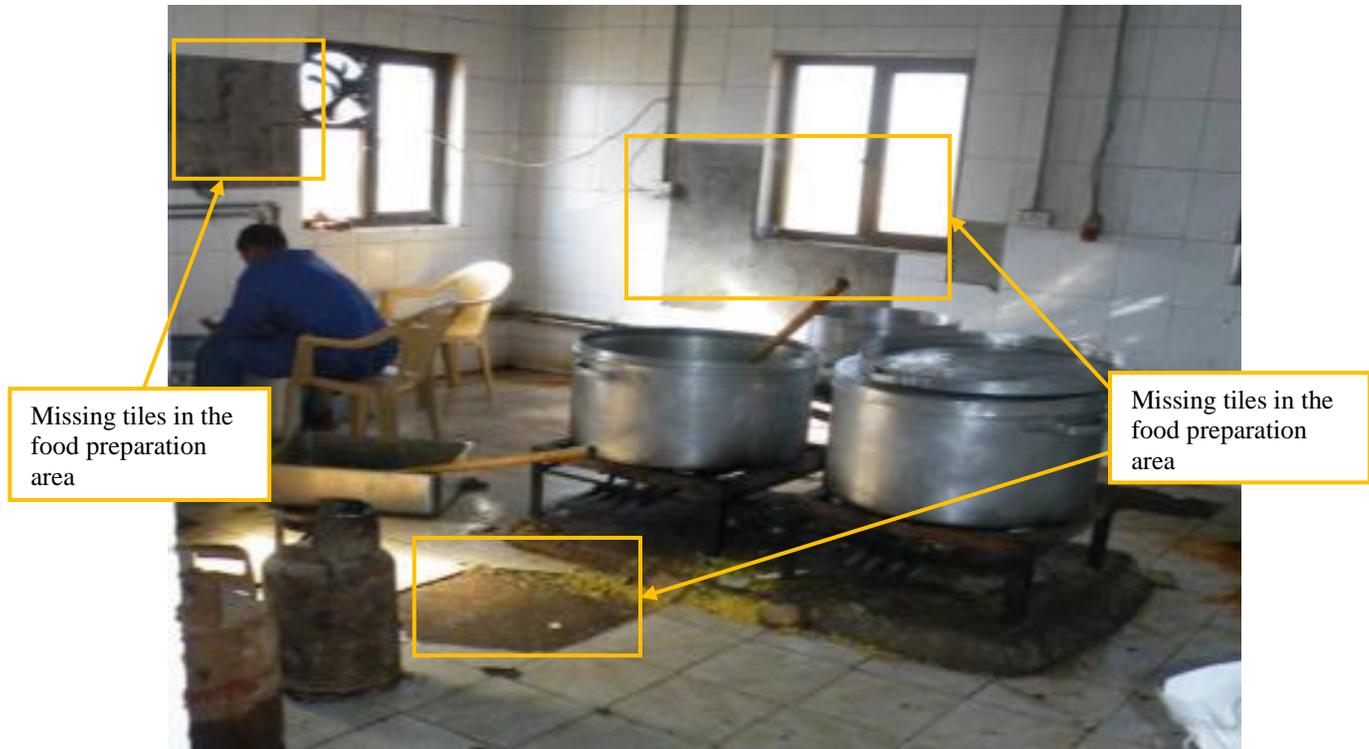
A separate building was used for preparing and cooking the food. This building was similar in construction, but was not well maintained. For example, wall and floor tiles were missing or damaged, and food, dirt, and debris covered the floor and walls (Site Photo 12). Although the food preparation area was designed for electrical food preparation and heating equipment, no electrical equipment was present. Instead, meals were cooked using portable gas cylinders with open-flame grates. The building appeared adequately constructed.

Site Photo 12. Food preparation and cooking area

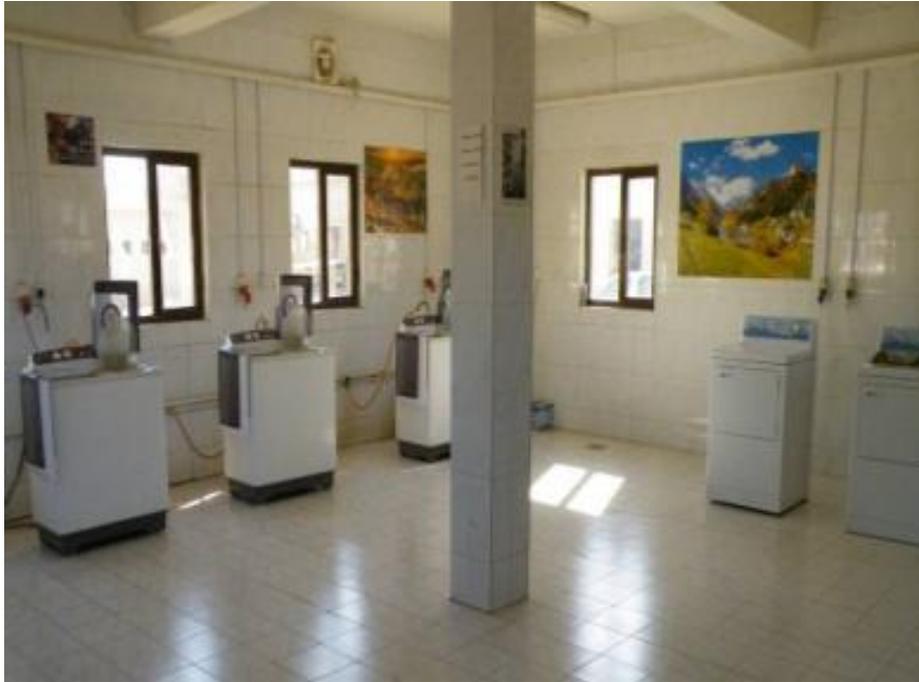
The laundry facility was constructed using the typical brick/block construction with mortar/plaster exterior. The interior was finished with large wall and floor tiles (Site Photo 13). SIGIR found the laundry facility to be well-maintained and in operation at the time of the assessment. The laundry facility was equipped with several washers and dryers, with several electrical and plumbing hookups for additional machines. The electrical and HVAC systems appeared adequately installed and operational.

Site Photo 13. Laundry facility interior

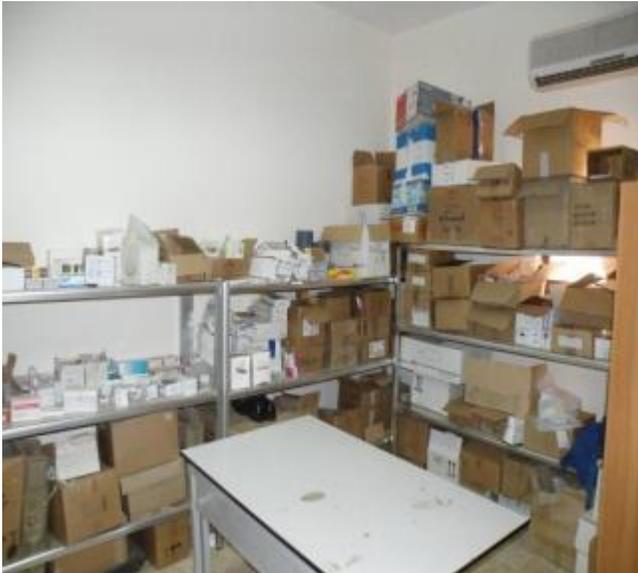
The medical building was constructed using bricks/blocks with mortar/plaster finish. The construction and maintenance of the building was adequate. The interior consisted of a few rooms and was clean but not sterile. At the time of the site visit, no one was being treated; however, medical supplies were readily available (Site Photo 14). SIGIR determined that the medical building was equipped to provide minor medical care to personnel, including dispensing medical supplies, preventing infectious disease, and disbursing pharmaceuticals. SIGIR observed an Iraqi medical technician on site and available.

Site Photo 14. Interior medical room with supplies **Site Photo 15. Equipment maintenance building**

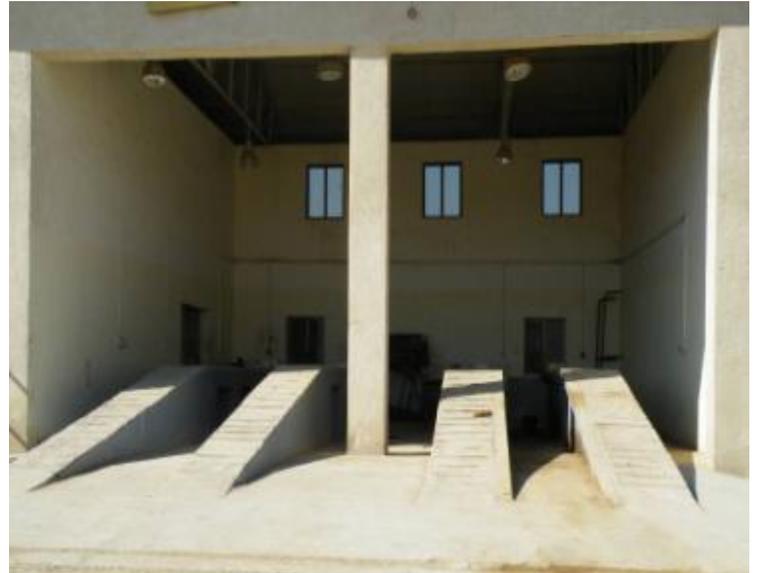
At the time of the assessment, vehicles were not being serviced (Site Photo 15). However, on-site personnel stated that the maintenance building was functioning, and SIGIR observed that the building was adequately maintained.
