May 20, 1999

AZEEZALY S. JAFFER  
MANAGER STAMP SERVICES

SUBJECT: Review of the Printing Error in the  
Grand Canyon Stamp (RG-LA-99-001)

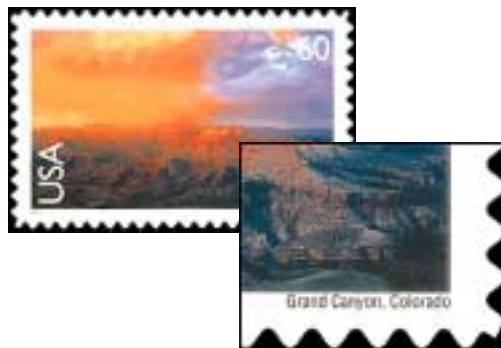
On or about May 11, 1999, Stamp Services staff discovered an error after the stamp was printed while it was been perforated. Specifically, the words "Grand Canyon, Colorado" appeared in the right-bottom corner of the stamp instead of Grand Canyon, Arizona. Beginning May 18, 1999, several national publications including the *USA Today*, *The Washington Post*, and the *Linn's Stamp News* published articles about the stamp error and were critical of the Postal Service's process.

According to Stamp Services officials, Postal Service staff asked the stamp designers to identify the location by adding the words "Grand Canyon, Colorado" to the bottom-right corner of the stamp. Although, the Grand Canyon was created by the Colorado River, the Grand Canyon National Park is located in Arizona.

The stamp had previously been reviewed by the Citizens' Stamp Advisory Committee and by the Postal Service's research consulting firm. However, once the words were added to the stamp, it did not go back to the consulting firm and Postal Service Management for final revisions, which is the established process. Instead, the printer added the words and initiated production. While the stamp was in final printing production, Stamp Services staff noted that the additional wording was incorrect.

We suggest that Stamp Services Management adhere to existing control processes when authorizing changes to the approved stamp design. Specifically, if any subsequent revisions are made, resubmit the revised artwork for approval by Stamp Services staff before production is authorized.
