**HADITHA PRIMARY HEALTH CARE CENTER
HADITHA, IRAQ**

SUSTAINMENT ASSESSMENT

**SIGIR PA-08-134
JANUARY 28, 2009**

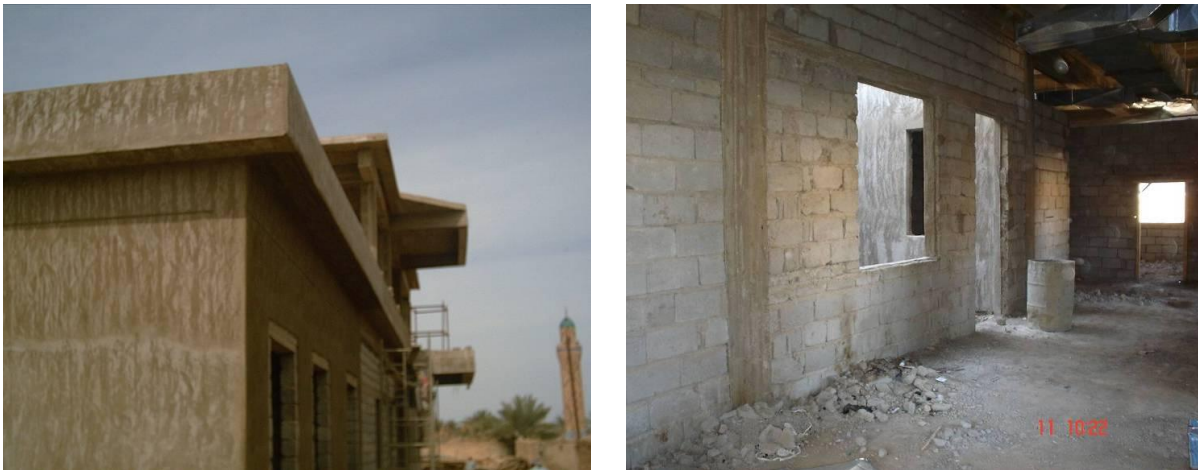
Site Photos 1 and 2. Interior and exterior views of the state of construction in March 2006
(Courtesy of GRC)

Site Photos 1-3 document the condition of the Haditha PHC when Parsons was terminated in March 2006.

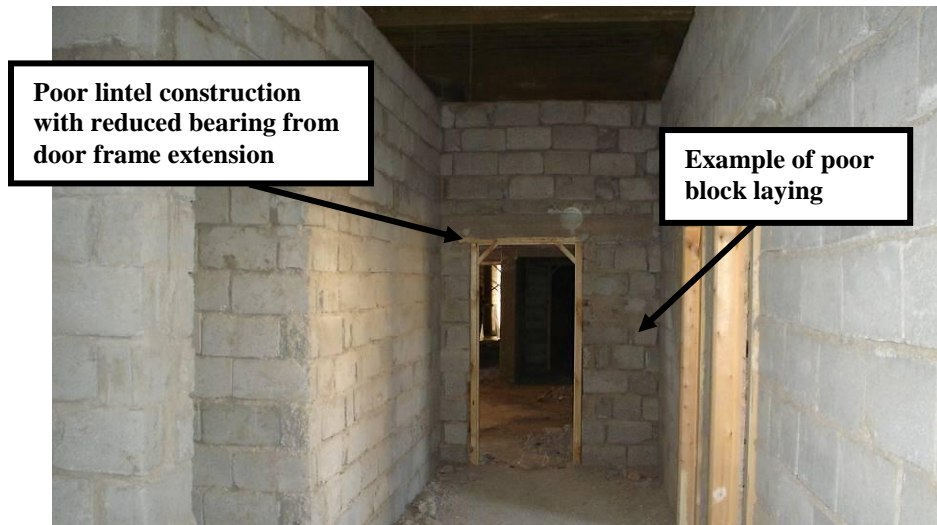
**Poor lintel construction
with reduced bearing from
door frame extension**

**Example of poor
block laying**

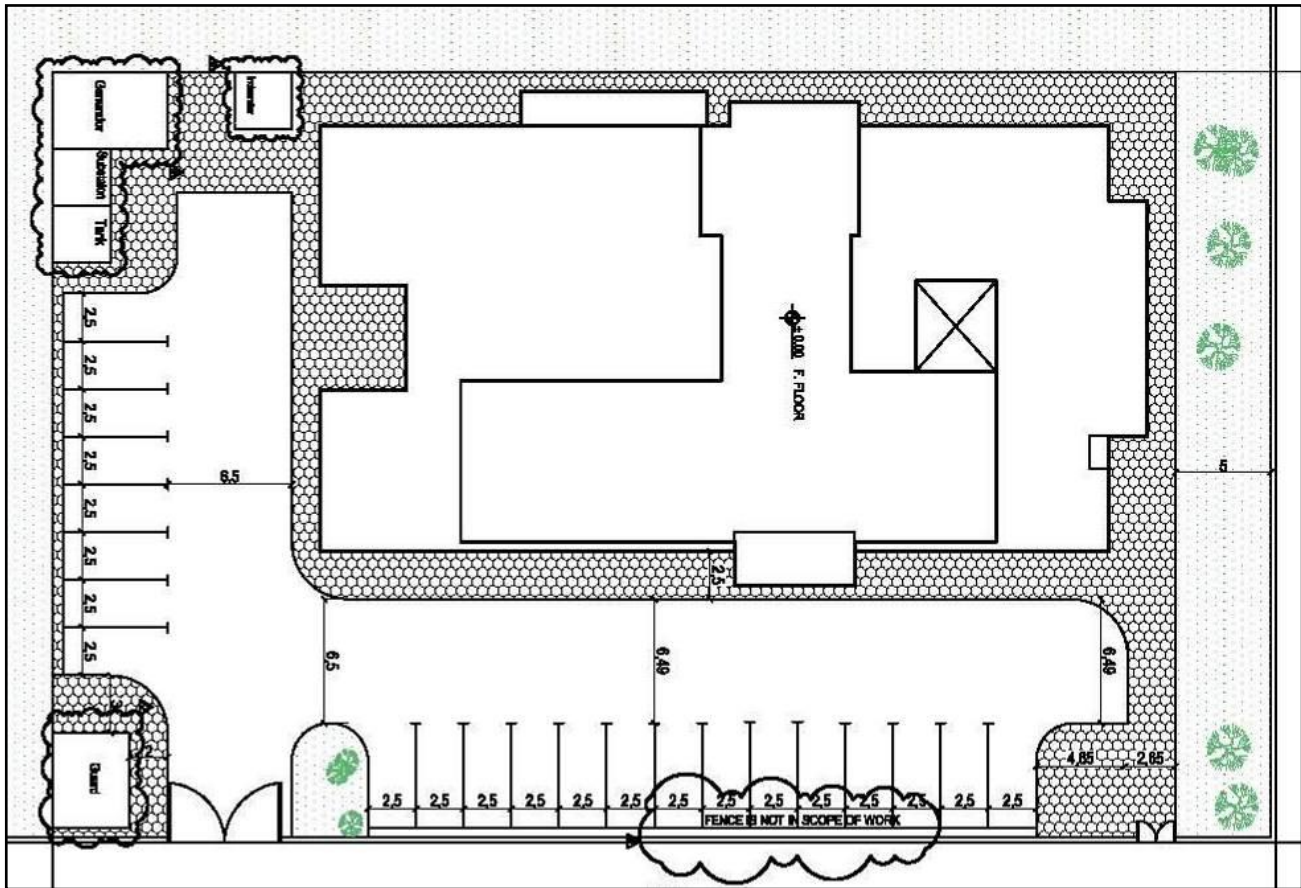
Figure 4. Site design drawing

The new contractor, prior to construction, submitted a site design to the GRC Al Asad Resident Office, which lacked specific details on types of materials, drainage, utilities, and security lighting (Figure 4).

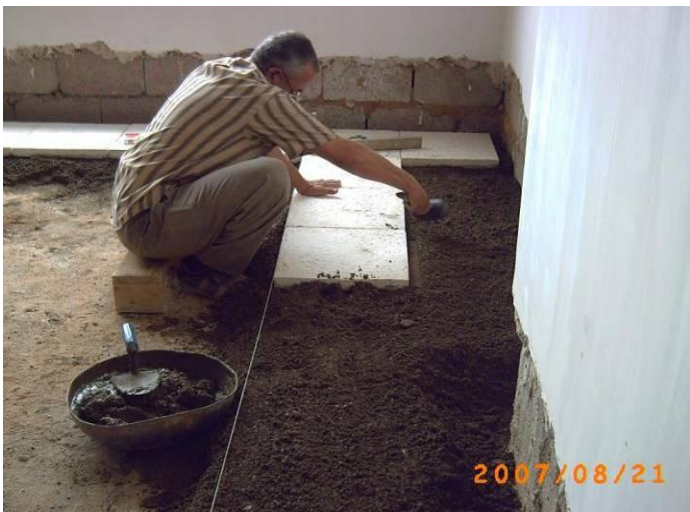
Site Photo 4. Tile placement
(Courtesy of GRC)

Site Photos 4-7 document various construction work activities at the PHC, including the laying of tile flooring, interior HVAC duct work, and electrical wiring (both adequate and inadequate).

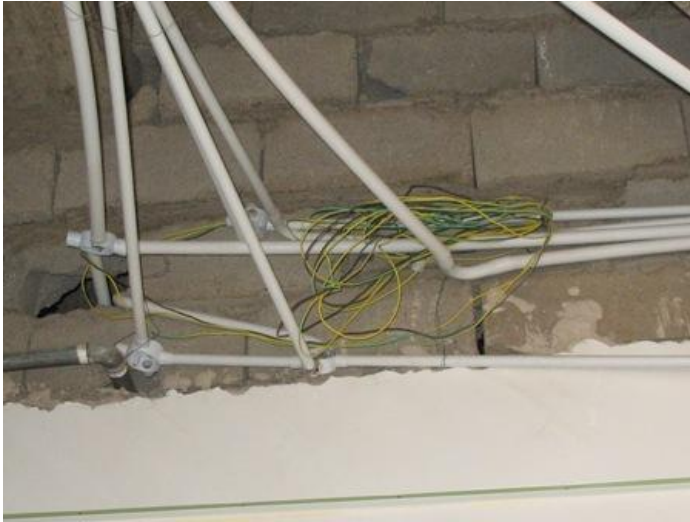
**Site Photo 6. Example of poor electrical work
(Courtesy of GRC)**

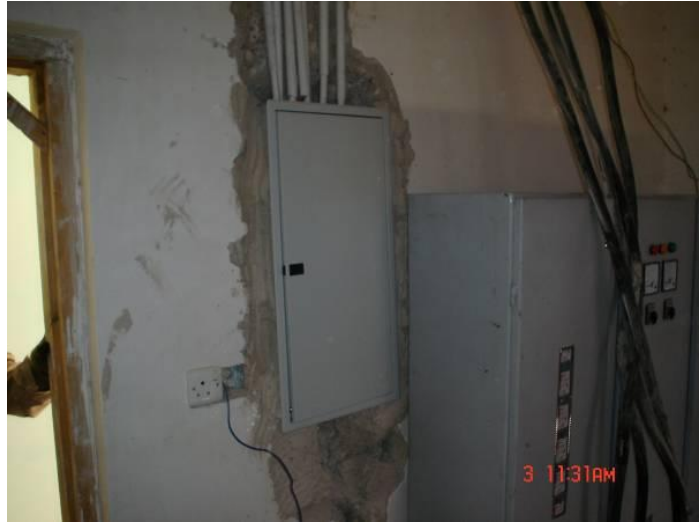
**Site Photo 7. Main distribution panel (adequate electrical work)
(Courtesy of GRC)**

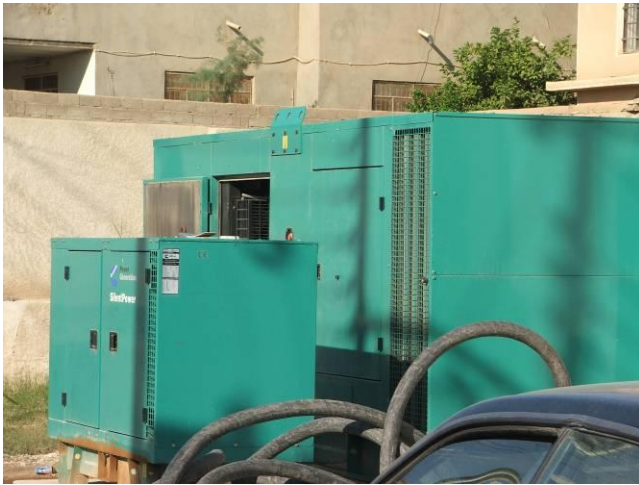
Site Photo 9. Backup generators

The Haditha PHC receives power from the national grid; however, the national grid is unreliable and provides approximately five hours of electricity per day. The remaining hours of operation are supplemented using one of the two generators located on site (Site Photo 9). In addition, a fuel storage tank was provided for the two generators (Site Photo 10). The larger generator (one megawatt) is used for primary power; while the smaller generator (500 kilovolt) is for emergency backup. Since the Haditha PHC is connected to national grid power, an automatic transfer switch is critical to instantly transfer to generator power once electricity from the national grid is lost. Any hesitation or delay in transferring power from the national grid to a generator means the facility will not have power, which could result in harm to patients undergoing procedures requiring power.

During the site visit, power from the national grid was unavailable and the facility was operating via the primary generator. However, according to the administrator, the generator’s automatic transfer switch did not work, which required PHC staff to manually start the generator. Due to time limitations on site, SIGIR could not identify the cause of the automatic transfer switch’s malfunction. The end result is now when power is lost from the national grid, a PHC representative has to manually switch on the generator.

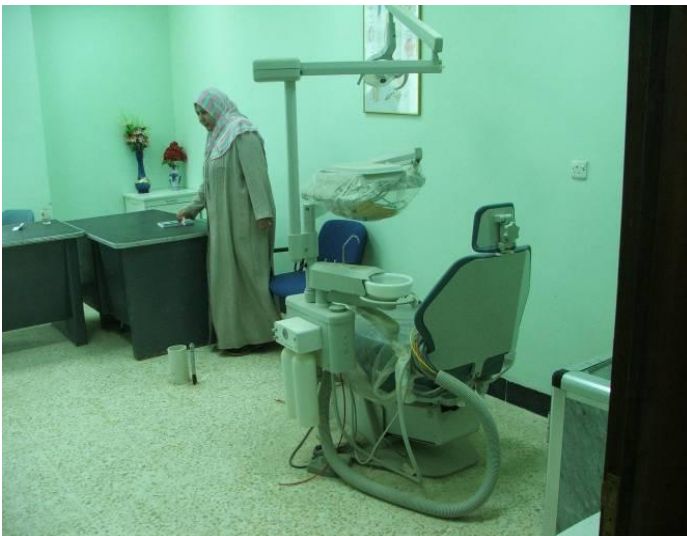
During the site visit, SIGIR observed that the dental equipment, specifically the dental chair, was not installed and/or connected (Site Photo 11). According to the dentist, the chair requires connection to power, water and drain lines, and air and vacuum lines (Site Photo 12). A GRD representative stated the "PVC and Copper pipes for the dental room were missing so the dental chair was not completely installed." SIGIR noticed what appeared to be an empty junction box and conduit intended as a utility connection to the dental chair; however, it appeared that no utilities were installed in the junction box or extended to the conduit (Site Photo 13). Minor construction will be required to extend the utilities to the conduit, under the floor, and to the chair. A dental X-ray machine was installed in the clinic (Site Photo 14); however, the administrator stated that until the installation of the dental chair was complete, the X-ray machine could not be used.

The administrator stated the facility has a full time dentist; however, without the dental chair being installed and connected to purified water and drainage, there is little benefit the dentist can provide outside of very minor routine dental care.

Site Photo 11. Uninstalled dental chair

SIGIR recommends that the Commanding General of the Gulf Region Division (GRD) perform all installation of, and training on, the medical equipment currently at the Haditha PHC, according to its prioritization listing.

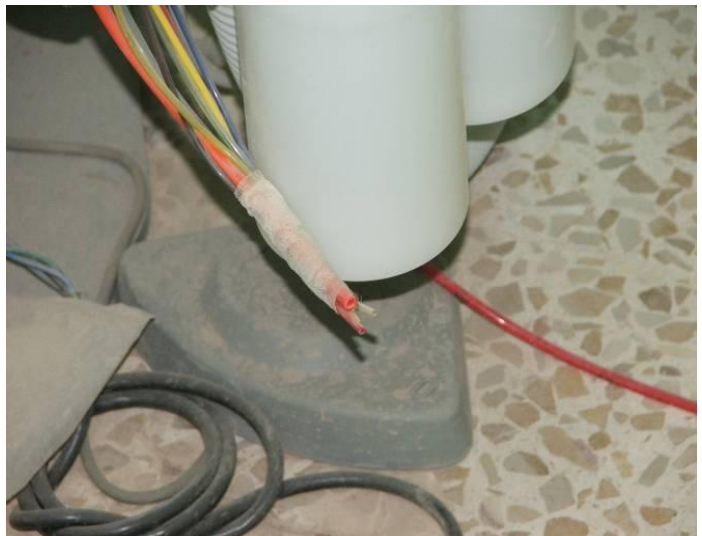
Site Photo 12. Disconnected utilities

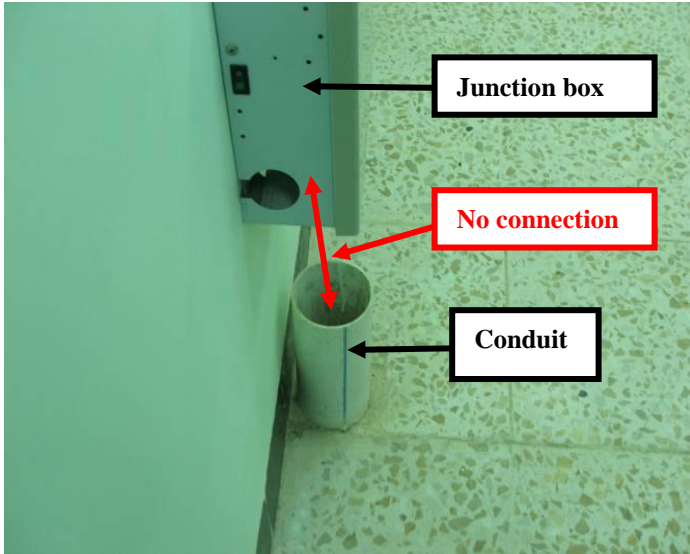
Site Photo 13. Missing utility connection

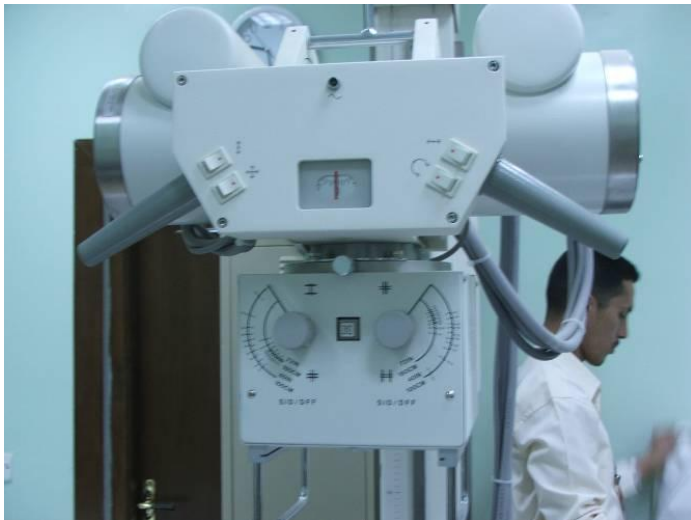
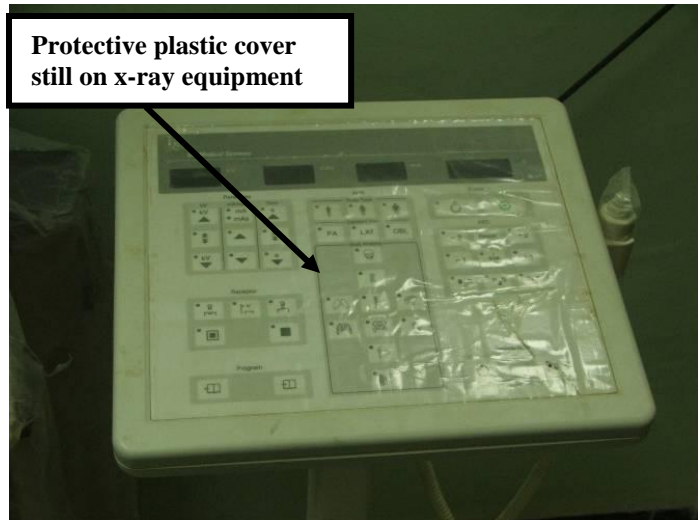
During the site visit, SIGIR observed the X-ray equipment was placed in the imaging room but was not connected. According to GRD representatives, the X-ray machine was installed but training could not be completed due to an inadequate power supply cable. Until a power supply cable is provided, the X-ray machine will continue to be inoperable.

Site Photo 15 and 16. Due to inadequate power supply cable, the x-ray equipment is not used

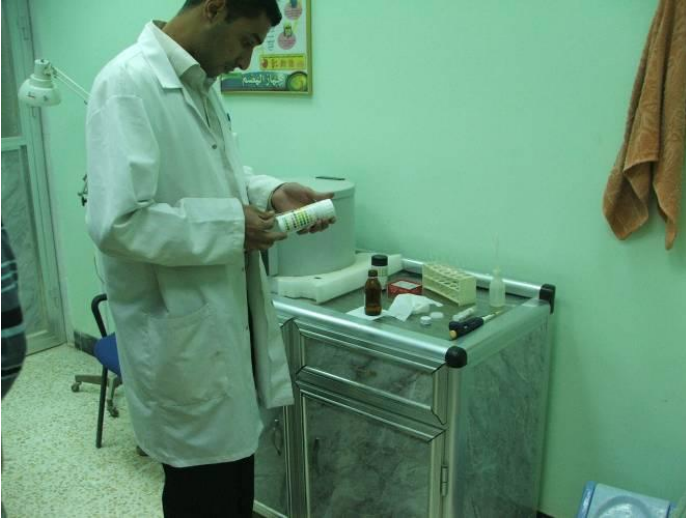
The medical laboratory appeared to be functioning. The laboratory was clean and appeared well maintained. During the site visit, SIGIR observed testing being performed (Site Photo 17). The equipment not in use was covered and appeared well organized (Site Photo 18).

Site Photo 17. Performing lab tests

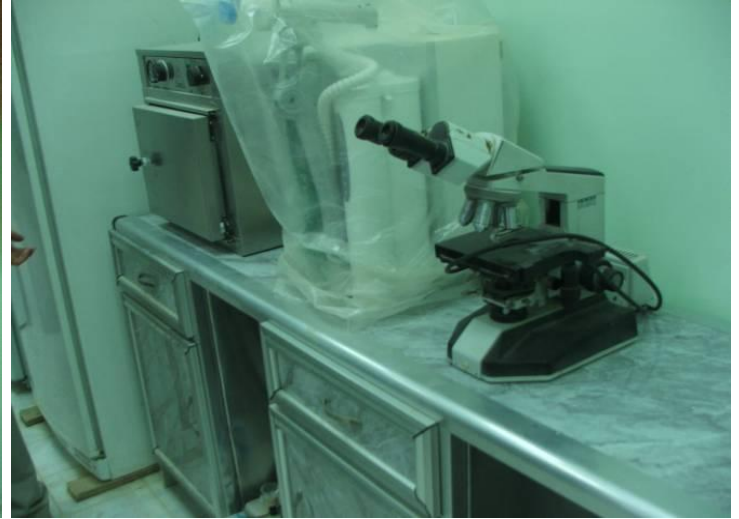
Site Photo 18. Laboratory equipment

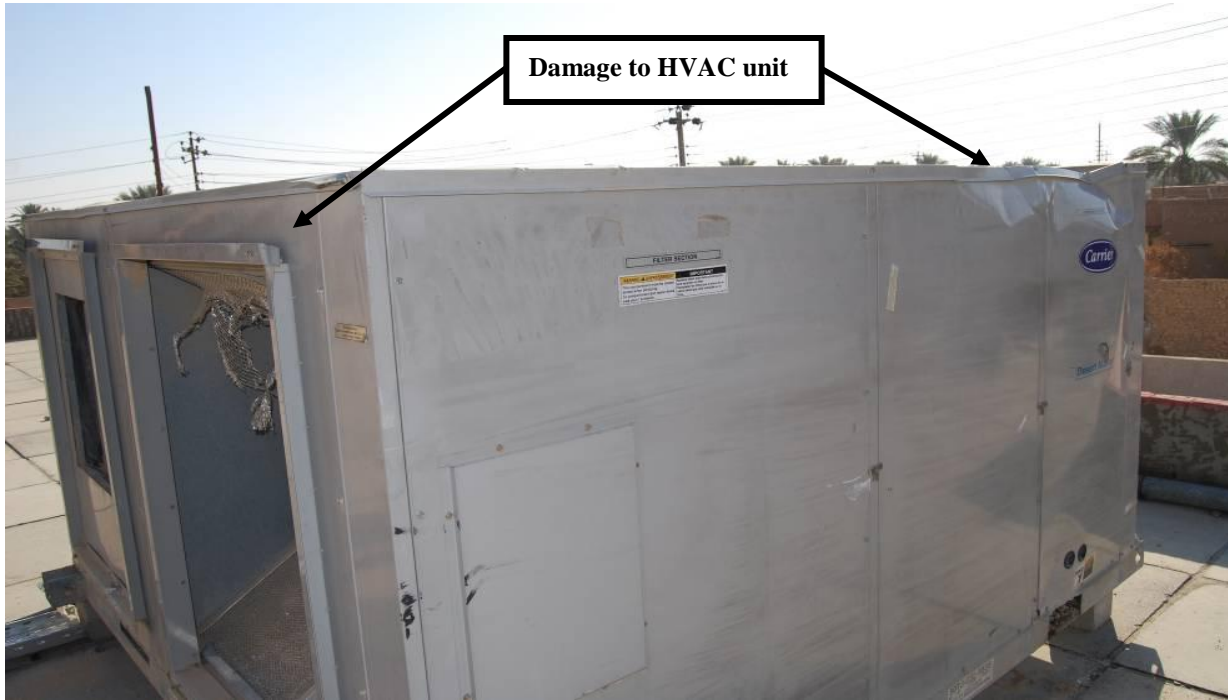
According to the administrator, the HVAC units do not work. In fact, the HVAC units have not worked since the facility was turned over to the MoH. Due to the cooler ambient temperatures at the time of the site visit, and the limited time on site, SIGIR was unable to verify that the HVAC units were not working. One of the HVAC units appeared to be severely damaged (Site Photo 19). This damage was previously identified in a GRC Al Asad Resident Office site inspection; however, the project file lacked any documentation to indicate whether the unit was tested prior to installation. SIGIR also noted the remaining units had some minor damage. SIGIR observed an automatic damper was installed in the rooftop duct work with no shielding (Site Photo 20) and poorly installed duct insulation (Site Photo 21).

Further, GRD provided HVAC units that were installed by the contractor did not have heating coils and thermostats; consequently, the unit will not be able to provide heat during the winter months. Even though the site visit occurred in early November, SIGIR noticed cold temperatures throughout the PHC.

Site Photo 19. Damaged HVAC unit

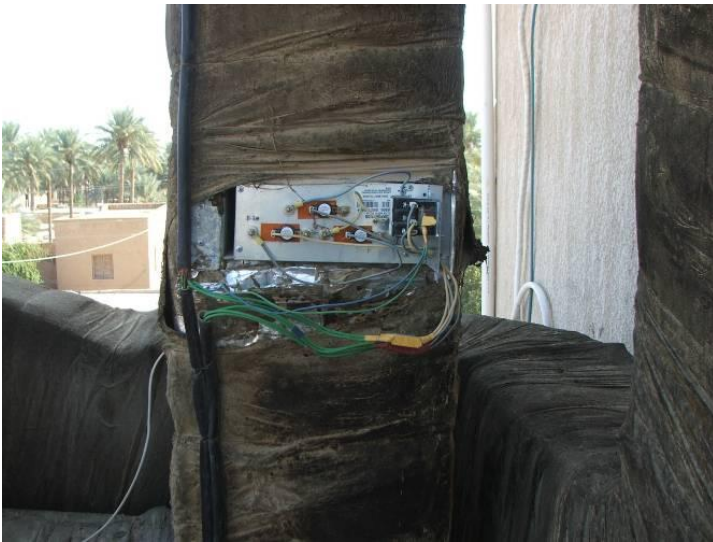
Site Photo 20. Unshielded damper

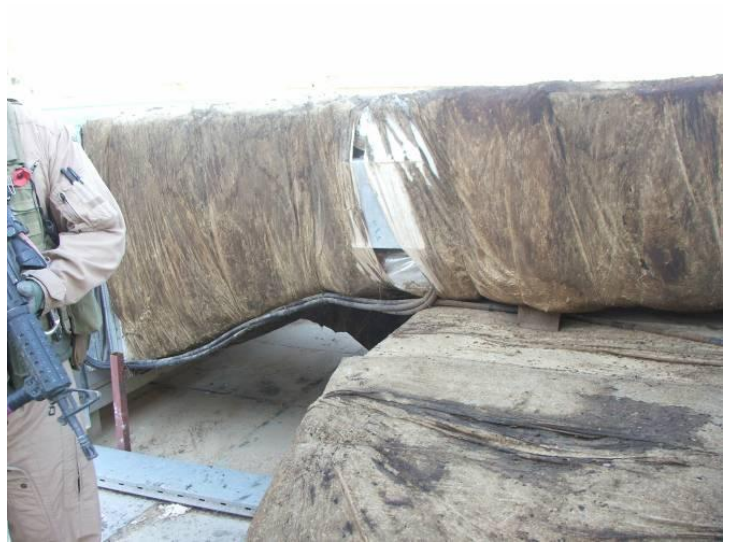
Site Photo 21. Duct insulation

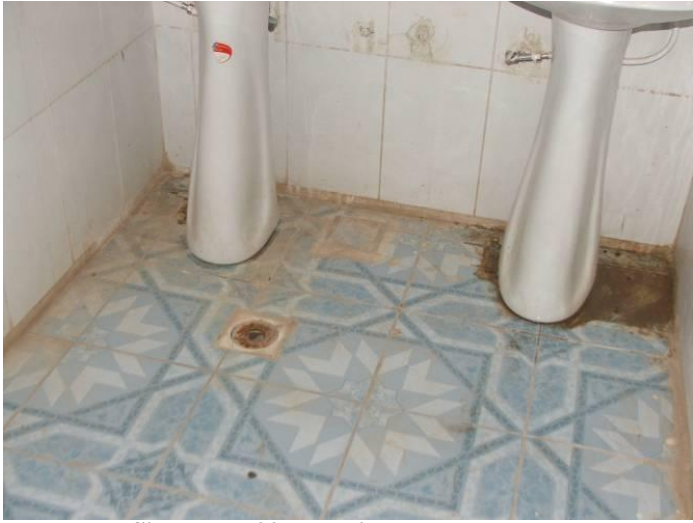
During the site visit, SIGIR inspected a bathroom and found the lavatory was leaking (Site Photo 22). In addition, one side of the building's sewer system appeared to be blocked. The blocked sewer system made several bathrooms unusable (Site Photo 23). According to the administrator, plumbing issues were present at the time the facility was turned over to the MoH.

Site Photo 22. Leaking lavatory

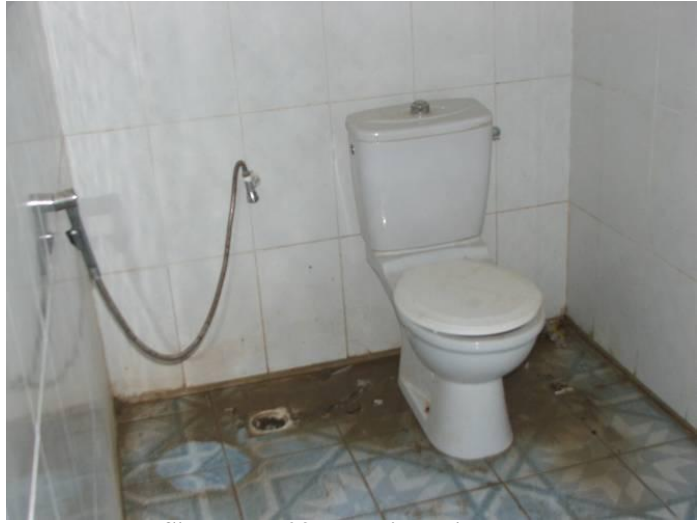
Site Photo 23. Leaking toilet

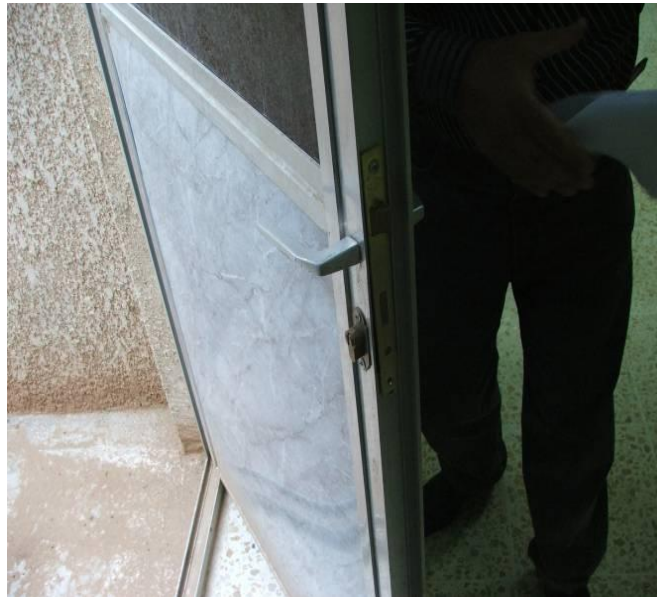
SIGIR noticed the quality of the window and door hardware was poor. Several of the window latches did not work and were not adequate to prevent unauthorized entry. For example, the administrator pointed out one specific door that could not be adequately secured (Site Photo 24).

Site Photo 24. Low quality door latch
