Synthesis of Literature Relevant to Roundabout Signalization to Provide Pedestrian Access

Final Report

Vaughan W. Inman
Science Applications International Corporation

January 11, 2007

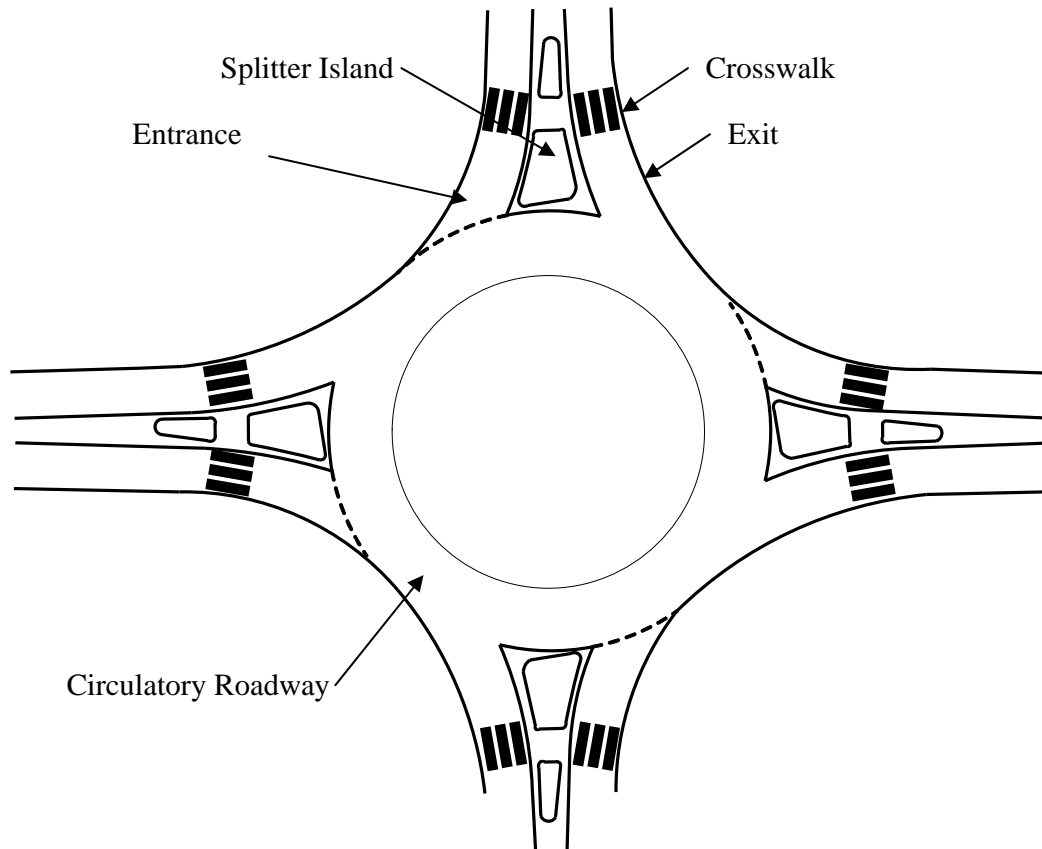
Figure 1. Illustration of single-lane roundabout with crosswalks.

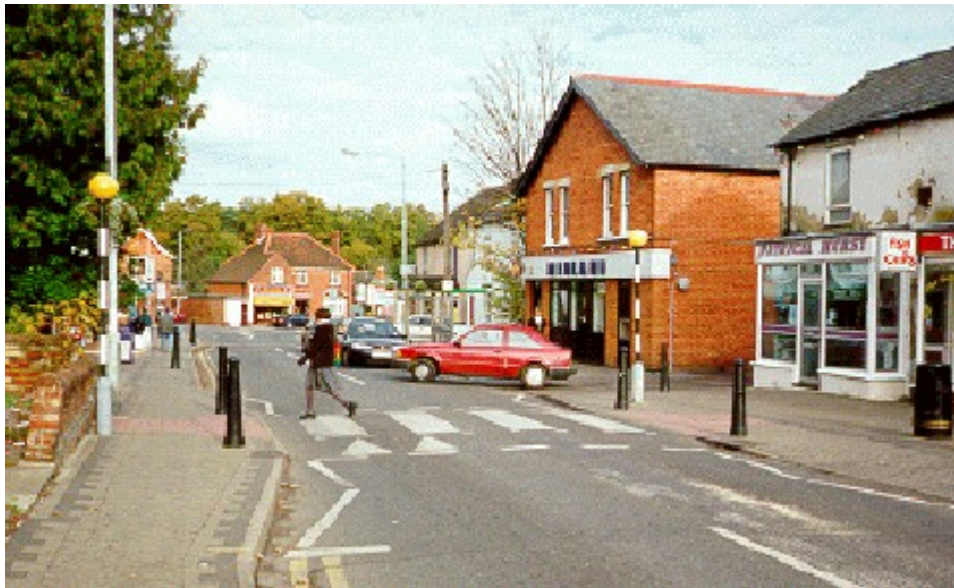
The zebra crossing is the oldest mid-block crossing type currently in use that gives priority to pedestrians. The important features of a zebra crossing can be seen in Figure 2. These consist of wide longitudinal strips to delineate the crossing, zigzag striping at the roadway edges and between lanes to indicate that parking and passing are not permitted, and black and white striped poles topped by flashing amber globes (Belisha beacons). These crossings may have other features such as a raised crosswalk, bulb-out, median refuge, and bollards. Pedestrians in a zebra crossing have priority over vehicles, but unlike in the U.S. and some other countries, U.K. motorists usually respect that priority and often stop for pedestrians who are waiting at the curb (and thus do not yet have priority) (10). Pedestrians may claim priority by standing in the crossing, which is different from most U.S. states where pedestrians are expected to wait for a gap before entering the roadway at uncontrolled crosswalks. Once a pedestrian claims priority in a zebra crossing, all vehicles that can do so are required to stop before entering the crossing.

Figure 2. Zebra crossing in the U.K.(10).

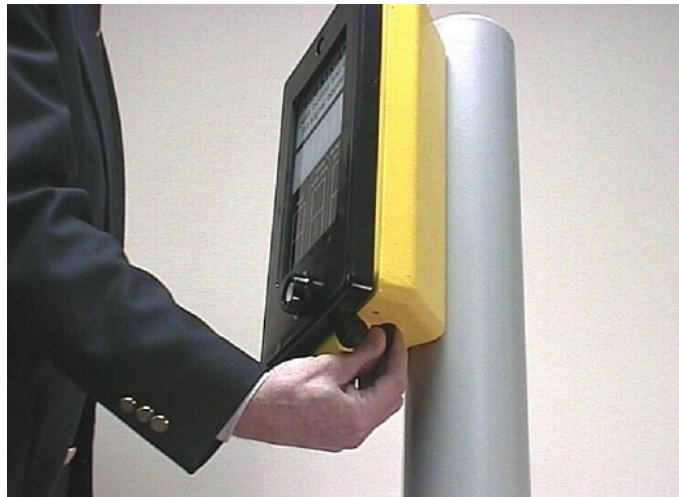
Puffin (Pedestrian User Friendly INtelligent) crossings are similar to Pelican crossings, but employ sensors to detect when pedestrians have cleared the crossing. This enables both shortening of the delay for traffic when pedestrians clear the crossing quickly, and extension of the walk phase when pedestrians need more time. Another difference between pelican and puffin crossings is that puffin crossings have the pedestrian signal head above the call button, which is on the near side of the crossing. Figure 3 shows a pedestrian signal call unit used in Dorset County, U. K. The pedestrian in the figure has his fingers on a rotating tactile cone that is intended to indicate the crossing phase to pedestrians who are blind, or deaf-blind. Because Puffin crossing visual indications are on the same side of the crossing as the pedestrian, pedestrians with low vision can often see these indications when they may not be able to detect or interpret far side signal indications found at Pelican crossings. (12) Puffin crossings may also have microwave, infrared, or pressure pad, detectors to sense pedestrians waiting to cross, and obviate the need for pressing a call button.

Figure 3. Pedestrian signal call device used at Puffin crossings.

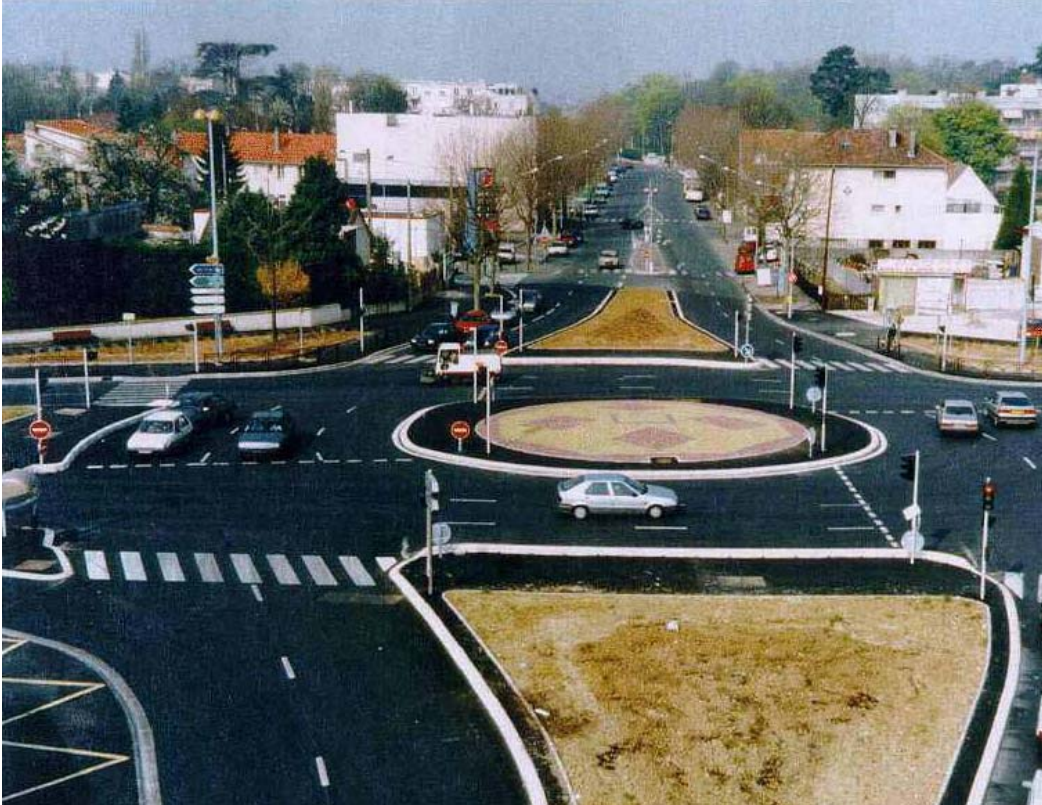
Figure 5. Signalized roundabout in France where crosswalks are located adjacent to the circular roadway. Note that France only allows post mounted signals. It is possible that overhead signals may be used in the US.(19)

Note that the traffic signals shown in Figure 5 are mounted on posts at the roadway edges, not on mast arms. Because of the low speed environment, it may not be necessary to locate roundabout traffic signals over the travel lanes to achieve adequate conspicuity.

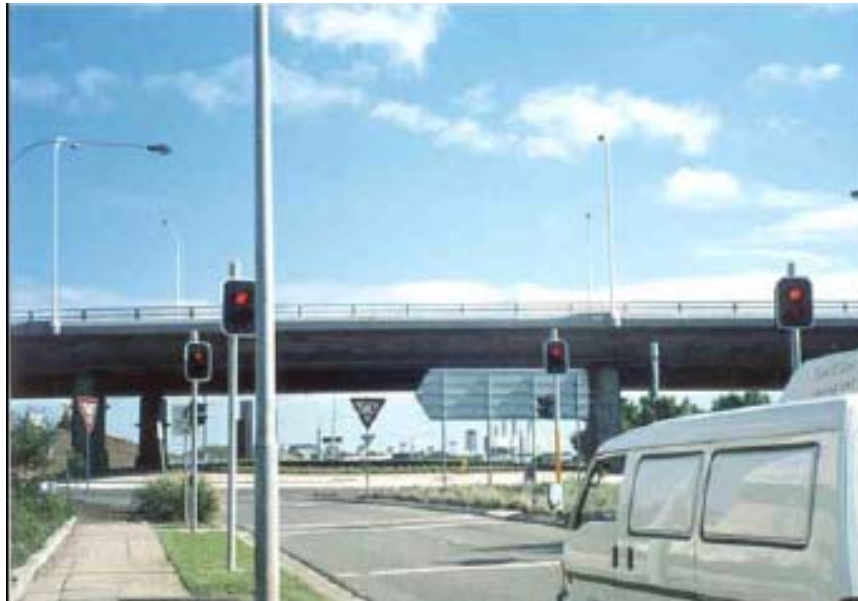
Baranowski has reported a roundabout in Sydney, Australia, that was designed to interrupt pedestrian flows that were anticipated to be heavy during the 2004 Olympic Games (14). Figure 6 shows one of the crossings at that roundabout. The crosswalks on either side of the splitter island are not offset, as recommended in the U.K. and France. According to Baranowski, the two-lens (amber and red) signals first flash amber, then goes to solid amber, and then to red. When not active, the signals are unlit (off). At the roundabout entrance, this avoids the confusion drivers might experience, if they received a green signal only a few feet upstream of the yield control. We have requested further information on the signal timing from the Australian contacts, as well as whether the configuration in the photograph is according to a VicRoads standard, or if it is experimental.

The signals are post-mounted. Two of the signals are mounted on posts at the stop bar, and two additional signals are mounted at the upstream side of the crosswalk. The two signals at the stop bar would emphasize the desired stop location, whereas the two signals at the crosswalk are far enough from the stop bar so that drivers can see them when stopped at the stop bar. Note, however, that the vehicle in the picture appears to have stopped upstream from the stop bar, perhaps so that the driver could maintain line of sight to all four signals. If drivers stop or slow well upstream of the stop bar, they may

Figure 6. Signalized roundabout crosswalk in Sydney, Australia (14).

In the U.S., the MUTCD requires that traffic signals be placed 40 ft beyond the stop bar to ensure that drivers who are stopped at the stop bar can see them. Signal heads at the stop bar, as shown in Figure 6, would be permissible in the U.S., as long as there are also yoked signals 40 ft beyond. It appears from the figure that the VicRoads standard may be similar to that in the MUTCD, as the two pairs of signals appear to be about 40 ft apart.

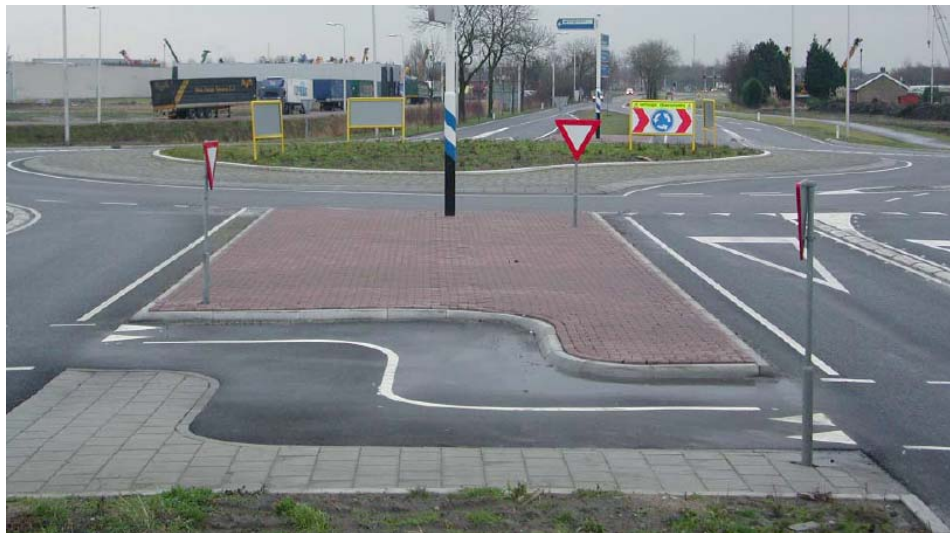
Figure 8. Jog in bicycle path in splitter island at turbo-roundabout (22).

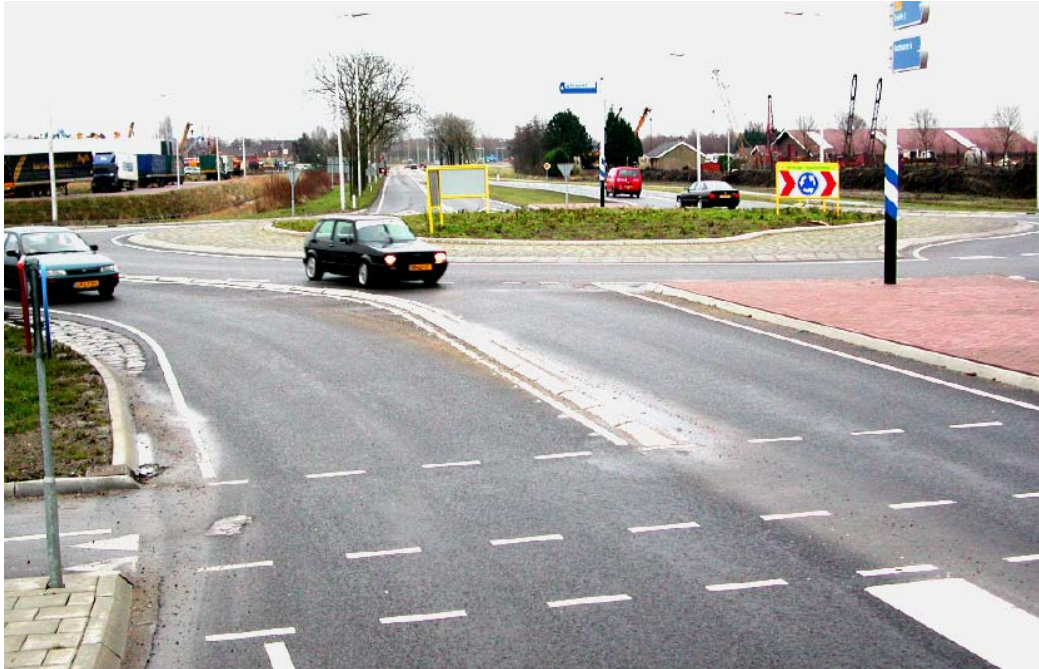
Figure 9. Typical juxtaposed pedestrian and bicycle crossing at a turbo-roundabout (22).

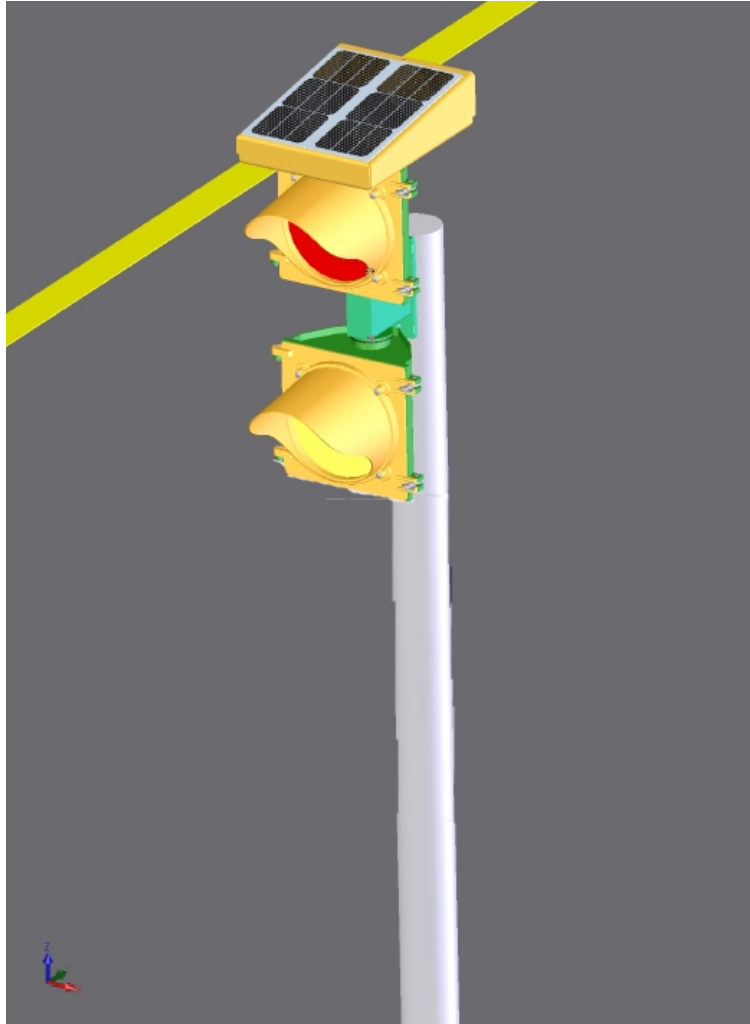
Figure 11. Two-lens solar powered pedestrian crossing signal.

The cost of installing mast arm signals at traditional intersection is about \$150,000. The cost of such an installation at a four-legged roundabout would be approximately \$600,000 under the assumption that each leg operates independently as a conservative estimate. The configuration shown in Figure 10, which does not require mast arms, would cost less. Figure 11 shows a solar powered unit that would be off when not activated by a pedestrian call and would flash amber, and then show steady amber, and then red when activated. All the signals at a crossing could be controlled through radio communication. The solar powered unit would have low installation cost because it would not require trenching to supply power or to control the remote signal faces. The manufacturer of the solar powered unit provided an estimate of \$2,775 for a unit with two eight-inch lenses, solar panel, batteries, control logic, and radio. This estimate does not include the accessible pedestrian signal call unit or signal, mounting pole, or installation. A Virginia Department of Transportation manager estimated that the cost of installation of similar devices that do not require trenching is about \$1,500.
