IMAGES OF SHORELINE AREAS AFFECTED BY COSCO BUSAN INCIDENT

THESE ARE SELECTED IMAGES FROM THE COSCO BUSAN OIL SPILL NRDA GOOGLE EARTH FILE. THE ENTIRE GOOGLE EARTH .kmz FILE MAY BE ACCESSED AND DOWNLOADED AT THE FOLLOWING SITE:

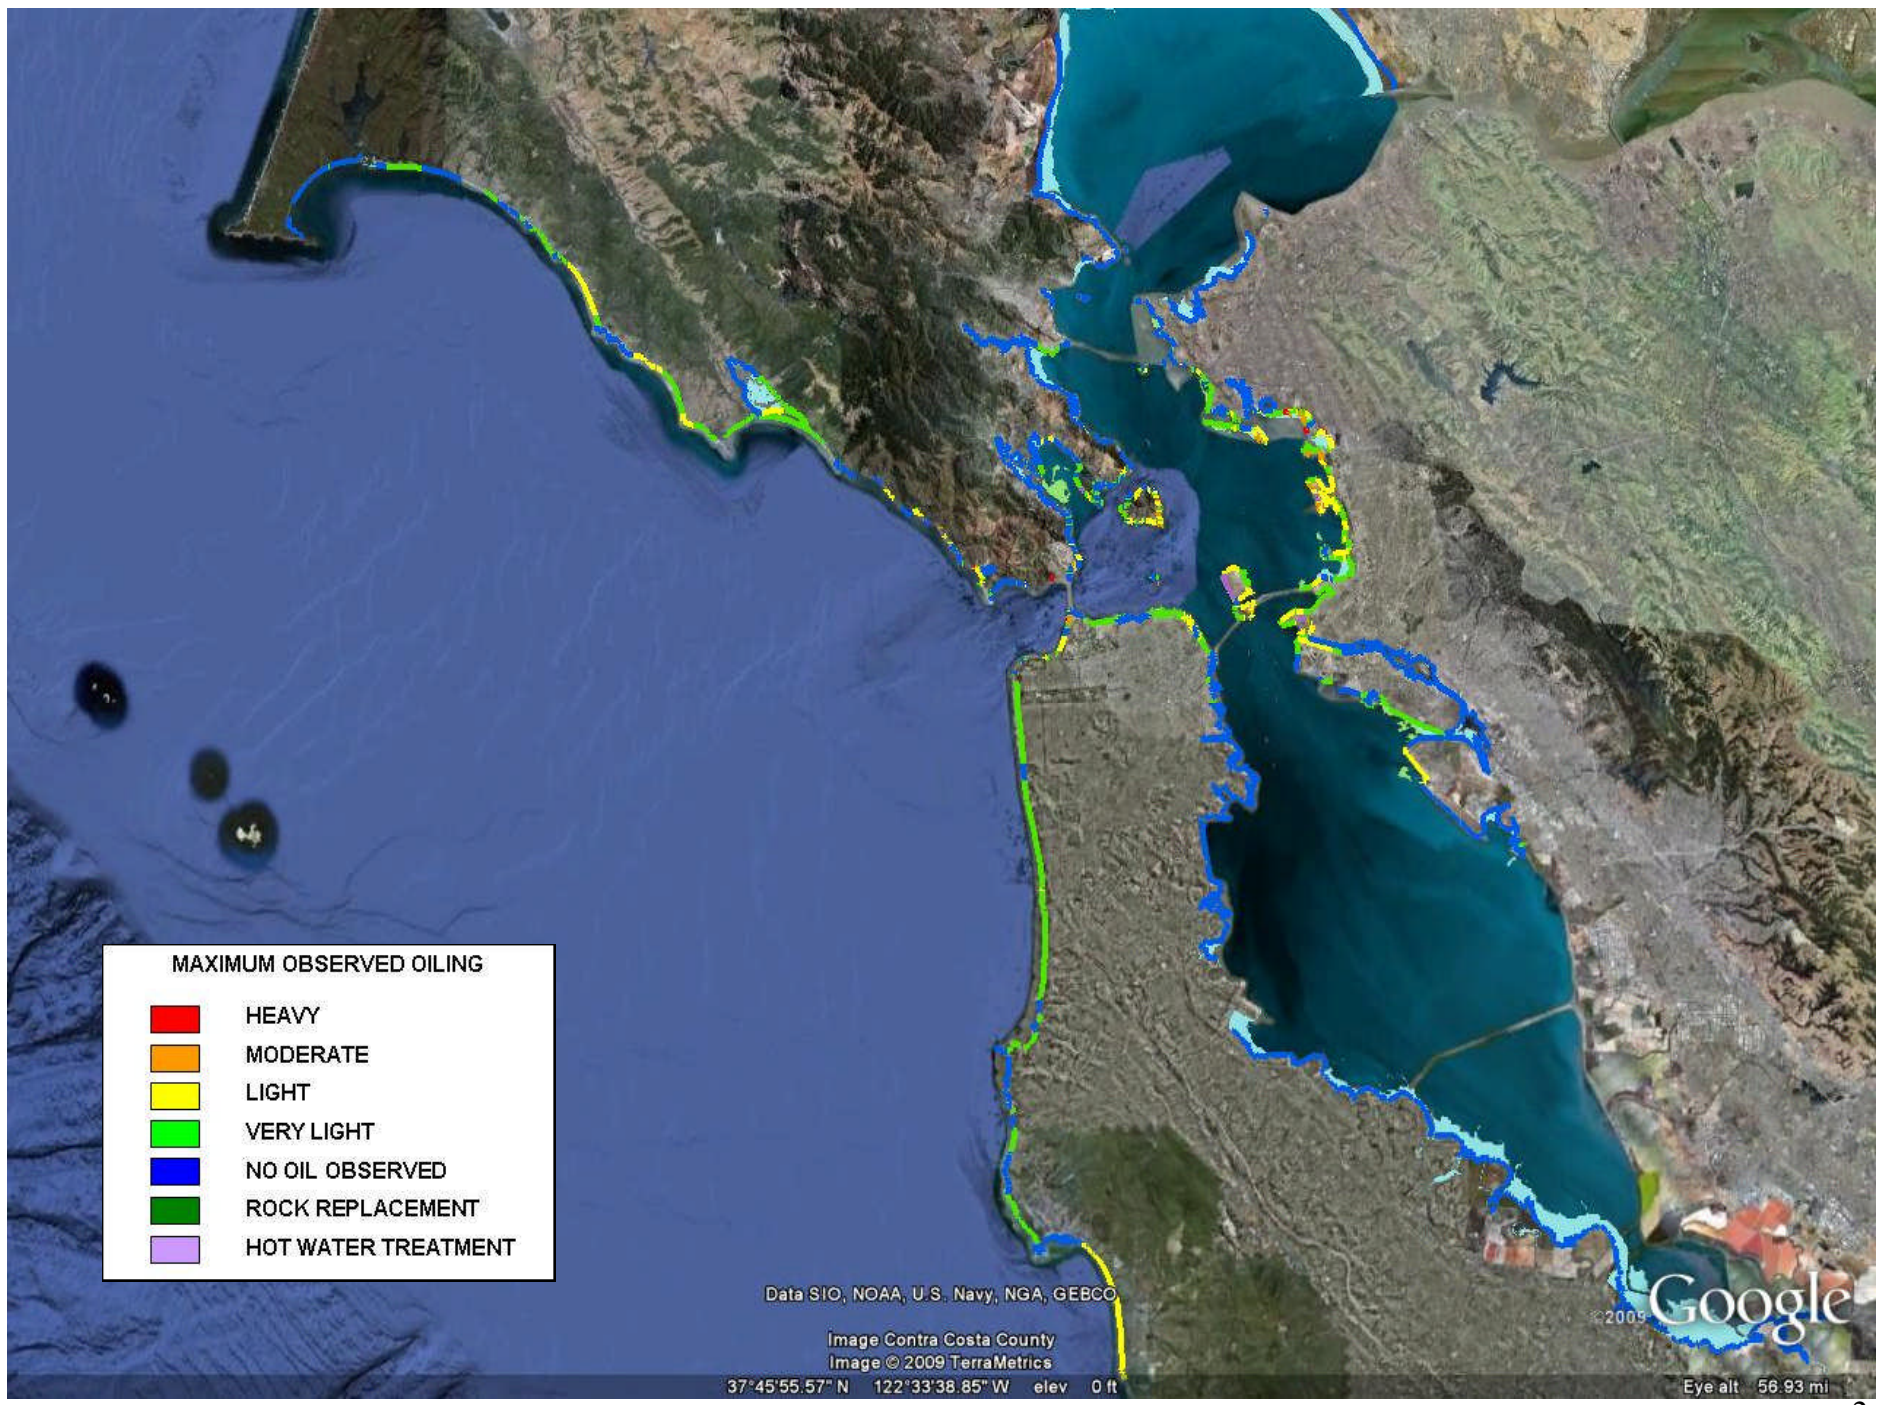
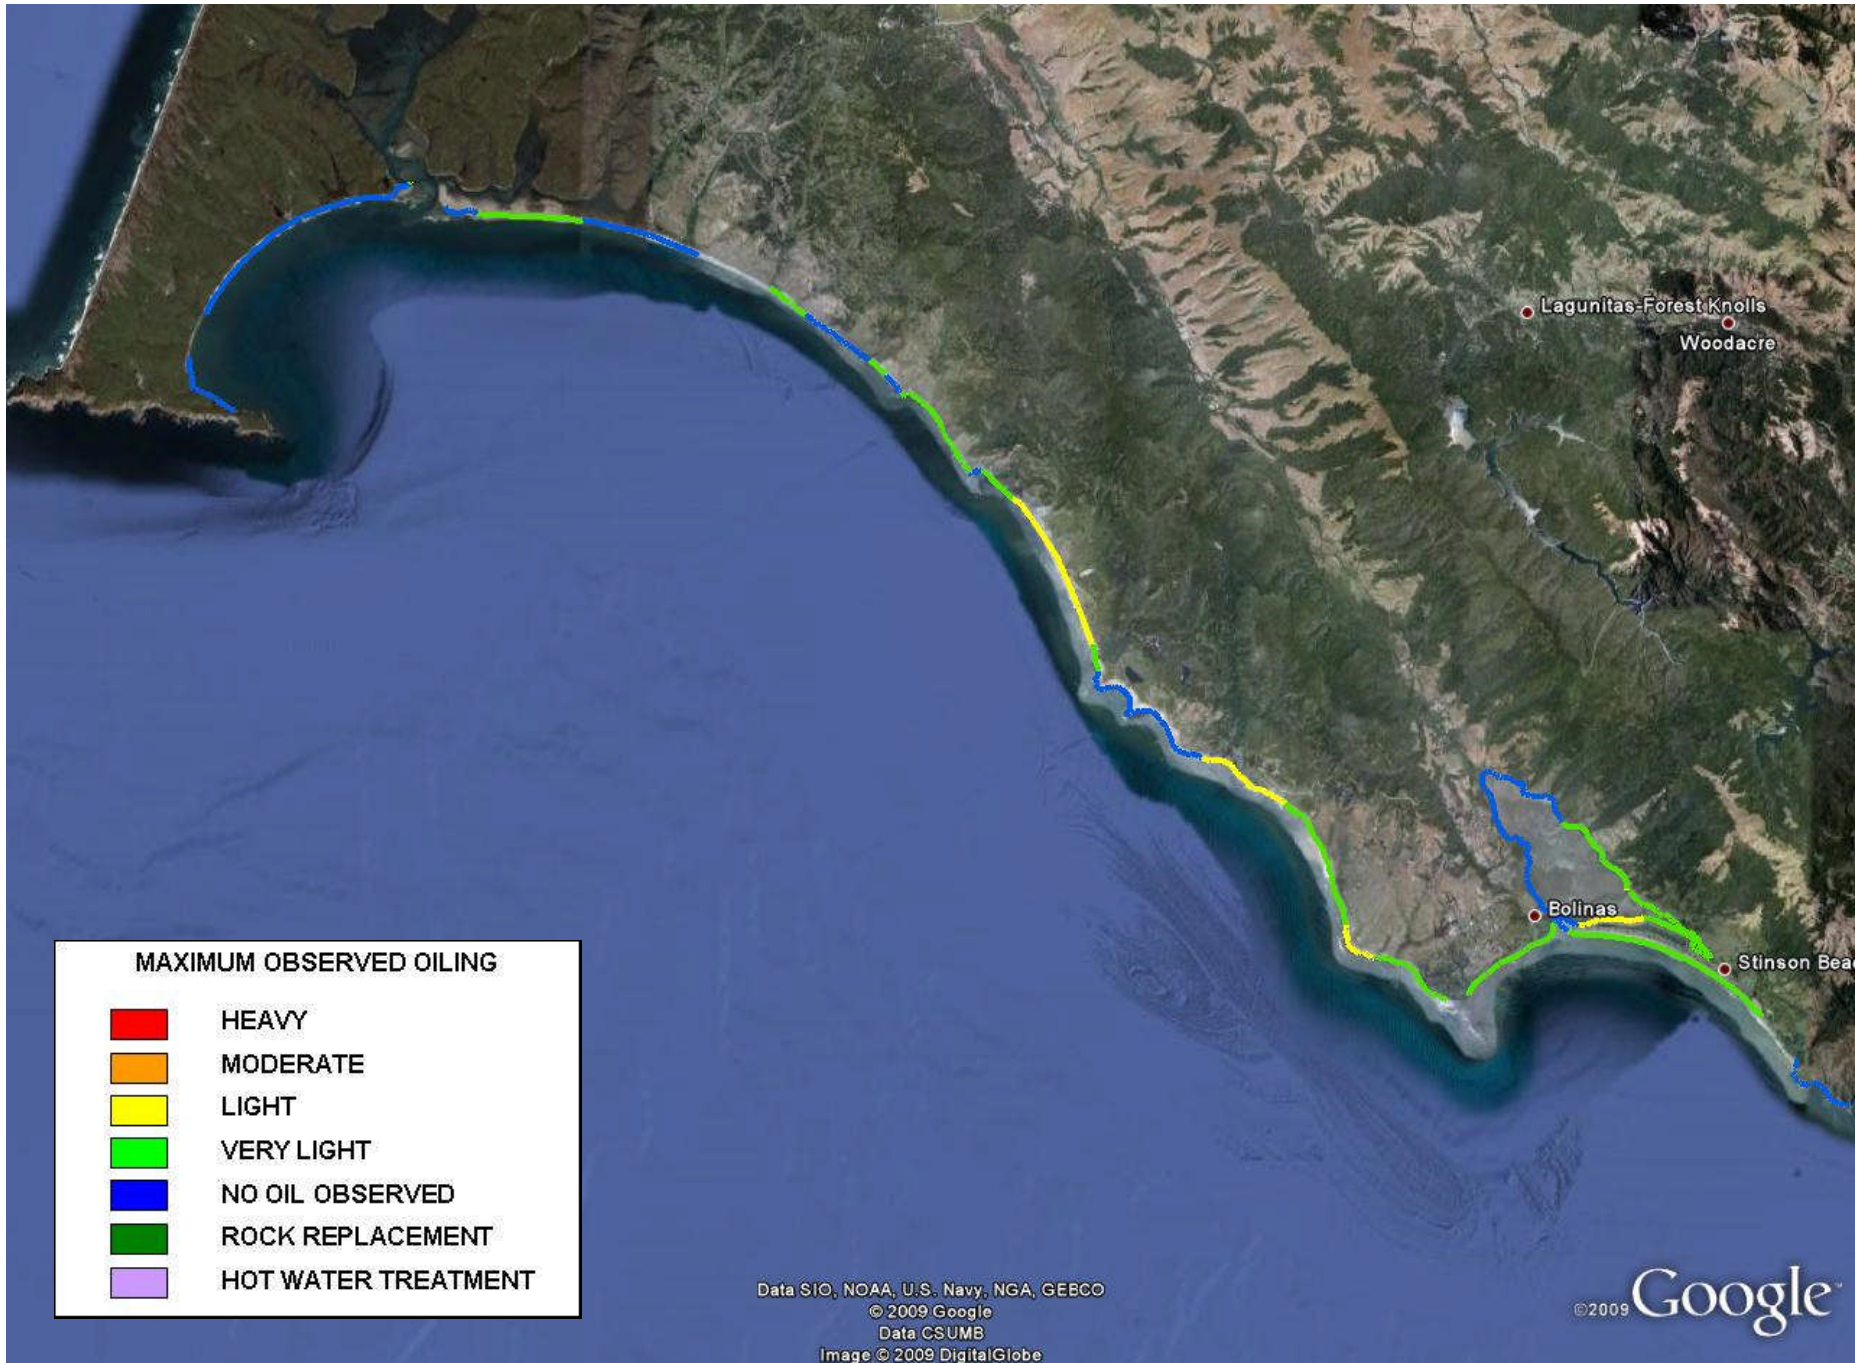
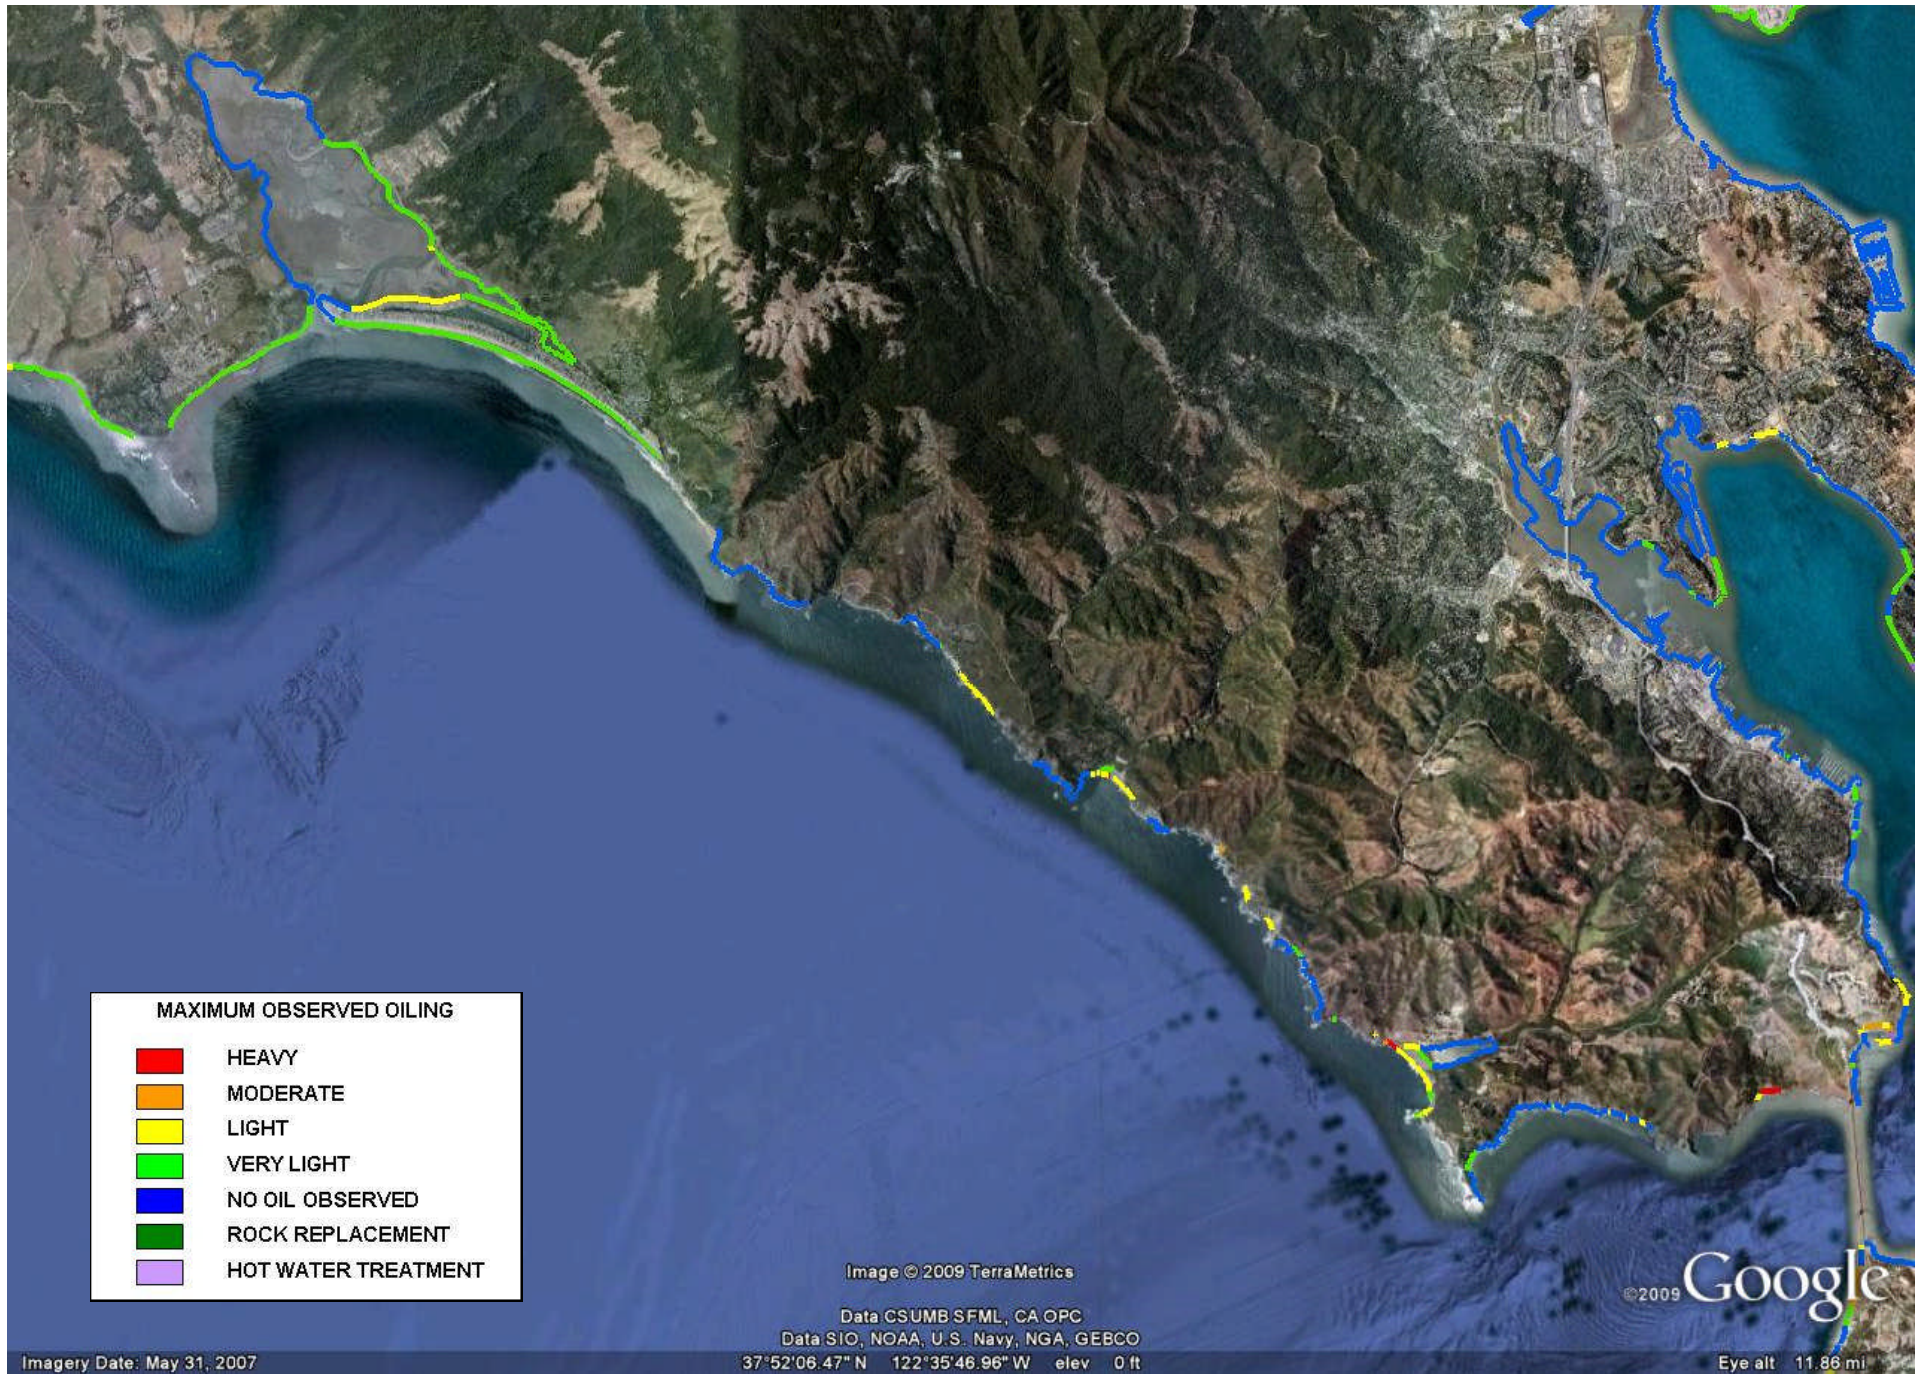
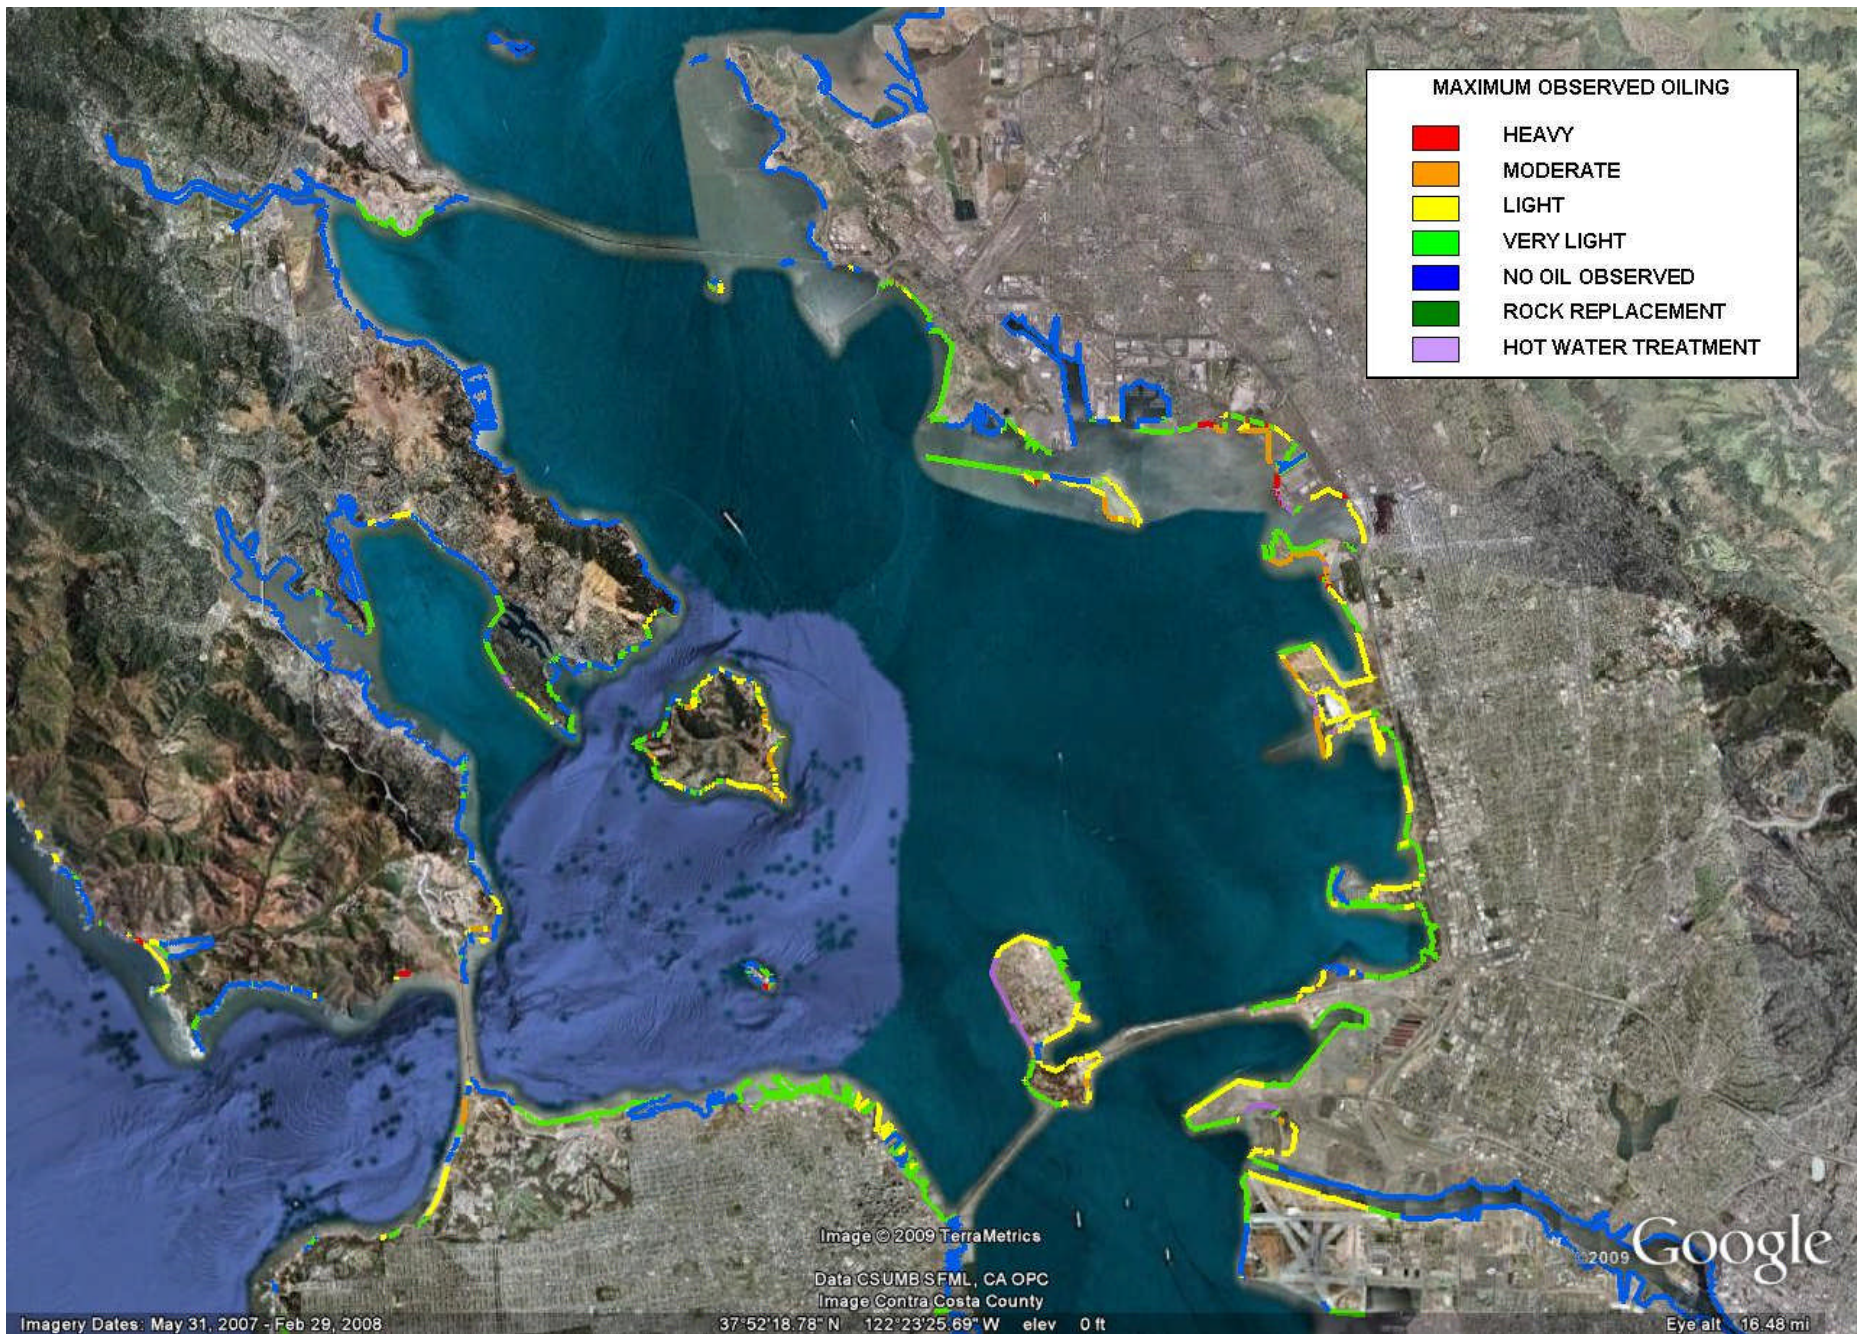
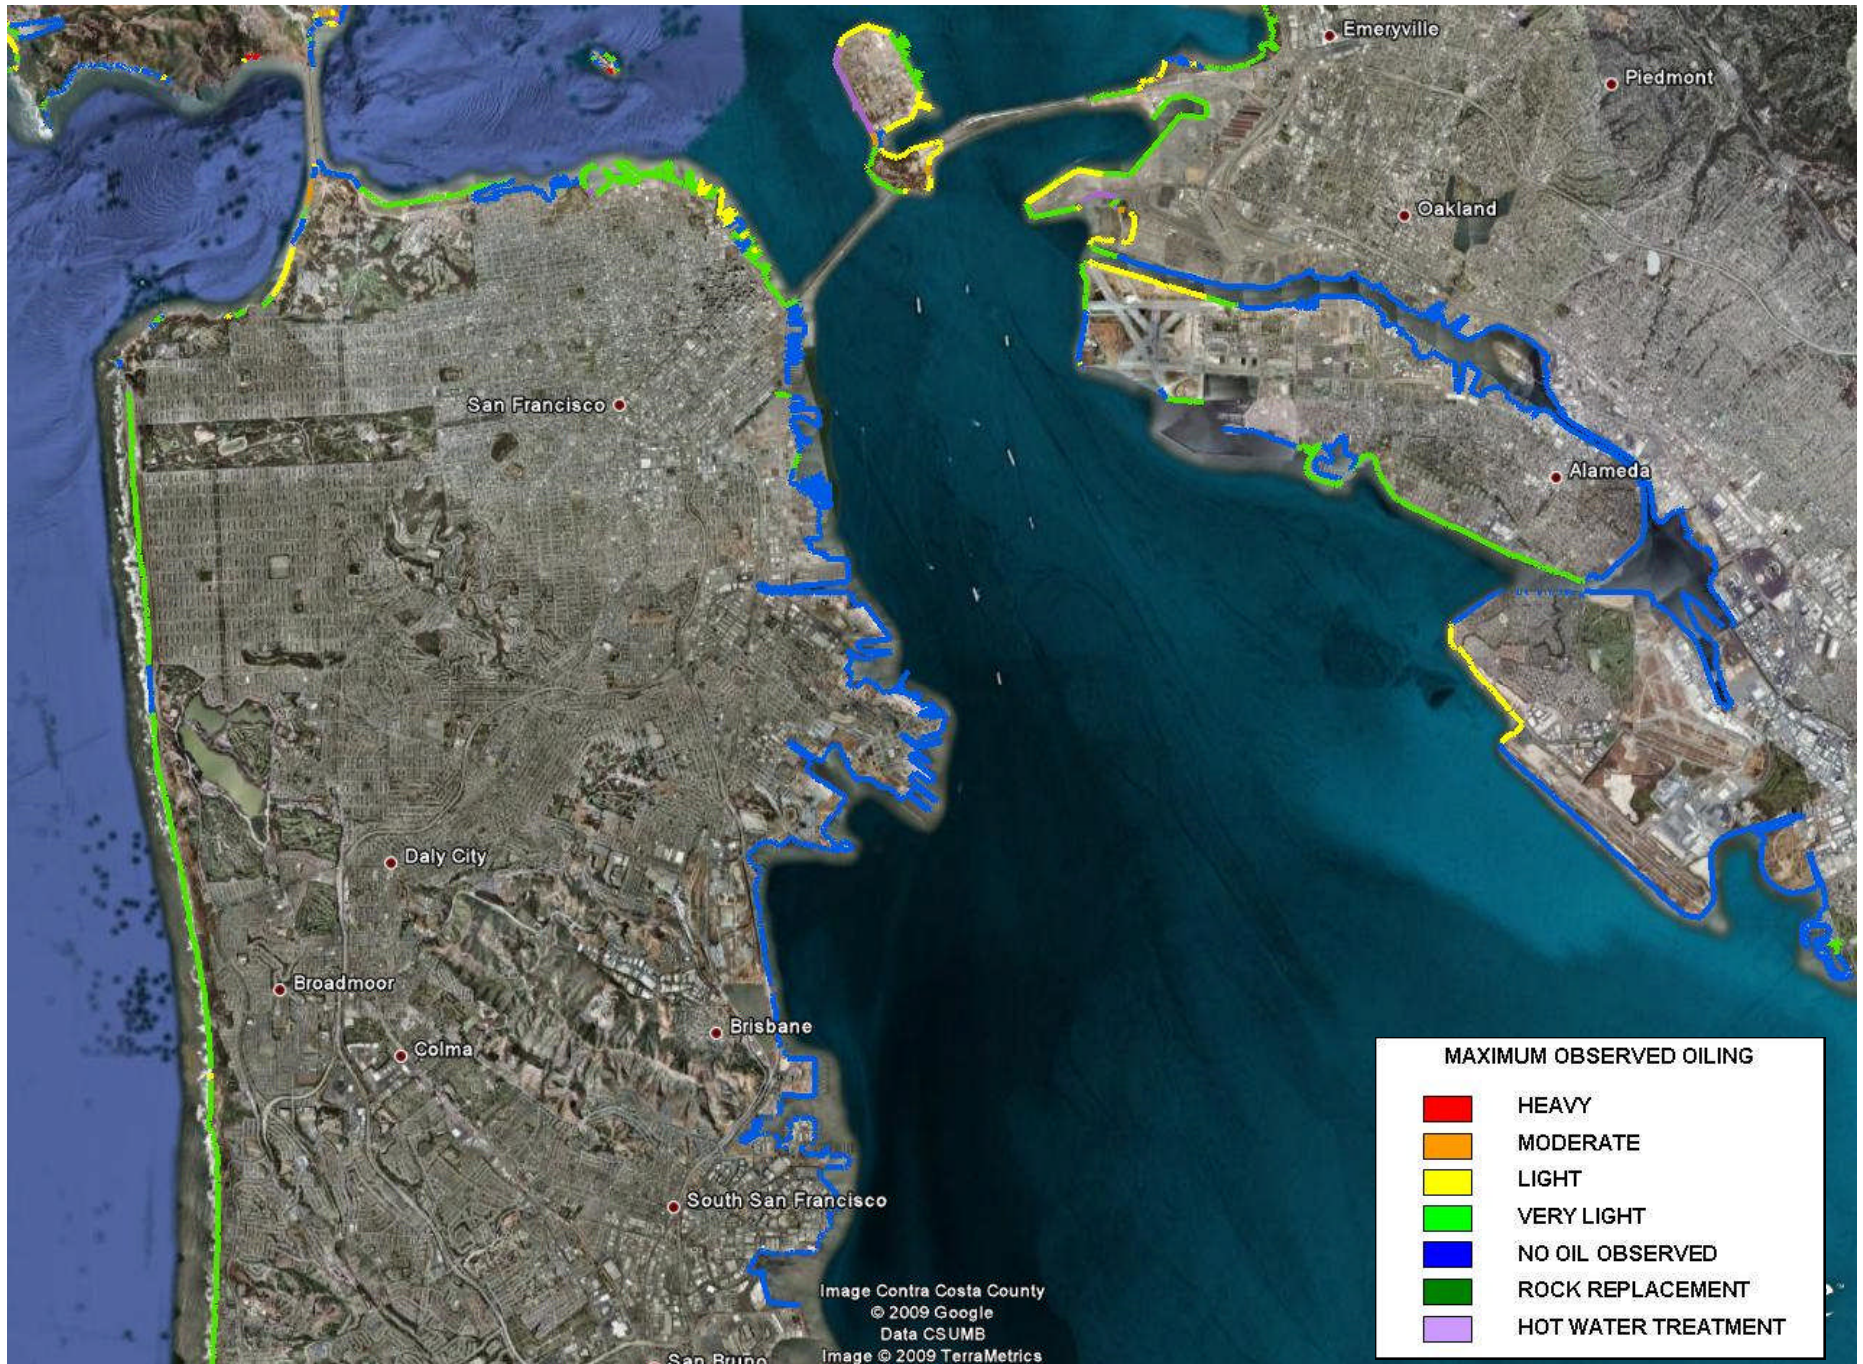
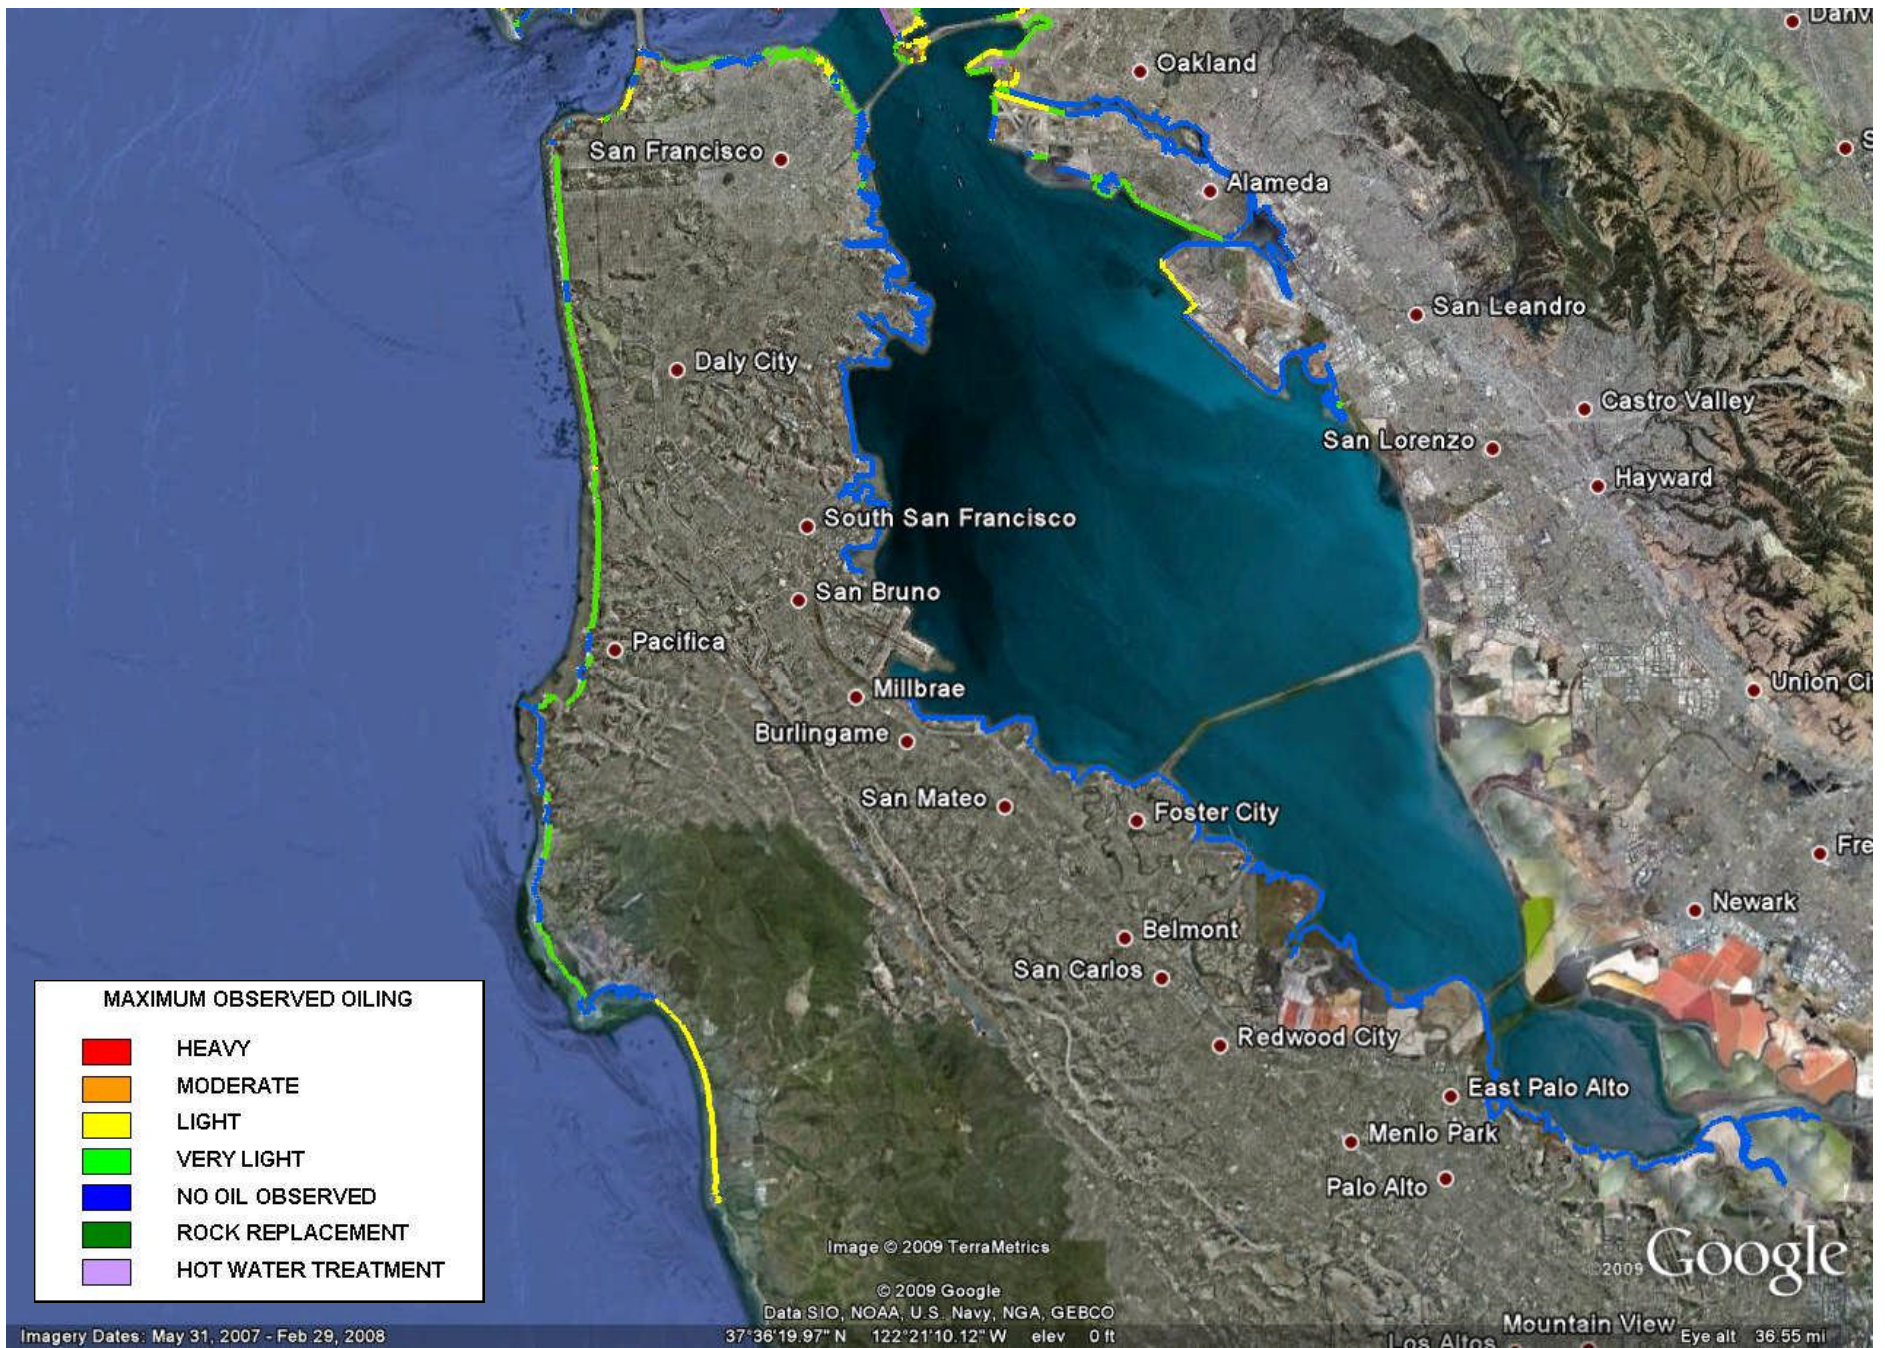
THE FOLLOWING IMAGES INDICATE SHORELINE AREAS AFFECTED BY THE COSCO BUSAN INCIDENT, INCLUDING OILING DOCUMENTED BY SHORELINE CLEANUP ASSESSMENT TEAMS (SCAT) AND AUGMENTED BY NRDA TEAMS, SHORELINES THAT WERE TREATED BY HOT-WATER CLEANING AND AREAS IN WHICH OILED ROCK WAS REPLACED.

THE IMAGES ALSO SHOW DEGREES OF OILING WHICH HAVE BEEN DETERMINED BY A COMBINATTON OF MATRICES, INCLUDING: WIDTH OF OILED AREA, OIL DISTRIBUTION, AND DEPTH OF PENETRATION OR THICKNESS OF OIL LENS IN ACCORDANCE WITH SCAT METHODOLOGY.
