# Common Problems Arising in the Installation of Accessible Pedestrian Signals

**June 2009**

Prepared by:  
Janet M. Barlow, COMS, Accessible Design for the Blind

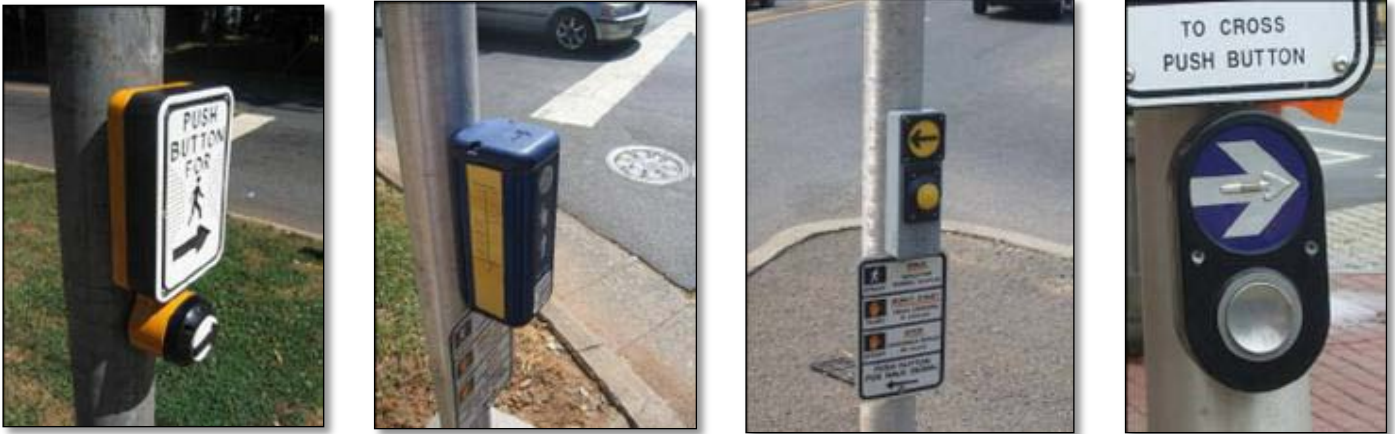
Figure 2: Examples of pushbutton-integrated APS from various manufacturers (left to right, Campbell, Prisma, Novax, Panich).

Figures 1 and 2 show several of the pushbutton-integrated APS devices that are available in the US. All include a pushbutton that is at least 50 mm (2 inches) in diameter, audible and vibrotactile WALK indications, a pushbutton locator tone, a tactile arrow, and automatic volume adjustment. Configuration, functioning, and adjustment methods vary somewhat by manufacturer. (See *Interfacing Accessible Pedestrian Signals with Traffic Signal Control Equipment*.)

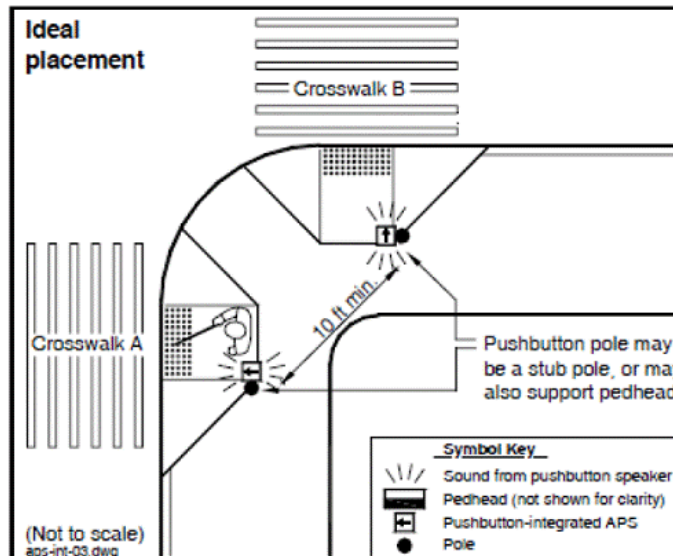
Figure 3: Optimal location of pushbutton-integrated APS - two pushbuttons on one corner, mounted on two separated poles – rapid tick WALK indication.

Pushbutton-integrated APS rely on relative proximity to the crossing location, not on difference in sounds, to clarify which street crossing is being signaled. Proposed MUTCD revisions and draft PROWAG, supported by recent research<sup>7</sup>, specify that each APS device shall be installed on a separate pole. Devices must be located a minimum of 3m (10 feet) apart, no more than 3m (10 feet) maximum from the curb line (and closer, if possible), and between the curb ramp landing and the outside crosswalk line, or no more than 1.5m (5 feet) maximum from the outside crosswalk line. See Figures 3 and 4 for illustrations of pushbutton locations.

*Remedy:* If possible, move the APS to separated poles, each close to the crosswalk it controls and indicates (see Figures 3 & 4).

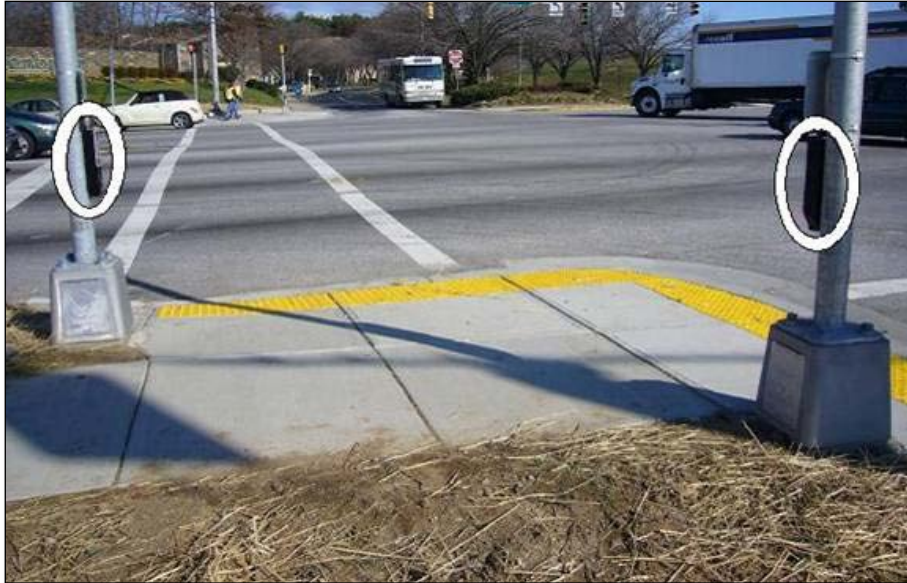
Figure 4: Installation of APS on two separated poles, aligned with crosswalk lines (APS devices circled)

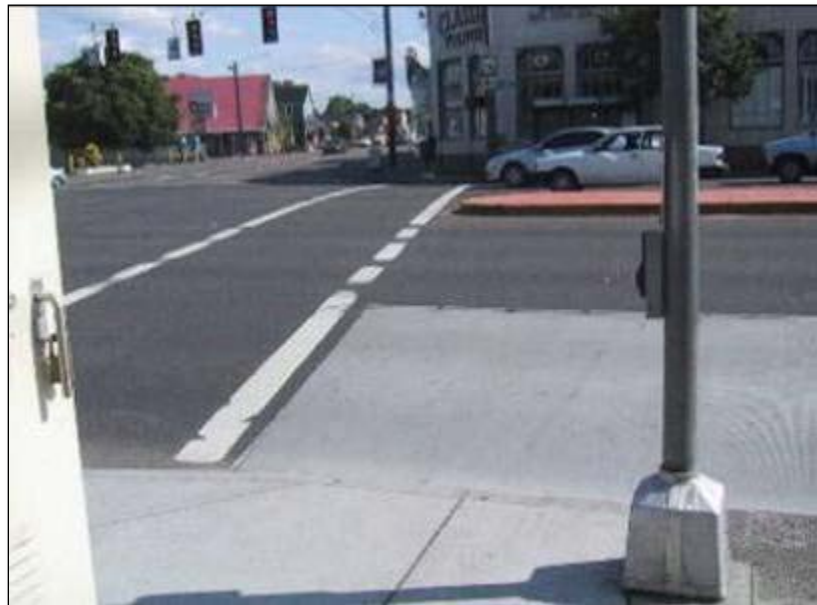
In the situation pictured in Figure 5, pedestrians who begin their crossing beside the pushbutton would be outside the crosswalk lines and may not be anticipated by turning drivers.

Figure 5: APS is located about 8 feet from the crosswalk and curb ramp landing.

Remedy: One solution is to move the pole closer to the crosswalk lines, so the device is in reach of the landing of the curb ramp and adjacent to the crosswalk.

This will assist pedestrians who are blind in finding the APS pushbutton and in beginning crossing from within the crosswalk area.

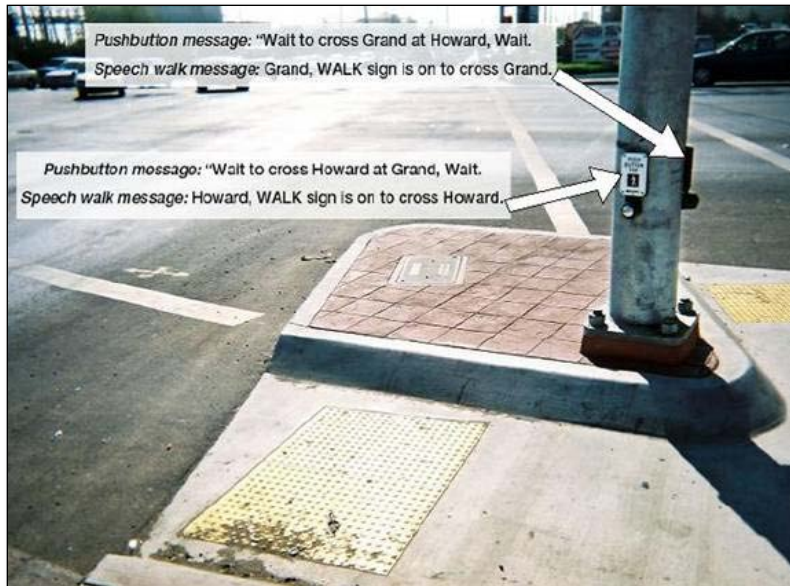
Figure 6: Example of pushbutton information messages and speech walk messages, if two APS must be mounted on the same pole Alterations only.

In Figure 6, it appears that the required APS separation (10 feet minimum) could have been achieved here by locating stub poles to the left side of the left ramp and the right side of the top crossing. That would have provided much less ambiguous information for pedestrians using these crossings. While a common pole can be made to work, it should not be the selected solution where separated poles are possible.

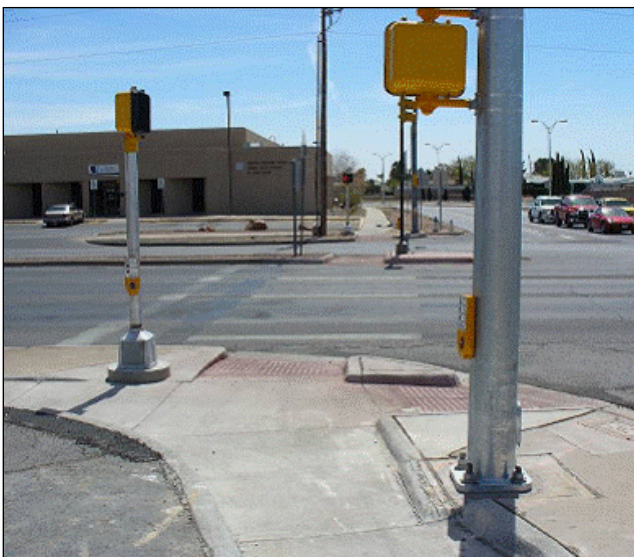
In Figure 7, APS have been installed on the wrong poles. The APS on the pole in the left of the photo has an arrow pointing toward the street on the right in the photo. Since the APS is closer to the departure curb and curb ramp for crossing straight ahead (in line with the photographer's direction of travel), a pedestrian hearing the sound from that APS would expect that the APS governs that crossing, and may not even be able to hear the further distant APS that is actually for the crossing he/she intends (in the foreground of Figure 7).

Figure 7: Installation where APS are installed in wrong locations; both are too far from street they control and will be heard as closer to the other street.

Remedy: Each APS should have been installed on the pole closest to the crosswalk it controls, as shown in Figure 8 (pushbutton for street on right is on the back side of the pole, out of view from photographer's angle). For example, the APS for the crossing on the right in Figure 7 should be installed on the pole near the right side of the photo, and on the side of the pole toward the curb ramp, but still reachable from the level sidewalk. This will allow pedestrians to push the button and then hear the APS at the crosswalk departure point. The APS on the pole to the left in Figure 7 should be installed parallel to the crosswalk that it controls (the one straight ahead in the photographer's view).

It may be possible to realign the APS on each pole and reconnect the wiring. However, APS can be wired to a control board in the pedestrian signal head or through the controller, so it may be necessary to move the pedestrian signal head (or to completely rewire each APS) to conform. The wiring and device output needs to be checked after modification to assure that the APS is signaling the correct crossing phase.

If the APS has a speech message, the APS needs to be moved to the pole closer to the crosswalk it signals, which will also require reversing the arrow and signs on the APS housing. If speech WALK messages or pushbutton information messages are installed, the functioning and accuracy of both should be checked after re-installation of APS devices.

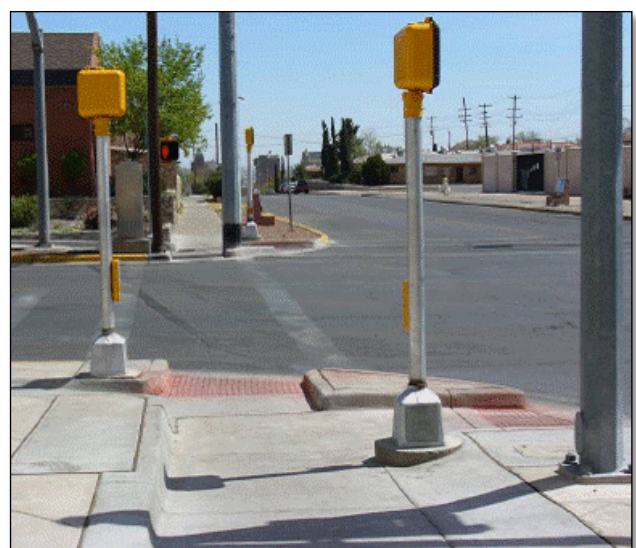
Figure 8: Installation where APS are installed in correct locations in relation to crosswalks.

Installation of the APS on a stub pole or separate pedestrian signal pole, as shown in Figure 8, rather than on a mast arm pole, is likely to provide better placement.

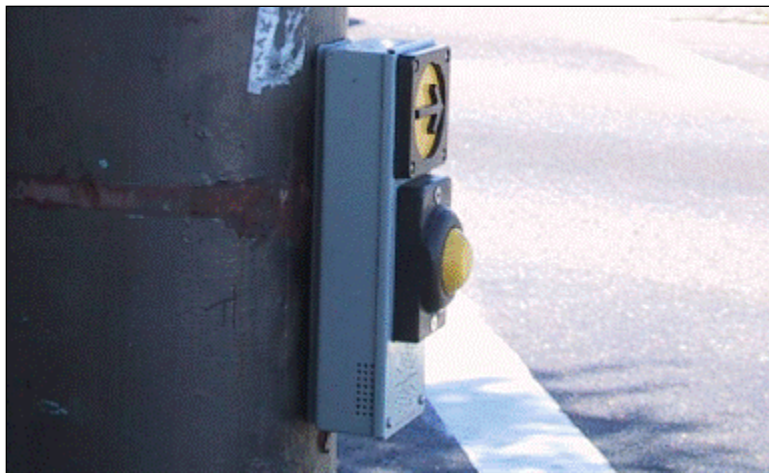
**Figure 9: Tactile arrow not aligned with crosswalk direction.**

Misleading wayfinding information will be conveyed if the tactile arrow is oriented toward the center of the intersection, rather than parallel to the crosswalk. In the photo below (Figure 9), the arrow is out of alignment with the crosswalk direction. Even small misalignments can inadvertently direct a blind pedestrian outside the crosswalk area or into the parallel traffic.

Remedy: The APS needs to be removed and reinstalled. The arrow must be aligned with the direction of travel on the crosswalk.<sup>19</sup>

Since the tactile arrow is on the face of the device or on the pushbutton, the APS mounting affects arrow alignment. If the needed adjustment is minor, it may be possible to shim behind one side of the device to align the arrow with the crosswalk. In other cases, it may be necessary to drill new mounting holes and reposition the APS on the pole. The arrow should be aligned as shown in Figure 10.

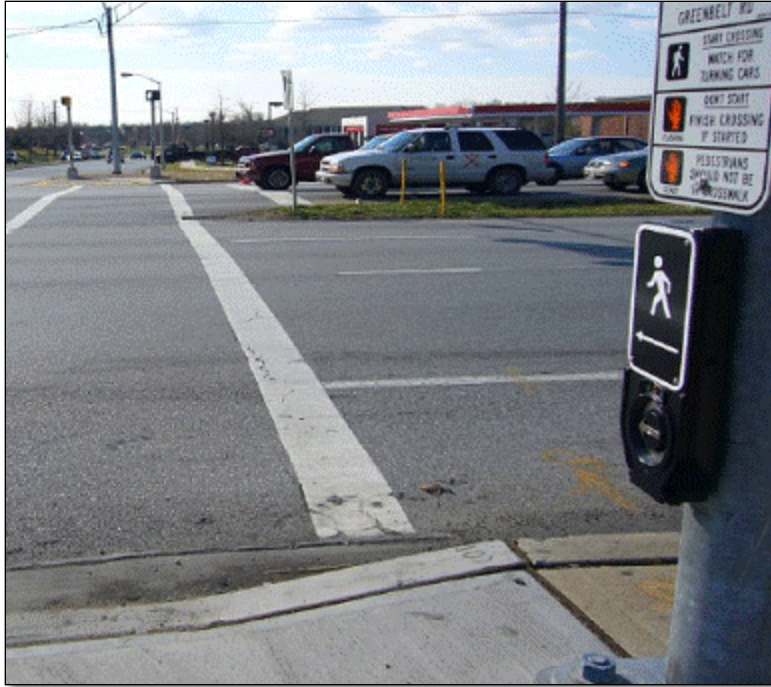
Figure 10: Location where tactile arrow is aligned with direction of travel on the crosswalk.

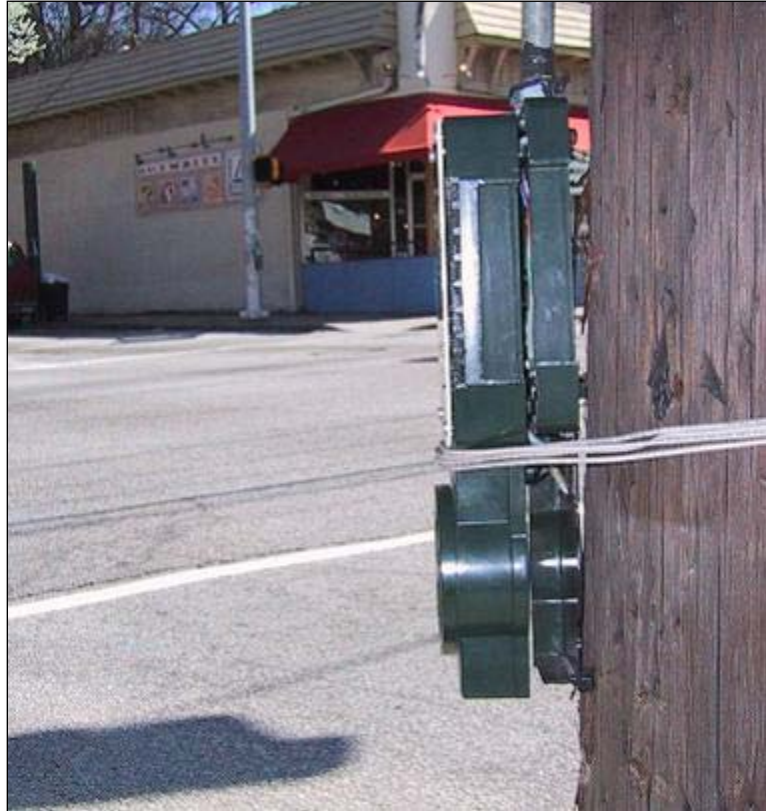
Figure 11: APS that was damaged in a crash and temporarily reinstated with wire.

In another situation, shown in Figure 11, the APS was temporarily reinstalled, still functioning, but oriented incorrectly. It was several weeks before a crew reinstalled it properly. Meanwhile it provided inaccurate information. When the APS is not correctly installed, there is a risk that a person who is blind will cross a street with the wrong WALK indication or in the wrong direction.

Remedy: All maintenance personnel need to know enough about APS installations to recognize an APS, and to either call someone to check details of reinstallation, or to correctly re-install the APS themselves. Training is needed to avoid dangerous errors in reinstallation or repair.

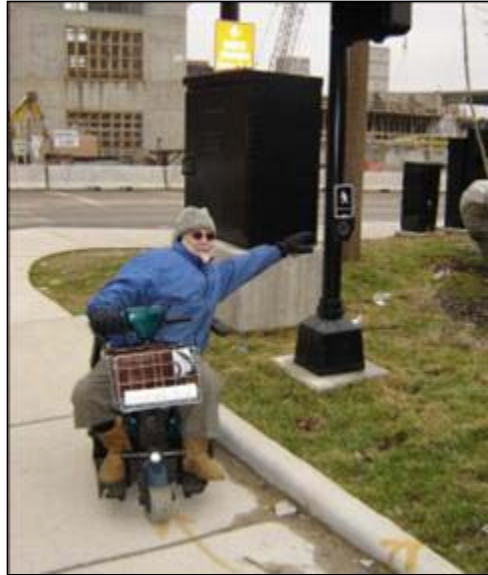
**Figure 12: In this new construction, APS is located too far from the sidewalk to be reached by a user of a wheelchair or scooter.**

APS devices can be located in landscaped areas if the pushbutton is reachable from a level paved area. Figure 12 shows a location where new APS (and new sidewalks) were installed, but the APS are not usable. Besides the inaccessibility for wheelchair users, a person who is blind will have difficulty finding and getting to the pushbutton, even with the pushbutton locator tone sounding.

Remedy: Installation in landscaped areas must be carefully planned and monitored for accessibility. APS should be within the reach range (1.2 m/48 inches vertically, .25m/10 inches horizontally) for an individual who uses a wheelchair.<sup>20</sup> The APS shown in Figure 13 are appropriately located within the landscape strip, reachable from a paved level surface, and aligned with the crosswalk lines.

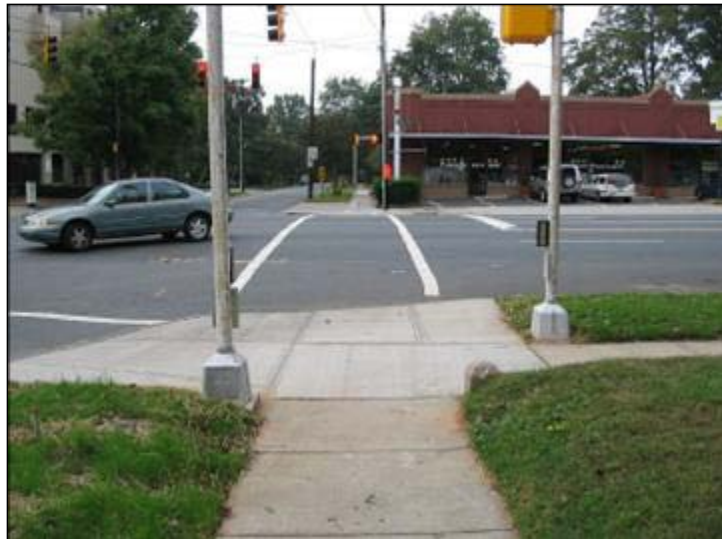
**Figure 13: APS installed on poles in the landscape strip, and still within reach from a level paved sidewalk surface.**

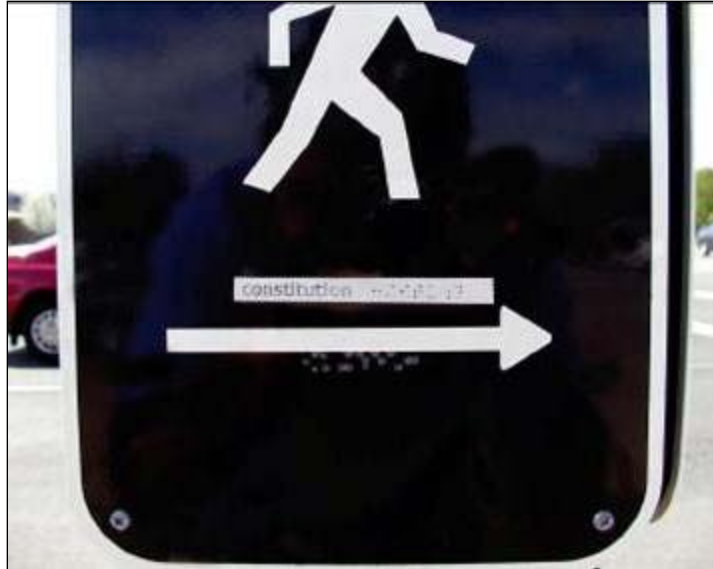
**Figure 14: Braille sign installed backwards, with manufacturers' label showing. Label includes street name and print of how Braille should look. Braille beneath arrow is backwards version of the print version shown on label and is indented, rather than raised.**

Where the APS device includes the street name in Braille, care must be taken to install the signs in the correct location and orientation.

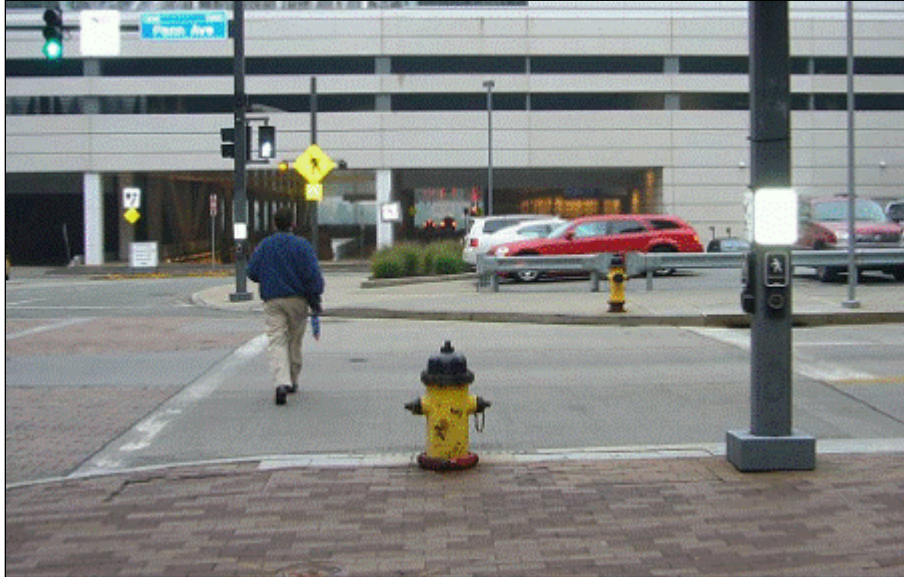
Figure 15: APS is located on mast arm pole more than 10 feet outside the crosswalk lines. In addition, a fire hydrant is between the crosswalk location (and the curb ramp) and the APS.

By installing APS on existing poles without careful evaluation of usability and function, jurisdictions may be obviating the benefits such devices provide. In the location shown in Figure 15 (a pre-timed intersection), the APS was installed on the available mast arm pole, resulting in an installation in which the APS volume had to be set to be quite loud in order to be heard at the crosswalk and where using the tactile arrow and vibrotactile WALK indication could result in a hazardous crossing.

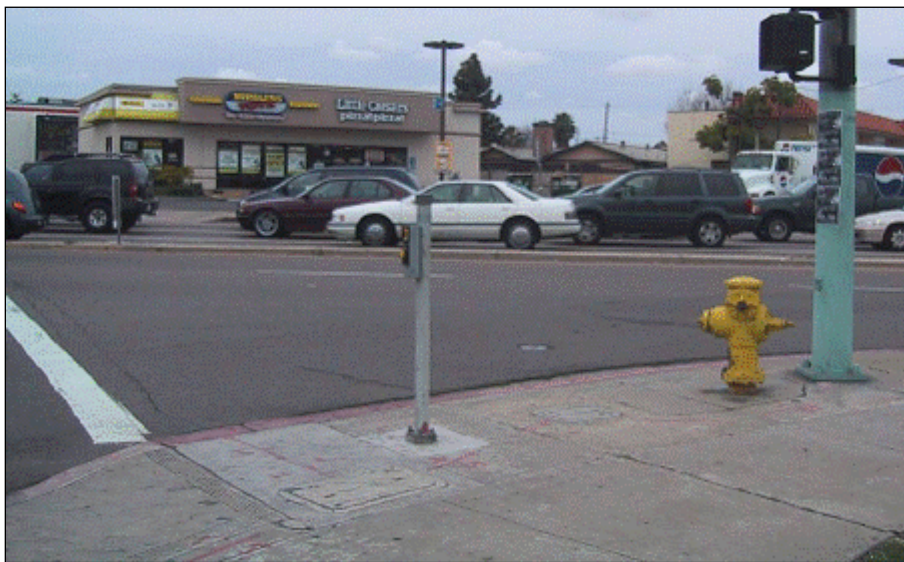
Figure 16: Stub pole was installed to locate APS near the crosswalk.

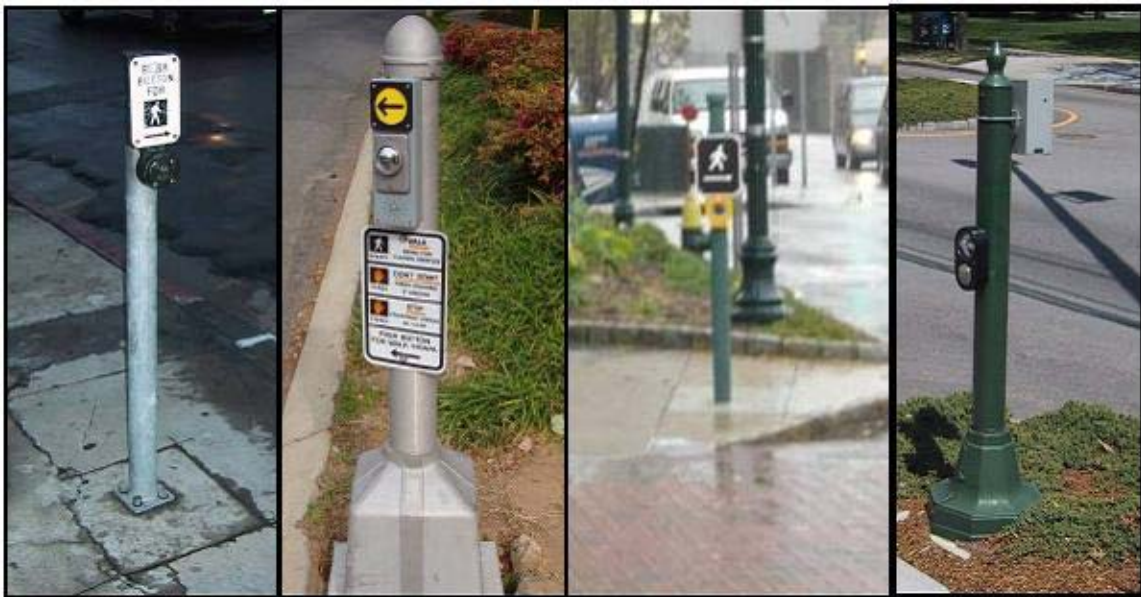
Figure 17: Examples of stub poles – different materials and installation.

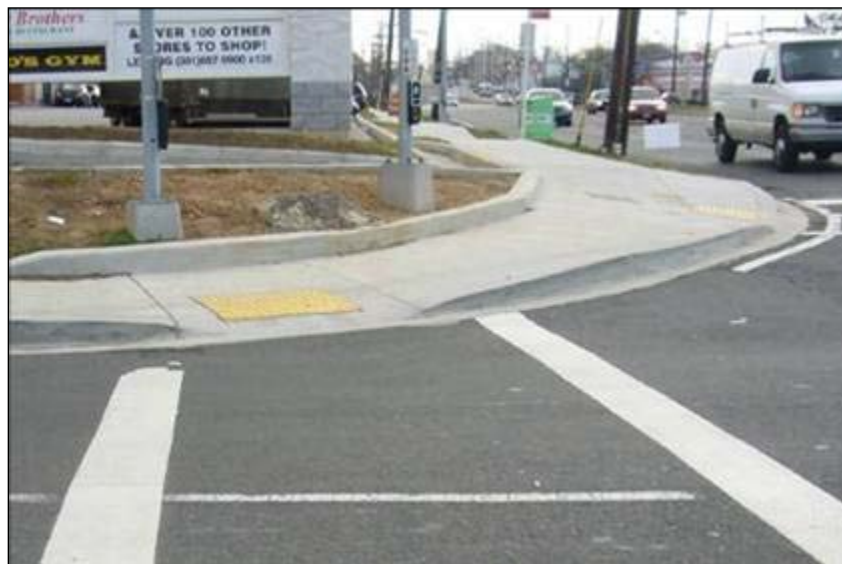
**Figure 18: APS and curb ramps that were not installed as designed.**

The APS to cross the street that is on the right in Figure 18 is not located according to the plans and the arrow points to the curb ramp, rather than being aligned with the direction of travel on the crosswalk. The poor location is more easily seen in Figure 19, taken from across the street. A red circle highlights where the pedestrian signal pole was supposed to be installed.

By the time the designer saw the installation, however, and noted the lack of compliance with specifications and with ADA requirements, the inspector had signed off on the job. The contractor and inspector both need to understand APS installation and use before making decisions in the field about revisions to plans.

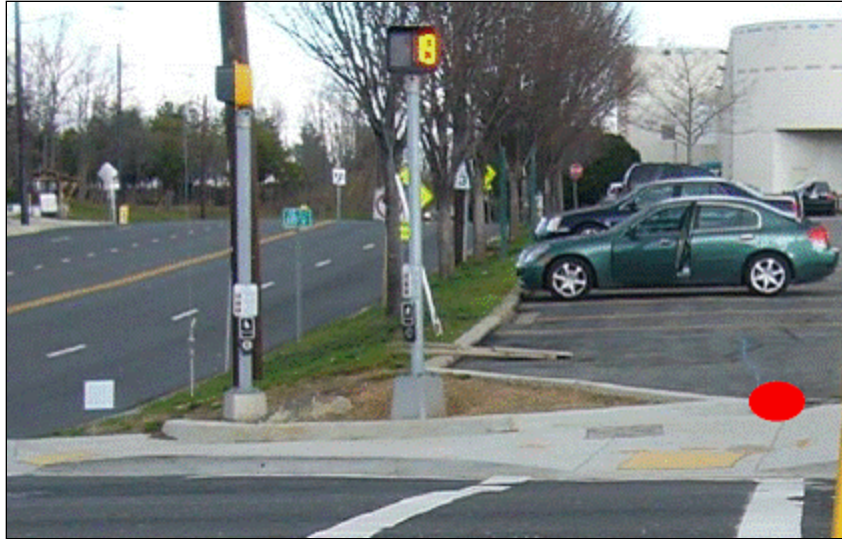
Figure 19: Another view of the same corner. Note shifting slopes and cross slopes on the ramps in addition to poor APS location.

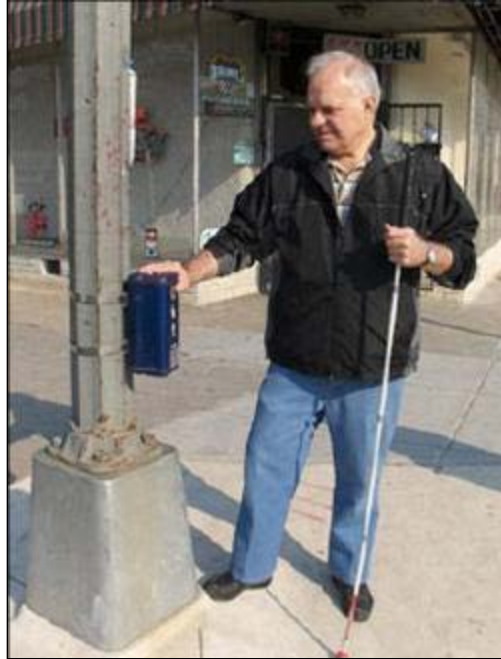
**Figure 20: Deaf-blind user stands with his hand on the original APS to feel the vibration in order to know when to begin to cross.**

Eventually, the pedestrian and the DOT signal technicians arranged to meet at the site. Demonstrating the APS, the technician said: "See? The button ticks so you know it's there. When you press the button, the light comes on to let you know that it's working. When the WALK signal begins, you hear a fast ticking sound". After the interpreter signed that information in the pedestrian's palm, the user shook his head sadly and signed back: "I am 100% deaf. I am 100% blind. I need the signal to vibrate." The vibrotactile feature on the APS was not working and the technicians hadn't noticed. (See figure 20).

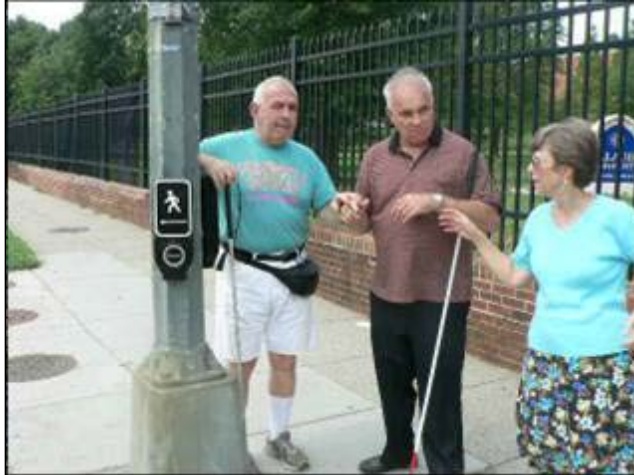
**Figure 21: Orientation and mobility specialist explains the APS to two individuals who will be crossing there (two APS on same pole). One crossing is a few feet to the left of the photo; the other is approximately 20 feet to the right, straight ahead of individual standing with his arm on top of the APS.**

On the other corner, APS for the two different crossings were both installed on one pole, as shown in figure 21 and 22. The distance to the crossing (on crosswalk A) results in other problems. While there, it was noted that the Flashing Don't Walk (FDW) signal also was extremely short – so short (3 seconds) that it was possible for a pedestrian to leave the pushbutton and prepare to cross the street while the vibrotactile indication was still active, but step into the street after the FDW had ended.

This timing issue is complicated by the fact that the pedestrian pushbutton for THIS crossing is well over 10 feet from the street (see figures 21 and 22). It takes this deaf-blind pedestrian nine seconds to get to the crosswalk after detecting the vibrotactile signal. After he arrives at the departure curb, it takes him 18 more seconds to complete the crossing.

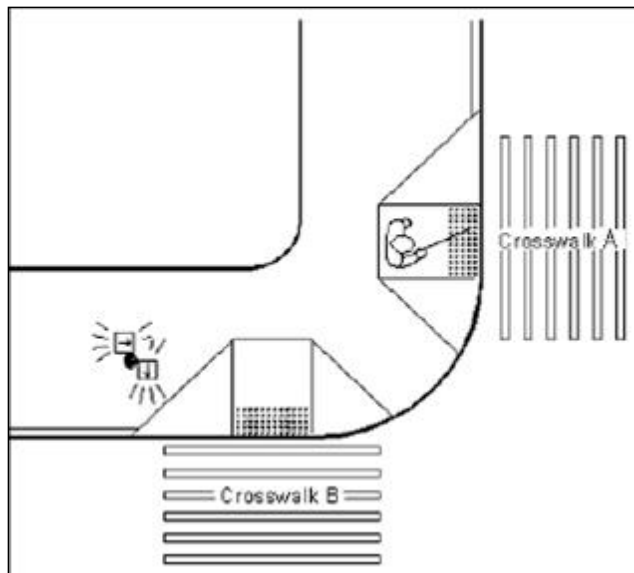
**Figure 22: When two APS are mounted on an existing signal pole, one is poorly located. The pushbutton for crosswalk B is near the crosswalk, but the pushbutton (and vibrotactile arrow) for crosswalk A is a long way from the crosswalk.**
