FINAL REPORT

Archaeological Investigations at the Commercial Pacific Cable Company Station and Marine Barracks, Midway Atoll National Wildlife Refuge

March 2012

PACIFIC CONSULTING SERVICES, INC.

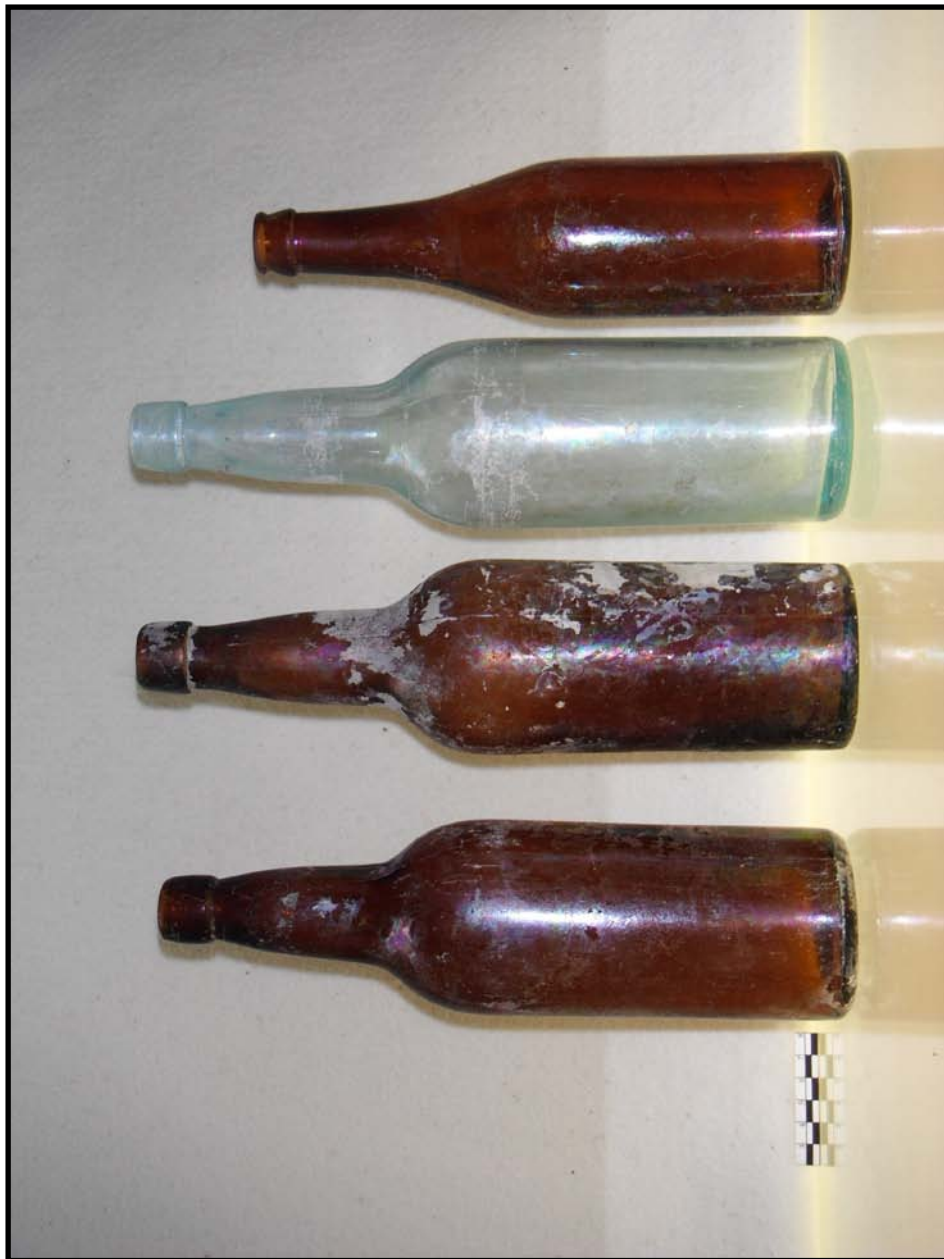
Figure 28. Photograph of Beer Bottles: Types 1, 2, 3, and 4 (L to R).

Type 1 is a mold blown, hand-finished, amber beer bottle (Figure 28). Ten examples are present in the collection: two were recovered in TU-2, Feature 2; and eight were recovered from TU-2, Feature 3 (Table 2). Nine of the examples are complete (Table 2, Artifacts 1-7, 9 and 10) and one example (Artifact 8) is missing the neck and finish. The bottles are relatively thick-walled and fashioned from amber glass with numerous small and large bubbles and occasional inclusions. The base profile is round; corresponding to variety 3.20 described by Fike (1987:10). These bottles have a cylindrical body, rounded shoulders and a slightly convex, tapering neck. The base of Type 1 consistently measures 7.60 cm (3 in) in diameter. The nine complete examples of Type 1 vary slightly from 28.5 cm to 28.7 cm (about 10.5 in) in height. These bottles were individually hand-blown into a three- piece, post mold and the finish was hand crafted with a lipping tool.

Type 1 was blown into a post-bottom mold. Bottles blown into a post mold exhibit mold seams which extend from below the finish, down the sides to a circular seam on the bottom of the bottle symmetrical with the bottle base (Toulouse 1969:587; Munsey 1970:38-50). Molds of this type were in general use between ca. 1880 and 1910, by 1917 these manufacturing techniques had been universally replaced by the automatic bottle machine (James 1956:17-18). Type 1 is finished with a simple ring type finish described by Fike (1987:8) as type 2.8. This finish consists of a collar about 2.0 cm (.8 in) in height which has been applied to the neck of the bottle with a lipping tool. Closures of this type were sealed by a cork which was held in place by a wire which passed over the top of the bottle and tied around the base of the collar (Munsey 1970:118).

Type 2 is a mold blown, hand-finished, amber beer bottle similar in description to Type 1 (see Figure 28). One example (Table 2, Artifact 11) is represented in the assemblage which was recovered from TU-2, Feature 3 (Table 2). The bottle is fashioned from amber glass exhibiting small and large bubbles and occasional inclusions. The base profile is round; corresponding to variety 3.20 as described by Fike (1987:10). The bottle has a cylindrical body, rounded shoulders and a slightly convex, tapering neck. The bottle measures 7.60 cm (3 in) in diameter and 29.0 cm (about 10.5 in) in height (see Figure 28). This bottle was blown into a three- piece, post mold and the finish was hand crafted with a lipping tool. The bottle exhibits a simple ring type finish (see Fike 1987:8 type 2.8) consisting of a collar about 2.0 cm (.8 in) in height which has been applied to the neck of the bottle with a lipping tool. This bottle was closed with a cork which was held in place by a wire tied around the base of the collar (see Munsey 1970:118).

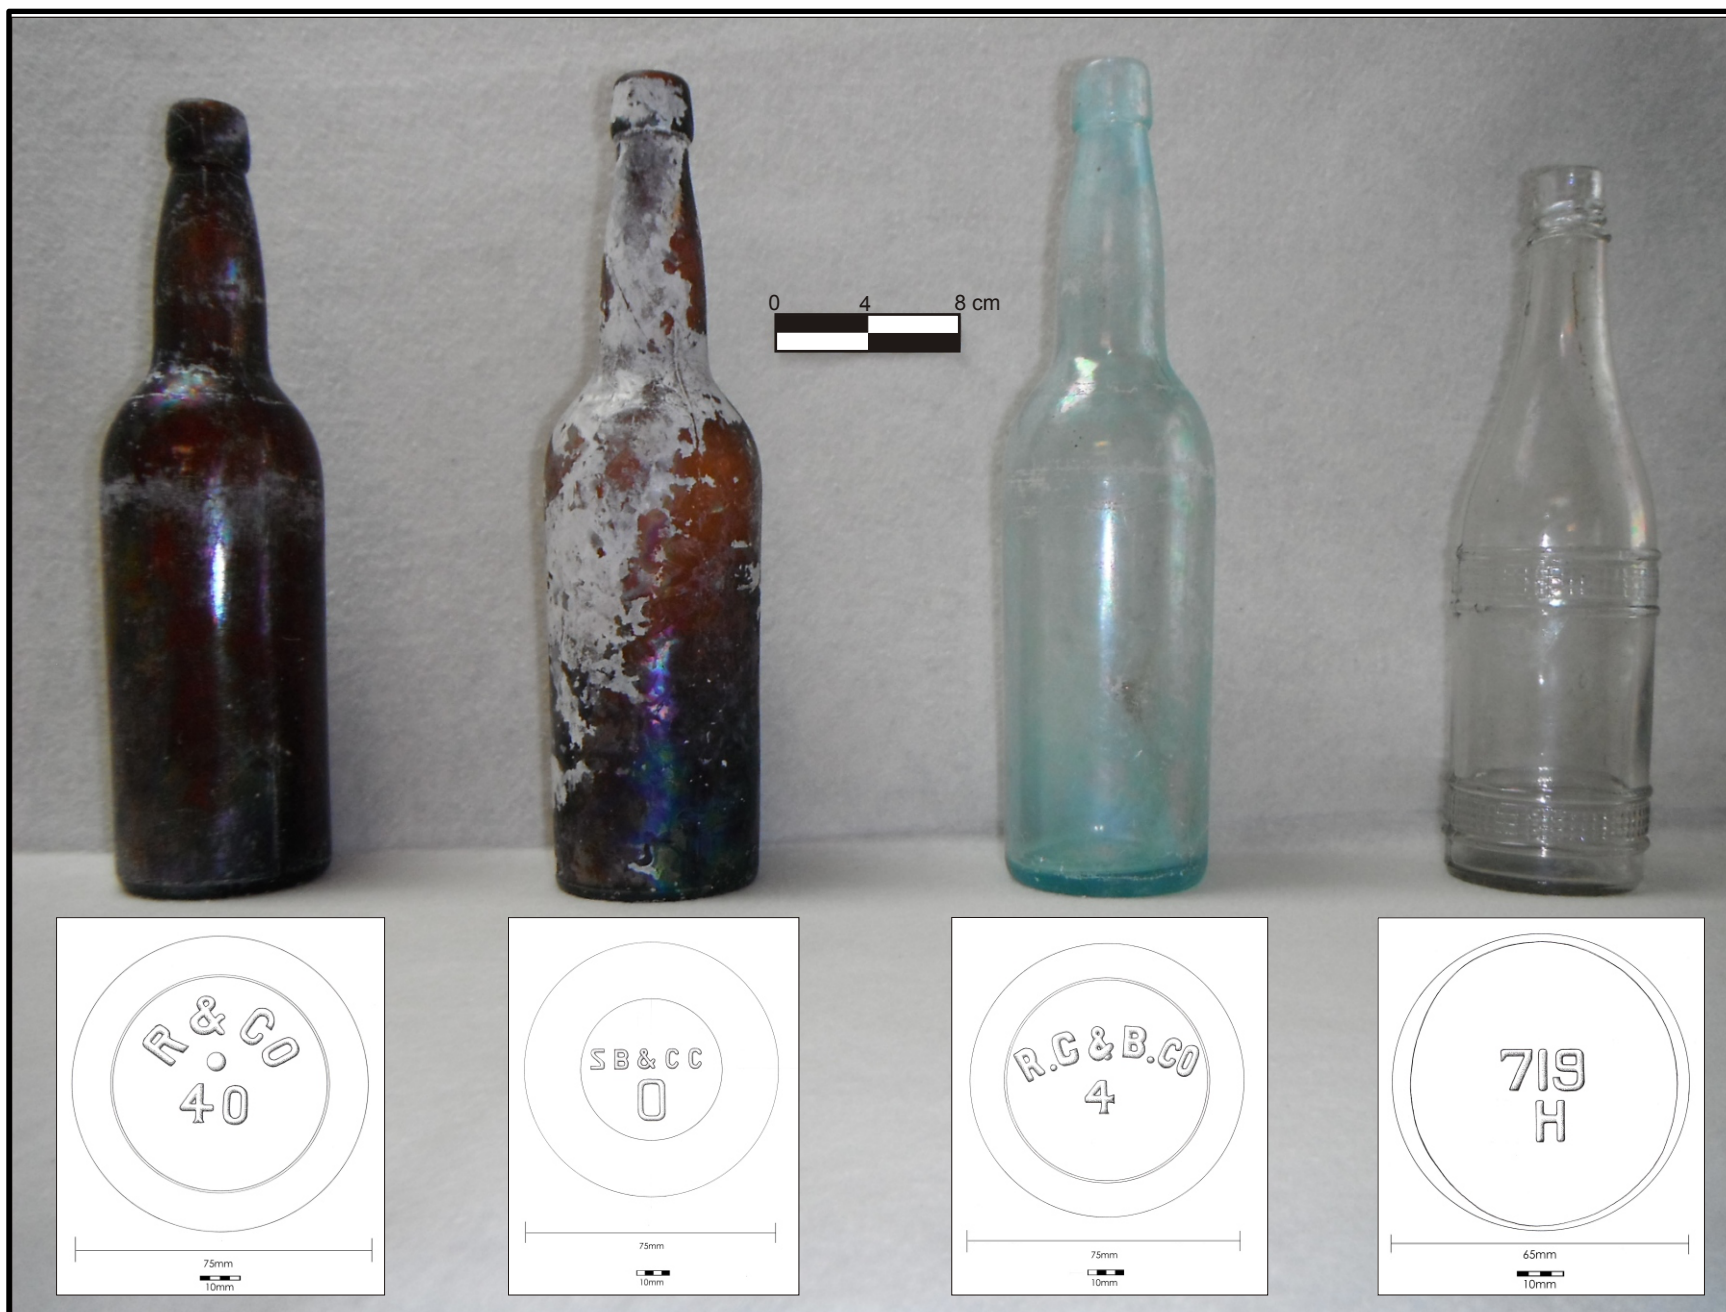
Figure 29. Photograph and Drawings of Bottle Makers Mark Types (from left to right) 1,2,3, and 9.

All of the Type 1 bottles carry the makers mark "R & CO" on the base of the bottle along with a number, ranging from 28 to 40 which probably represent the mold number (Figure 29). Toulouse (1971:439) states that the user of the "R & CO" maker mark remains unknown but is found on export beers exhibiting 1880 to 1900 manufacturing techniques. "Most of the bottles carrying this identification are amber, although some are green and aqua. Most are made with a post mold and all are hand-finished for cork stoppers" (Toulouse 1971:439).

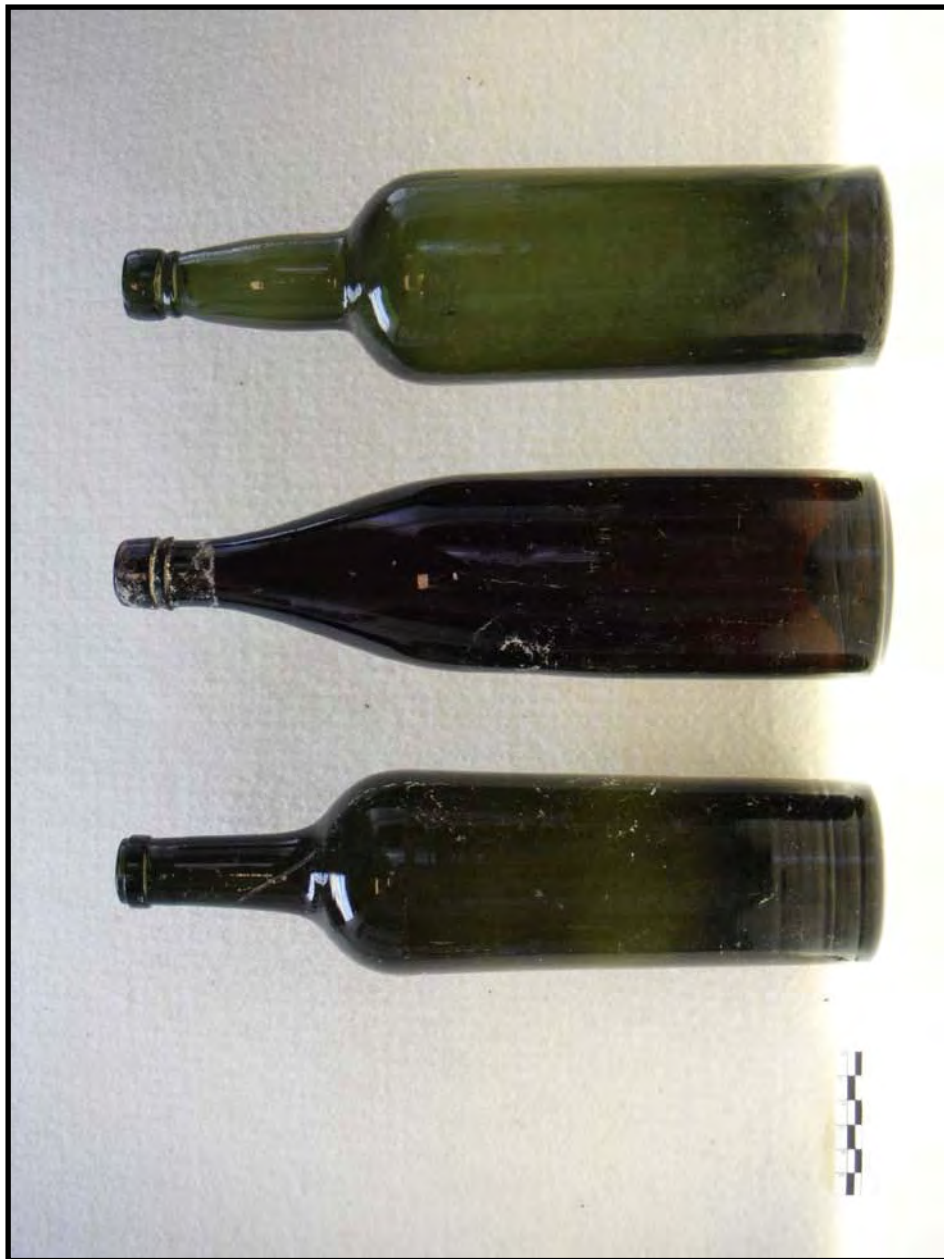
Figure 30. Photographs of Wine, Champagne, and Brandy Bottles, Types 5, 6, and 7.

Type 5 is a mold blown, hand-finished, dark olive green bottle which contained wine or champagne (Figure 30). Three examples of Type 5 were recovered from Test Unit 2, Feature 3 (Table 2). Two of these (Table 2, Artifacts 14 and 15) are complete and one (Table 2, Artifact 16) is a basal fragment. The bottle has a round basal profile (Fike 1987:10). The body of the bottle slopes slightly outward from the base to the shoulder. The base diameter of Type 5 is 7.0 cm (2.8 in) and the height in the two complete examples is 29.1 cm (11.5 in). This bottle was blown into a turn mold and exhibits no mold seams. In the turn mold, the base and body of the bottle are blown into a single piece shoulder height mold and the shoulder neck closure is finished by hand. When the body of the bottle is in the mold it is rotated, obscuring the mold

seams. Because the bottle is rotated in the mold, turn mold bottles carry no embossed lettering or maker marks. The turn mold process was used between 1880 and 1910 and its attributes are most commonly found on wine bottles (Munsey 1970:38-50).
