**BIOLOGICAL ASSESSMENT REPORT
YUMA SECTOR TACTICAL INFRASTRUCTURE
PORT OF ENTRY, ANDRADE, IMPERIAL COUNTY, CALIFORNIA TO
GRAY'S WELL, IMPERIAL COUNTY, CALIFORNIA**

December 31, 2007

Report Title: Biological Assessment Report, Yuma Sector Tactical Infrastructure, Port of Entry, Andrade, Imperial County, California to Gray's Well, Imperial County, California.

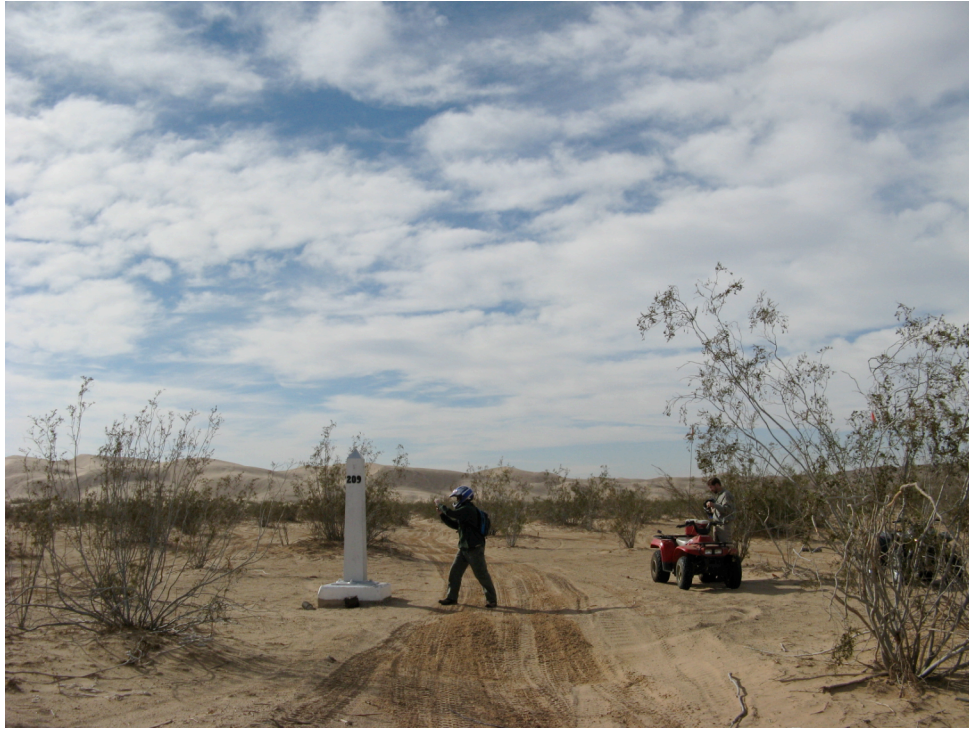
Plate 1. Mojave Creosote Scrub community at Boundary Monument 209.

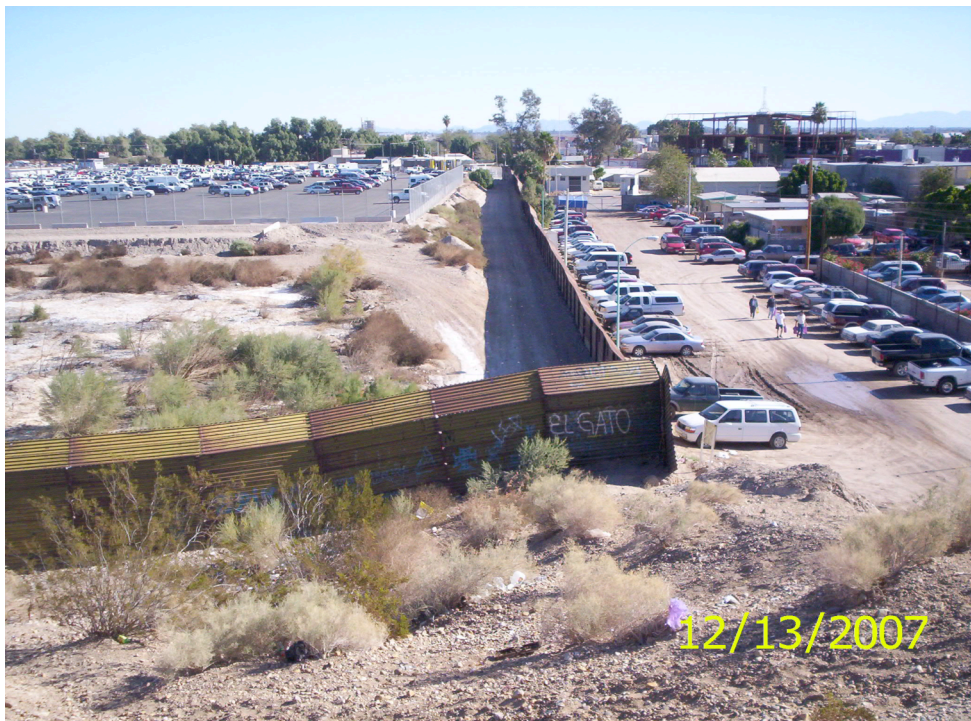
Plate 2. Existing fence and Urban/Disturbed/Exotic vegetation along border near the Port of Entry at Algodones/Andrade. Baja California is on the right of the photograph.

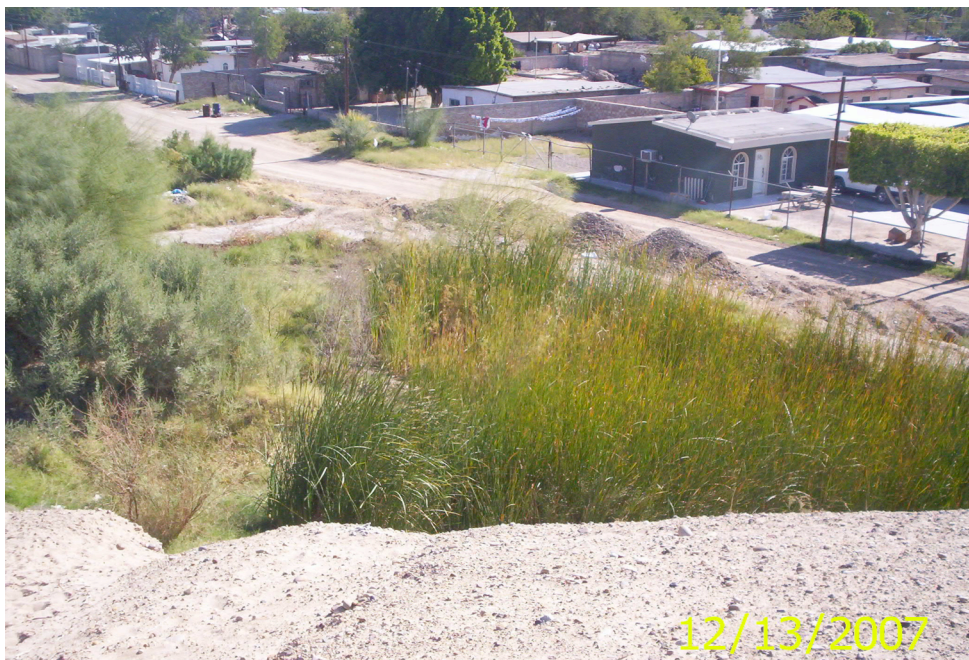
Plate 4. Area of hydrophytic vegetation and standing water identified as “Wetland 1” on the Vegetation Map (Figure 3). Algodones, Baja California, Mexico is in the background. Potential fence construction would parallel the road seen near the houses and is not likely to intrude into this wet area. The site does provide marginal suitable habitat for the Yuma clapper rail. If construction occurs in this area during the rail breeding season, a focused survey would be conducted to determine if rails are present. If rails are present, noise attenuation measures would be required.

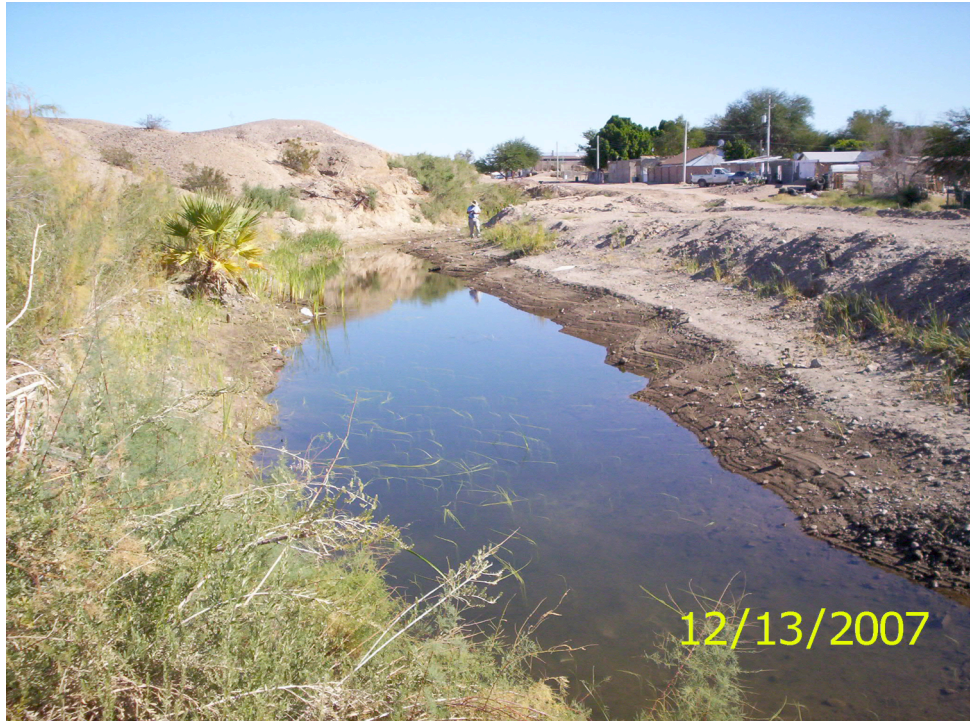
Plate 5. Area of hydrophytic vegetation and standing water identified as “Wetland 2” on the Vegetation Map (Figure 3). Construction of the proposed fence would be limited to the berm on the right (south) side of the photograph. Potentially suitable habitat for the Yuma clapper rail and California black rail may occur in the area on the left side of the photograph. If construction is planned for this area during the rail breeding season, a survey would be required to determine if rails are present. If rails are present, noise attenuation measures would be required.

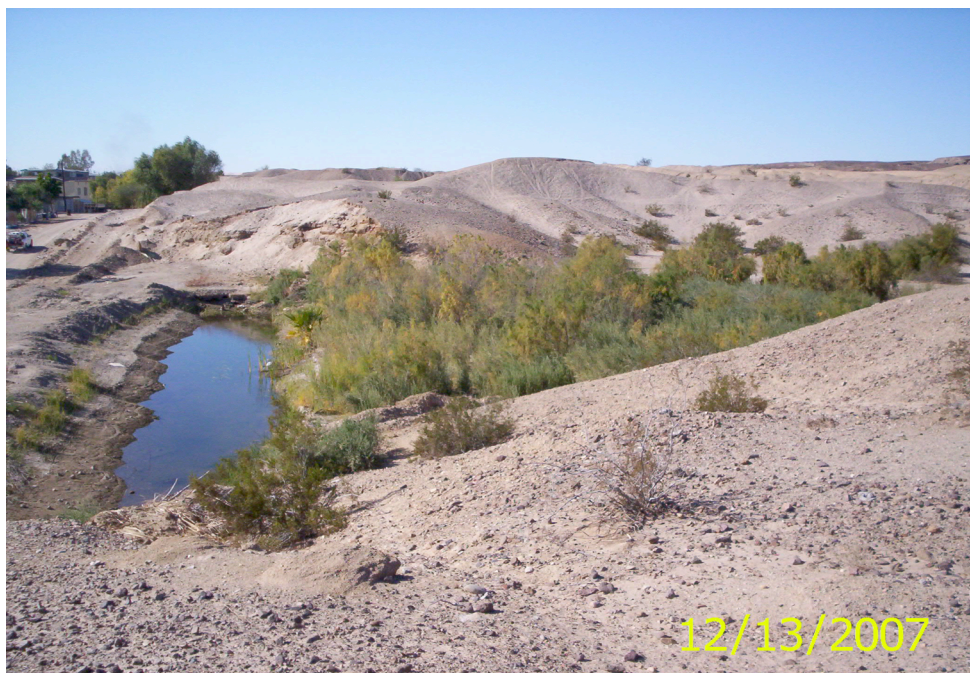
Plate 6. Second area of hydrophytic vegetation identified as Wetland 2 on the Vegetation Map (Figure 3).

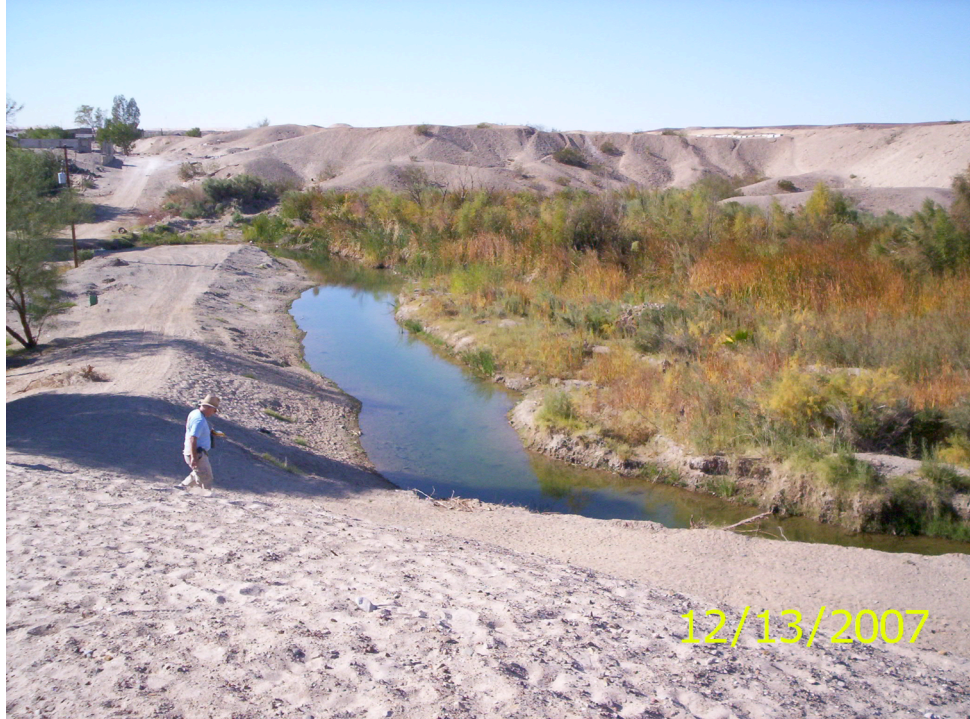
Plate 7. Third area of hydrophytic vegetation encountered and identified as Wetland 3 on the Vegetation Map. Construction of the proposed fence would be limited to the berm on the right (south) side of the photograph. Potentially suitable habitat for the Yuma clapper rail and California black rail may occur in the area on the left side of the photograph. If construction is planned for this area during the rail breeding season, a survey would be required to determine if rails are present. If rails are present, noise attenuation measures would be required.

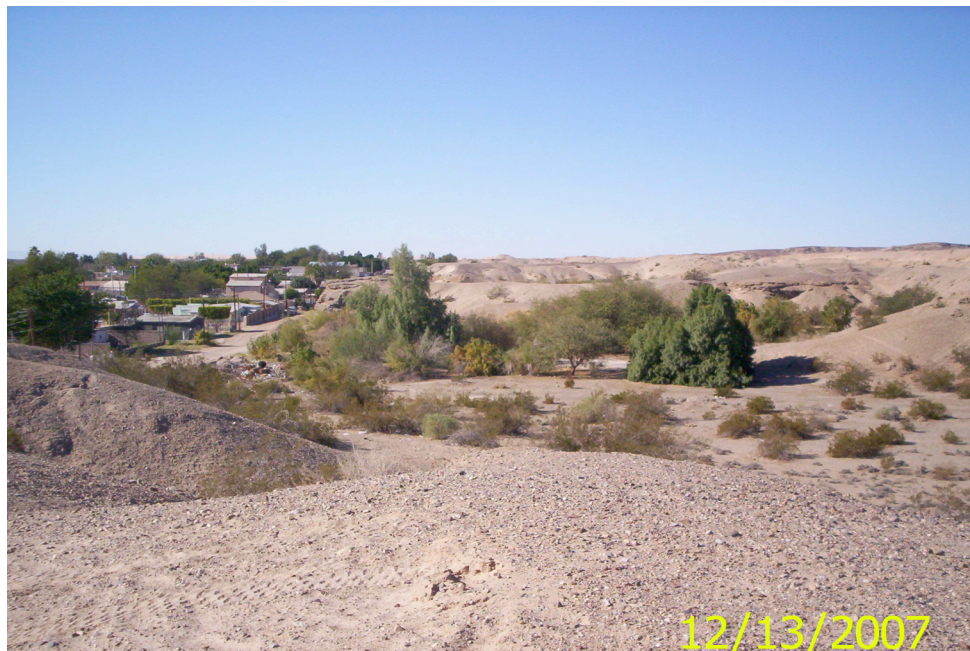
Plate 8. Typical wash along the survey route. Generally vegetation in these areas consists of salt cedar, palo verde, creosote bush, and scattered smoke tree.
