ES-2 Crash Test Performance

SAE Government Industry Meeting Side Impact Session

Randa Radwan Samaha Research and Development/NHTSA

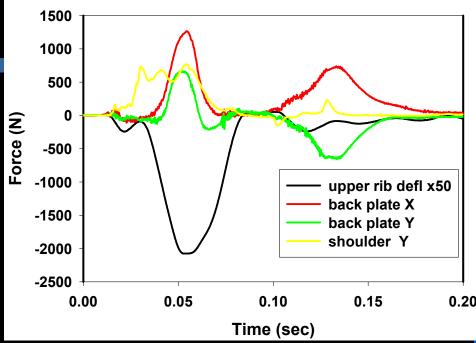
Cougar/201 Pole with ES-2 Driver Loads vs Upper Rib Deflection

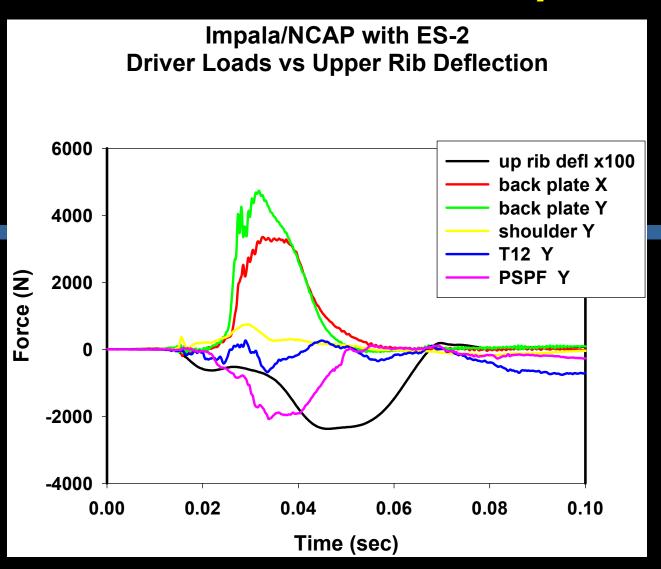
Back Plate "Grabbing" in Side NCAP Test of Impala

- Data for two out of seventeen vehicle models crash tested suggest back plate "grabbing" by intruding structure. Large back plate loads occurring early in time relative to the lower spine loads were observed.
- Back plate loads and corresponding momentum contribution were low for the remaining fifteen vehicle models.

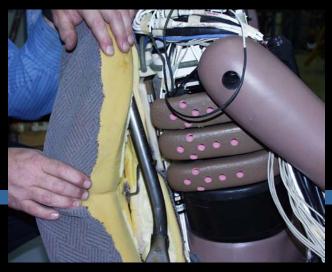
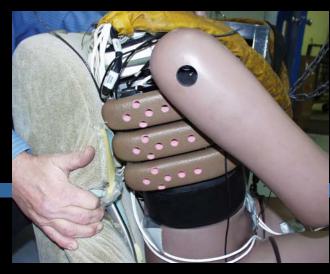
Side View of ES-2 Dummy in Seats

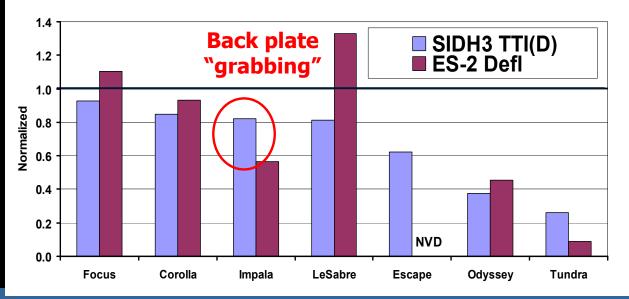
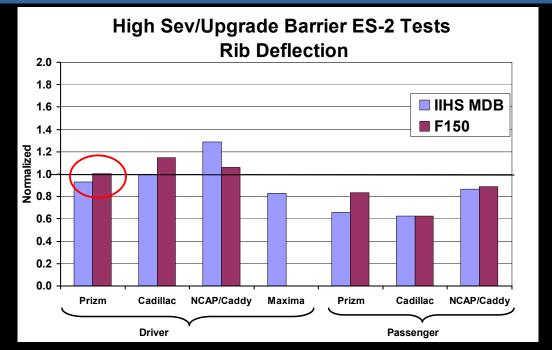
2002 Side NCAP Fleet Performance Tests- Driver

ES-2 rib deflection vs SID TTI(D)

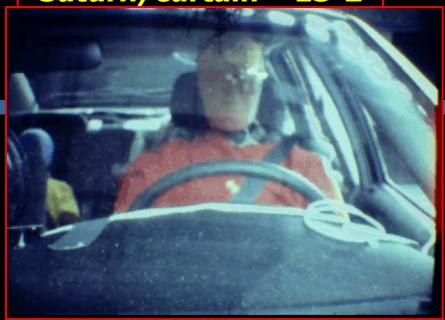
Saturn/curtain — ES-2

- ES-2 demonstrated ability to detect usefulness of head protection
 - Head/neck/shoulder kinematics comparable to SIDH3
 - Head loading levels and timing similar to SIDH3
- Existing ES-2 rib deflection criterion indicate higher level of thoracic injury than the measured SIDH3 TTI(D) in the same vehicles

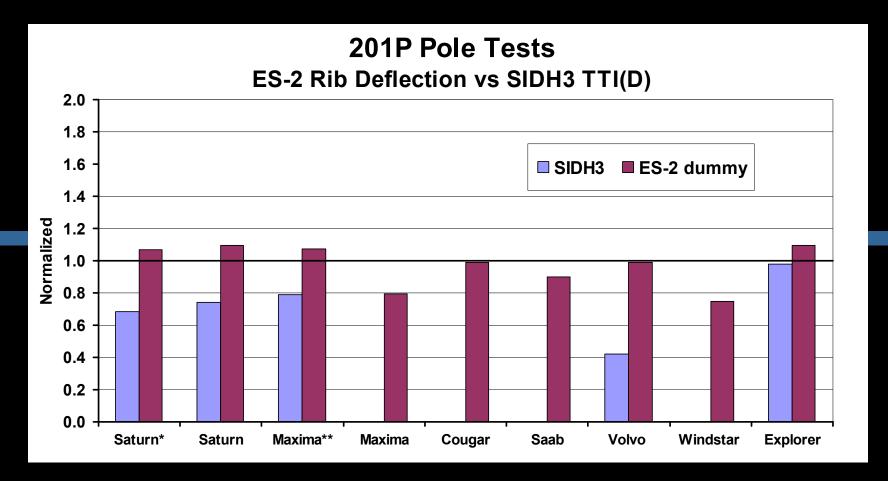
ES-2 Detects High Thoracic Loads in a Side Pole Test

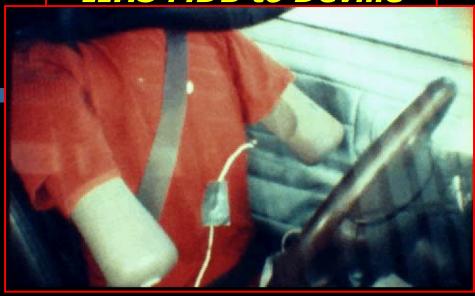
IIHS MDB to Deville

- ES-2 demonstrated excellent durability
- Rib deflections within maximum range (max range reached only in IIHS MDB to Caddy test at NCAP speed)
- ES-2 demonstrated ability to detect high abdominal loads due to intruding armrest in IIHS MDB to Cadillac test

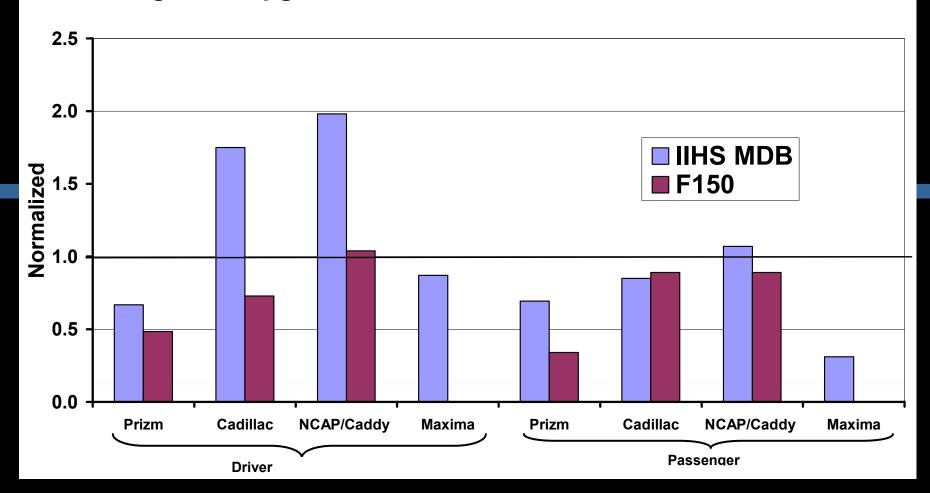
ES-2 Detected Intruding Armrest in IIHS MDB Cadillac Test

High Sev/Upgrade Barrier ES-2 Tests- Abdomen Force

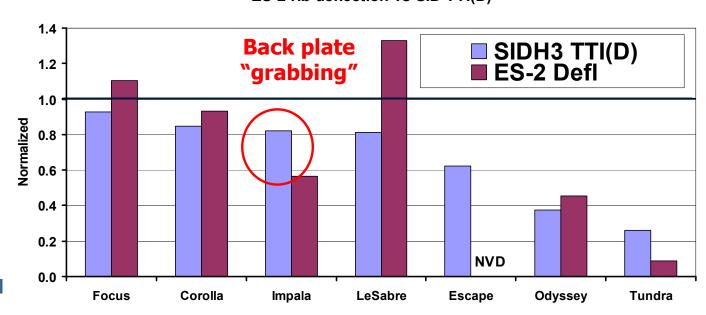
2002 Side NCAP Fleet Performance Tests- Driver ES-2 rib deflection vs SID TTI(D)

EU/214 Criteria Limits TTI=85/90 Defl=42 mm

ES-2 driver rib deflection exceeded limit for two of the vehicles for which TTI(D) was within the limits!
