Cargo Hose Rupture and Release of Anhydrous Ammonia During Offloading of a Werner Transportation Services Cargo Tank Motor Vehicle at the Tanner Industries Plant Swansea, South Carolina July 15, 2009

Accident Summary Report

NTSB/HZM-12/01/SUM PB2012-917002

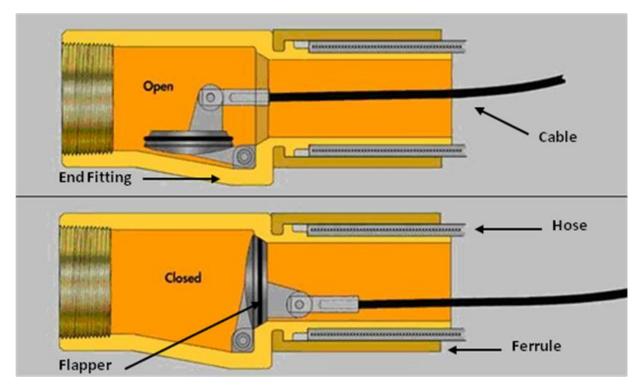
Figure 2. Schematic depicting Smart-Hose safety system.

Smart-Hose Technologies of Philadelphia, Pennsylvania, purchased the LPG transfer hose from Durodyne and installed the Smart-Hose safety system to fabricate the complete accident hose assembly as a Lifeline III LPG Transfer Hose. The Smart-Hose safety system consists of an internal cable running through the bore of the hose connected to specially designed unseated flapper valves located on each end of the cable. In the event of hose or coupling separation, catastrophic hose rupture, or excessive hose stretching, the system is designed to shut off the flow of LPG in both directions as the flapper valves release and instantly seat. (See figure 2.)
