The anatomy of an accident: Colgan Air flight 3407

Robert L. Sumwalt
February 12, 2010

Loss of Control on Approach
Colgan Air, Inc., Operating as
Continental Connection Flight 3407
Bombardier DHC-8-400, N200WQ

DCA09MA027

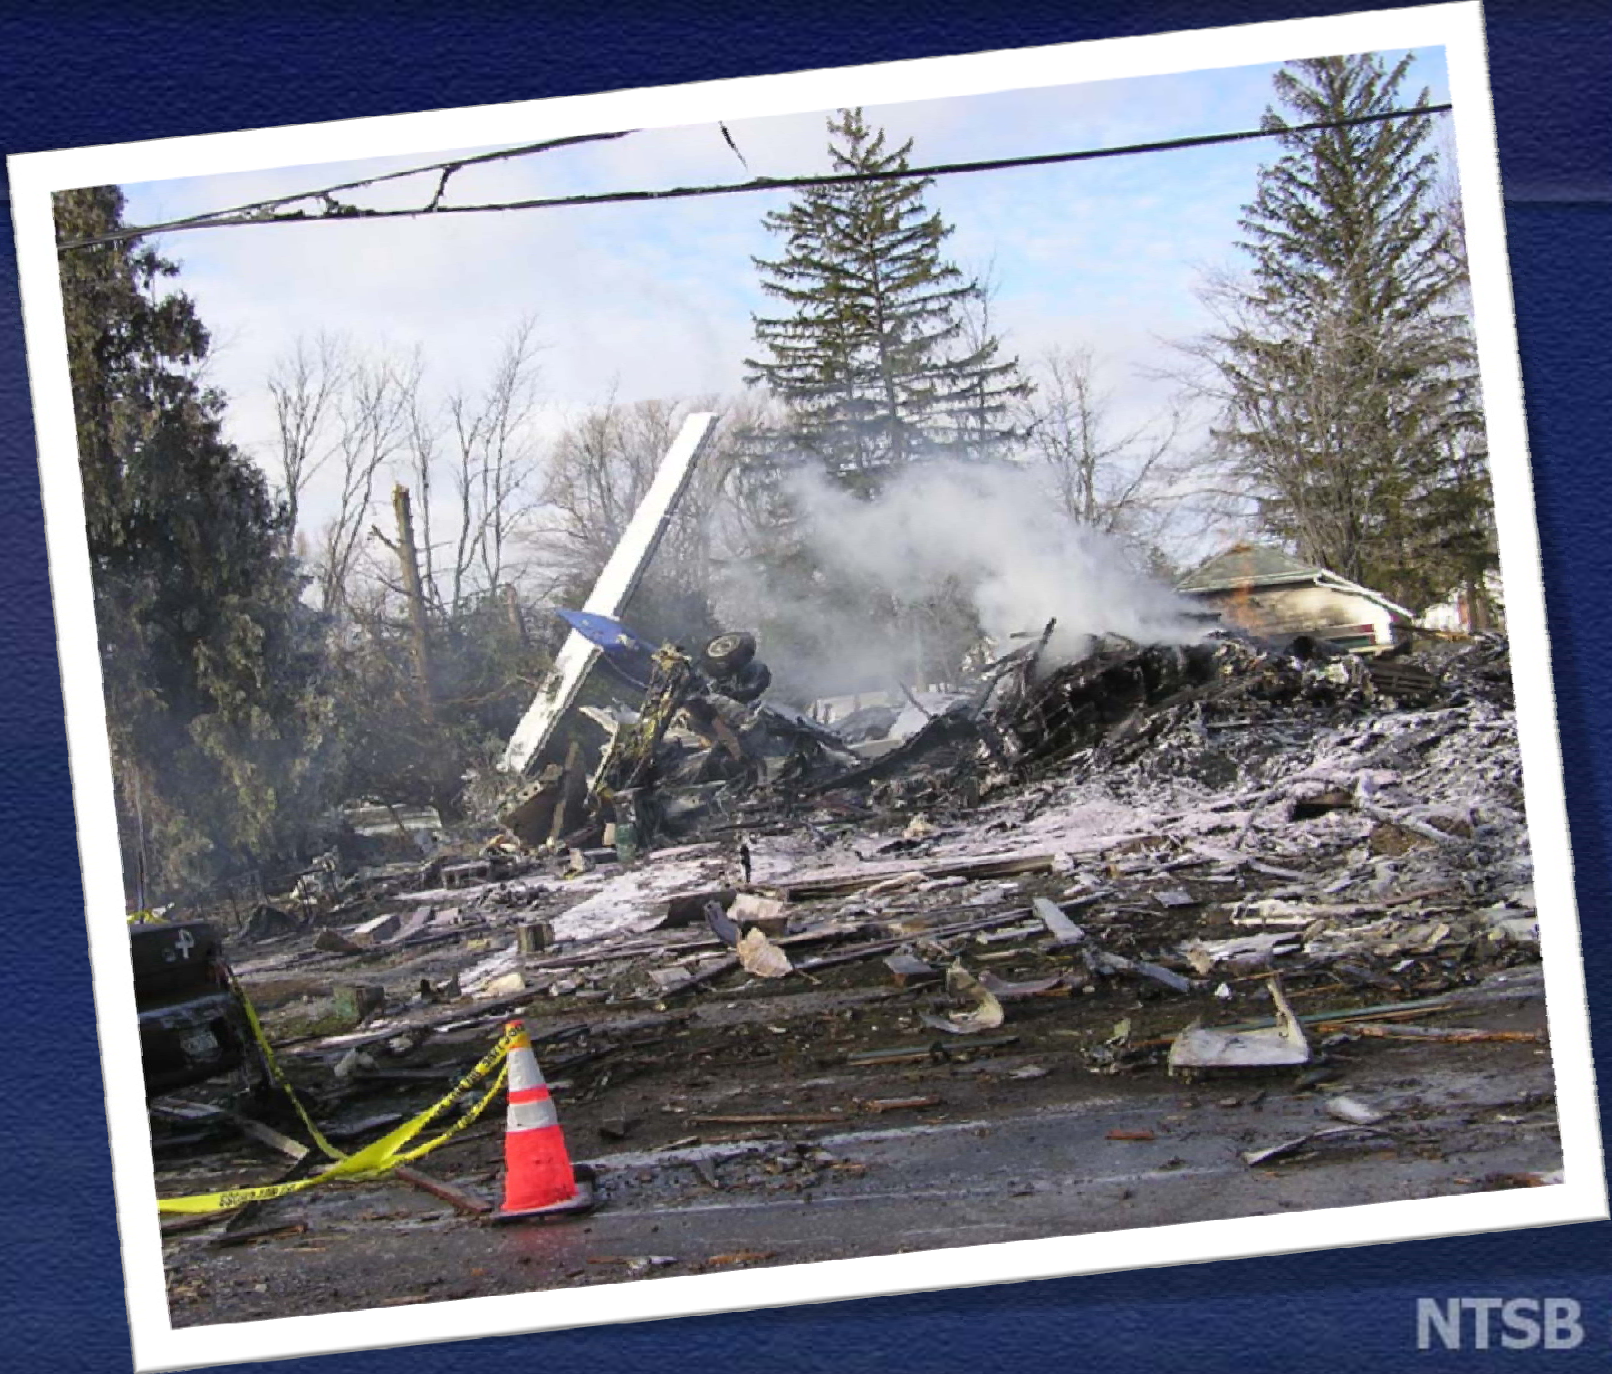
- Approximately 3 miles from outer marker:
 - power was reduced to slow for approach
 - gear extended
 - props to max RPM
- Airspeed decreased 50 kts in 21 seconds

- Stick shaker (stall warning) activated at 131 knots
- Autopilot disconnected
- Captain reacted with “startle and confusion”
- Captain pulled nose to 19 degrees nose up pitch
- Stall, extreme roll
- Stick pusher activated 3 times
 - countered by captain’s actions of pulling
- Loss of control

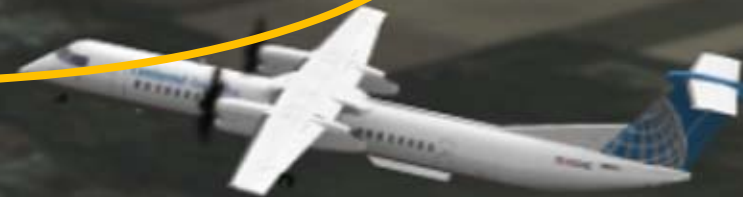
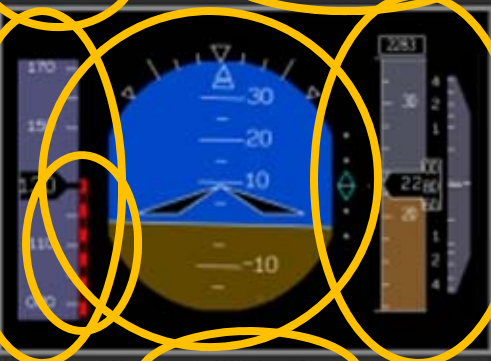
22:16:27

130

knots

2280

feet

Shaker ON

Pusher OFF
