ORPHANAGE AND SENIOR CITIZEN
ASSISTED LIVING CENTER
ERBIL, IRAQ

SUSTAINMENT ASSESSMENT

SIGIR PA-09-178
OCTOBER 21, 2009

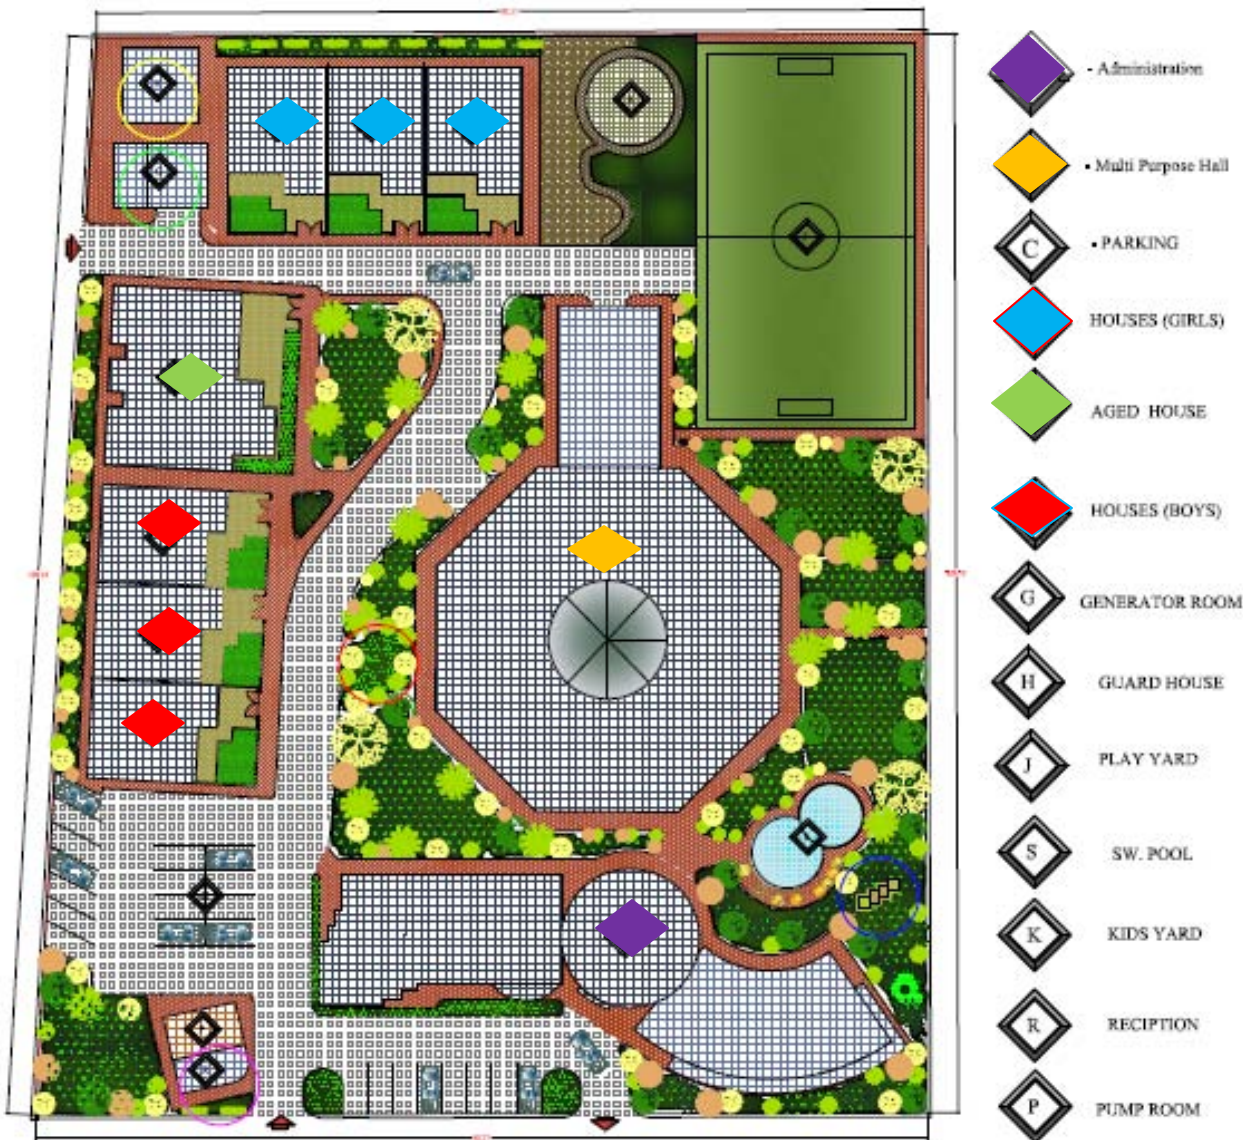
Figure 1. General site plan (Courtesy of the USACE)

The contract included conceptual drawings for the project. The government furnished conceptual drawings included a general site plan with building locations and the parking layout. The contractor provided a detailed site plan depicting the specific locations of the administrative, multi-purpose hall, girls' residential house, boys' residential house, senior citizens' residential house, the parking, and other support buildings (Figure 1).

The contractor-furnished site plan appeared well-planned and maximized the use of the limited space available. Landscaping and walkways were indicated on the site plan; the walkways provided good internal circulation around the buildings, and the landscape provided a buffer from the main and side streets, allowing the residents some privacy.

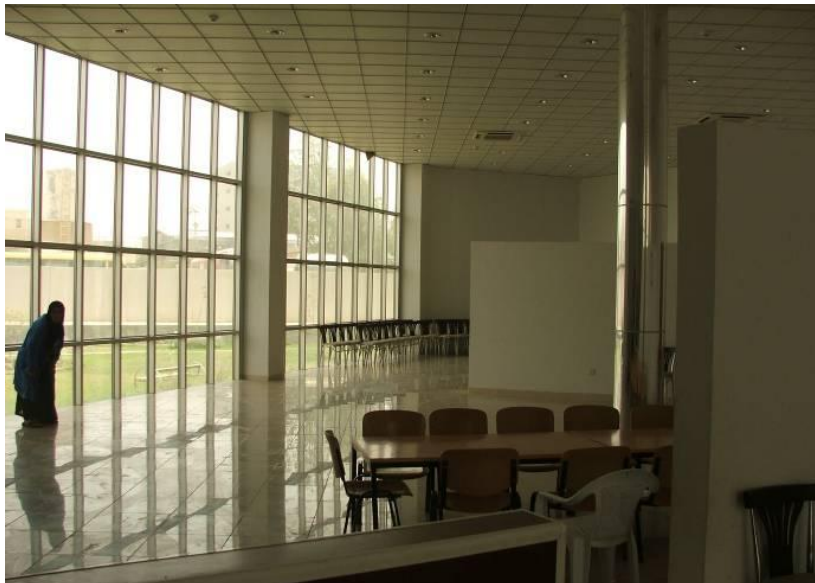
Site Photo 9. Multi-purpose building cafeteria

The cafeteria incorporates a floor to ceiling glass exterior wall as an architectural feature that permits ambient light and creates a pleasant atmosphere in the cafeteria (Site Photo 9). The cafeteria was finished with plaster walls and ceramic tile flooring. The placement and quality of the tile was similar to the construction seen in the auditorium. The cafeteria was furnished by MOSA with commercial grade furniture.

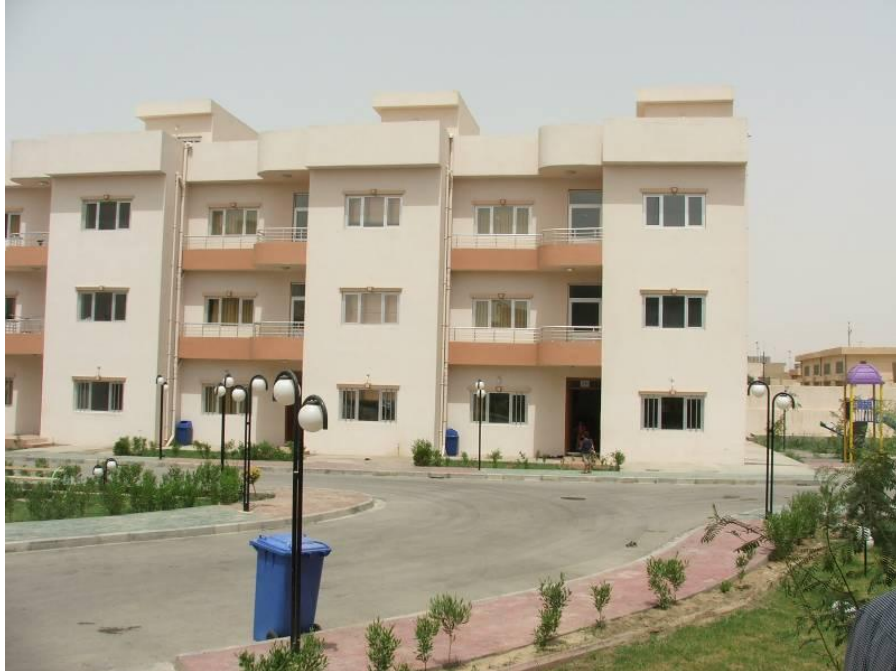
Site Photo 11. Exterior view of residential house for boys

Two residential houses were constructed to provide housing for the younger occupants of the facility (Site Photo 11). Each residential house was divided into three separate, three-story units. One residential house was for male children and the second residential house was for female children, and each dormitory separated the children by age.
