**HUMER KWER HEALTH CENTER
SULAYMANIYAH, IRAQ**

SUSTAINMENT ASSESSMENT

**SIGIR PA-09-186
APRIL 20, 2010**

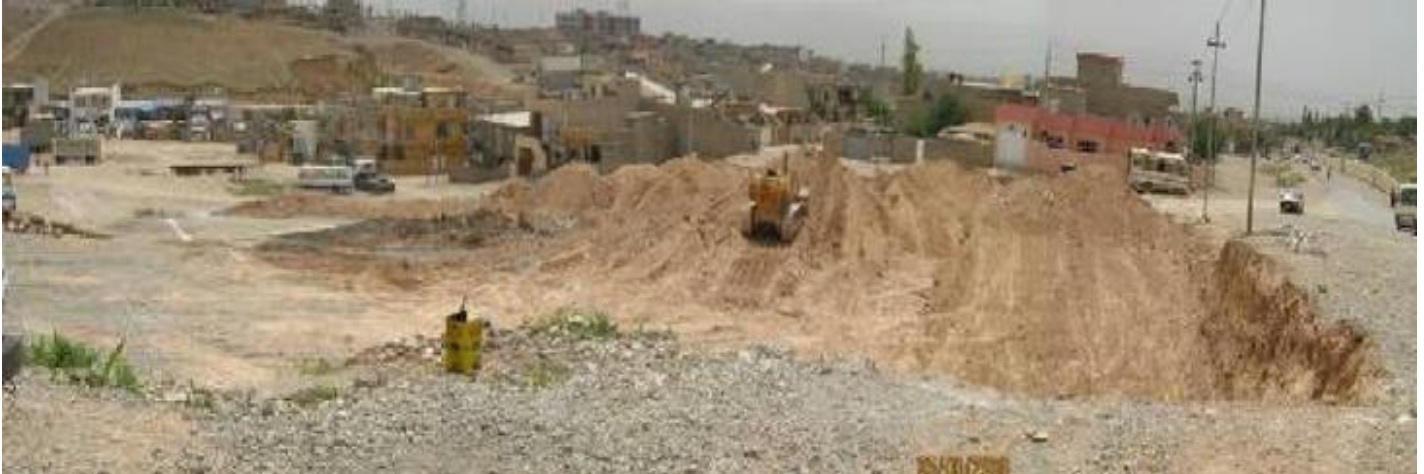
with GRN Kirkuk Area Office (KAO) personnel. The project site was vacant land, located in a residential area of Sulaymaniyah (Site Photo 1). The project terrain is relatively steep with a uniform slope from the primary access road at the higher end of the project site to a minor access drive at the lower end of the project site. During the site assessment, the GRN KAO local national engineer stated that the facility serves a population of 60,000 people from the surrounding area.

Site Photo 1. Initial excavation of project site

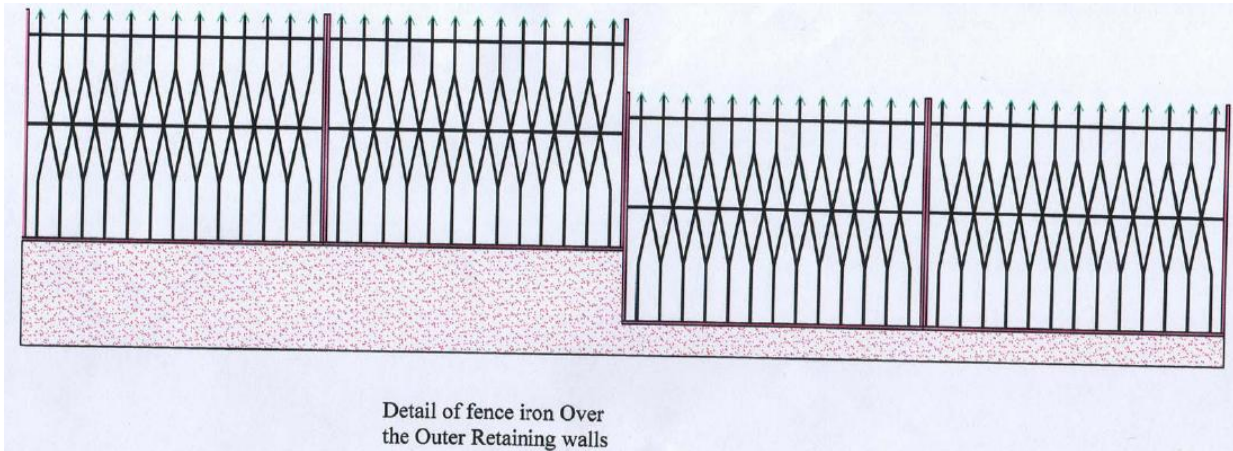
The perimeter security wall details provided with the conceptual design drawings included details for the concrete masonry unit⁴ (CMU) wall, foundation, and reinforcement for the gates and is identical on the contractor's drawings. In several areas the need for a retaining wall precludes the construction of a CMU security wall. In these areas, the contractor proposed a steel fence mounted to the top of the retaining wall (Figure 2).

**Figure 2. Steel fence secured to retaining wall
(Courtesy of GRN)**

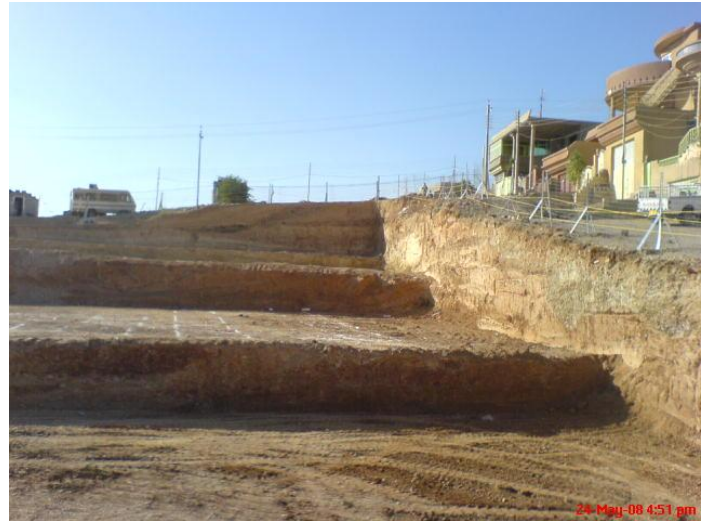
Before new construction could begin, the contractor cleared and excavated the project area. Site Photo 2 shows the obstructed future site of the Humer Kwer Health Center, with debris that required removal, and Site Photo 3 shows the site after the contractor excavated and cleared the area.

Site Photo 2. Site layout before modification (Courtesy of GRN) Site Photo 3. Site after excavation (Courtesy of GRN)

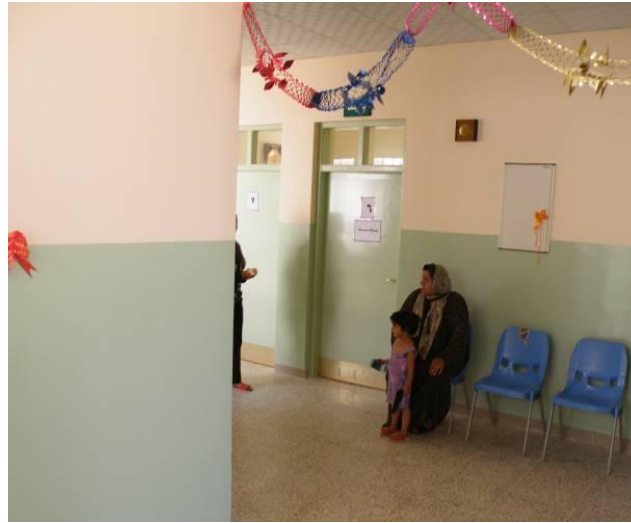
Upon entry to the health center is a small waiting area (Site Photo 7) and a registration window for incoming patients. The waiting area was furnished with chairs, which were

Site Photo 7. Patient waiting area

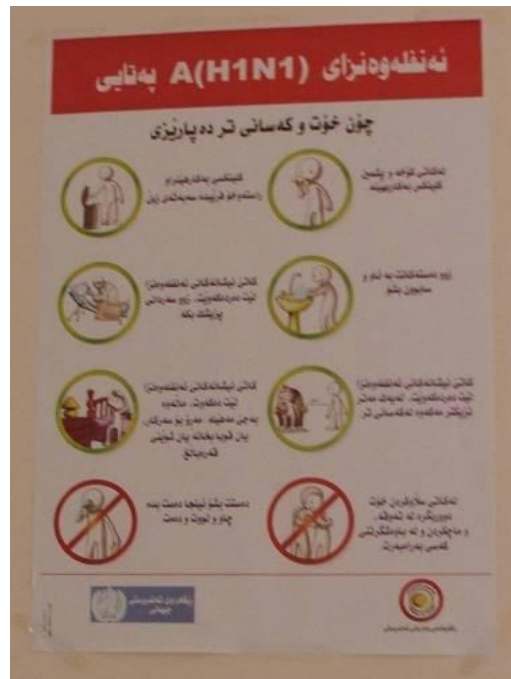
Educational posters were placed throughout the facility to promote awareness of public health issues (Site Photo 8).

Site Photo 8. Health education poster in Humer Kwer Health Center

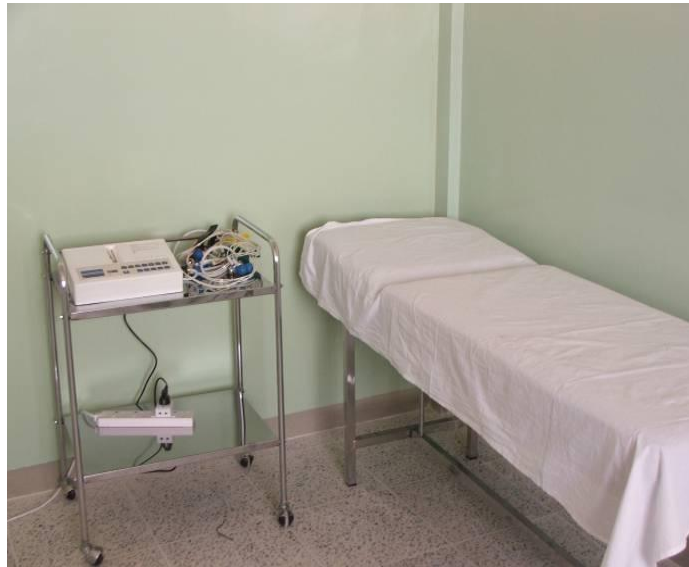
Patient exam rooms are located on the upper level of the facility (Site Photo 9). The contractor provided some furniture for the exam rooms and the Ministry of Health provided the medical equipment.

Site Photo 9. Patient exam room

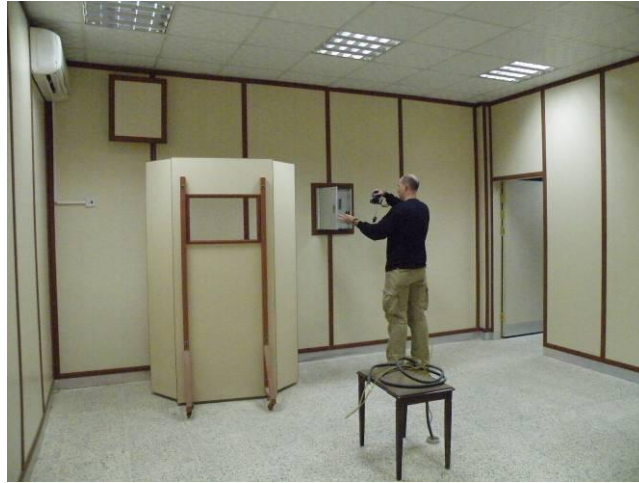
The diagnostic facilities and pharmacy are located on the lower level. The diagnostic facilities included an X-ray room, darkroom, and medical laboratory. The X-ray room appeared finished, but was lacking X-ray equipment. The local national project engineer stated that the X-ray equipment was awaiting transfer to the health center. The contractor installed a moveable barrier to protect the X-ray technician and extended the electrical line through the floor to be connected to the X-ray equipment (Site Photo 14). The pharmacy appeared secure, stocked, and able to dispense medication. The supplies were neatly organized on shelves.

Site Photo 14. X-ray room
