Collision of Two Washington Metropolitan Area Transit
Authority Metrorail Trains Near Fort Totten Station
Washington, D.C.
June 22, 2009

Railroad Accident Report

NTSB/RAR-10/02
PB2010-916302

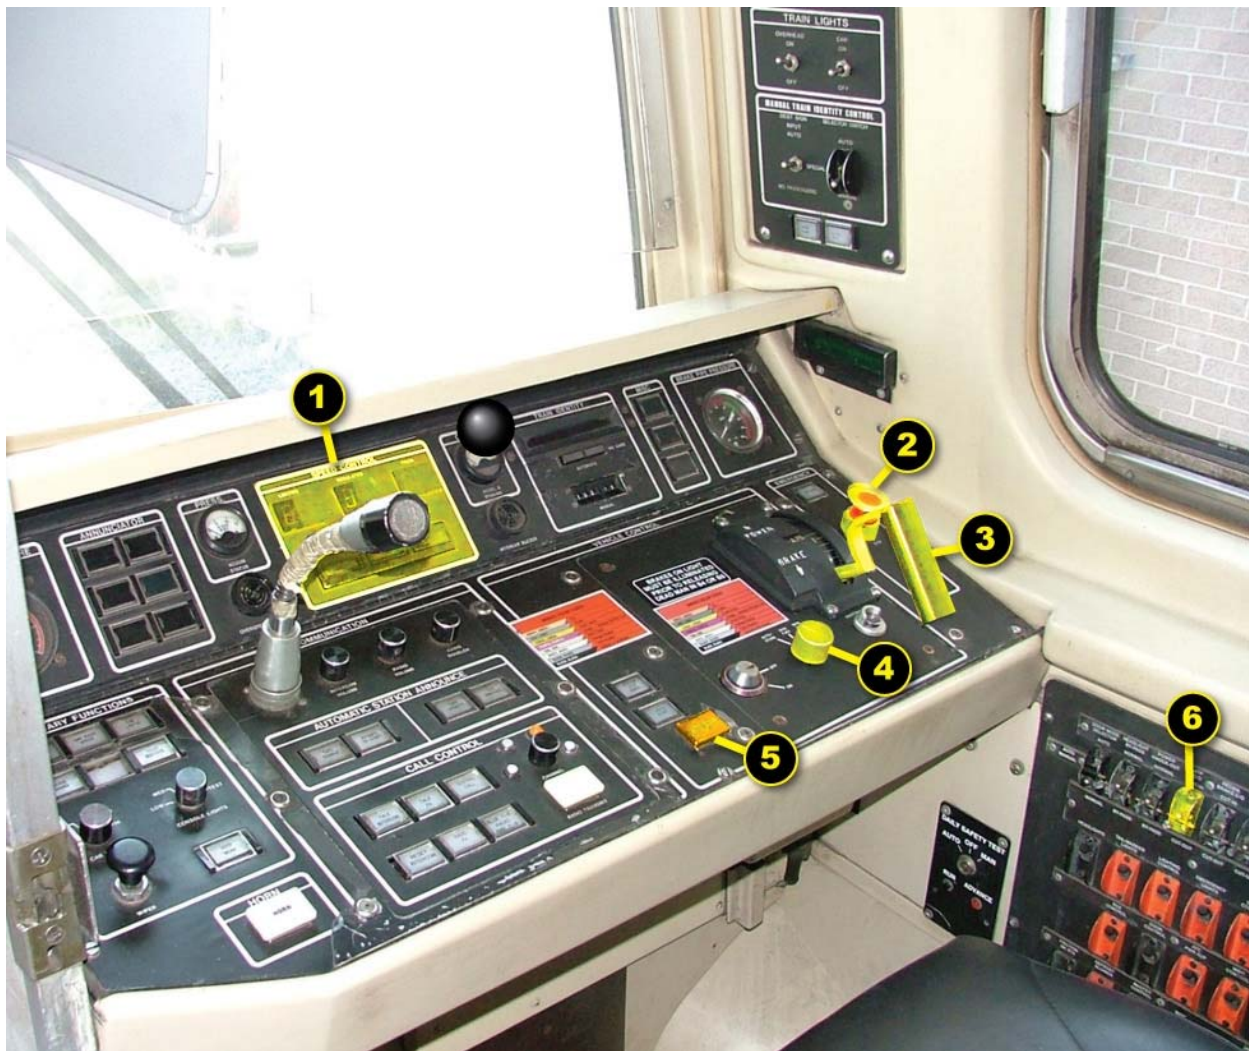
Figure 3. Exemplar Rohr 1000-series car operator's console: (1) speed control indicator panel, (2) emergency brake "mushroom," (3) master control handle, (4) mode director switch, (5) automatic train operation stop, and (6) automatic train protection cutout switch.

Investigators examined the control compartments on both trains. The control console of train 112 was covered with a layer of broken window glazing and other debris but was generally intact. The emergency brake mushroom was found in the depressed, or *stop*, position. The button operated freely when manually released and depressed, making a distinctive "snapping" sound when operated in either direction. The automatic train operation (ATO) selector was in the "auto" position; the automatic train protection (ATP) switch on the operator's panel (see figure 3) was properly positioned for revenue service and was cut in and sealed,¹⁶ and the master controller was in the "Auto/Store" position. The key was missing from the key-up switch, and the switch was in the "off" position. When another key was inserted, the switch operated.

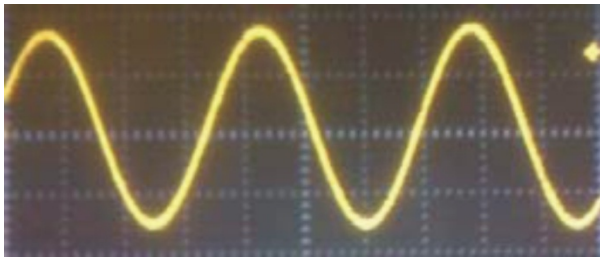
Oscillation type 1: A clean sinusoidal audio waveform.

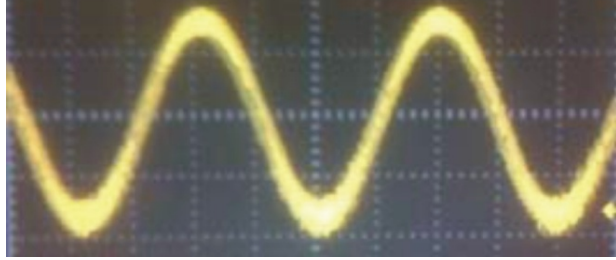
Oscillation type 2: The entire waveform appears uniformly thickened as though out of focus. Indicates a harmless and continuous oscillation at some higher frequency (25 megahertz for example).

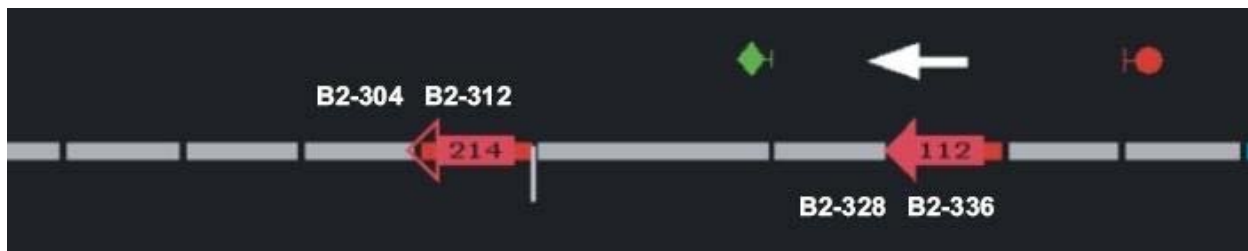
4:56:50 p.m. Train 214 is detected occupying track circuit B2-312, with train 112 several blocks behind on track circuit B2-336. Red track circuit symbols indicate track occupancy. The transparent arrowhead for train 214 indicates that the train is being operated in manual mode. Performance data indicated that the front of train 214 was actually at chain marker 315+00, corresponding to track circuit B2-312. The front of train 112 was actually at chain marker 338+48, corresponding to track circuit B2-336. The solid arrowhead for train 112 indicates that this train is in automatic mode.

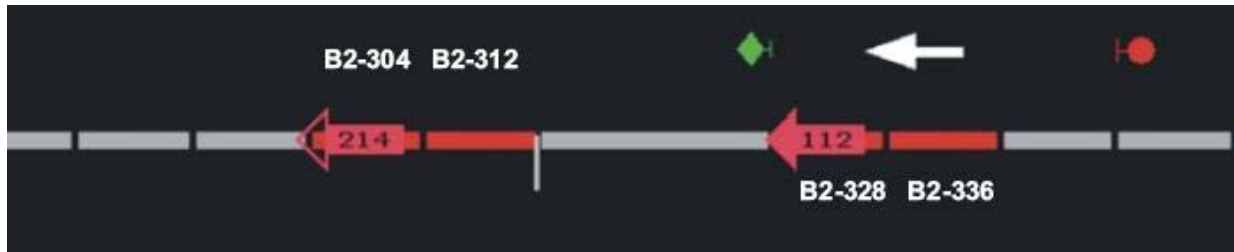
4:57:02 p.m. Both trains have moved forward into the next block in their direction of travel. Track occupancy is being detected on track circuits B2-304 and B2-312 for train 214 and on track circuits B2-328 and B2-336 for train 112. Performance data indicated that the front of train 214 was at chain marker 312+00, corresponding to track circuit B2-312. The front of train 112 was at chain marker 335+70, corresponding to track circuit B2-328.

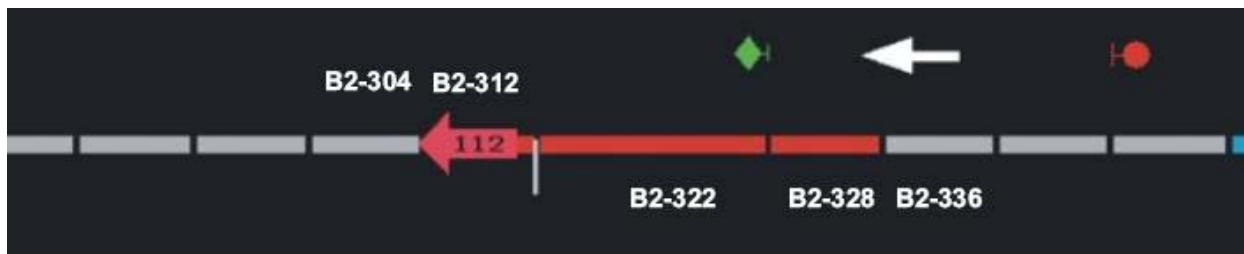
4:57:46 p.m. Train 112 is displayed as occupying three track circuits, all of which are displayed as normally reporting blocks. Performance data indicated that the front of train 214 was actually at chain marker 307+00, corresponding to track circuit B2-304. The front of train 112 was at chain marker 324+64, corresponding to track circuit B2-322.

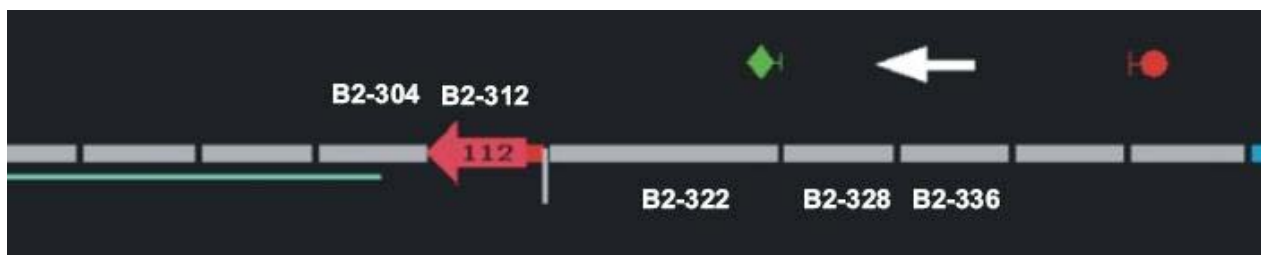
4:58:10 p.m. Train 112 is displayed as occupying a single track circuit (B2-312). All track circuits are now displayed as normally reporting blocks. The green line indicates that third-rail power is down ahead of B2-312. Performance data indicated that the front of train 214 was actually at chain marker 307+00, corresponding to track circuit B2-304. The front of train 112 was at chain marker 311+00, also corresponding to track circuit B2-304.
