# National Transportation Safety Board

## Aircraft Accident Brief

Accident Number:	CHI01MA011
Operator/Flight Number:	N/A
Aircraft and Registration:	Cessna 335, N8354N
Location:	Hillsboro, Missouri
Date:	October 16, 2000

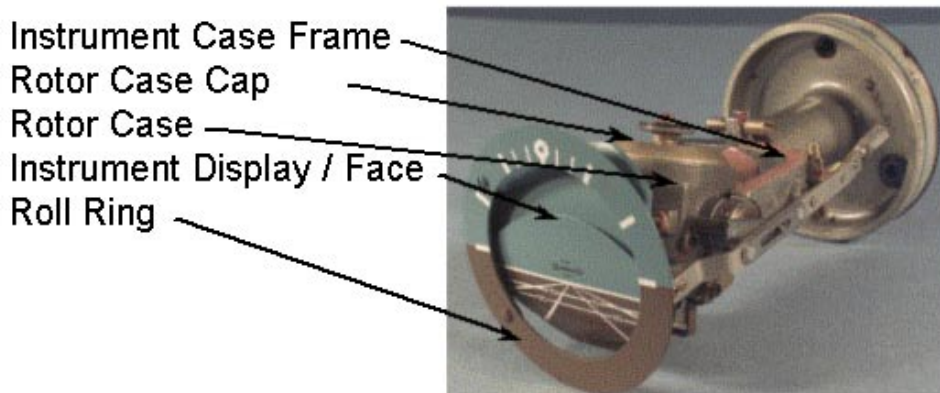
The following components from the left-side attitude indicator/flight director were identified in the wreckage: the gyroscopic rotor, the rotor case cap, two pieces of the rotor case, the instrument face display (including the roll ring), and pieces of the instrument case frame. (See figure 3 for a photograph of an exemplar attitude indicator and its components.) The model of the attitude indicator installed on the accident airplane contained an arm that provides mechanical linkage from the rotor housing to the pilot's display. This arm was located on a fragment of the instrument case frame.

**Figure 3.** Photograph of an exemplar attitude indicator and its components.

Examination of the interior diameter of the rotor case revealed faint, unevenly spaced diagonal scratches. The measured angle between the scratches and the direction of rotation was between  $4.0^\circ$  and  $5.2^\circ$ . The scratches were consistent with the direction of rotation of the rotor and with the direction the rotor was moving when it exited the case. No other circumferential score marks were found on the inner surface of the case that paralleled the direction of rotation.

Diagonal marks were found on the end of the rotor. Nearly all of the other scratches on the cap were oriented across the direction of rotation at various angles. The center fastener hole on the cap was ripped, with more than half of the periphery remaining. The width of the tears matched the width of the gouges in the rotor. The exterior of the cap contained scratches that resembled the width and approximate locations of the motion-limiting stop wires mounted on an exemplar instrument.
