Inspection / Investigation Report No. 11287051

U.S. Department of Transportation
Pipeline and Hazardous Materials Safety Administration
Office of Hazardous Materials Enforcement

Type of Inspection: ACCIDENT/FAILURE INVESTIGATION **Result:** NO FURTHER ACTION

DOT Requested Analysis
of
Failed SCUBA Cylinder/Valve Assembly

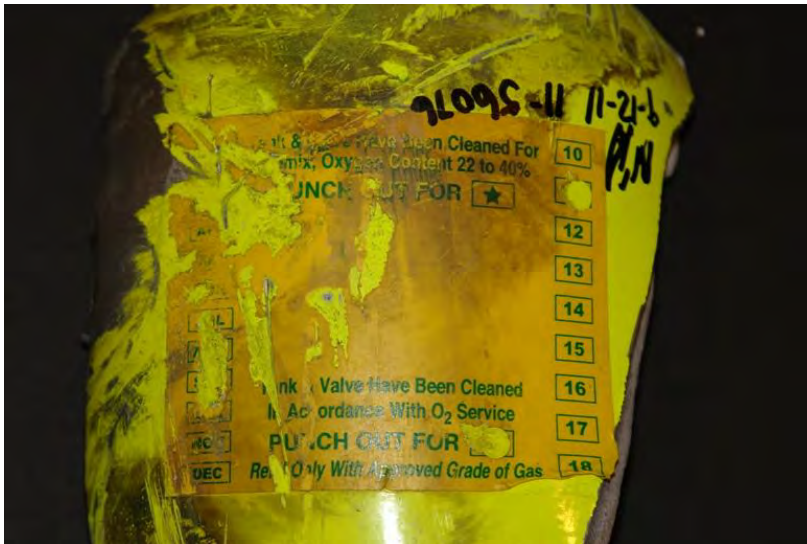
Figure 2. Label on smaller fragment.

The cylinder fragment had on its exterior surface a full decal and part of another. The first decal, seen in **Figure 2**, appears like that used by the International Association of Nitrox and Technical Divers (IANTD), as seen in **Figure 3**, which states if the decaled cylinder has been cleaned for use with Nitrox¹ or Oxygen.

The remaining legible content of the label indicated the “Tank & Valve Have Been Cleaned For Premix, Oxygen Content 22 to 40%” was not punched out, while the “Tank & Valve Have Been Cleaned In Accordance With O₂ Service” was punched out at 2011. The month is obscured. There is no indication as to who may have stamped and applied the decal, or as to what procedure was followed to certify the cylinder was properly cleaned.

In accordance with the federal regulations, the incident cylinder should have possessed a label indicating that the contents of the cylinder were compressed gas oxygen. The incident cylinder possessed two decals or labels. The first, shown in **Figure 2**, indicated that the cylinder had been cleaned in accordance with O₂ service. There is no indication as to who may have stamped and applied the decal, or as to what procedure was followed to certify the cylinder was properly cleaned. The failure to provide this information is counter to the suggestions of the Compressed Gas Association,¹² and a violation of the ASTM G 93 which states as follows:

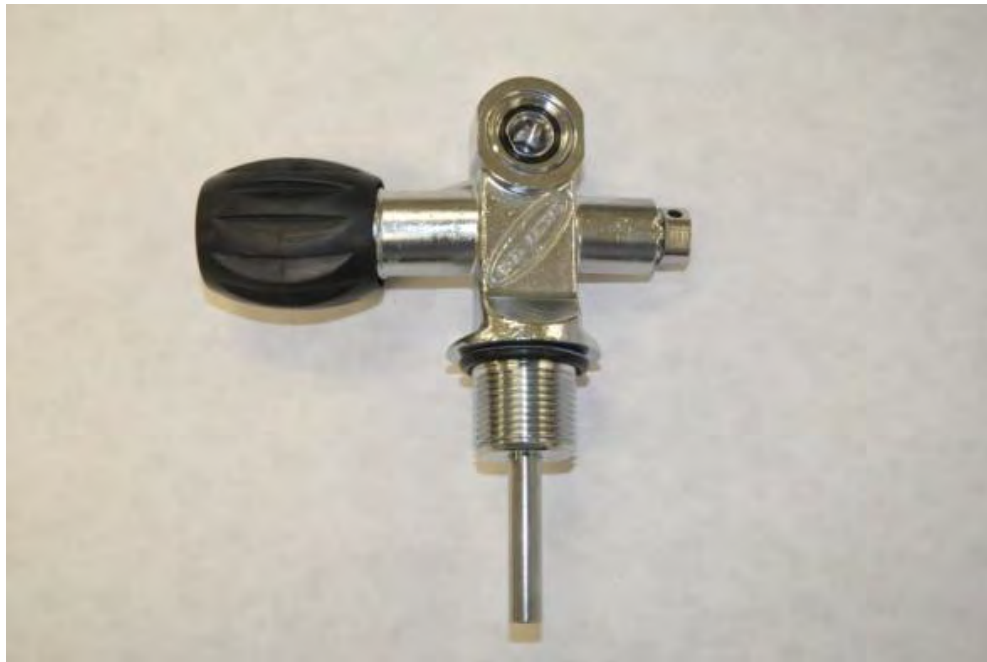
Figure 8. Front view of the exemplar cylinder valve. The valve stem assembly and housing is concealed by the black valve handle.

The exemplar cylinder valve, shown in **Figure 8**, has four distinct sections. Proceeding from the left side of the valve in a clockwise direction they were: the valve stem assembly and housing, the high pressure regulator fitting, the pressure burst disk assembly, and the threaded cylinder attachment with a pick-up tube.

The cylinder attachment consists of a straight threaded insert with an 8.05 mm diameter, 4.01 cm long dip tube fit into a center bore, see **Figure 8**. The nominal thread diameter and pitch measured as approximately 25 mm with a 2 mm pitch (1.035 inches and 13 tpi), respectively. An O-ring is provided at the cylinder mating surface.

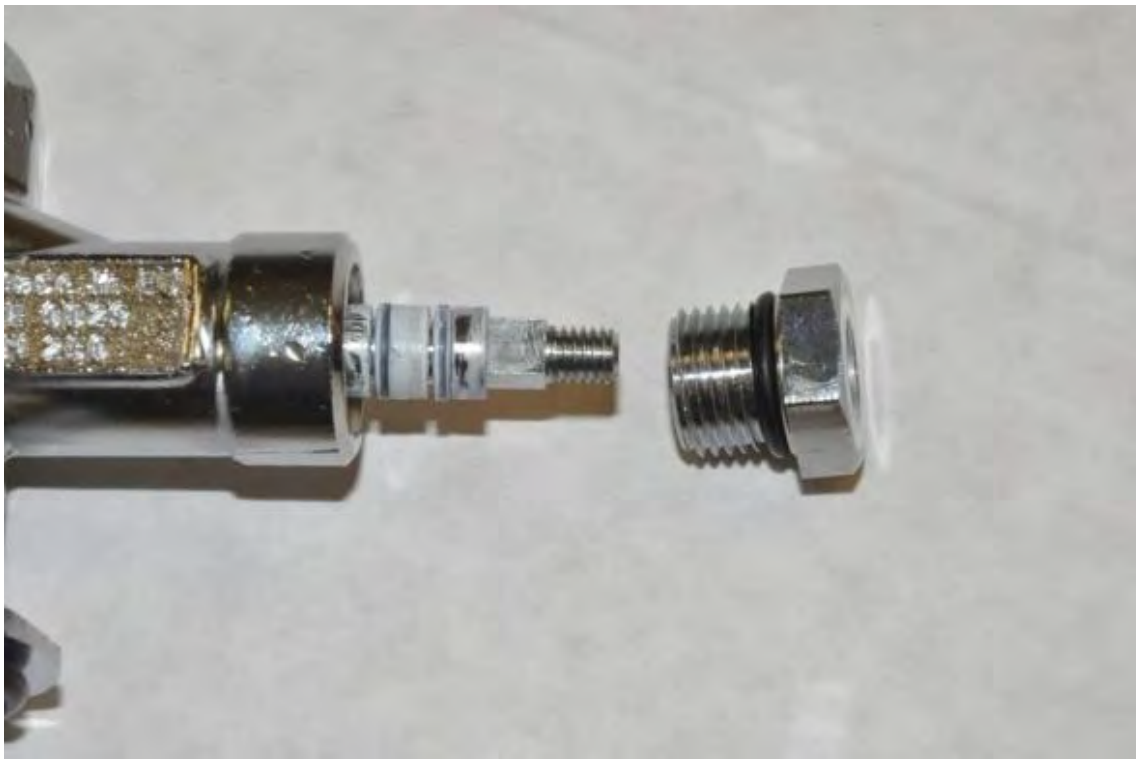
Figure 9. Rear view of the partial exemplar valve stem assembly showing the gland nut, O-ring, and valve stem.

stem. Between the threaded rod and the main portion of the valve stem, a square cross section was present that provided the rubber valve handle a means for turning the valve stem. A gland nut with a smooth center bore secured the valve stem inside the valve body. The smooth bore provides for free rotation of the valve stem. An O-ring, 1.28 cm in diameter, served to seal the connection between the gland nut and the valve body, see **Figure 9**. RTI removed this nut to expose the valve stem. As it is not secured by any part other than the nut, it could be removed from the valve body simply by pulling it straight out.

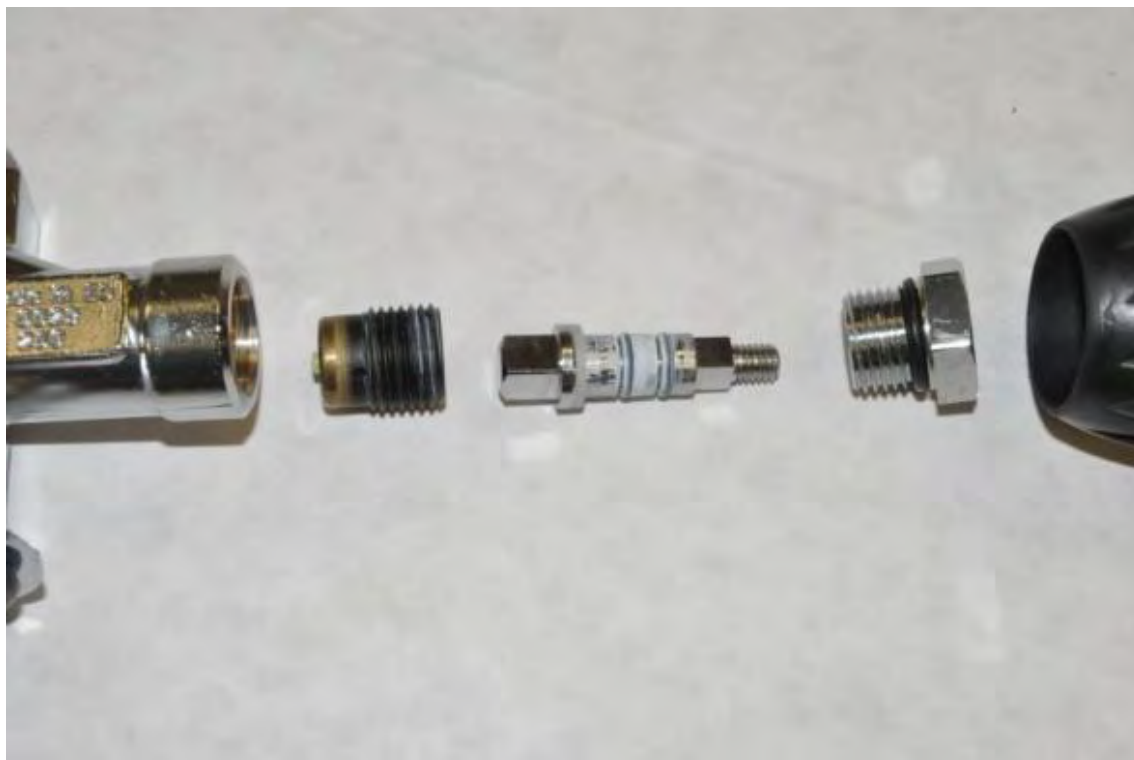
Figure 10. Rear view of the fully disassembled exemplar valve stem assembly showing the valve seat body and its orientation in the assembly.

Upon removal, RTI observed the stem to be covered in a white grease-like substance, and that it incorporated two polymer bushings and two O-rings, see **Figure 10**. The stem ended in a square mandrel approximately 8.53 mm long. RTI observed the inner wall of the portion of the valve body, within which the valve stem resides, to be threaded. A threaded, square bored valve seat

body resided at the inner end of this portion of the valve body. RTI removed it by reinserting the valve stem and rotating counter clockwise to unthread the valve seat body. Once removed, the valve seat body appeared to be made of bronze with a black colored coating over most of the surface area. **Figure 10** shows the valve seat body and provides orientation. The interior end incorporated a plastic valve seat.

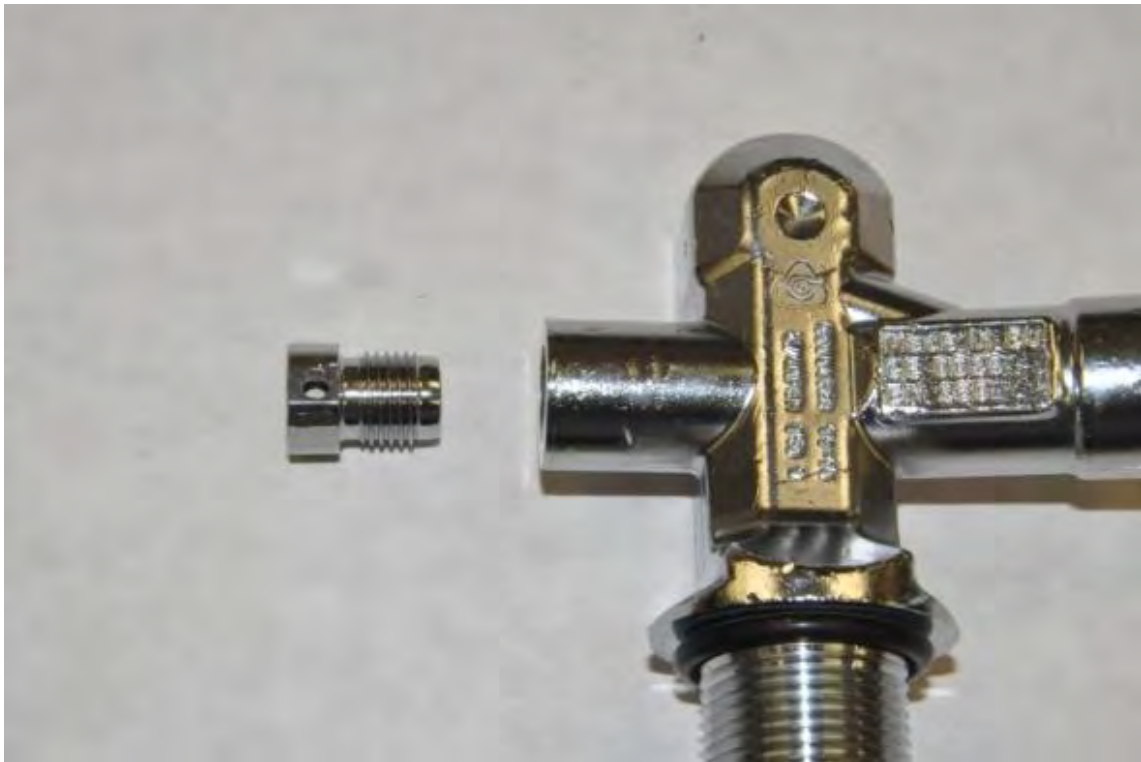
Figure 11. Rear view of the exemplar pressure burst disk assembly as removed from the valve body.

Referring to **Figure 11**, RTI next removed the pressure burst disk assembly, which consists of a hollow threaded plug, a 34.1 MPa (5000 psi) burst disk, and retaining rings. Threads on the plug stop short of the head by approximately 2.411 mm. The head of the plug is bored through, presumably to allow a dispersed release of excess high pressure gas should the burst disk fail. **Figure 12** shows the burst disk and retaining ring as installed in the plug. Markings on the outer surface of the assembly head indicate that the assembly is to be installed with 40.7 N-m (30 ft-lb) of torque.

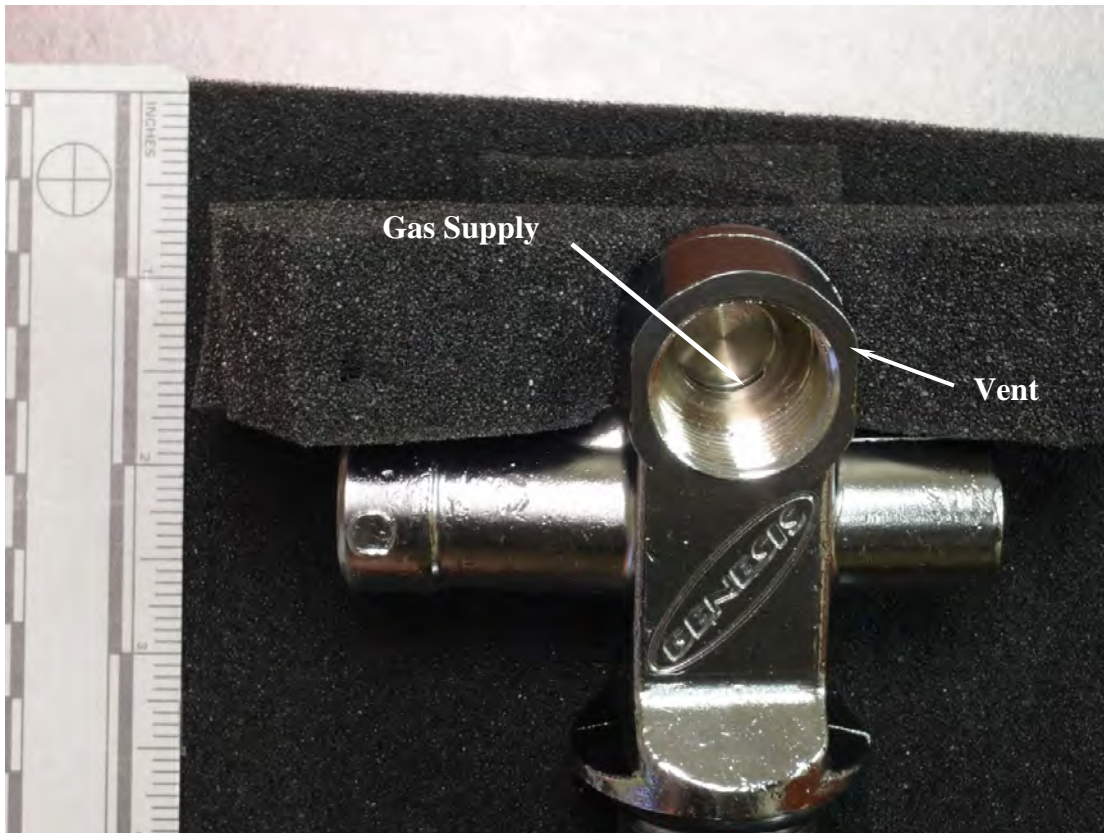
Figure 13. Front view of the exemplar cylinder valve showing the high pressure regulator port.

Finally, RTI removed the threaded protective insert into the high pressure regulator port. Removal of the insert revealed a shallow threaded bore leading to a gas supply rectangular opening proceeding down into the center of the cylinder valve body, indicated by the in **Figure 13**. Additionally, RTI observed a 1.9 mm diameter vent hole on the right side of the high pressure regulator port, indicated in **Figure 13**. This vent is approximately 7.42 mm forward of the rear inner surface of the port such that it is closed off when a fitting is fully threaded into the port.

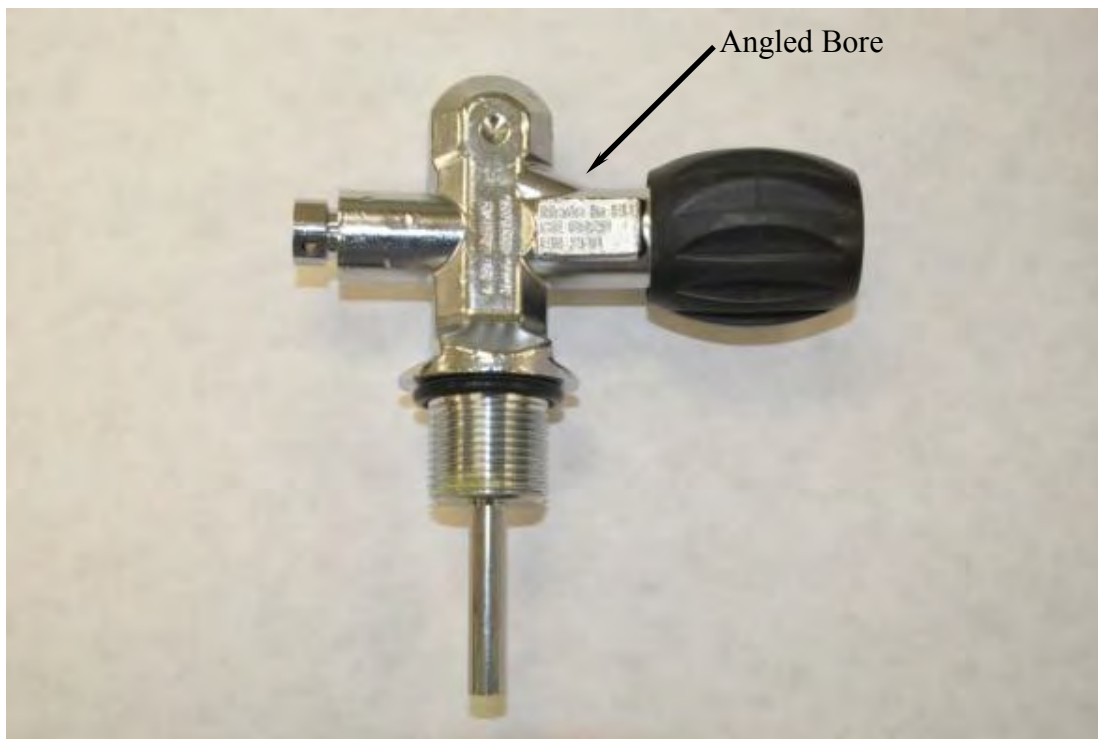
Figure 14. Rear view of the assembled exemplar cylinder valve showing the angled bore housing that connects the high pressure regulator port to the valve system assembly chamber.

Further detailed examination of the disassembled cylinder valve body revealed information about the path of high pressure gas from the cylinder through the valve. With the valve handle in the fully closed (inserted) position, high pressure gas flowing from the cylinder proceeds up through the pick-up tube and is directed against the valve seat to the left and the pressure burst disk to the right. As the valve is opened, the gas is allowed to flow past the valve seat and makes its way to the regulator port. This is accomplished by way of an angled bore connecting the valve stem bore to the regulator port. The rectangular cutout visible inside the regulator port is the outlet of

the angled bore. The external housing of the angled bore is indicated in **Figure 14** showing the rear view of the exemplar valve.

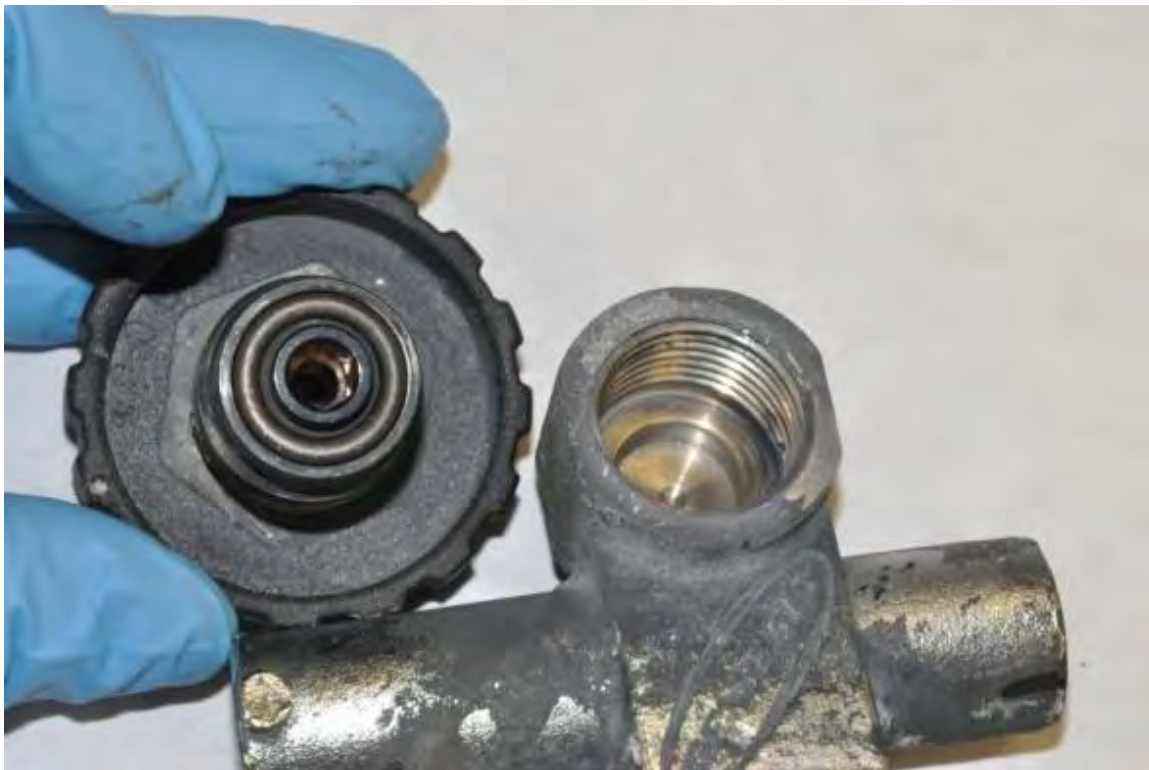
Figure 19. View of the incident valve high pressure regulator port showing discoloration sooting around the vent.

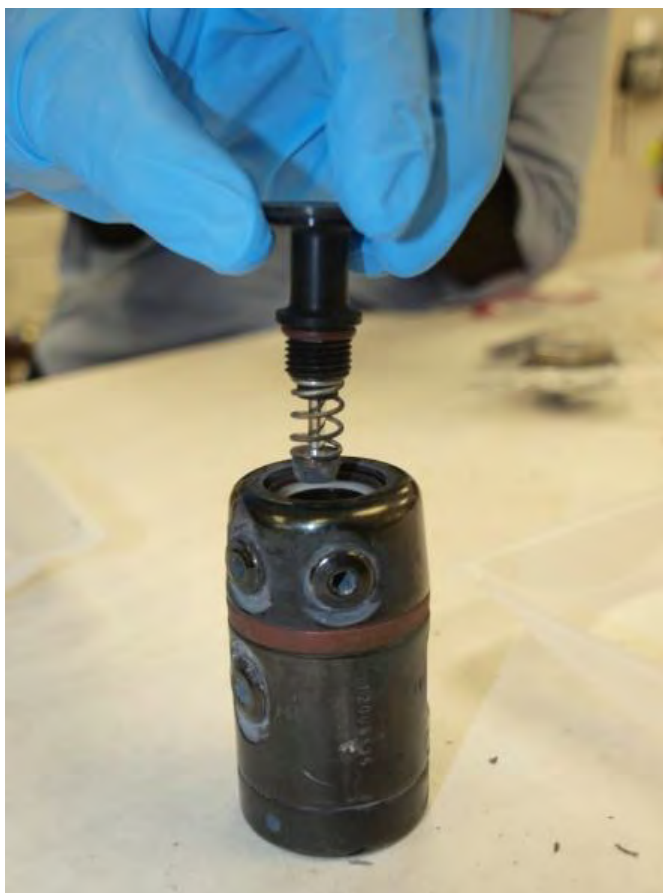
exposed high pressure port was again clean and bright. However, the bore between the port and the regulator barrel was covered in dark soot.

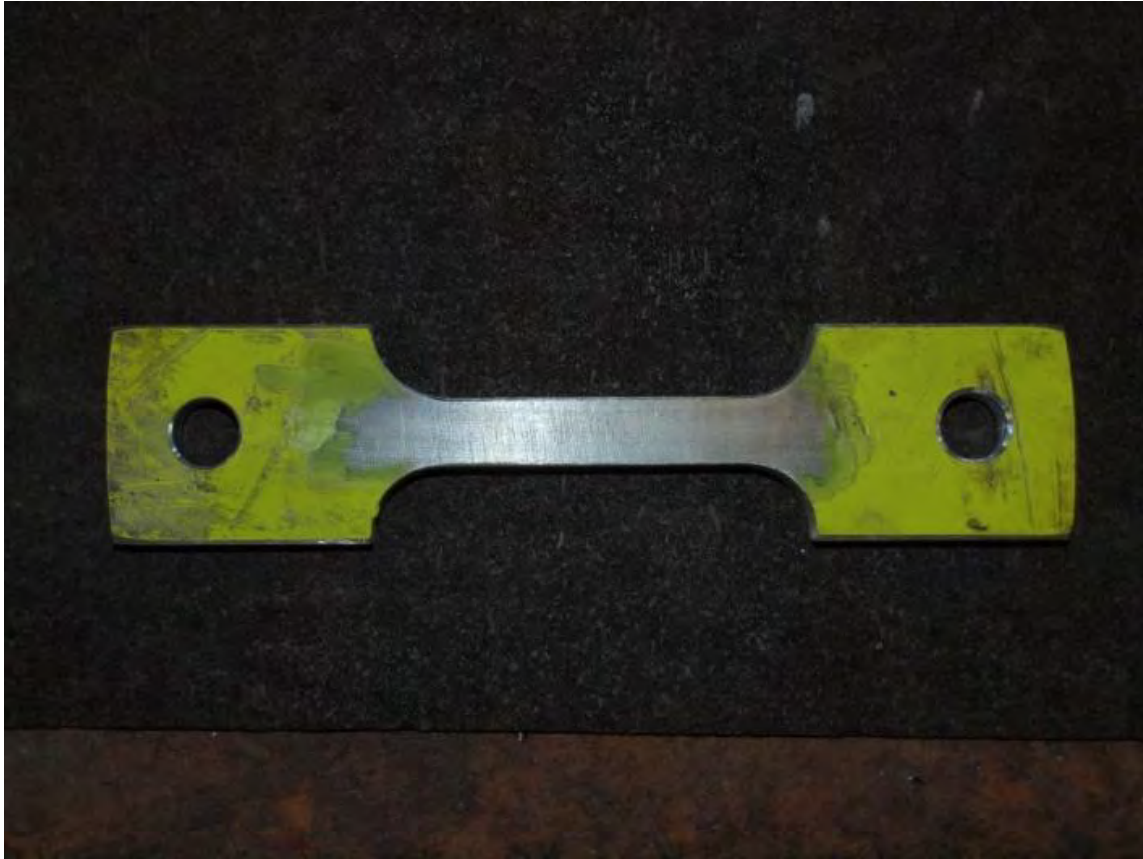
4.4.2 Machining

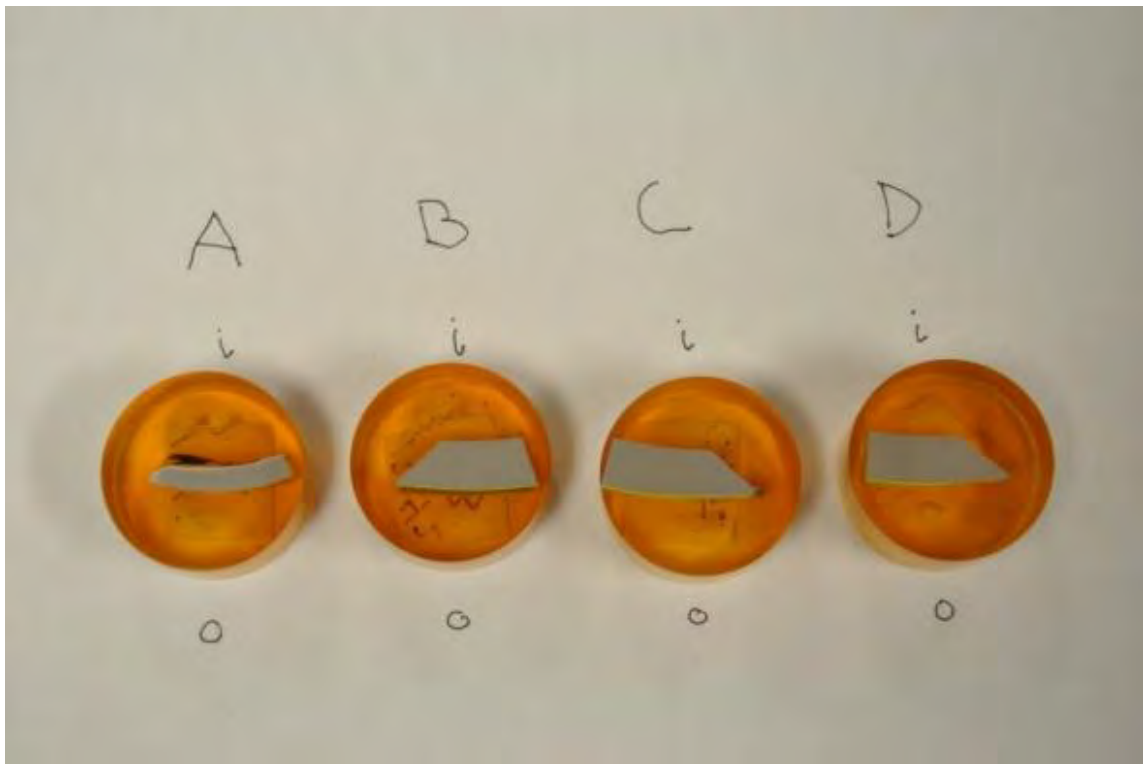
4.4.4 Metallographic Examination

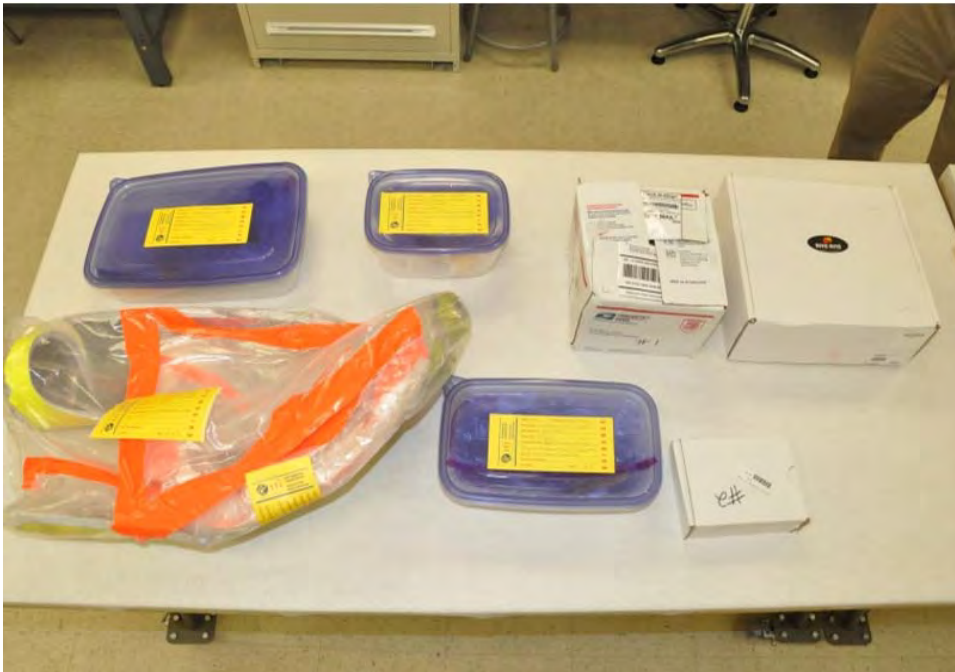
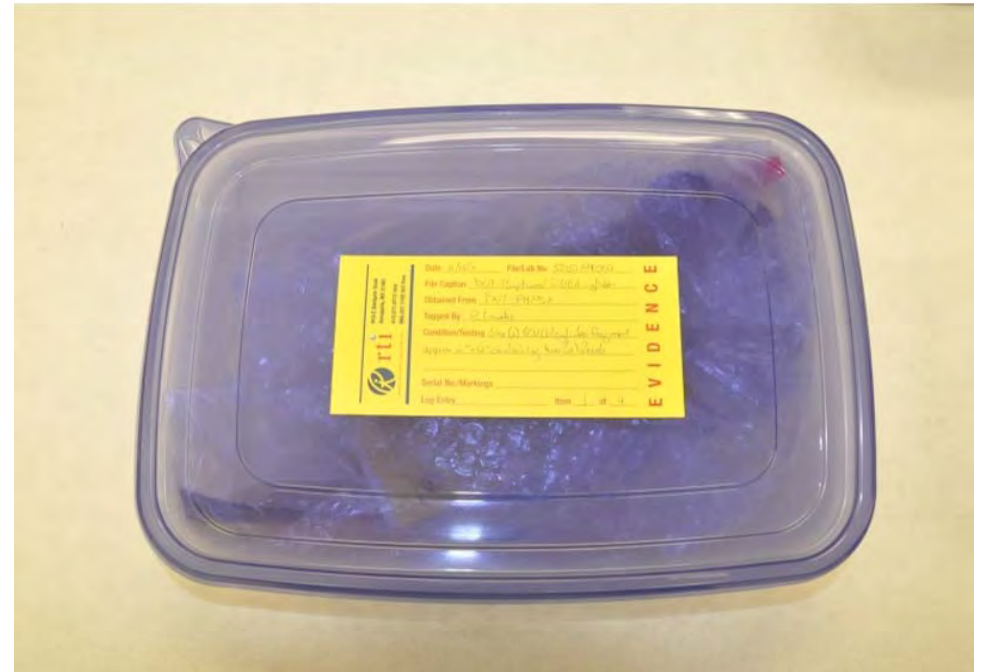
Date 11/15/11 File/Lab No. 5D151ME002
 File Caption DOT-Ruptured SCUBA Cylinder
 Obtained From DOT-PHMSA
 Tagged By R. Louder
 Condition/Testing One (1) SCUBA cylinder fragment approx 6"x12" containing two (2) decals.
 Serial No./Markings _____
 Log Entry _____ Item 1 of 4

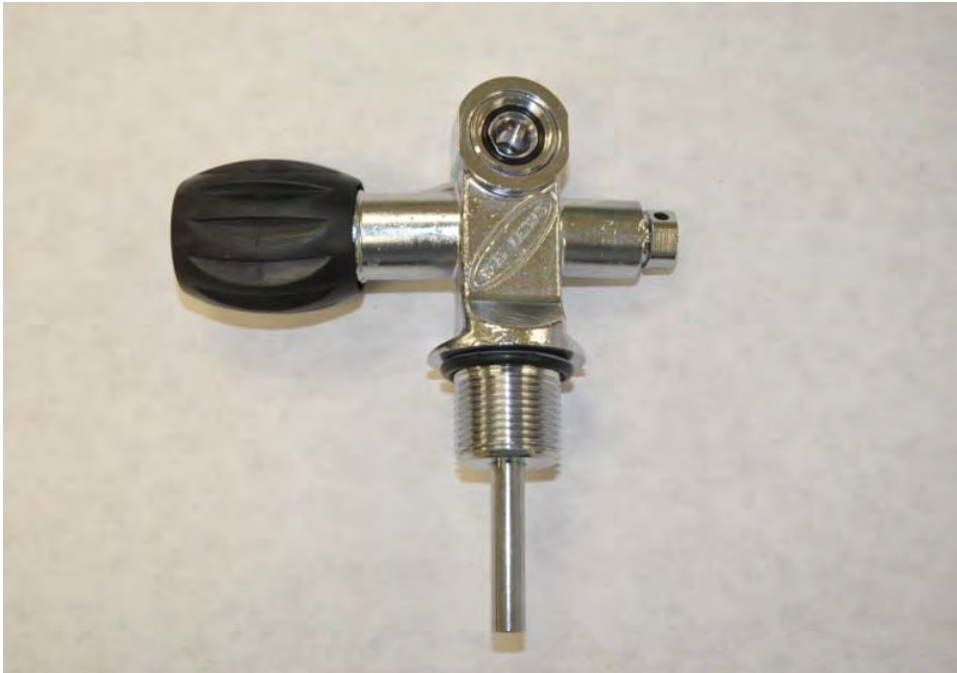
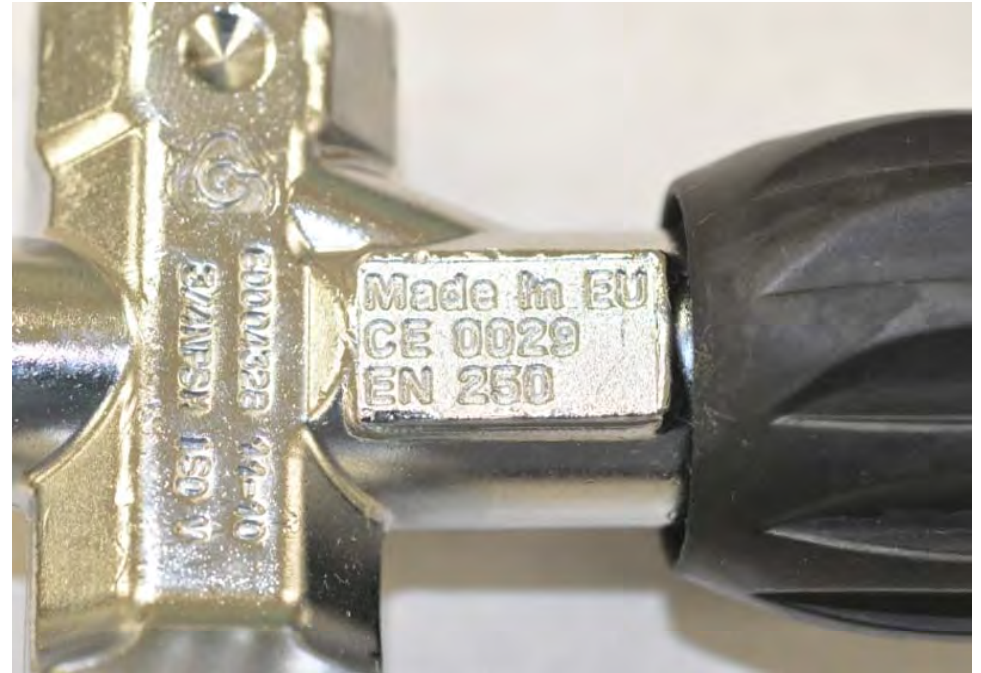
Date 12/30/11 File/Lab No. 50151.ME002
File Caption DOT-Ruptured SCUBA cylinder
Obtained From Dive Right In Scuba
Tagged By M. Wagenhofer
Condition/Testing Exemplar Valve #1
(Convertible 200 Bar Dia Valve)
Serial No./Markings 60004328 11-10
Log Entry _____ Item 1 of 2

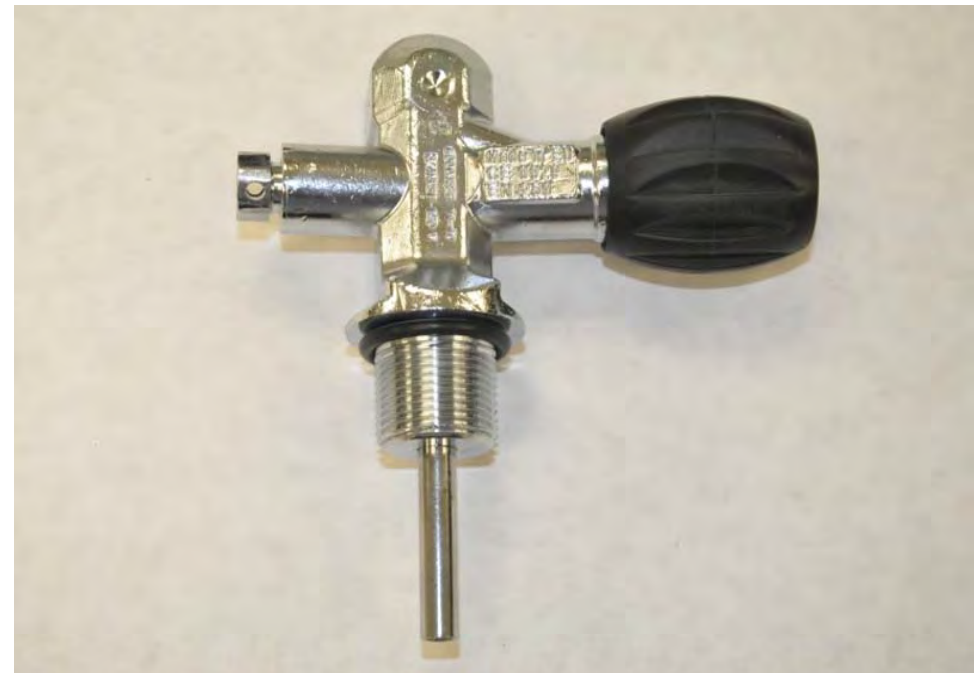
Condition/Testing Exemplar Valve #2
(Convertible 200 Bar Pin Valve)

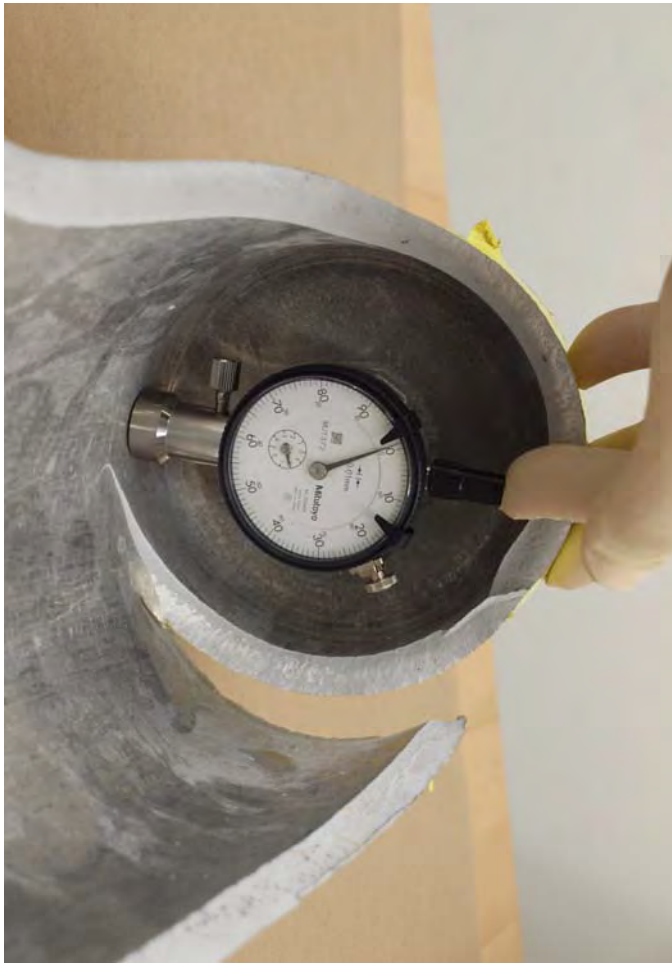
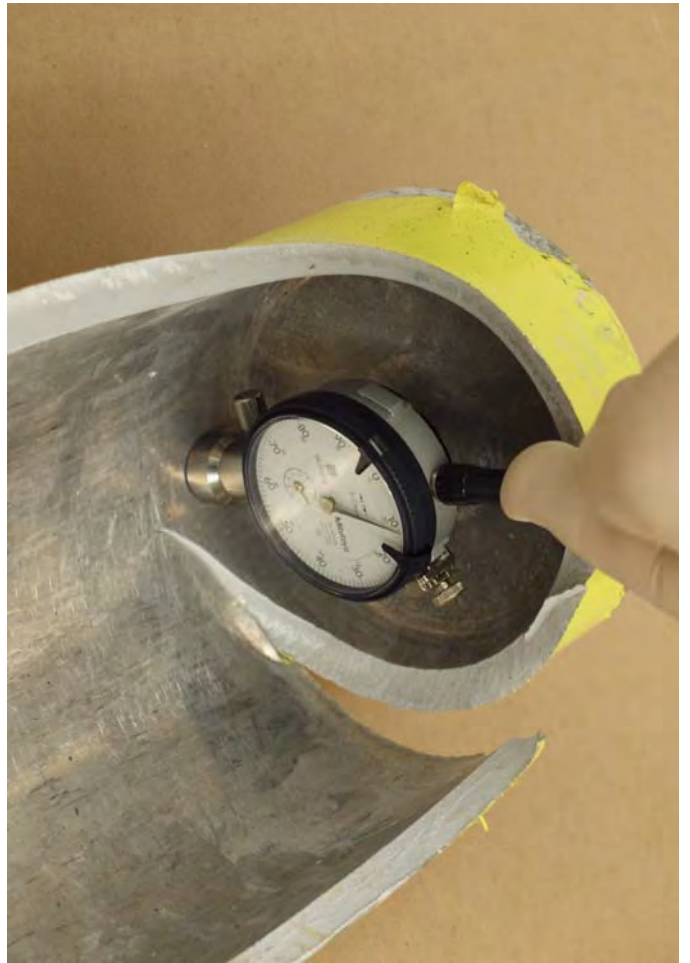
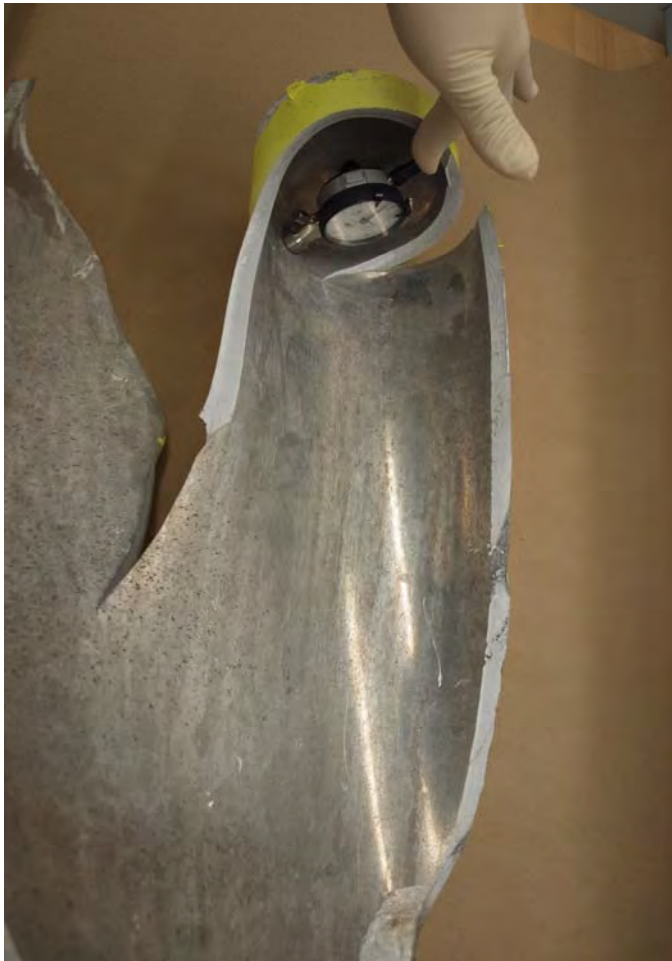
ATTACHMENT 14

Surface Curvature Measurements

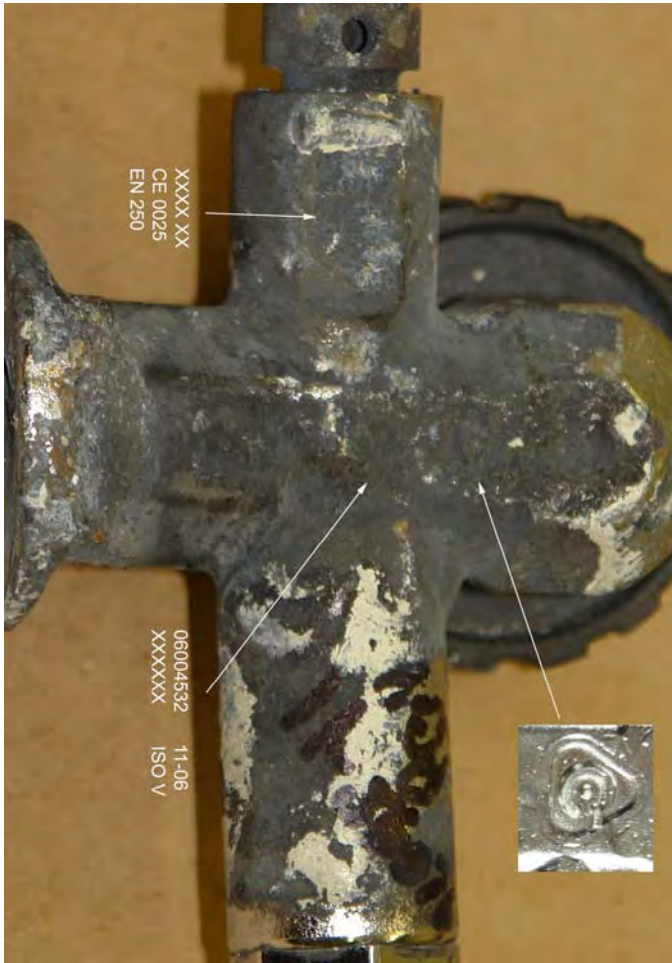
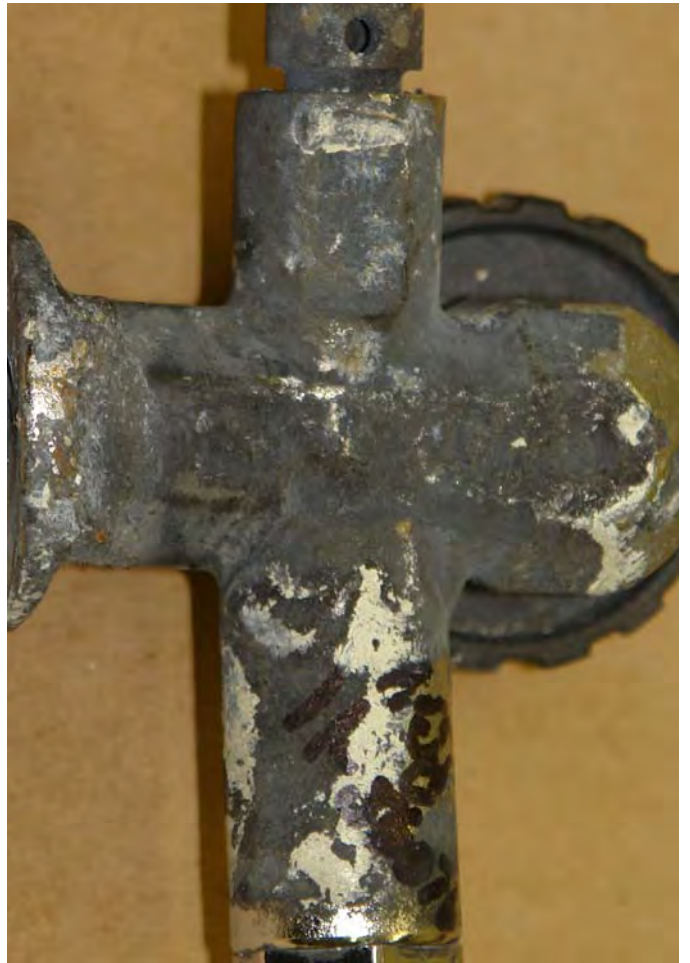
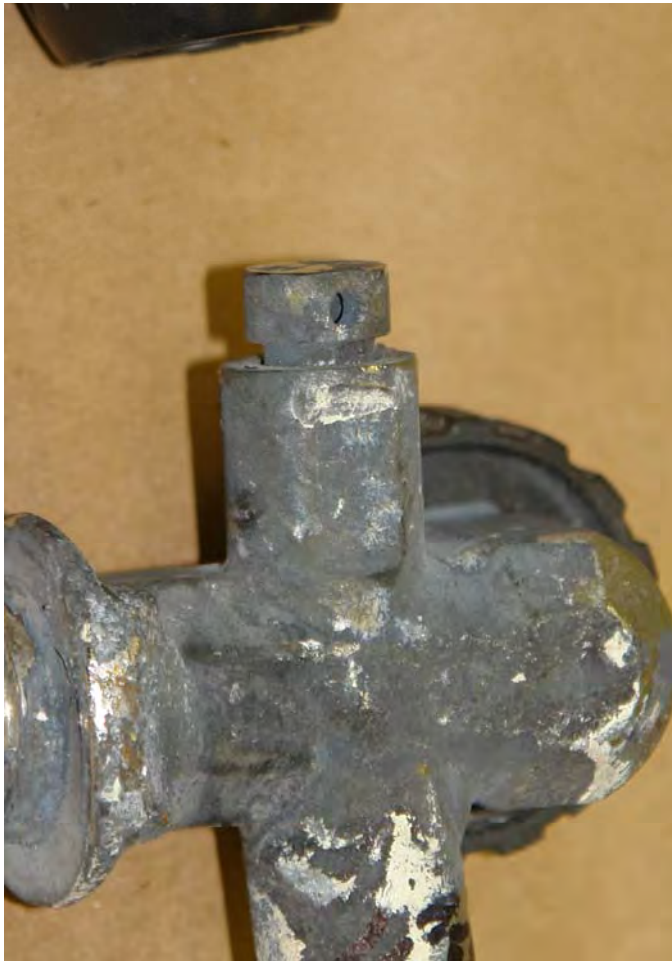
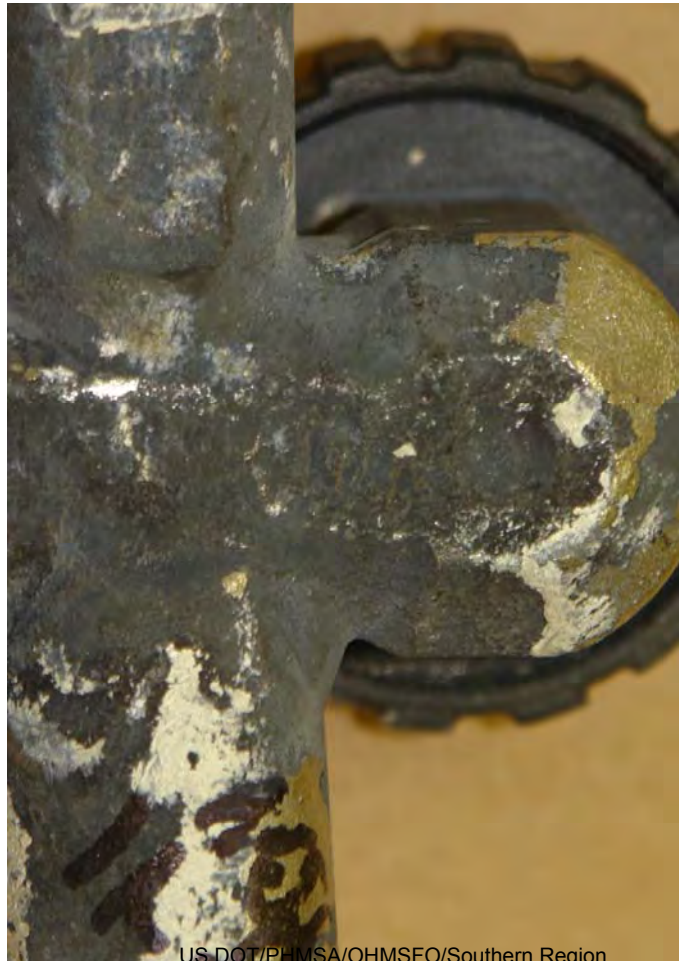
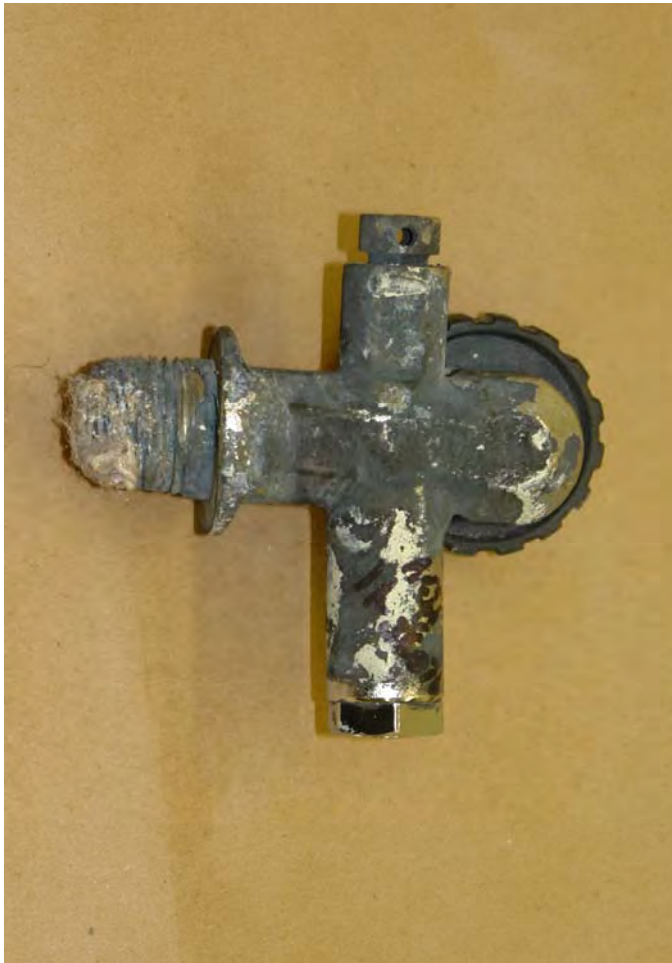
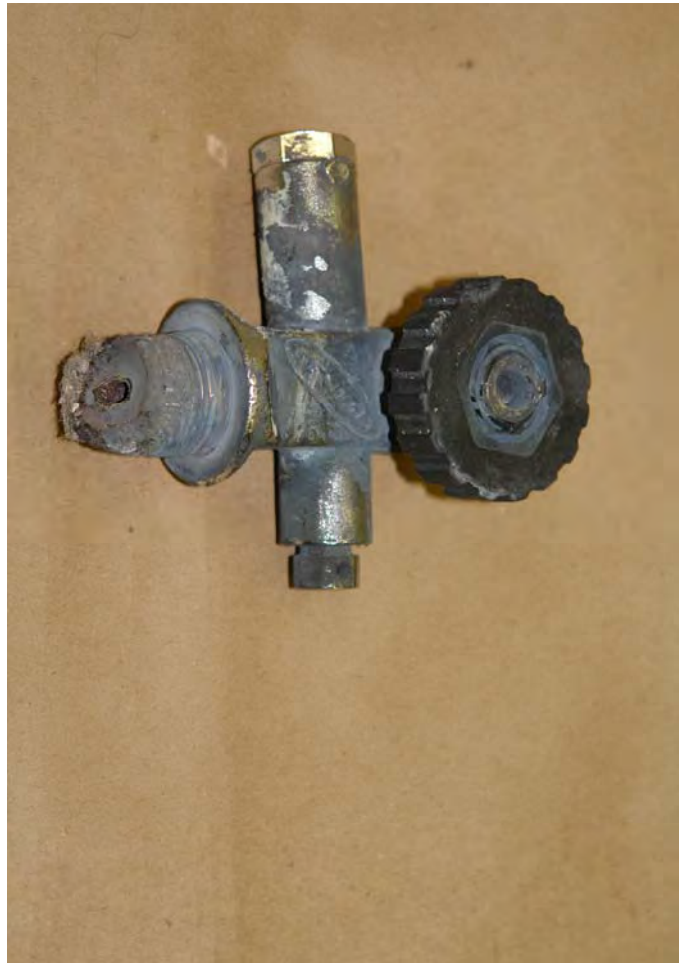
ATTACHMENT 15

Cylinder Valve Markings
