B-908 Aircraft Accident

STRUCTURES INVESTIGATION REPORT
CONCERNING ACCIDENT TO CIVIL AIR TRANSPORT
C-46 DM, B-908, NEAR TAICHUNG, TAIWAN,
ON JUNE 20, 1964

LABORATORY EXAMINATION OF ELEVATOR TRIM TAB CABLE FRACTURES

LABORATORY EXAMINATION
OF RIGHT AILERON DOWN CABLE FRACTURE

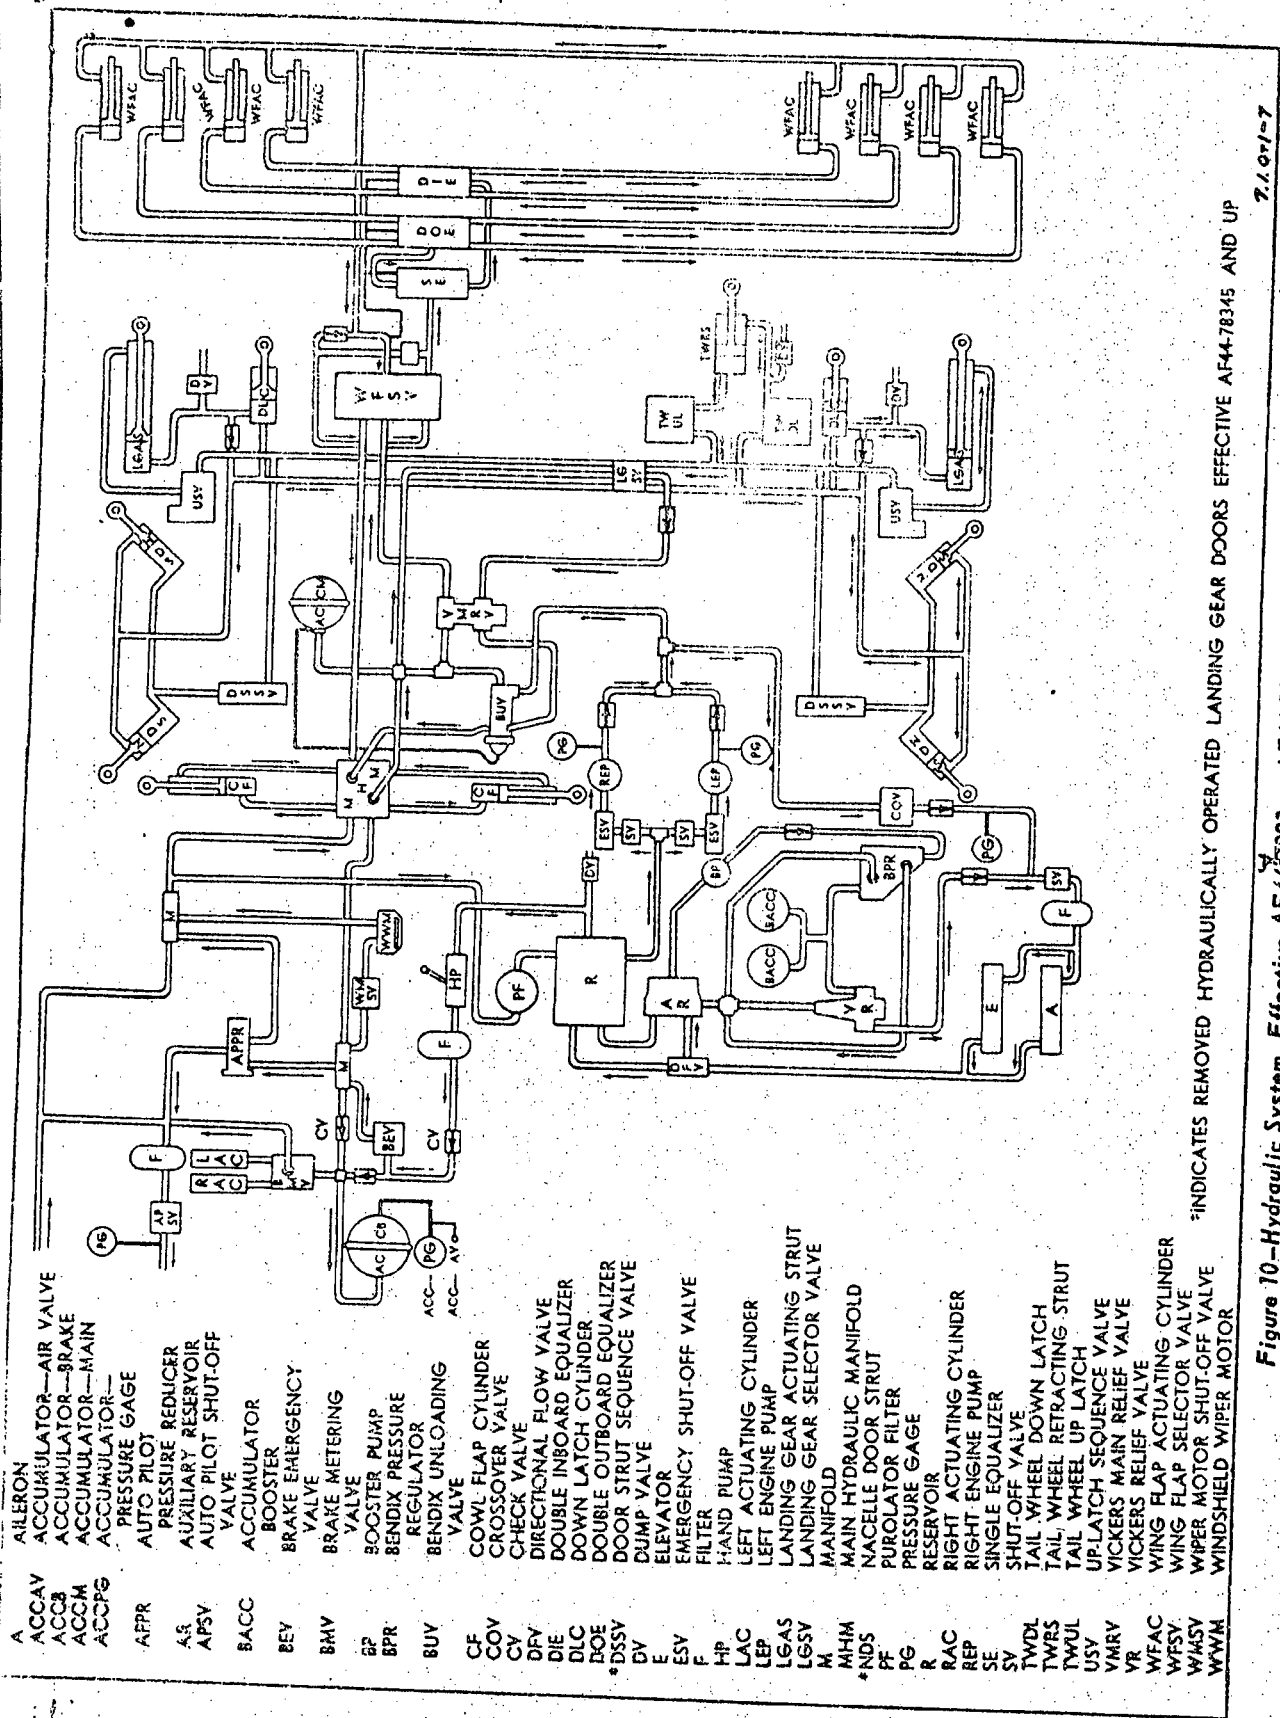
Figure 10—Hydraulic System, Effective AF44-7893 to AF44-7854 (Sheet 2 of 3 Sheets)

Different versions of the C-46 family have minor variations of the hydraulic system. However, the attached copy of Figure 10 from T.O. 1C-46A-1, Section II, page 18, shows a hydraulic system schematic drawing representative of most C-46 airplanes in regard to the general arrangement of the main hydraulic system and the lines to the autopilot. It is pertinent to add that the normal main system pressure was 1040 to 1350 psi on serial numbers prior to AF 44-77895 and 1100 to 1350 psi on serial numbers AF 44-77895 and up.

However, sufficient contamination of the hydraulic system to cause blockage of the main system filter, which returns fluid directly to the

main reservoir, can, with jammed check valves, cause back pressure in the brake and autopilot servo return lines capable of operating either, whether either system is "OFF" or "ON". This back pressure to any autopilot servo can approach nine times the normal maximum autopilot system pressure. If such a back pressure should occur it could require an extremely high pilot effort to overpower an unwanted action of the autopilot servo. The direction in which an autopilot servo will respond to any such back pressure is dependent on the position of the corresponding control valve at the time.

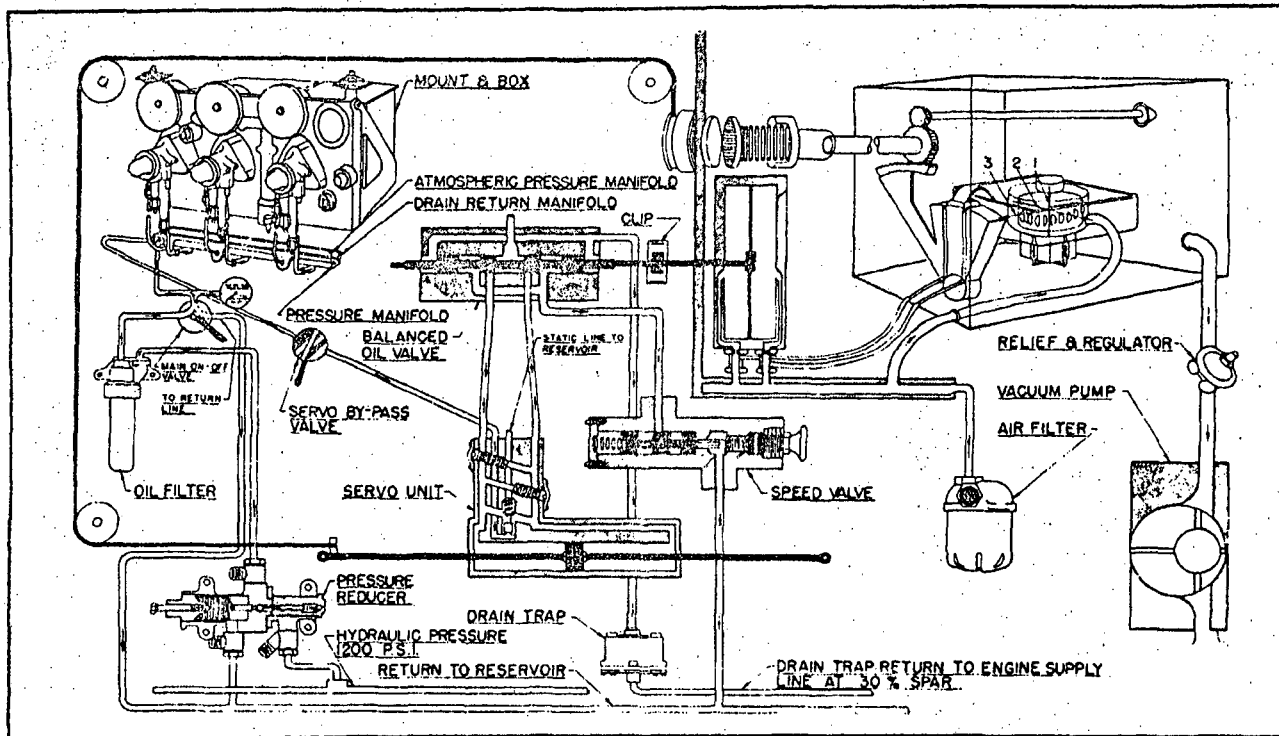
Figure 203—Automatic Pilot Schematic

Figure 203 on the attached copy of page 258, Section IV, Paragraph 17 of T.O. AN 01-251A-2 is a representative autopilot schematic drawing. The autopilot pressure reducer is designed to limit the hydraulic pressure in the autopilot system to 130 to 150 psi. With the maximum pressure of 150 psi a pilot can easily overpower any axis of the autopilot in the event of unwanted action thereof.
