SIGIR PA-08-138 July 25, 2008

SUBJECT: Report on Construction of the Kahn Bani Sa'ad Correctional Facility, Kahn Bani Sa'ad, Iraq (Report Number SIGIR PA-08-138)

Kahn Bani Sa'ad Correctional Facility, Kahn Bani Sa'ad, Iraq

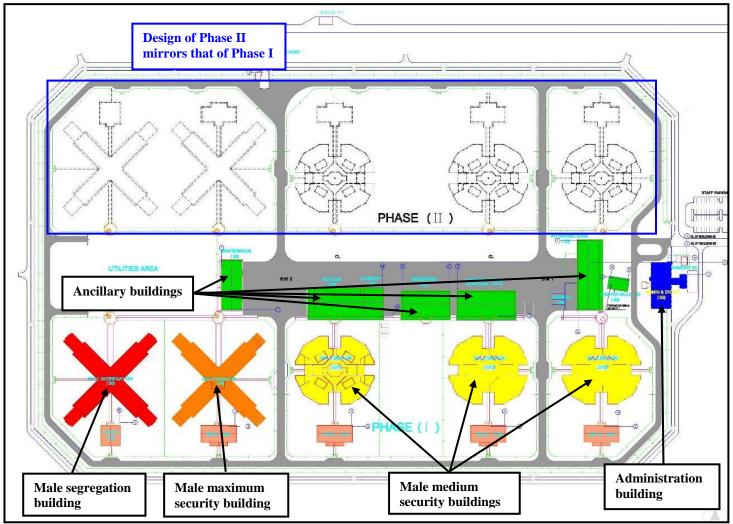
Figure 1. KBS Correctional Facility site plan

Parsons designed the Kahn Bani Sa'ad (KBS) Correctional Facility with living accommodation zones arranged as mirror images of each other, which reflects the two phases required for the project (Figure 1).

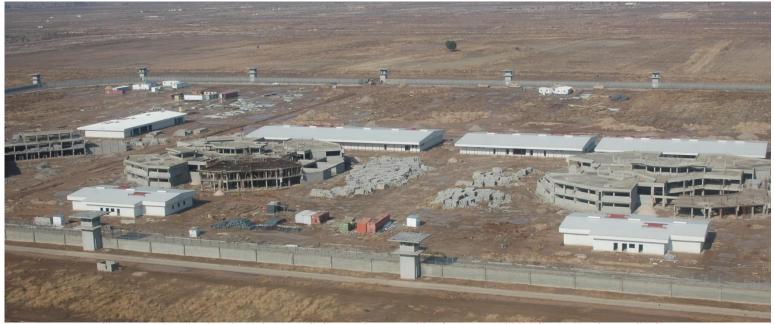
Site Photo 20. Aerial view of the KBS Correctional Facility from June 2007(Courtesy of the USACE)

GRD provided an inventory list of materials reportedly left on site by the follow-on contractor after being terminated (Appendix C). However, GRD photographs from June 2007 do not support the claim that more than \$1.2 million of materials were left on site (Site Photo 20). Certain items, such as chain link fence and concrete blocks, are noticeable in the photo; however, there are five conex boxes on site, the contents of which could not be determined. What is not visible, which would not be stored within conex boxes, is the most expensive material on the list – gravel. According to the inventory document at the time of termination, 15,000 cubic meters worth of gravel, valued at \$600,000, was on site. There was no documentation available to confirm that GRD inventoried the actual materials on site.

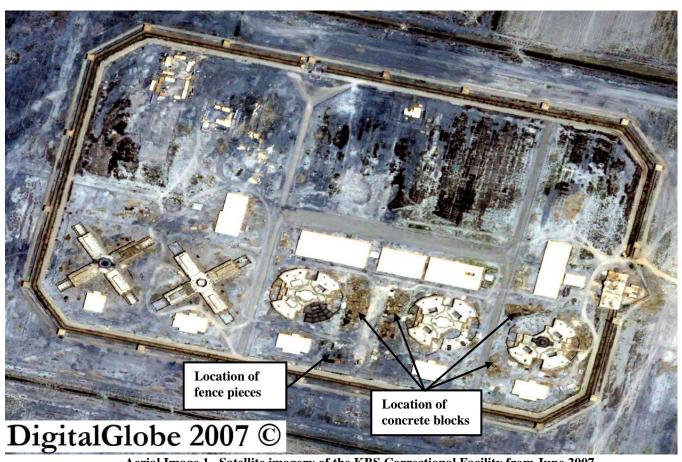
Aerial Image 1. Satellite imagery of the KBS Correctional Facility from June 2007

In an effort to determine the amount and location of any unused materials, SIGIR, utilizing its Satellite Imagery department, found imagery from the time period (Aerial Image 1). The imagery also confirmed the absence of \$600,000 worth of gravel at the site.

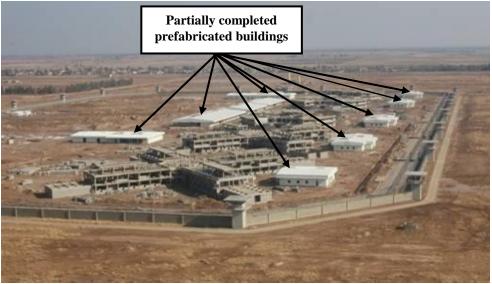
Site Photo 25. Aerial view of KBS Correctional Facility (Courtesy of the USACE)

SIGIR observed several partially completed prefabricated buildings at the facility (Site Photo 25). SIGIR inspected one building and found the concrete foundation had been

While not complete, the GoI should be able to make some functional use of the facilities.
