1 **Encinitas-Solana Beach Coastal Storm Damage**
2 **Reduction Project**

3
4 **San Diego County, California**

5
6 **Appendix C**

7
8 **Geotechnical Engineering**
9
10

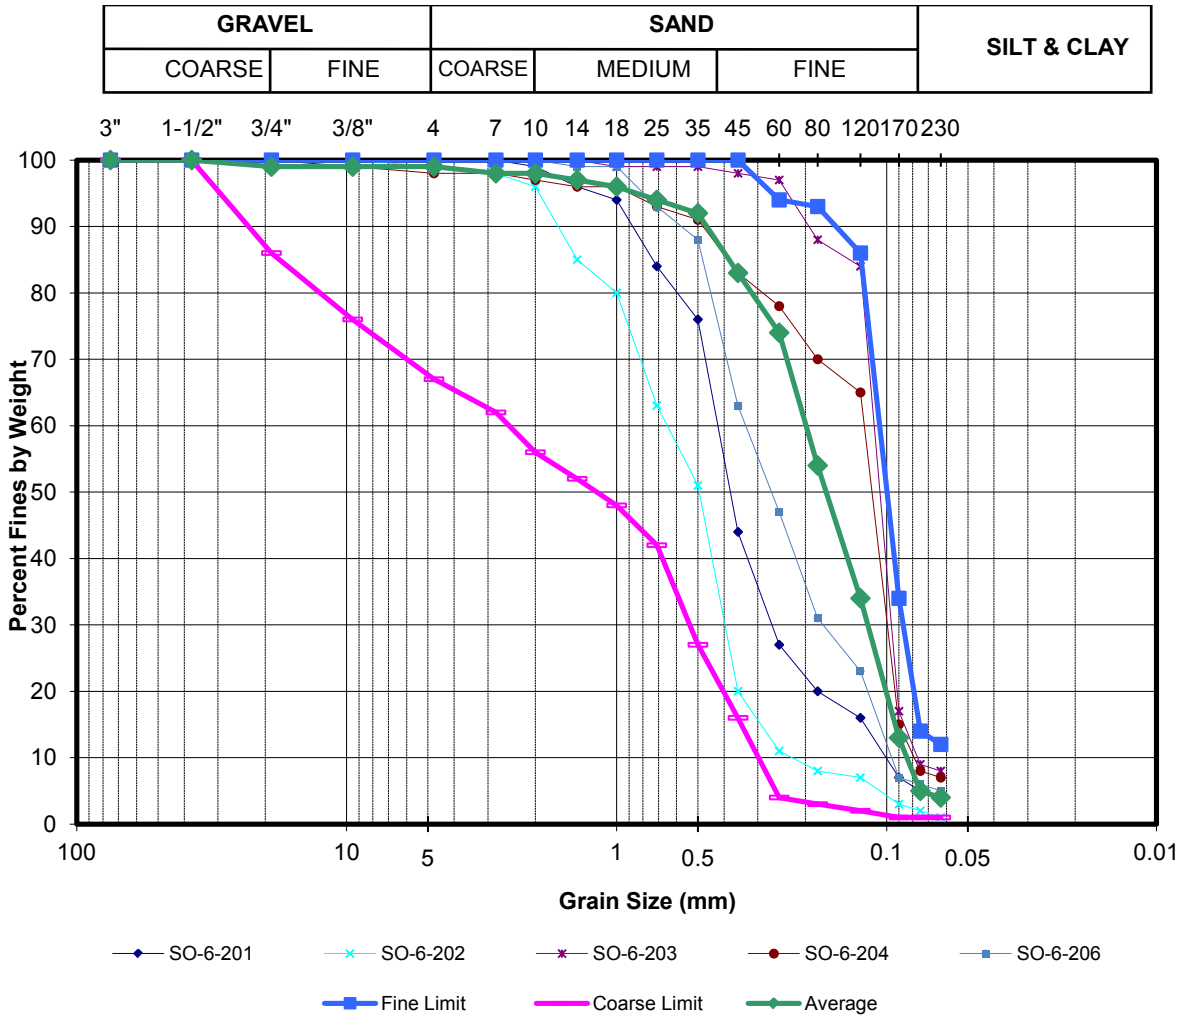
"RSBP II SO-6 offshore borrow site" (revised by USACE 2011)
Beach Compatibility Gradation Curves To 20 feet Depth for RSBP II vibracores SO-6-201, 202, 203, 204 and 205, using 2009 RBSP beach profile transect data.

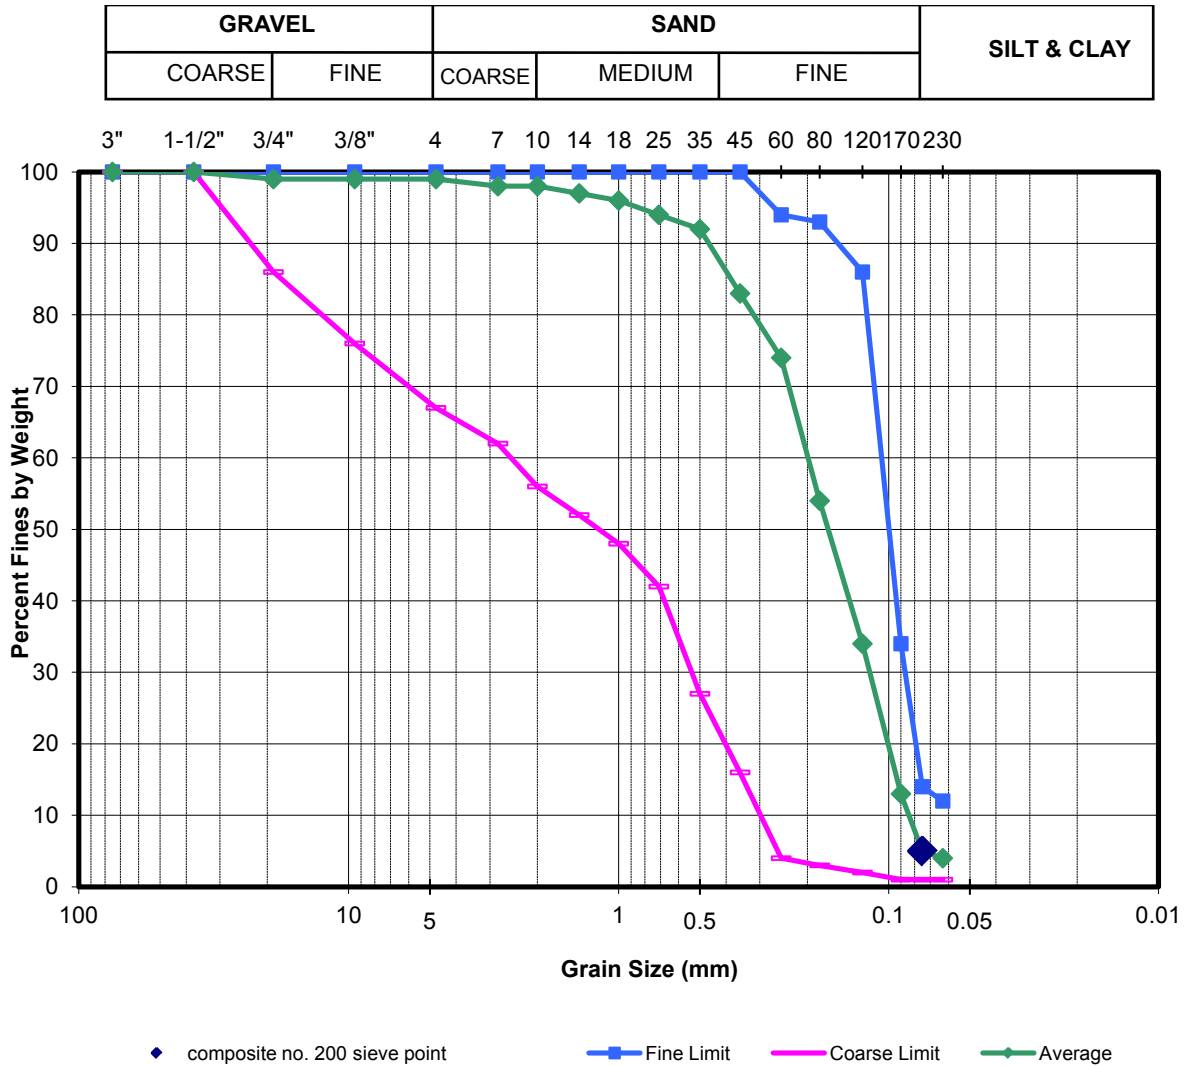
"USACE no.2 and RSBP II SM-1 offshore borrow areas" (revised by USACE 2011)
 Beach Compatibility points based on no. 200 sieve to 20 feet Depth for RSBP I&II and USACE vibracores, using 2009 RBSP beach profile transect data.
