Suggested Practices for Avian Protection On Power Lines: The State of the Art in 2006

PIER FINAL PROJECT REPORT CEC-500-2006-022

Avian
Power
Line
Interaction
Committee

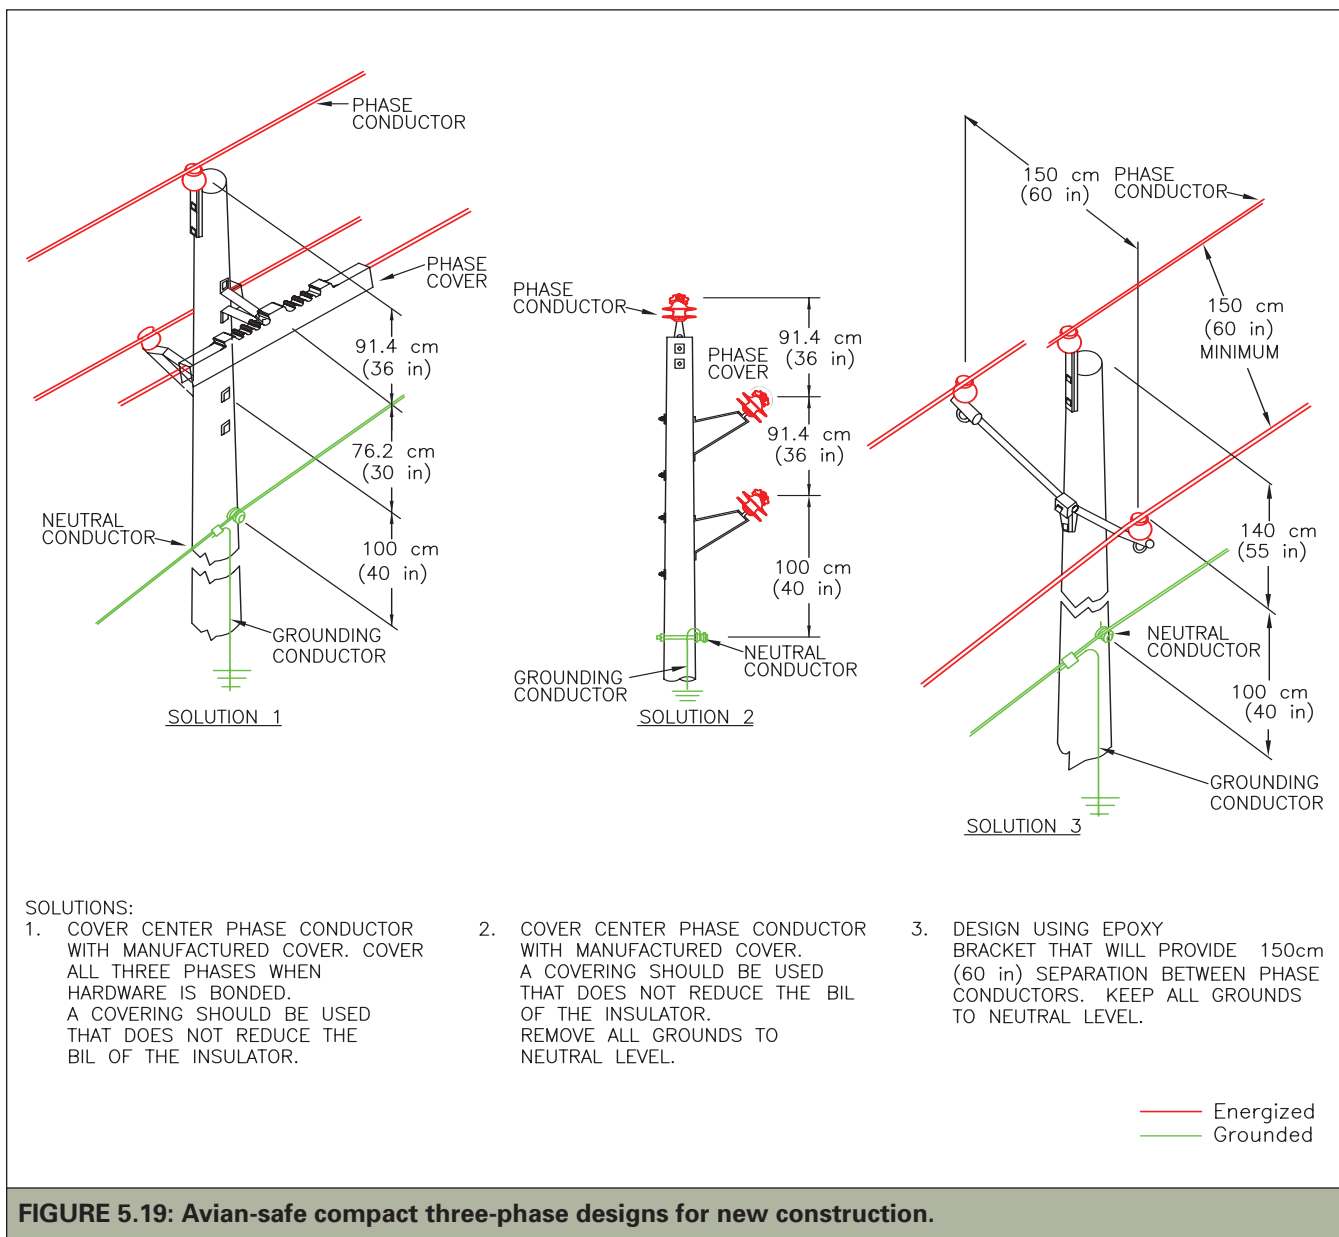
FIGURE 5.19: Avian-safe compact three-phase designs for new construction.

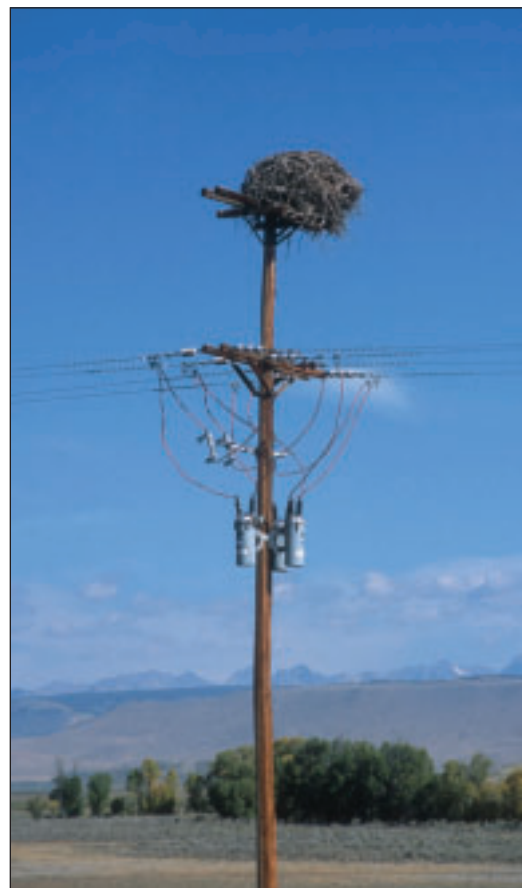
FIGURE 6.16: Osprey nest in Wyoming atop double dead-end pole. Nesting material that may drop onto the conductors or equipment poses fire, outage, and equipment damage risks.
