**AL ESCANDDRONA SCHOOL
UNDER THE COMMANDER'S EMERGENCY RESPONSE PROGRAM
BAGHDAD, IRAQ**

SUSTAINMENT ASSESSMENT

**SIGIR PA-07-110
JANUARY 14, 2008**

SUBJECT: Report on the Rehabilitation of the Al Escandrona School in the Karadah district of the city of Baghdad, Iraq (Report Number SIGIR PA-07-110)

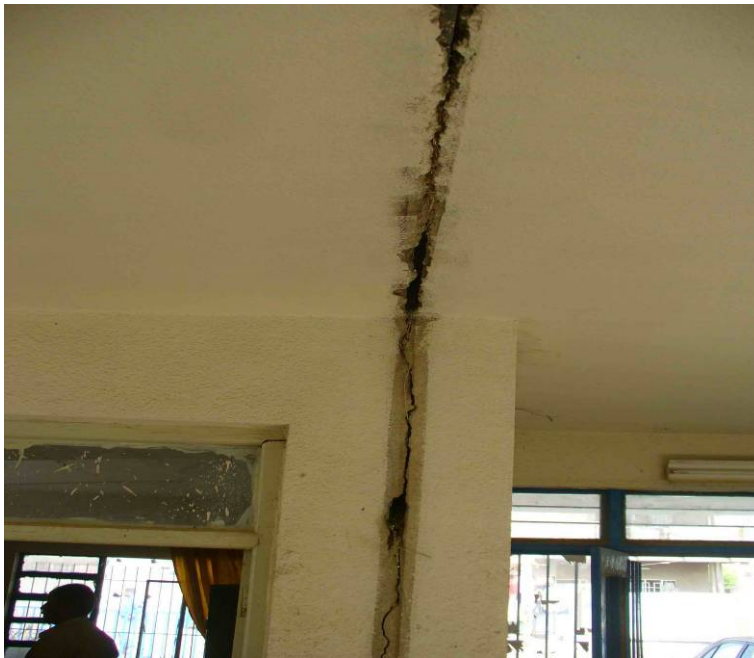
Before the rehabilitation project, the Al Escandrona School was in major disrepair due to years of neglect. The school had cracks in the school room (Site Photo 1), loose electrical wiring (Site Photos 2 and 3), broken windows that posed safety hazards for the children (Site Photo 4), and an unusable lavatory.

Site Photo 1. Open expansion joint before renovation (Photo courtesy of USACE)

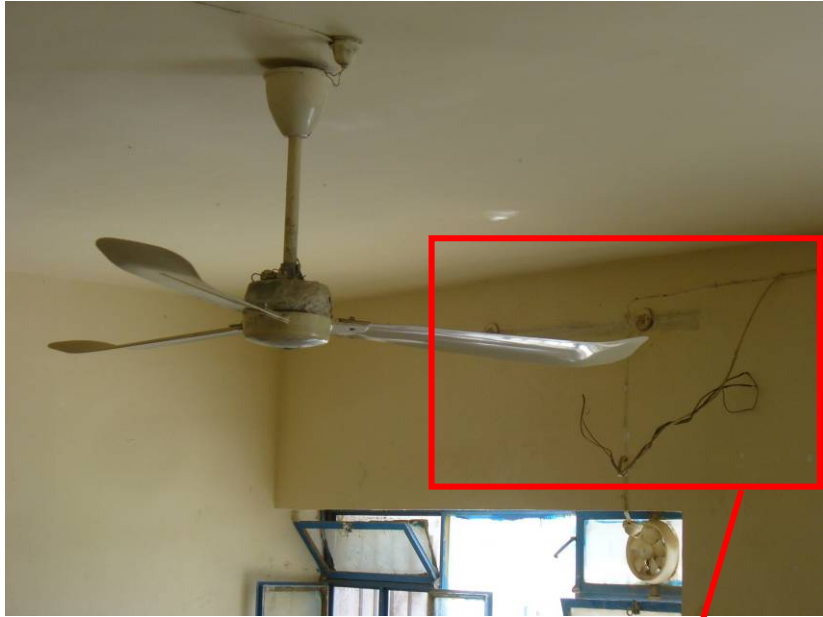
Site Photo 2. Loose electrical wiring before renovation (Photo courtesy of USACE)

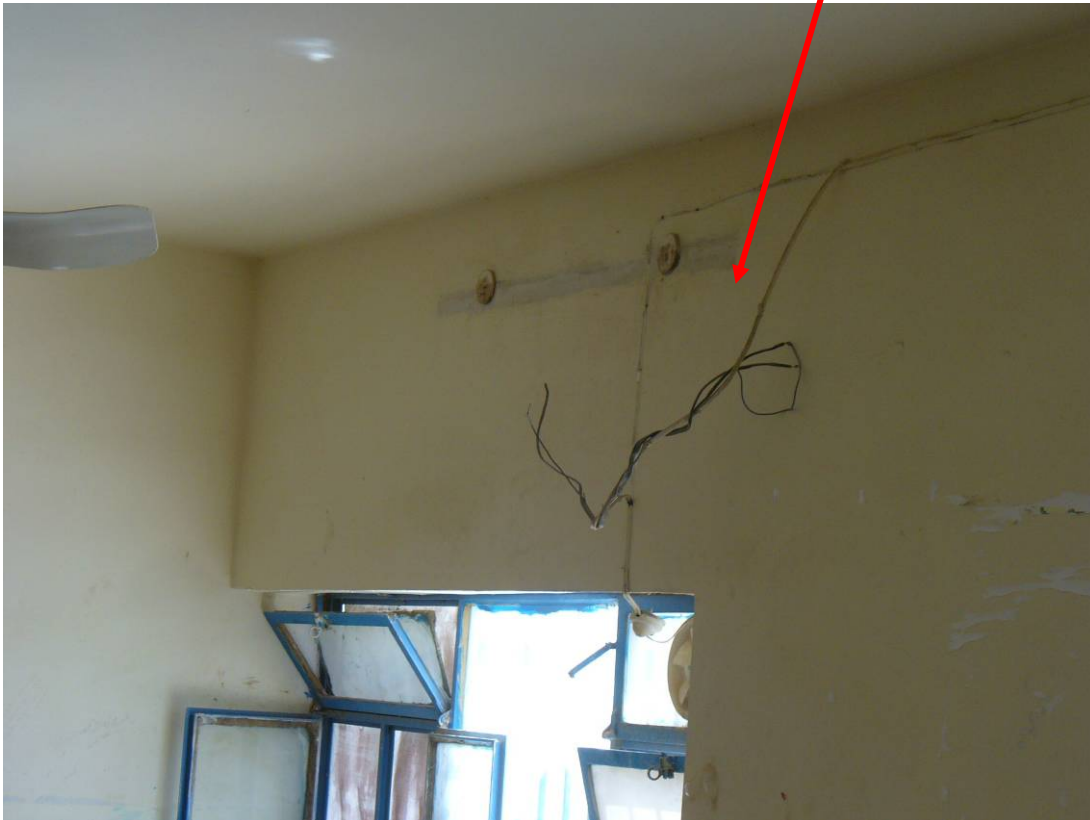
Site Photo 3. Broken light fixture with unsafe wiring before renovation (Photo courtesy of USACE)

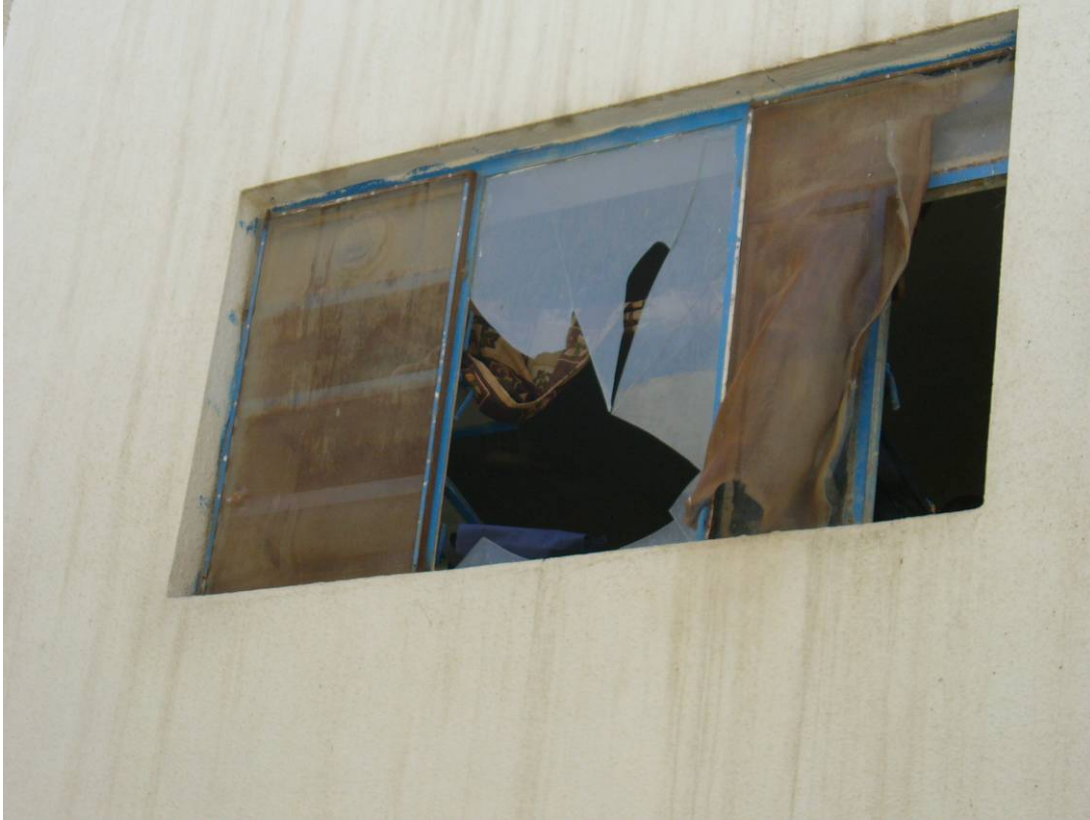
**Site Photo 4. Safety hazard – broken windows at the school before renovation
(Photo courtesy of USACE)**

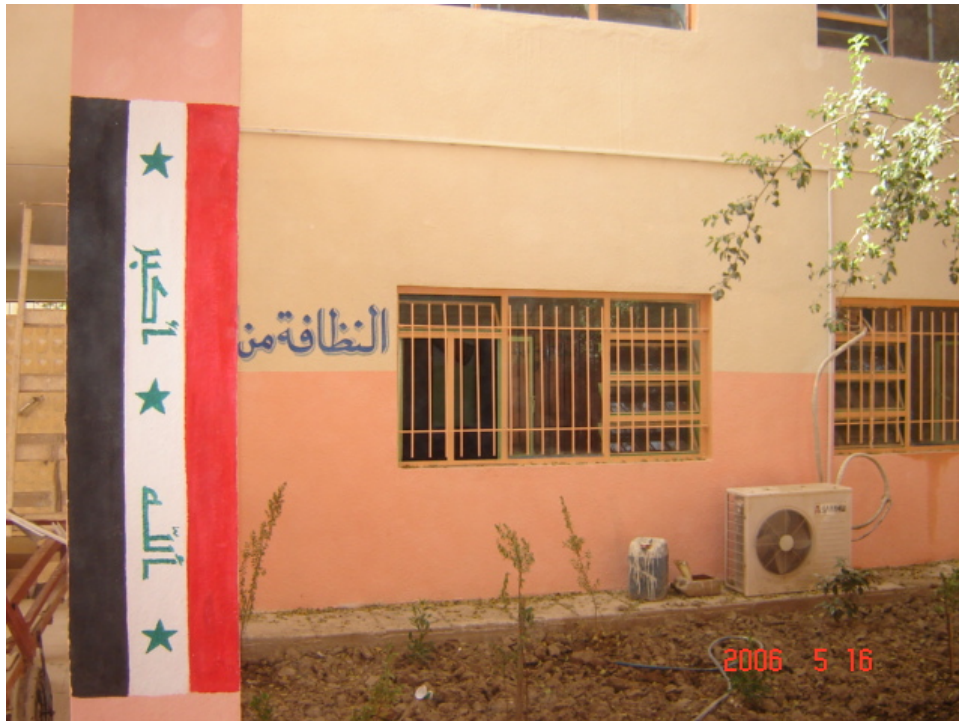
The contract called for general maintenance to be performed by the contractor on the building roof, walls, windows, doors, and exterior and interior painting. Site Photo 5 shows the school's exterior painting by the contractor.

Site Photo 5. Exterior painting after renovation (Photo courtesy of USACE)

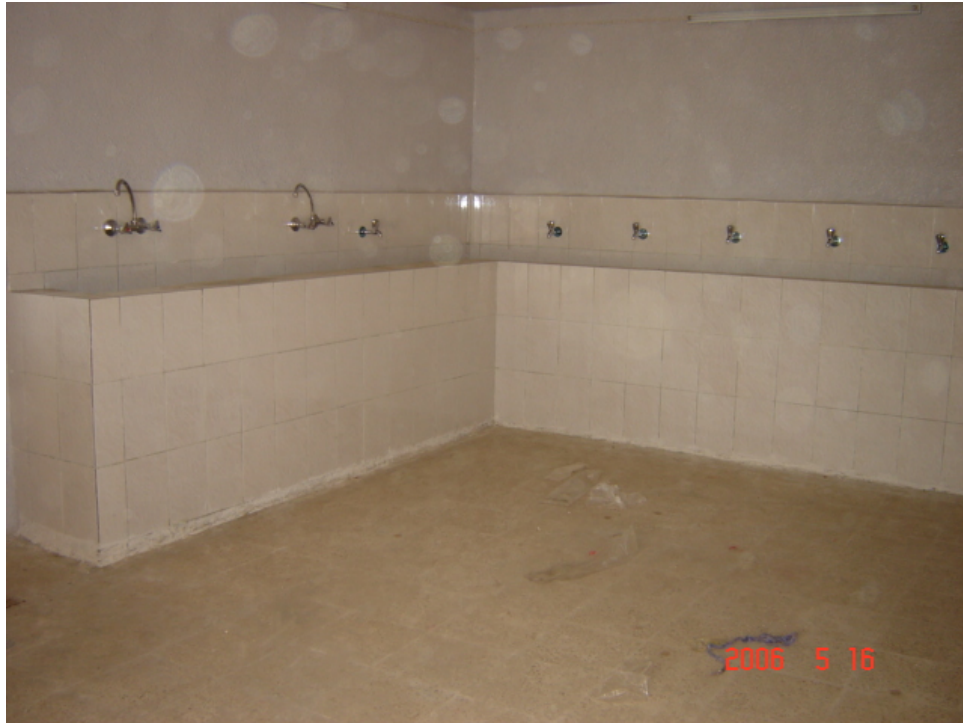
The contractor rehabilitated the lavatories, as required by the contract. Site Photo 6 shows the contractor's performance in tiling the lavatory and installing the sinks. The contractor installed new eastern-style toilets as well.

Site Photo 6. Sinks after renovation (Photo courtesy of USACE)

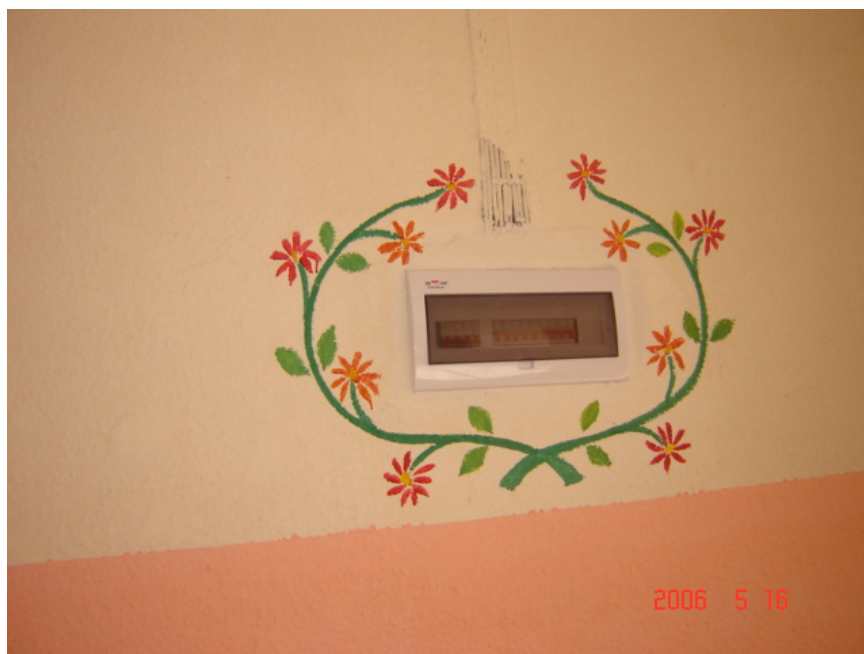
According to the contract, the contractor was to replace all electrical building network wiring. Site Photo 7 shows the electrical rewiring, the new electrical switch plates are shown in Site Photo 8, and the contractor-installed new air conditioning unit is shown in Site Photo 9.

Site Photo 7. Interior painting and electrical rewiring after renovation (Photo courtesy of USACE)

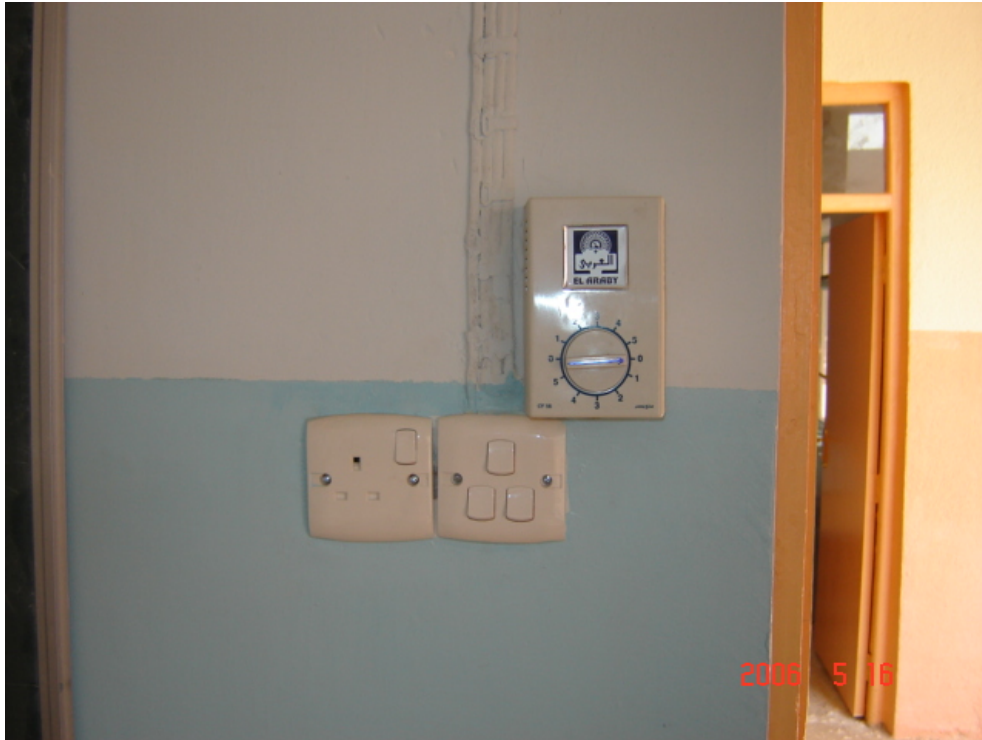
Site Photo 8. Correctly installed electrical switches and ceiling fan control after renovation (Photo courtesy of USACE)

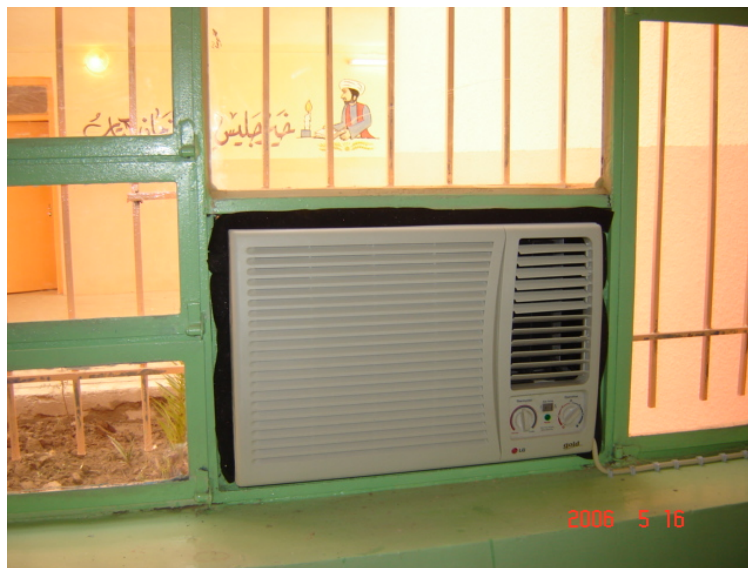
Site Photo 9. Proper air conditioning installation after renovation (Photo courtesy of USACE)

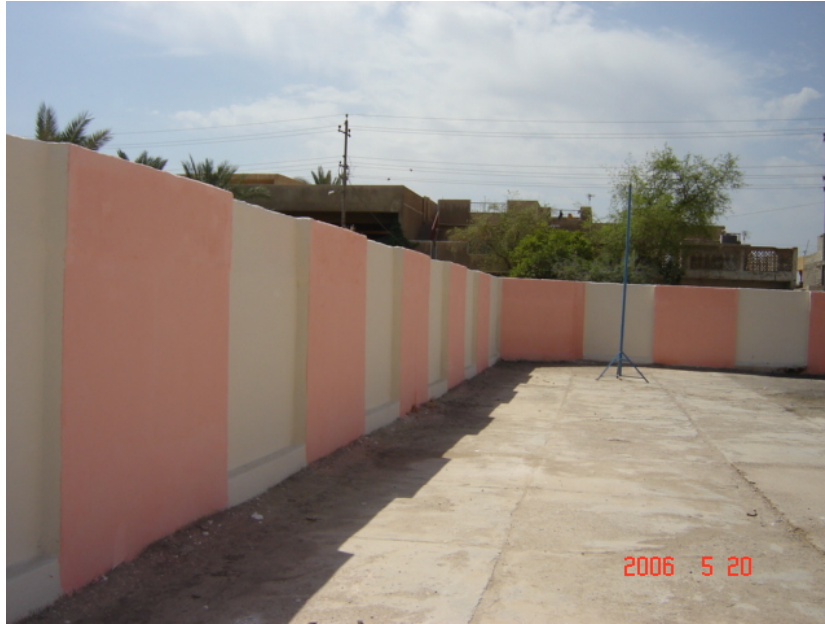
The contract stated that the contractor was to provide and install a security fence, and Site Photo 10 shows the fence/wall provided by the contractor as well as the painting for the fence/wall.

Site Photo 10. New masonry compound fence/wall (Photo courtesy of USACE)

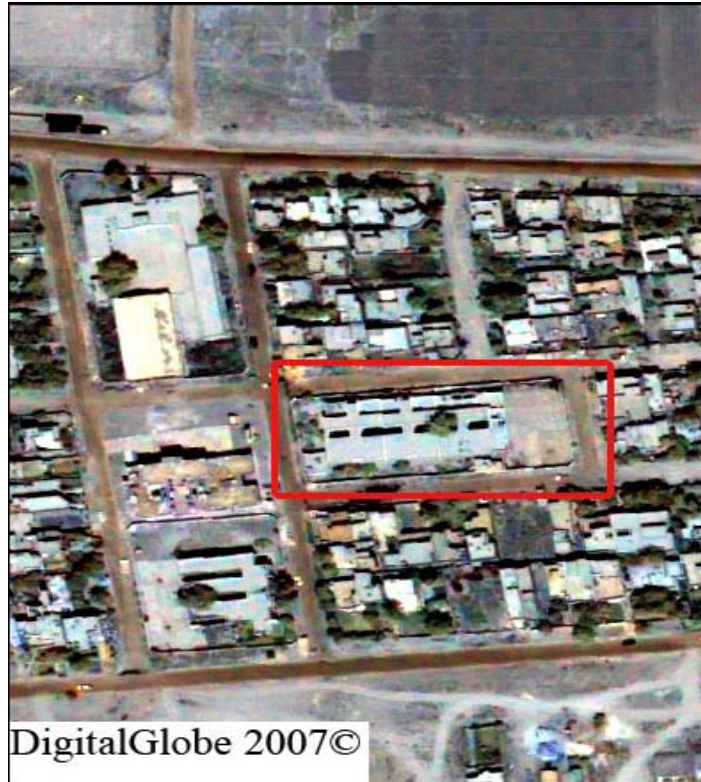
Aerial Image 1. Imagery overview of the Al Escandrona School taken on 16 September 2007.

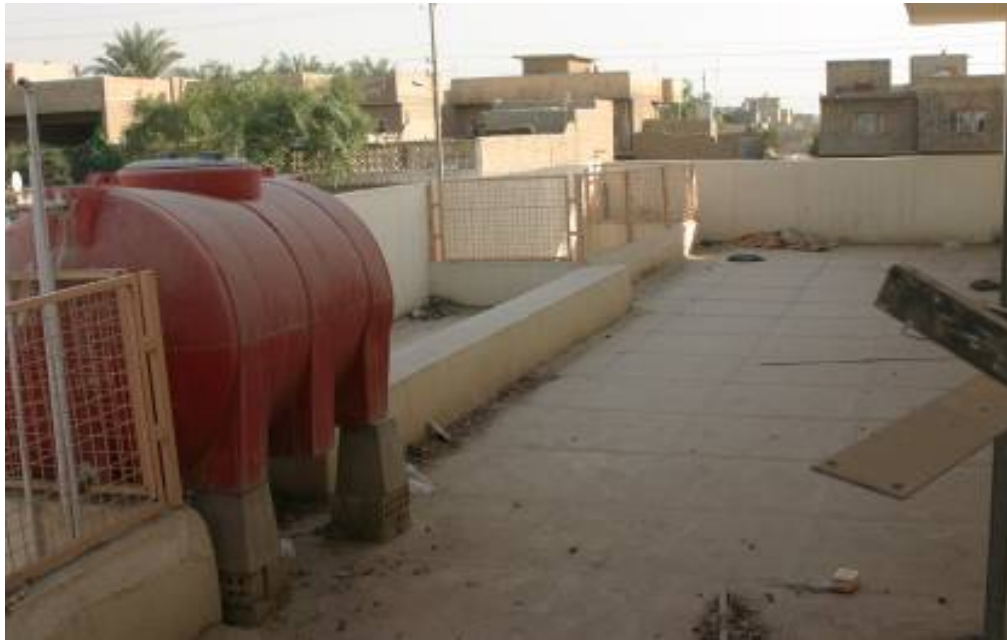
- general maintenance for the building roof, (Site Photo 11) walls, windows, doors, and painting on the exterior and interior (Site Photo 12)
- rehabilitated lavatory
- supply and installation of a new water plastic tank (Site Photo 11)
- replacement of all electrical building network wiring
- provision and installation of a 2.5 meter tall security fence (Site Photo 13)

Site Photo 11. Roof maintenance after occupancy and use (Photo courtesy of USACE)

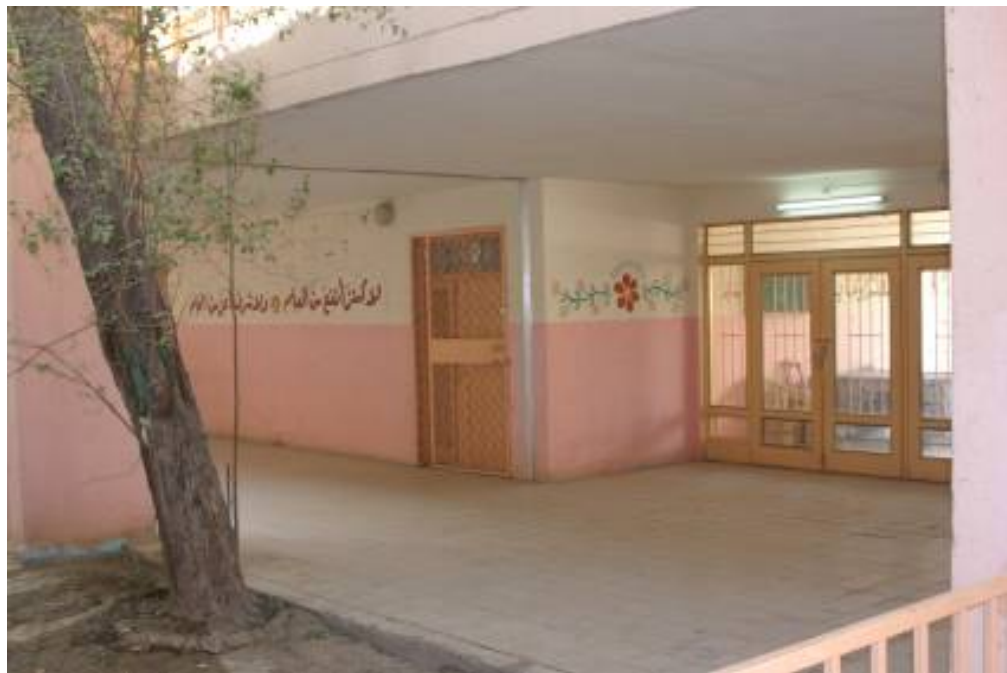
Site Photo 12. Interior painting after occupancy and use (Photo courtesy of USACE)

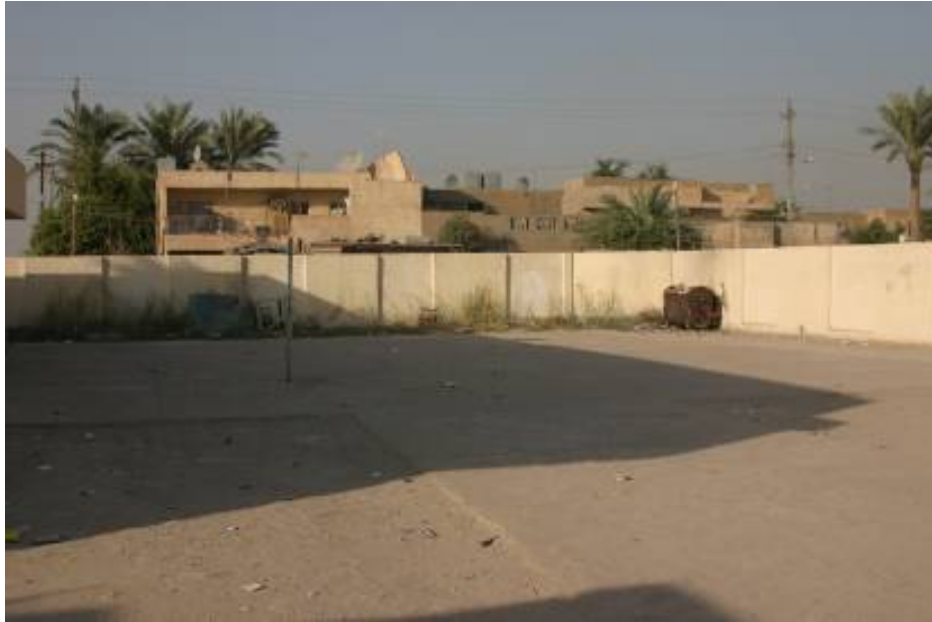
**Site Photo 13. School yard within compound wall after occupancy and use
(Photo courtesy of USACE)**

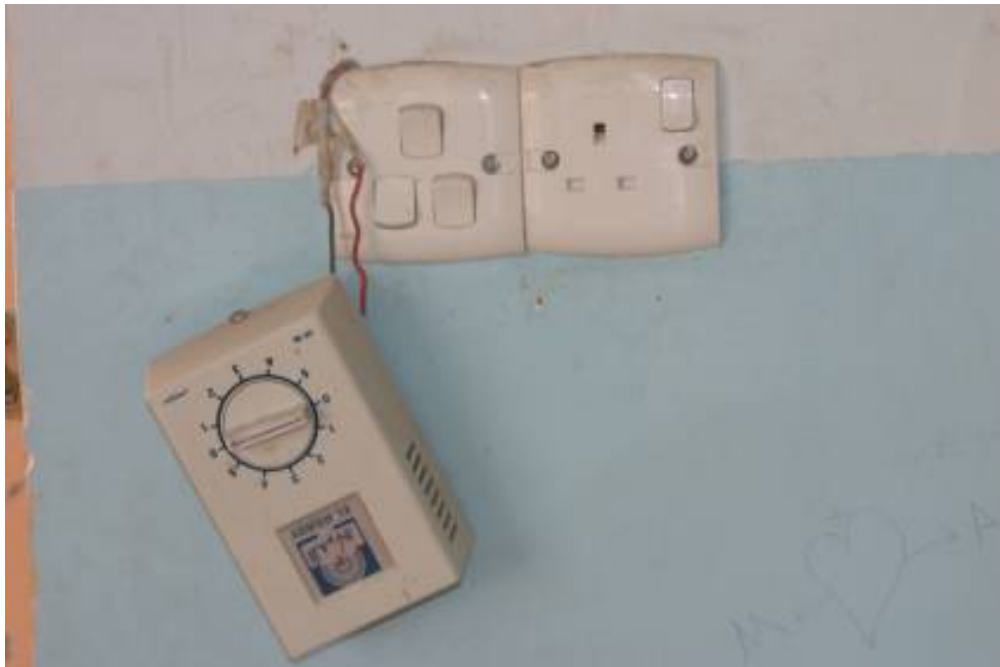
General school maintenance and upkeep was not continued after the turnover as shown in the USACE photograph (Site Photo 14) of a hanging thermostat. This was also evidenced by USACE photographs (not pictured) of a broken door handle and a hole in the wall which were provided to our assessment team. During the review of the USACE photographs, we did not detect any instances of incomplete construction.

**Site Photo 14. Tampered with wiring and added ceiling fan control after occupancy and use
(Photo courtesy of USACE)**
