AN UNDERWATER ICE STATION ZEBRA

**Recovering a Secret Spy Satellite Capsule
from 16,400 Feet Below the Pacific Ocean**

Recovering a KH-9 HEXAGON Capsule from 16,400 Feet Below the Pacific Ocean

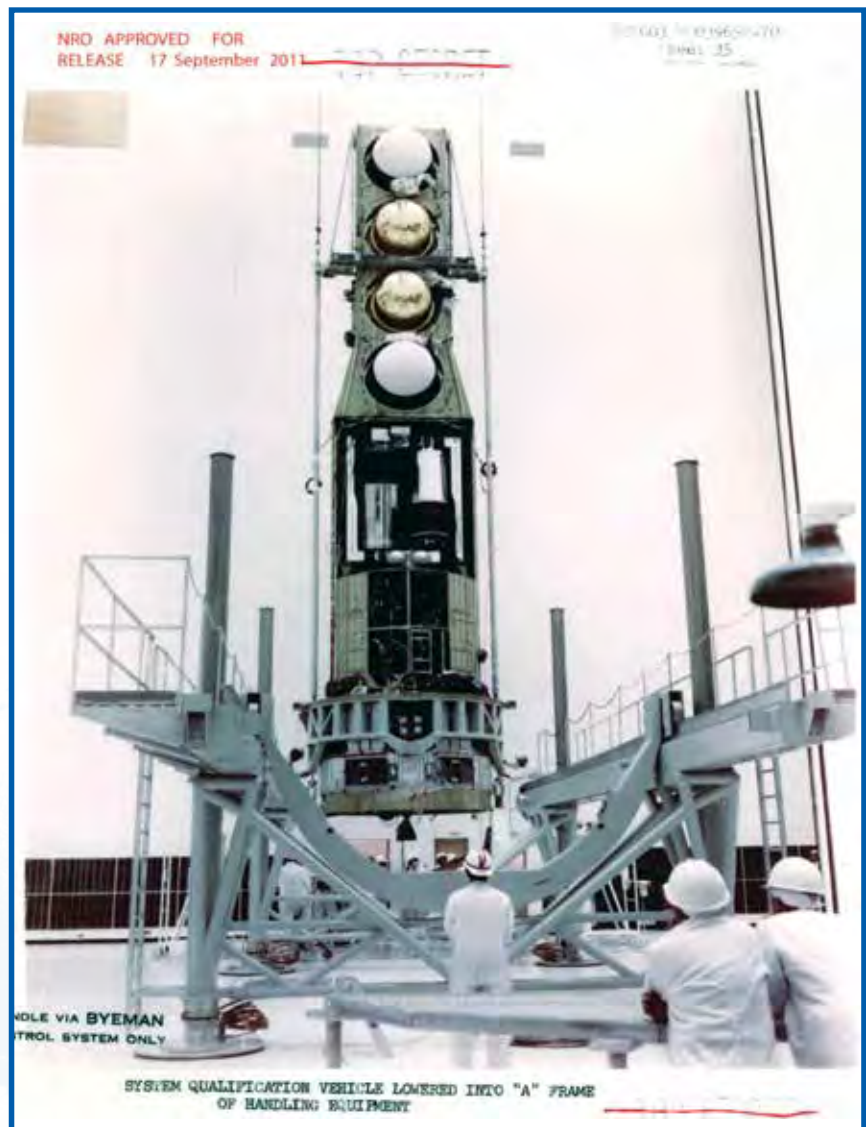
Figure 1: KH-9 HEXAGON satellite with its four buckets clearly visible.

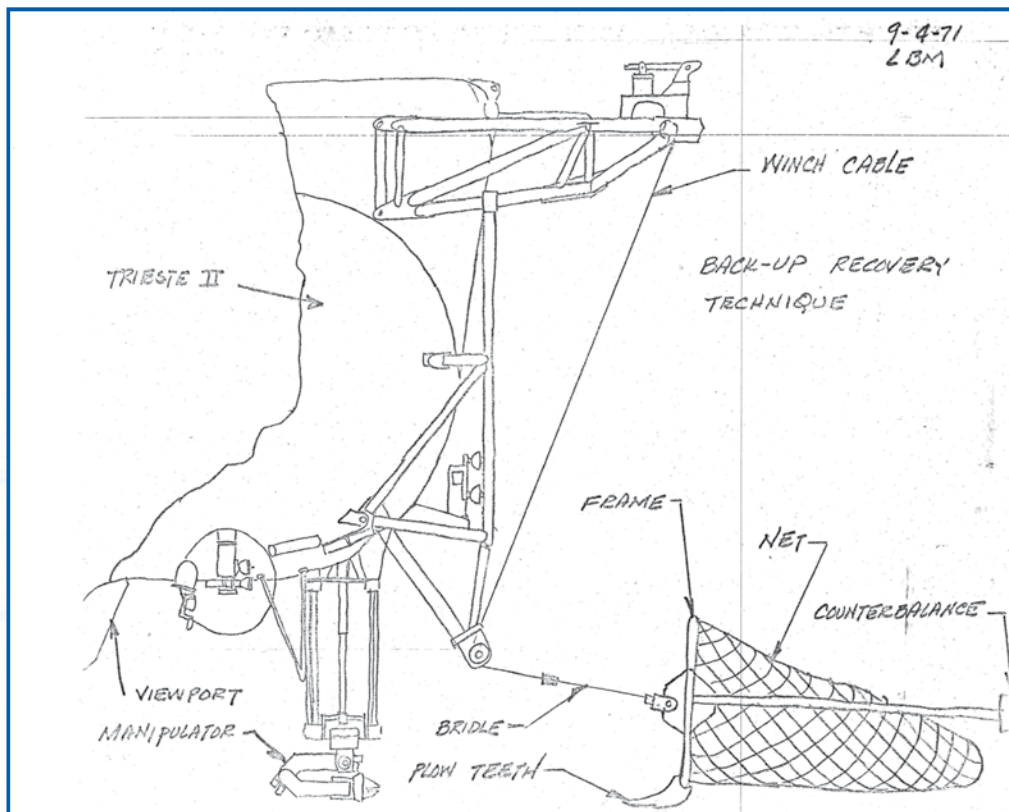
Figure 2: One of Perkin-Elmer's proposed net salvage methods, which the Navy feared would stir up the ocean bottom.

fears that corrosive seawater might have weakened key beryllium structural elements, caused the group to reject that idea in favor of methods that would envelop the sunken item. Molaskey’s team considered several net options (Figure 2), but those too were inadvisable as discussions with the Navy found such a device “would undoubtedly stir up sediment on the ocean floor to the extent that the operator’s visibility would be reduced essentially to zero for periods of up to an hour.”¹⁵ The final approach used a “hay hook” design to descend over, and close around, the bucket before bringing it to the surface (Figures 3 and 4).

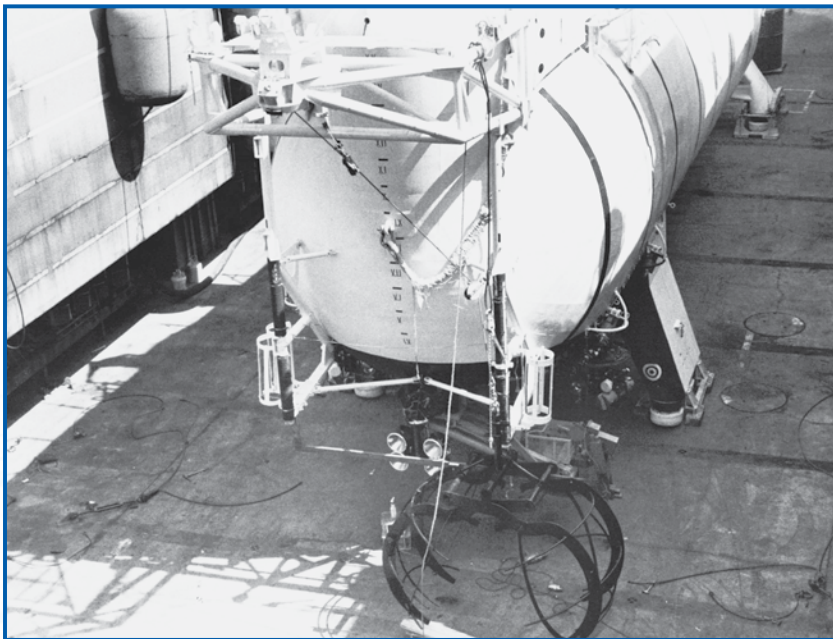
Figure 3: Perkin-Elmer designed "hay hook" attached to the *Trieste II*. Credit: CIA

at different depths in the sand to simulate immersion in the ocean bottom. The 900 lb hook was 150 lb over specifications owing to the installation of counterbalance weights, but it initially appeared to operate well. A closer

inspection, however, revealed it failed to open to the full 70 inches as designed. Molaskey nevertheless believed shortening the center rod on both sides by about three inches would easily correct the problem.²¹

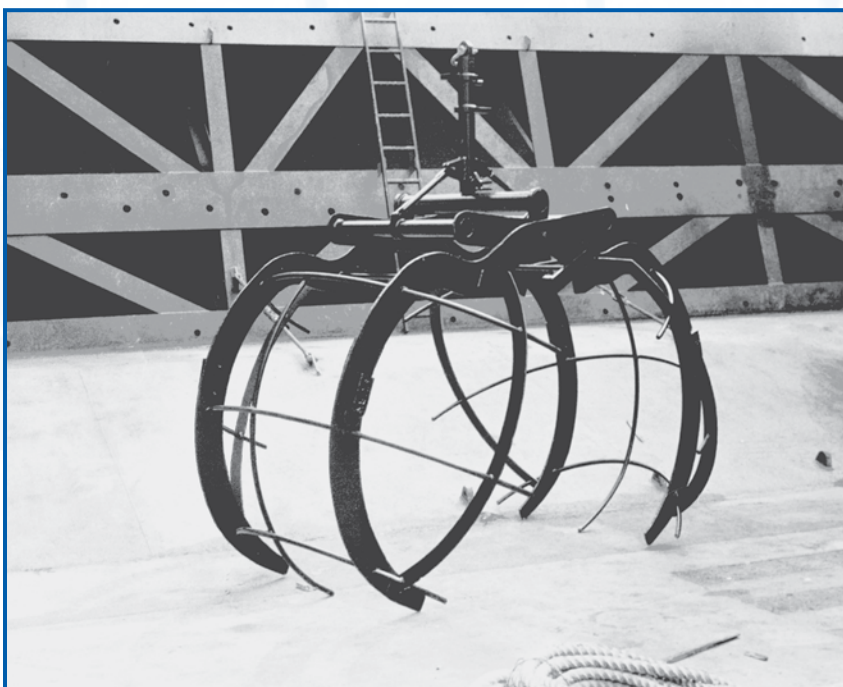
Figure 4: Perkin-Elmer "hay hook" in the open position. Credit: CIA

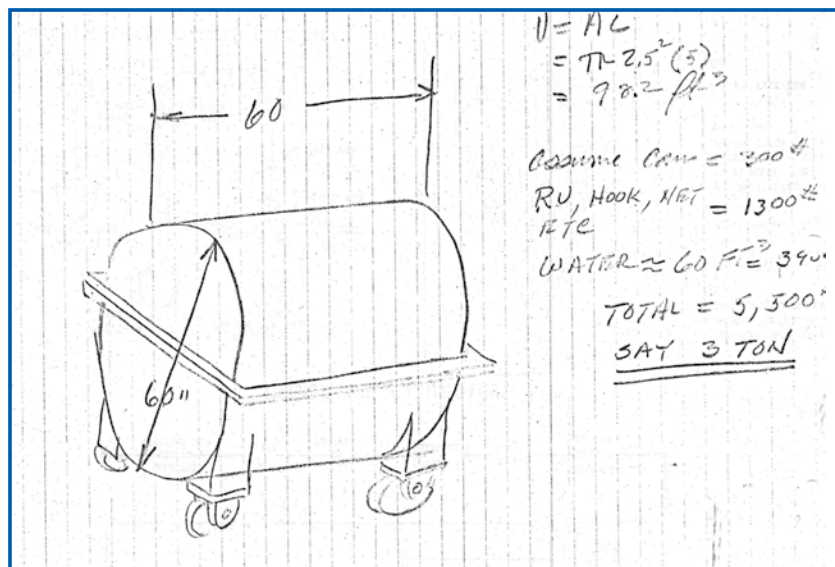
Figure 5: Early sketch of Perkin-Elmer designed shipping container intended to transport the salvaged bucket to Eastman Kodak’s film processing center in Rochester, New York. Credit: NRO

plywood box constructed around a two-foot by four-foot frame insulated by one-and-a-half inch glass wool blankets with the aluminum side facing the box’s interior. An outside cooling unit blew air into the box through an opening behind the cooling coil. On 2 November, as the IOU approached the search zone, discussions among the crew discovered that the device could not cool “8,000 pounds of sea water to below 40 °F in the outside ambit of about 90 °F in bright sunlight.” The crew painted the unit’s exterior white, constructed a duct to recirculate the cooled air, taped off all seams, and insulated the unit as much as possible in order to improve its cooling abilities. They then undertook the difficult task of placing the shipping container—which when hanging from the ship’s crane, swung like a “house wrecker’s ball” in even the smallest rolls—inside the cramped refrigerator box and filled it with seawater to start the cooling process. During this period, pieces of insulation fell into the shipping container, requiring the crew to overflow the container with water to remove the contaminants and send out calls to the mainland for more insulation.²⁶

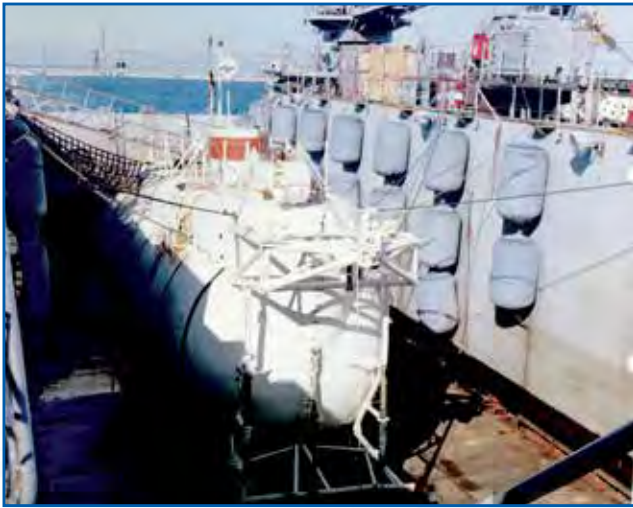
Figure 6: *Trieste II* (DSV-1) stowed in the *White Sands* dock well.
Credit: CIA

Plans called for the oceangoing tug *Apache* to tow the *White Sands*, a World War II era auxiliary repair dock with limited independent maneuverability, to an operating area, with the *Trieste II* (DSV-1) stowed in its dock well (Figures 6 and 7). Launching the *Trieste II* (DSV-1) required flooding the dock well and towing the submersible out to sea through the *White Sands* stern gate. Once launched, the approximately ten hour-long pre-dive checkout procedure, which included loading about 67,000 gallons of aviation gasoline and 30 tons of steel shot ballast into the small craft, would occur.

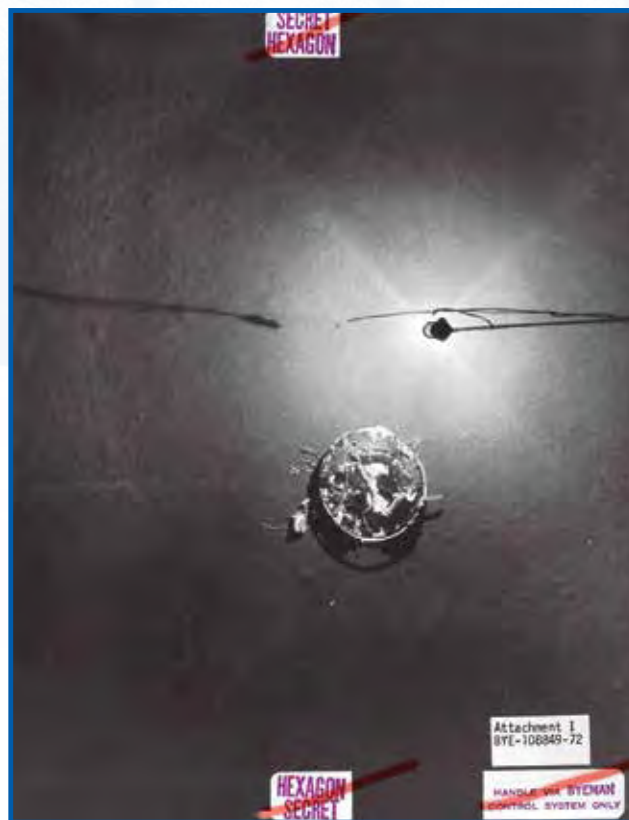
Figure 8: Photograph of the sunken bucket's intact upper structure, taken by the USNS *De Steiguer* search team on 20 October 1971 at 16,400 feet. Credit: CIA

five days later where the *Trieste II* (DSV-1) was unable to locate the dummy bucket on the ocean floor and experienced another navigation computer failure causing the submersible to surface about five miles from the target point. This caused concern not only for the equipment problems, but because the *De Steiguer* was already transiting to the search zone. The *Trieste II* (DSV-1) did not locate the dummy bucket until the test third dive on 11 October, but with the submersible’s power running dangerously low, and no time for additional test dives, Bartels, Stryker, and Taylor instead exercised the hook without actually maneuvering it over the dummy bucket. That gave the men confidence they could collect the item given enough time. When the *Trieste II* (DSV-1) surfaced and was back onboard the *White Sands*, the IOU headed for the search zone. On 20 October, the *De Steiguer* reported it found the lost bucket and had photographed it with the camera on the search fish (Figure 8).²⁵

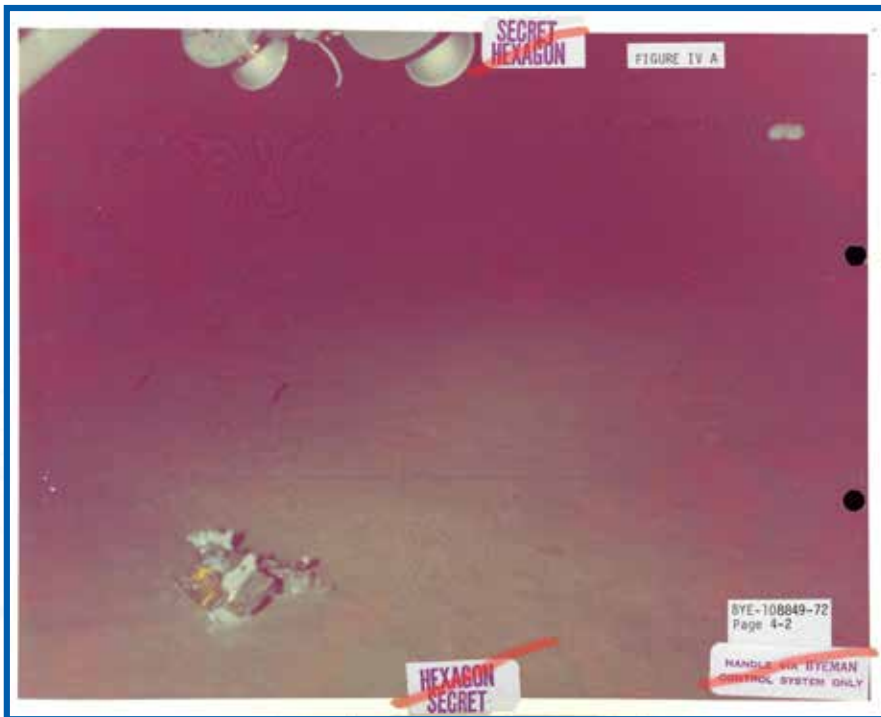
Figure 9: First piece of debris the *Trieste II* (DSV-1) sighted 25-26 April 1972.

At about 5:00 PM on 25 April 1972, Bartels, Stryker, and Taylor started their third dive for the bucket. Following a two-hour descent, and a three-and-a-half-hour search, they sighted a tangled mass of metal and screen wire harness 18 to 24 inches long and eight to ten inches wide (Figure 9). They next sighted two jagged gold foil pieces six to eight inches across (Figure 10). Transiting to a large sonar contact 800 feet away, they found what appeared to be a six-to-eight inch long piece of nylon webbing with a two-inch metal ring attached, and then, finally, the missing item embedded in the sea floor 18 to 24 inches.

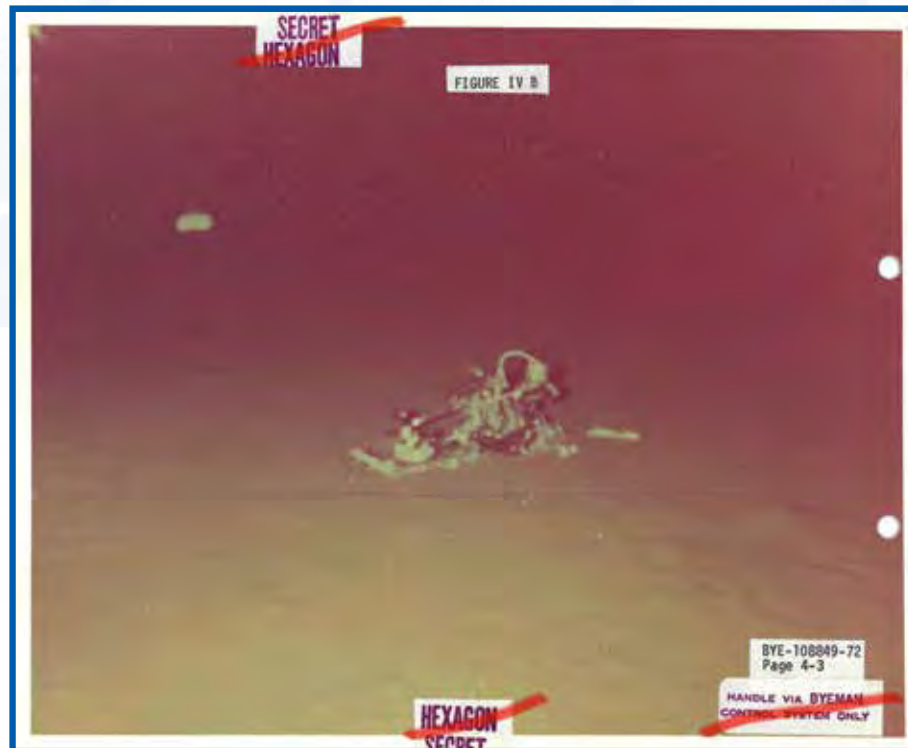
Figure 10: Second piece of debris the *Trieste II* (DSV-1) sighted 25-26 April 1972.

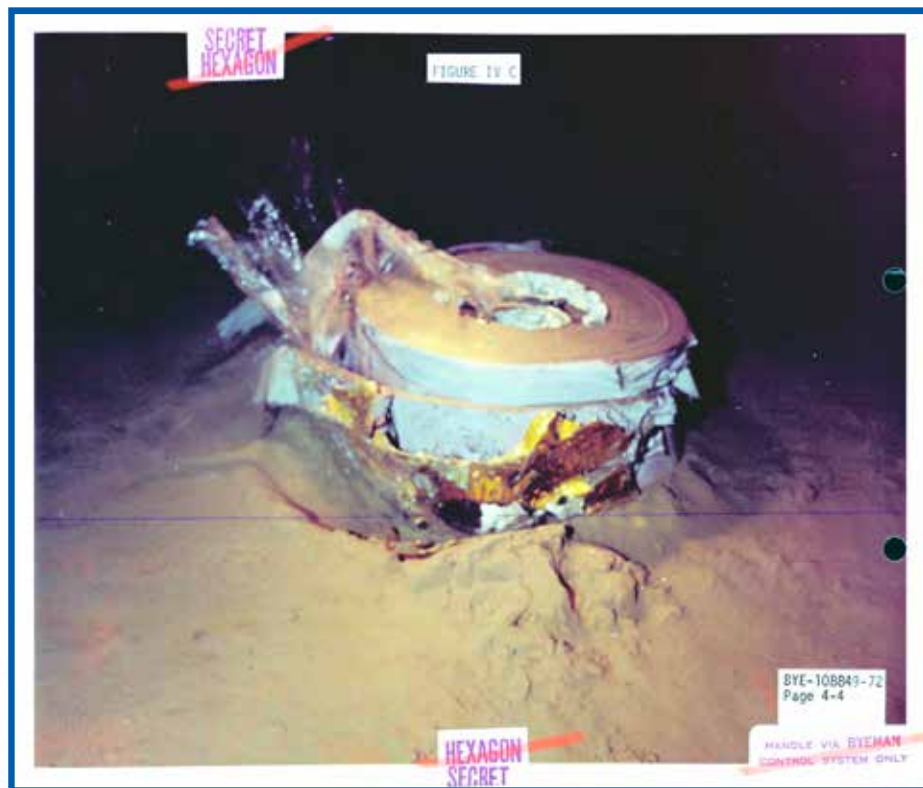
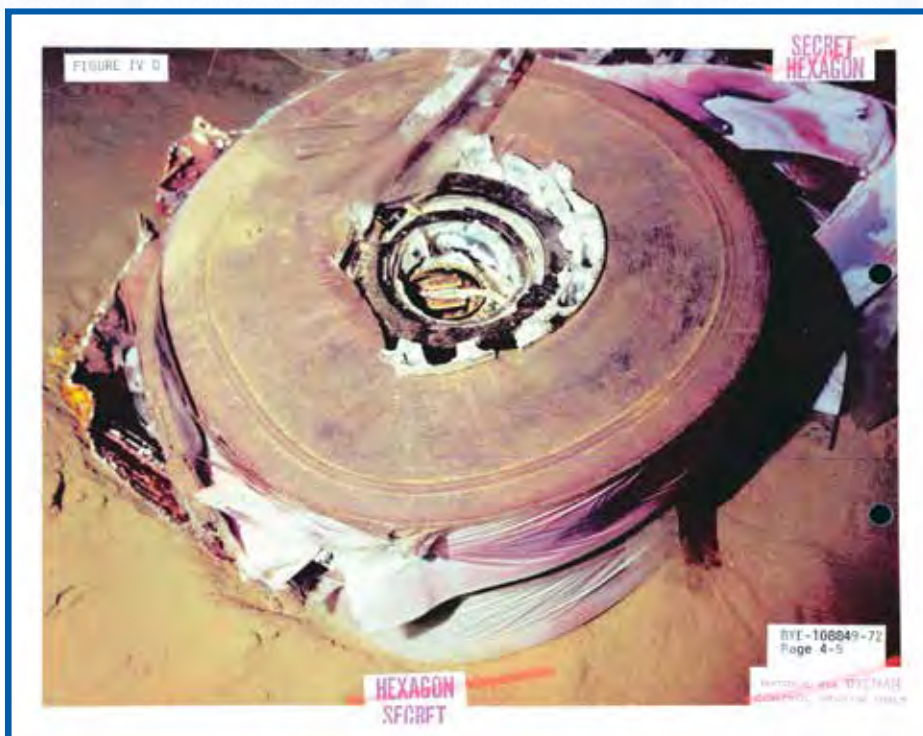
Figures 11 and 12. Film stacks on the ocean floor, 25-26 April 1972.

Evidence as to the object’s condition varies. A 29 April message said it appeared intact with a hole in the center of the aft thermal bulkhead and multiple strands of film streaming out another hole at the 9 o’clock position about two or three feet, undulating with the sea current. Photos of the salvage operation and post-recovery analysis, however, indicate that the bucket probably broke apart and that the film stacks (Figures 11 and 12) had detached from the structure and were laying exposed on the ocean floor. Only the bucket’s upper stage remained intact. This upper structure possibly appeared in the 20 October photos the *De Steiguer* search team took and could account for the apparently inaccurate 29 April report that the bucket was intact.³⁷

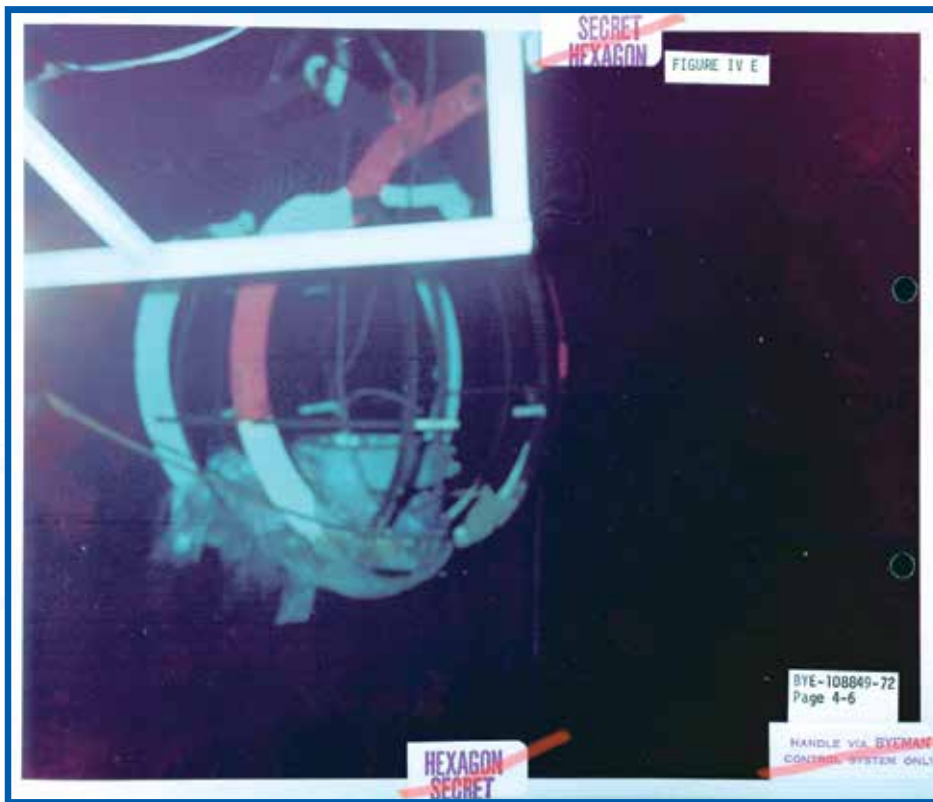
Figure 13: Film stacks inside the recovery hay hook shortly after leaving the bottom, 25-26 April 1972. Credit: CIA

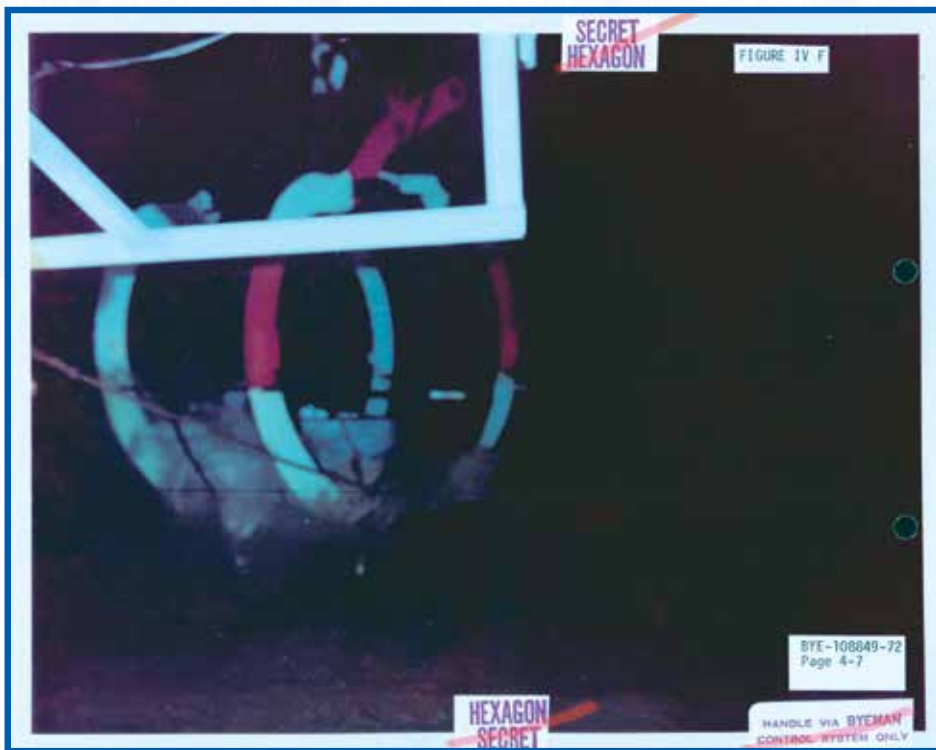
Figure 14: Photo showing the film stacks disintegrating in transit to the surface, 25-26 April 1972. Credit: CIA

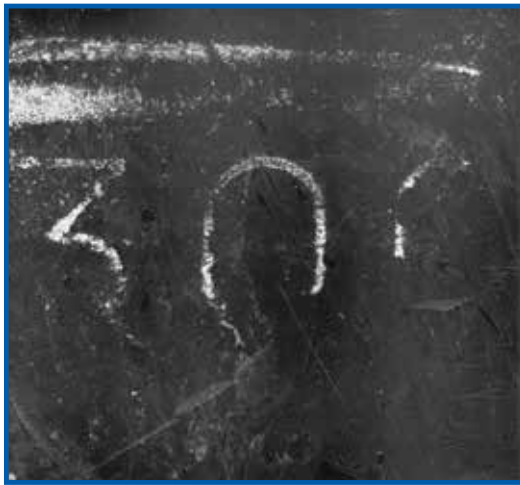
Figure 15: Photo taken during Eastman Kodak's post-salvage analysis of recovered film shreds showing the number 300 imprinted on the film. Paint transfer due to the extreme impact shock caused the imprint. Credit: CIA

1. Shock forces were severe enough for the film assemblies to hit or be hit by nearby mechanical assemblies. The force was sufficient to cause paint transfer in two places. Referring to Part #5 of the sketch red paint pigment was imbedded into the pelloid film base. On Part #7 the number "300" is partially legible. (See 20X enlargement). The material imbedded is brown-yellow paint pigment on the base side of the film. The pigment location of "300" and a length of 93 inches indicates this strip was probably an outer convolute.

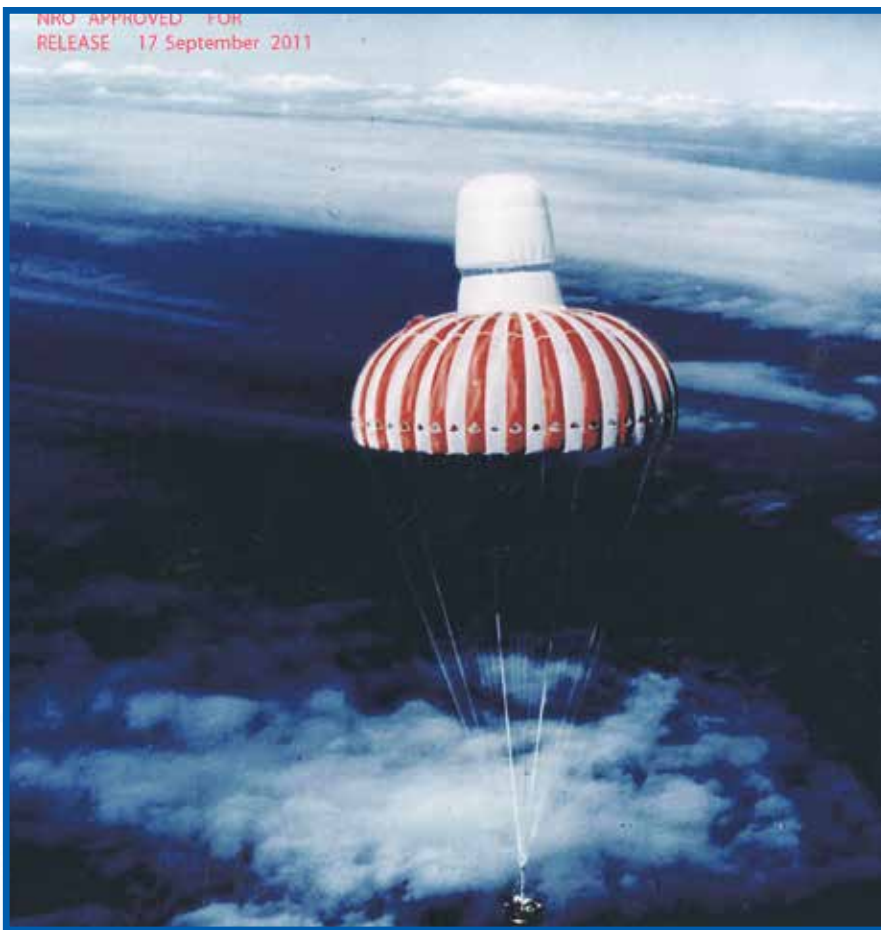
Figure 16: KH-9 HEXAGON Mark 8 “extended skirt” parachute with bucket below.

“extended skirt” chute (Figure 16), manufactured by Para Dynamics in El Monte, California. The Irving Air Chute Company designed a new drogue chute. Tests proved the new chutes were vastly superior to the original devices designed by the Goodyear Aerospace Company. Analysis of the recovered chutes from the first two and fourth HEXAGON buckets found the main shroud lines overstressed by a factor of two, which resulted from a failed design and a testing oversight that did not account for the high-shock of initial chute deployment. Calling the old chutes “at best marginal,” NRO Historian Robert Perry concluded in his recently declassified 1973 HEXAGON history that it seemed almost miraculous crews retrieved three of the four buckets: “by all odds,” Perry wrote, “the ratio should have been reversed.” As an added measure, technicians “baked” the new chutes at 370 degrees for eight hours to set their shape before installation into the bucket. To ensure quality, Aerospace and McDonnell-Douglas representatives inspected and packed each chute using a new vacuum technique, which extracted air to reduce volume. The parachute deployment altitude was also lowered to 40,000 feet so thicker air could further slow the descending object. The added time to correct the design defects delayed the second HEXAGON launch until 20 January 1972, but the new chutes worked perfectly on all four buckets.⁴⁰
